Walesby Hill, West Lindsey Lincolnshire

Archaeological Monitoring of Water Pipeline Installation.

Cambridge Archaeological Unit

Report No. 1047

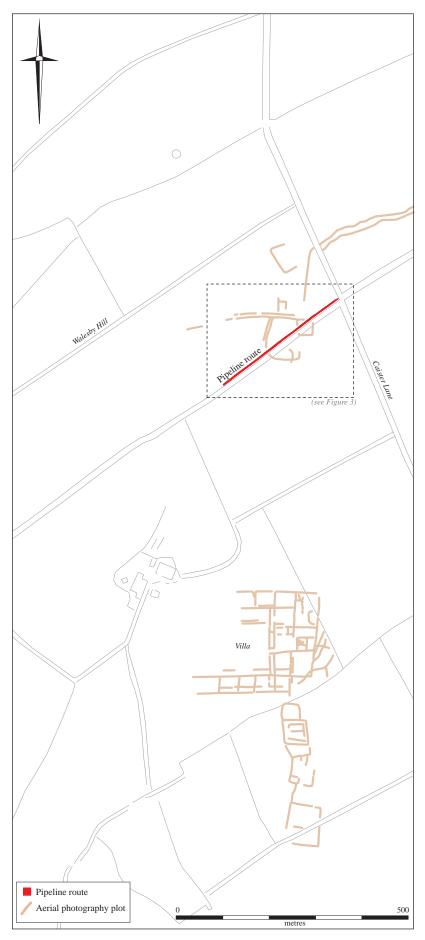
Figure 2. Pipeline trench plan with aerial photography plots (Jones 1998)

Results from the aerial photographic survey conducted as part of the National Mapping Programme have identified several features adjacent to the top of Walesby Hill (Jones 1998). A complex of cropmarks identified from the photographs comprised of a large enclosure approximately 90m square, bounded on the north and west sides by possible trackways. In the north east corner of the large enclosure, a smaller 30m square enclosure appears to be conjoined to it. The roadway leading up to the top of Walesby Hill from Walesby bisects both of the enclosures. A further small enclosure, approximately 15m square, to the north of the larger enclosure and on the same alignment, is considered to be contemporary (EH monument record 893051). A partial enclosure to the north and on a different alignment is considered not to be contemporary or part of the same complex. The course of the water main easement runs adjacent to the edge of the field, parallel with the road from Walesby and bisects two of the enclosures seen in the aerial survey (Fig.2).

The large enclosure (Fig.2. A) seen in the aerial survey is to the south of the east to west trackway (Fig.2. B) and to the south west of the small enclosure (Fig.2. C). This enclosure appears to have a further trackway (Fig.2. D) adjacent to it along its western perimeter or at least a double ditch system. At the point that the pipe trench would appear to bisect the south-west corner of the large enclosure, three ditches (F.16, F.17, F18) appear with a similar alignment to the aerial survey plots. The aerial survey plot only appears to show a double ditched trackway on the west side of the enclosure without a continuation around the south-west corner and the rest of the perimeter of the enclosure. Several linear features encountered during the excavation do not appear on the aerial survey and so the termination of the double ditch cannot be presumed with certainty. The feature most closely aligned with the inner ditch of the trackway or enclosure ditch is F.16 whilst F.17 and F.18 align with the projected course of the outer corner of the trackway or enclosure complex. The profile of F.16 showed a steep V-shaped ditch at least 2.40m in width and 0.90m in depth; this was the most substantial feature encountered during the excavation. The profiles of the putative outer ditch (F.17, F.18) although spatially on the right alignment demonstrate much slighter features than the large inner ditch (F.16). The pairing of the features (F.16 with F.17 or F.18) to make a trackway or double ditched enclosure would seem an unlikely although not improbable combination.

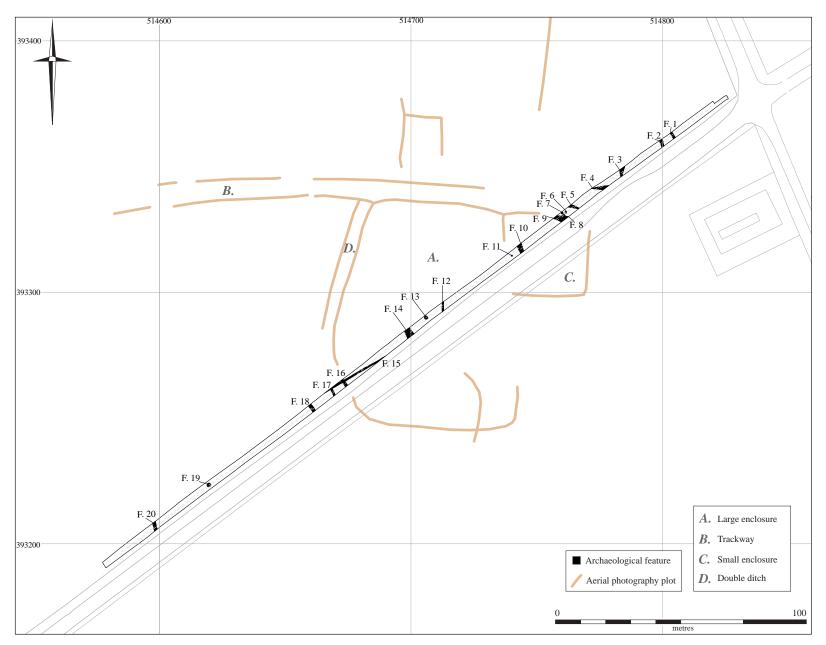
Figure 3. Pipeline trench plan with aerial photography plots (Jones 1998)

In total, twenty one features were recorded within the easement of the pipe trench. The features were distributed throughout the length of the cut for the pipe trench, with a cluster of seven features occurring between 60-80m south-west of the start point of the pipe trench. Although many of the sections were not recorded at precisely 90° to the alignment of the features, only the acute angle at which **F.15** bisected the trench cut produced a distorted profile. The majority of features (15) were identified as linear features (ditches), with two probable pits (**F.13**, **19**), and a further two possible postholes (**F.6**, **11**). The profiles of the ditches could be placed into two distinct groups, those with a shallow broad flat base (**F.3**, **4**, **9**, **10**, **12**, **14**,**15**) and a second group (**F.2**, **5**, **7**, **8**, **16**, **17**, **18**, **19**, **21**) with a narrow more V-shaped profile with a concave base. Most of the

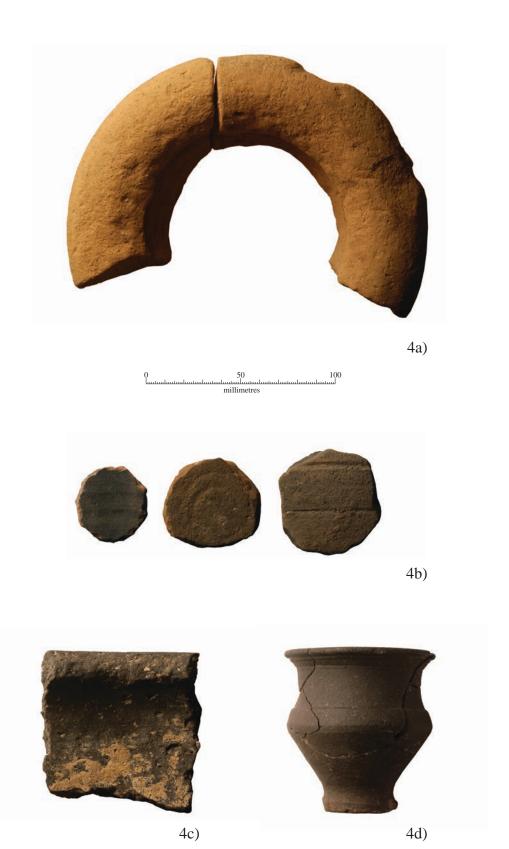
Figure 4. Ceramic artefacts from Walesby Hill

The assemblage comprised predominately small to medium sized sherds; however, there were a number of larger sherds identified. The mean weight of the assemblage is relatively high at 16.5g, with an EVEs (estimated vessel equivalent) total of 3.35. A minimum of 12 different vessels were recorded, including some which are semi-complete. A range of vessel fabrics were identified (see Table 1), with sandy fabrics being the most commonly occurring, representing 77% of the total assemblage. Shell tempered wares totalled 17%, while grog-tempered 6%. The majority of fabrics are likely to have been locally made, although the exact source is unclear. The exceptions to this were two refitting sherds from the rim of a Baetican amphora (Fig.4.a) probably a Dressel 20, oil amphora.

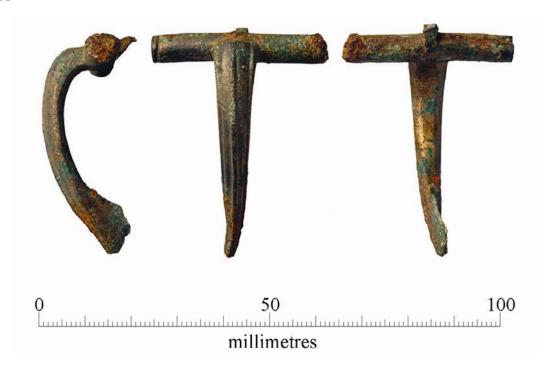
Fig 5: Brooch

<026> F. 13 [7] A copper alloy two piece T-shaped brooch of the Roman period. The brooch is largely complete, however the pin, spring cord and most of the catchplate are missing. The crossbar is cylindrical, on one side the crossbar is decorated at the end with a transverse incised line, the detail on the other side of the crossbar is obscured by ferrous corrosion. The bow has a pronounced moulded rib running down the centre of the bow with slight marginal ribs down each side. The Brooch appears to fit into Mackreth's Group 10.d of hinged Colchester Derivatives. Although the distribution of this group is largely in the south west there are other examples from the east of the country notably one from Cambridge, as part of an old museum collection, and another 10.d1 unequivocally from Norfolk (Mackreth pers. comm.). The suggested dating for the brooch is late first into second century, but not later than 150/175.

Within the area demarcated by the large enclosure ditch several features were noted. A small pit (**F.11**) and a slight linear feature (**F.12**) produced no dating evidence, but were most likely prehistoric or Roman in origin. Two other features (**F.13**, **F.14**) produced material dated to the mid 1st to mid 2nd century AD. Feature no. 13 was a small pit with a fragment of ceramic material dated to the mid 1st to mid 2nd century AD and a T shaped copper alloy brooch dated to the late 1st to mid 2nd century AD (see Appendix 2). The brooch has been identified as a Colchester derivative group 10d (D. Mackreth *pers.comm.*). The distribution of the type 10 is to the south-west with the type 10d having its heartland around Somerset; however, examples are known further afield including examples in the east of the country in Cambridge and Norfolk. The brooch from Walesby would appear to add a further outlier to the group.
