The Old Bishop's Palace, Ely, Cambridgeshire

Archaeological monitoring and recording

Report No. 1103

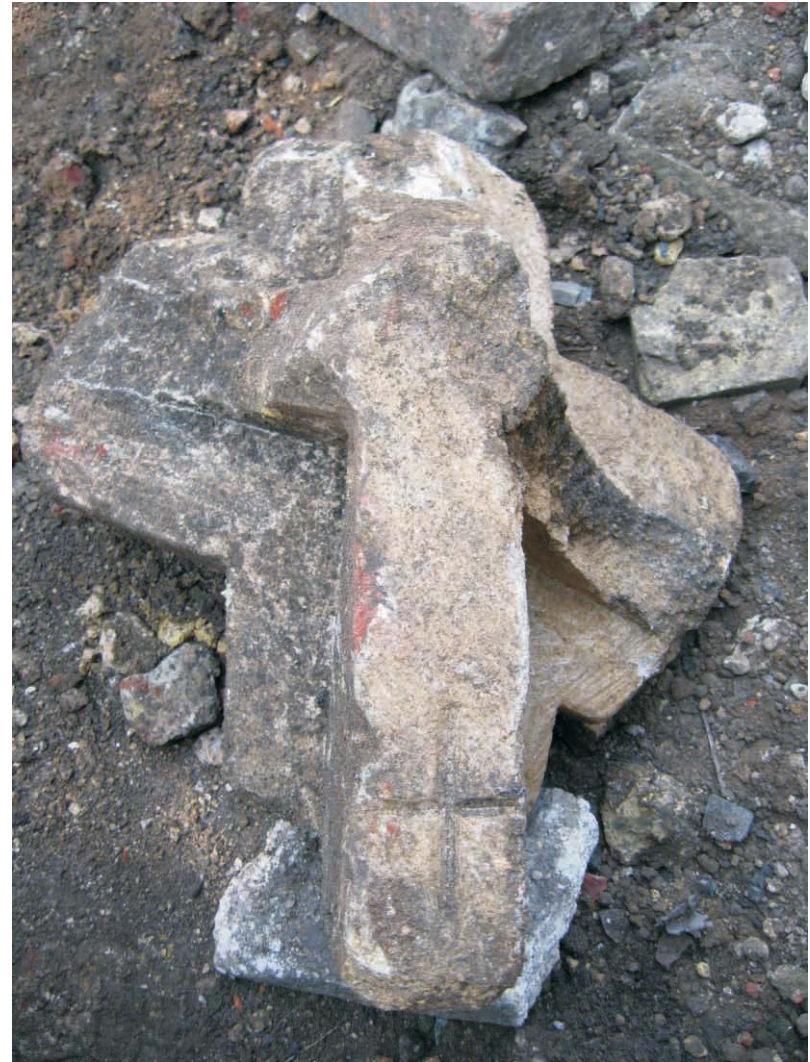
Figure 5. Masonry found in the Old Bishop's Palace gardens

and it was re-buried in the trench. In addition, further pieces of masonry were identified scattered throughout the garden of the Old Bishops Palace (Figure 5), where they were often used as garden furniture (*i.e.* to line pathways). It is assumed that these have come from some of the many of the buildings in the centre of Ely that were related to the cathedral and the Kings School and have since been demolished. Amongst this group, it is possible that the millions/transoms may have originated from the original the Bishop's Palace, although their unstratified context makes this assumption tentative (see further the moulded stone assessment report).

In addition to the above, a large assemblage of redeposited moulded stone was encountered within the palace garden during monitoring of the data cable trench. This group comprised a minimum of 26 fragments (see Figure 6), and a significant proportion of this assemblage was associated with fenestration. In the first instance, a minimum of eleven mullion/transom fragments were present. These were of uniform design, with simple cavetto mouldings. They each contained recessed grooves within their reveals, along with sockets for glazing bars, indicating that glazed panels comprised an integral part of their original design (Figure 6A). Also present were two arched fragments that were derived from uncusped lancet windows (Figure 6B). These are of simple Perpendicular form and were probably associated with an overhanging hood mould, thus suggesting that they were derived from a building, which was constructed between c. 1380-1520. In addition, a minimum of three column shaft fragments were present. Two of these were circular in form, and the third was hexagonal. Four door jambs from separate doors were also identified. These were again all relatively simple in form. The most diagnostic (Figure 6C) had a substantial plain roll moulding flanked by a simple plain chamfer. It is medieval in date. Finally, perhaps the most significant fragment in the group comprised the central cross-section of a quadripartite vault (Figure 6D). This had been extensively damaged, and its central boss had been removed. Nevertheless, it remained recognisable and an incised cross design was also apparent upon one of its ribs. This mark was most probably used to determine the prearranged location of the piece during the initial construction of the vault. It is again medieval in date.

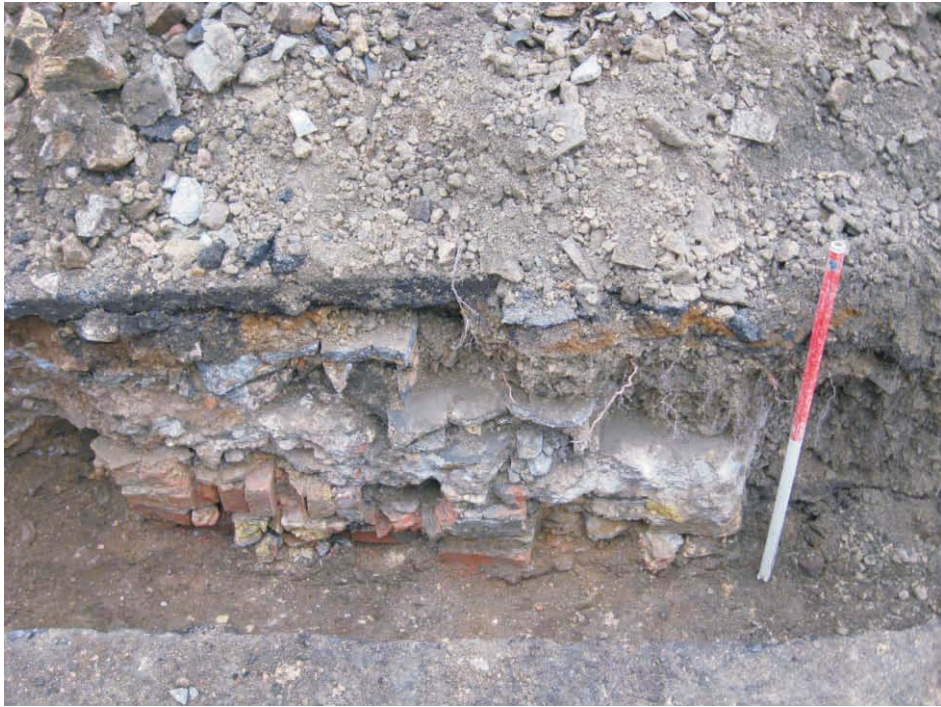
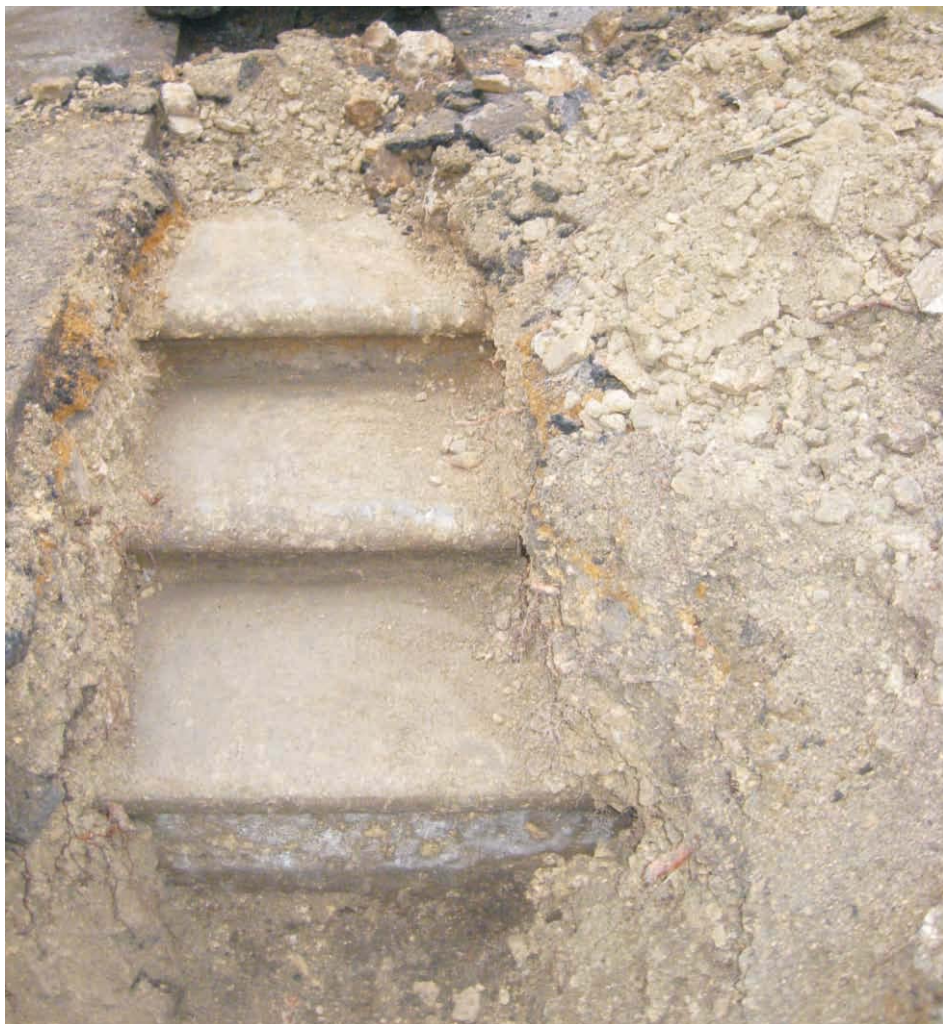
Figure 6. Concrete steps found in the Old Bishop's Palace

Towards the main building a set of concrete steps was found (Figure 6). These were moulded and built on top of a brick foundation, which in turn was built against made-up ground of probable late 19th to 20th century date. They are probably a twentieth century garden feature providing access up to the main building from the garden. No artefacts were found associated with them. They were subsequently covered over with made-up ground and a tarmac path. This may have happened as late as the 1990s and been a result of the Sue Ryder Foundation making the Bishop's Palace more suitable for disabled access.

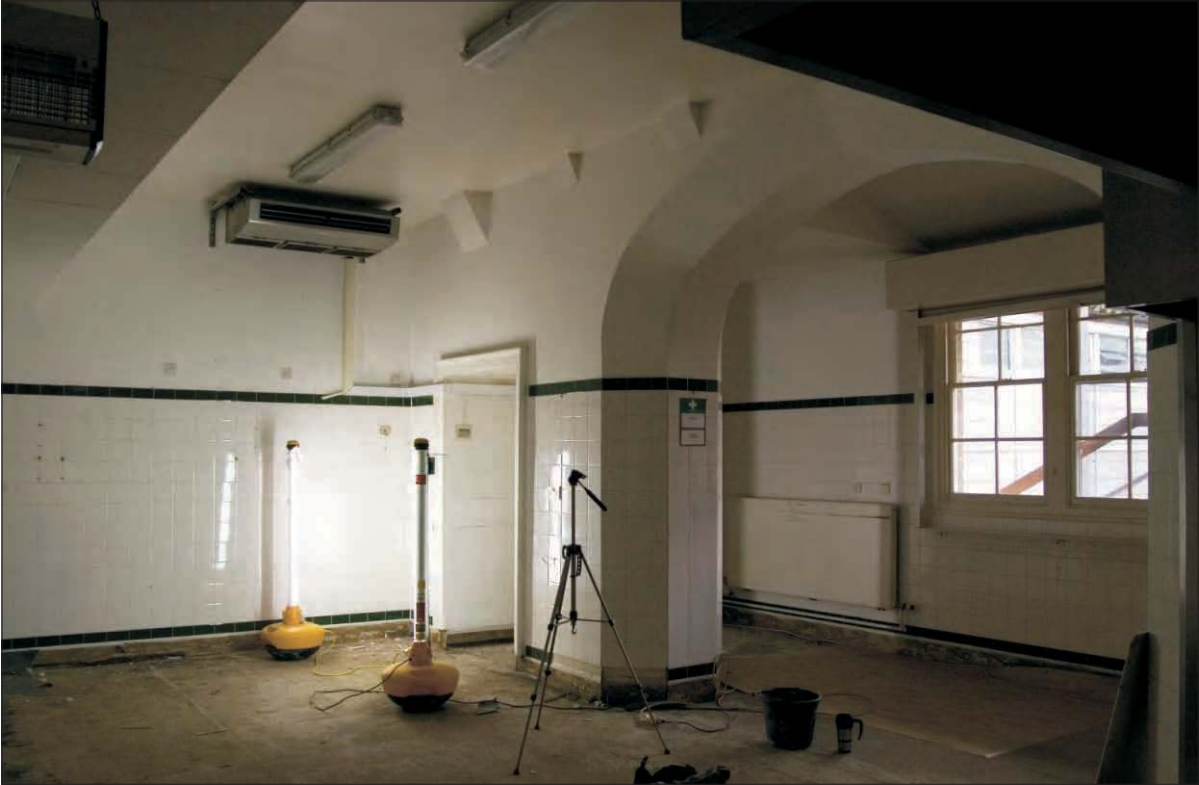
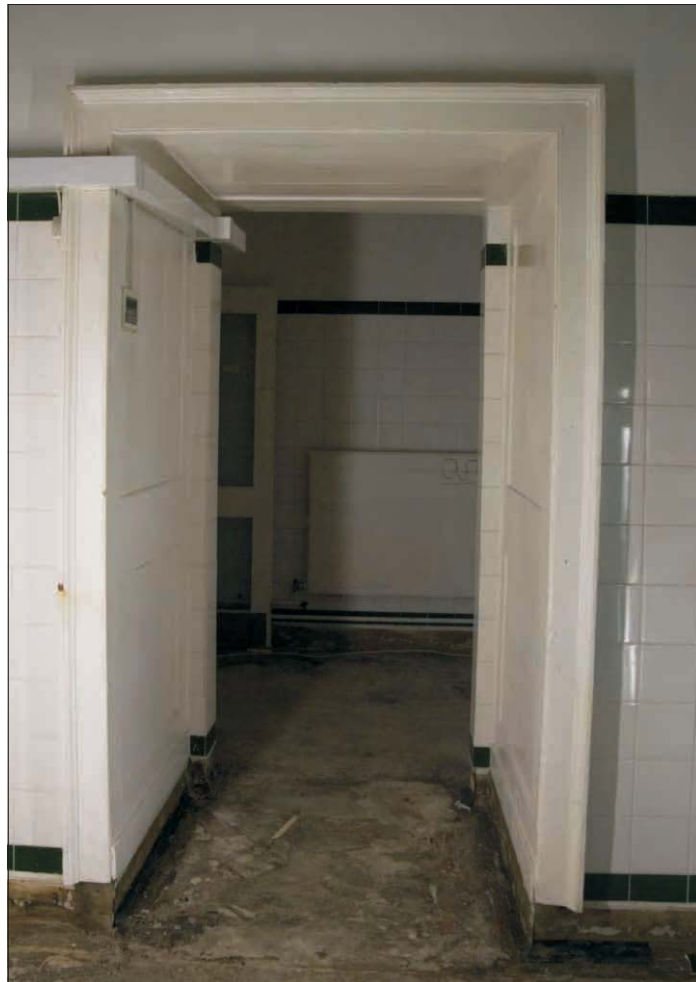
Figure 8. Kitchen Doorway

The wooden panelling lining this doorway was to be removed as part of the works. Lighting conditions were challenging, but all visible faces were photographed.

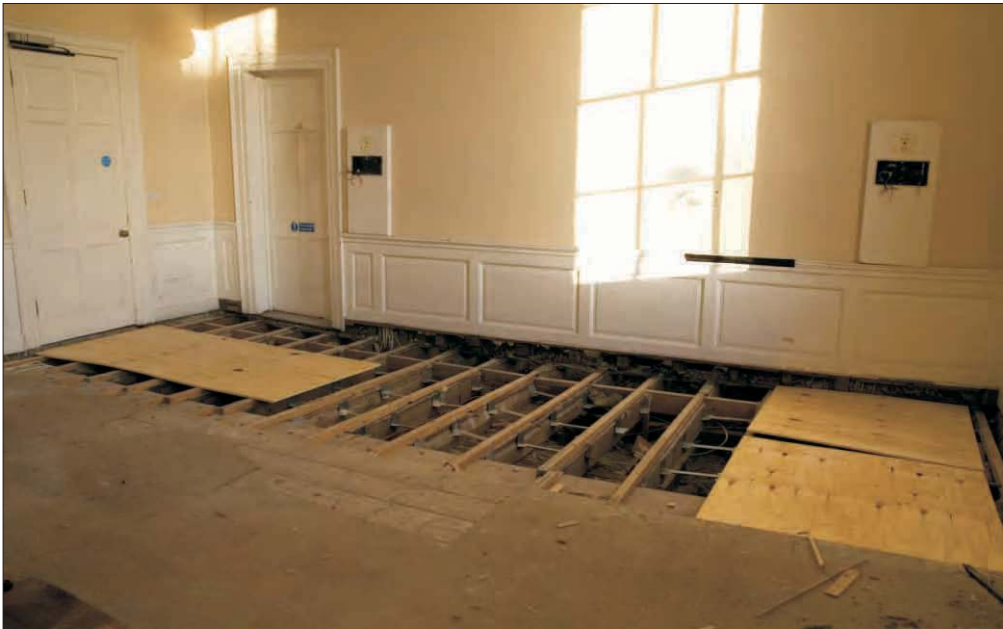
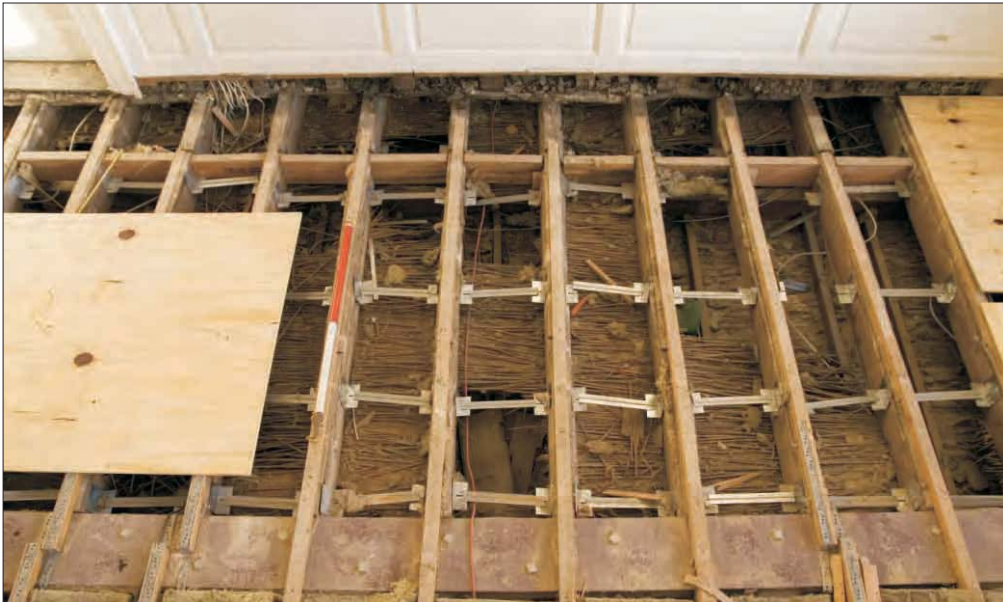
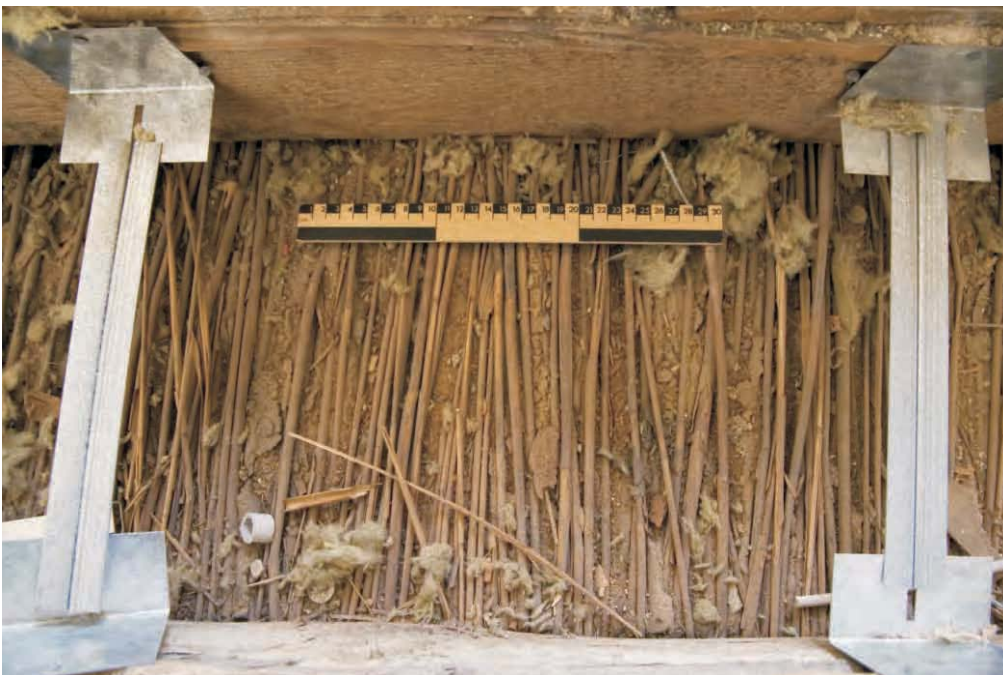
Figure 13. Reeded Ceiling 1 Location and Details

Two areas of reed ceiling were exposed by the removal of floorboards. The better preserved of these was in room 4122 where a coherent pattern to the reeding was still visible. The smaller example surviving in room 4123, however, had also suffered the greater damage.
