South Kelsey Mains Replacement, Lincolnshire

An Archaeological Watching Brief

Cambridge Archaeological Unit Report No. 1118

August 2012

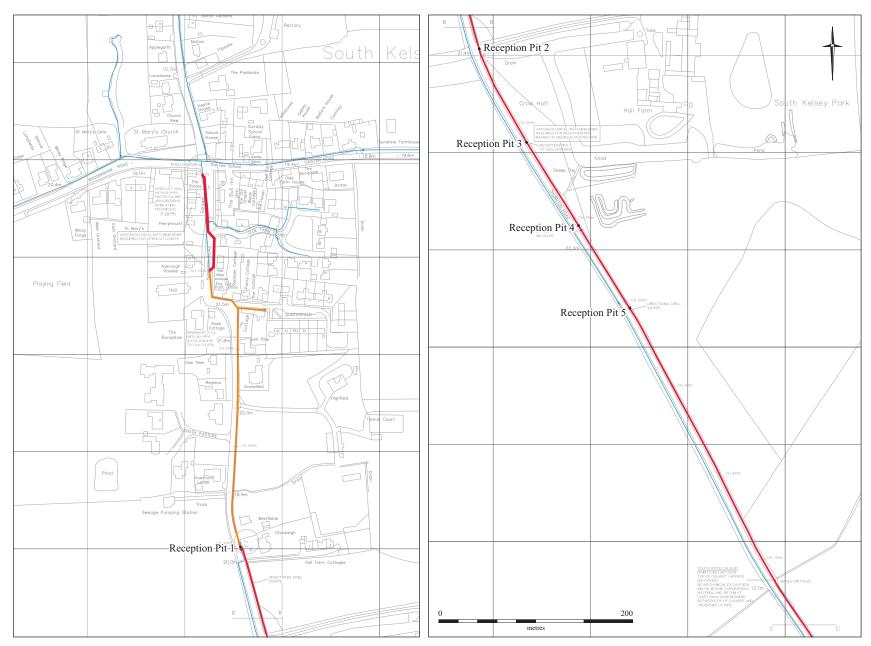
Figure 2. Trench plan

The trench was located approximately 30m south of the Church of St Mary in South Kelsey, adjacent to the Bull Inn. The trench measured 0.35m wide and was excavated to a depth of 1m. Approximately 50m of this trench was monitored. The trench cut through the present road and in between a recently disturbed extant sewer and the current water main pipeline. Subsequently, the new trench only cut through previously disturbed ground and no virgin ground was encountered. No archaeological features were exposed.

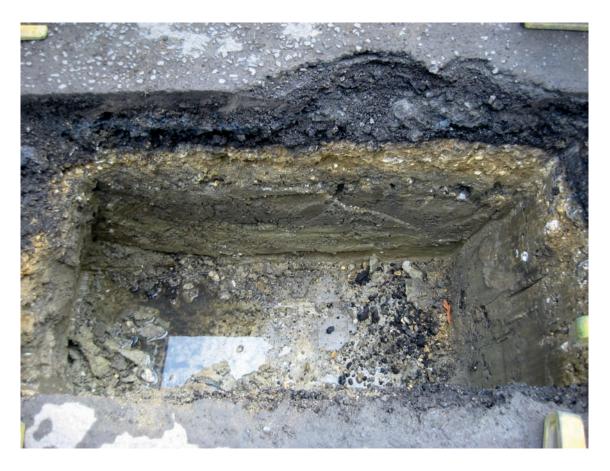
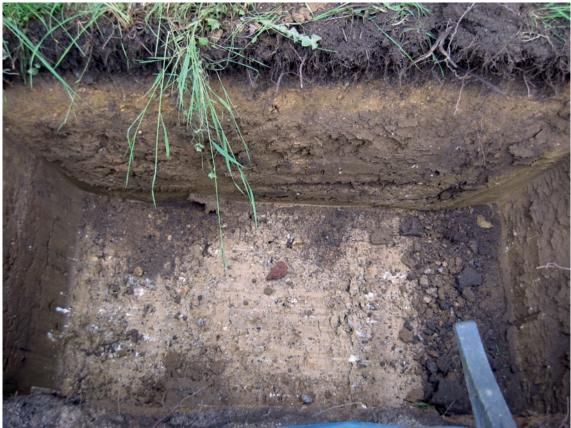
Figure 3. Reception Pit 2 (top) and Reception Pit 3 (bottom)

The reception pits measured 2m in length, 1m in width and 1m deep, and revealed a standard sequence of a thick subsoil deposit underlying modern layers (madeground overlain by tarmac or turf/topsoil) (Figure 3).

Pit	Location of	Type of Overburden	Thickness of	Thickness of Subsoil	_		
	pit		Overburden (m)	(m)	(m)		
1	Road	Tarmac	0.35	0.4	1		
2	Driveway	Tarmac	0.4	0.4	1.1		
3	Verge	Grass and sand	0.35	0.25	1		
4	Verge	Grass and sand	0.30	0.3	1		
5	Verge	Grass and sand	0.35	0.45	1		
Subsoil	l – Mid-pale grey o	clay with occasional chall	k flecks. Firm.				
Natural substrate – Pale creamy-brown clay with frequent chalk flecks. Firm.
