# 90-96 Victoria Road, Chelmsford, Essex

## An Archaeological Evaluation Assessment

**June 2013**

**Report No. 1174**  
**Event No. CF 72**

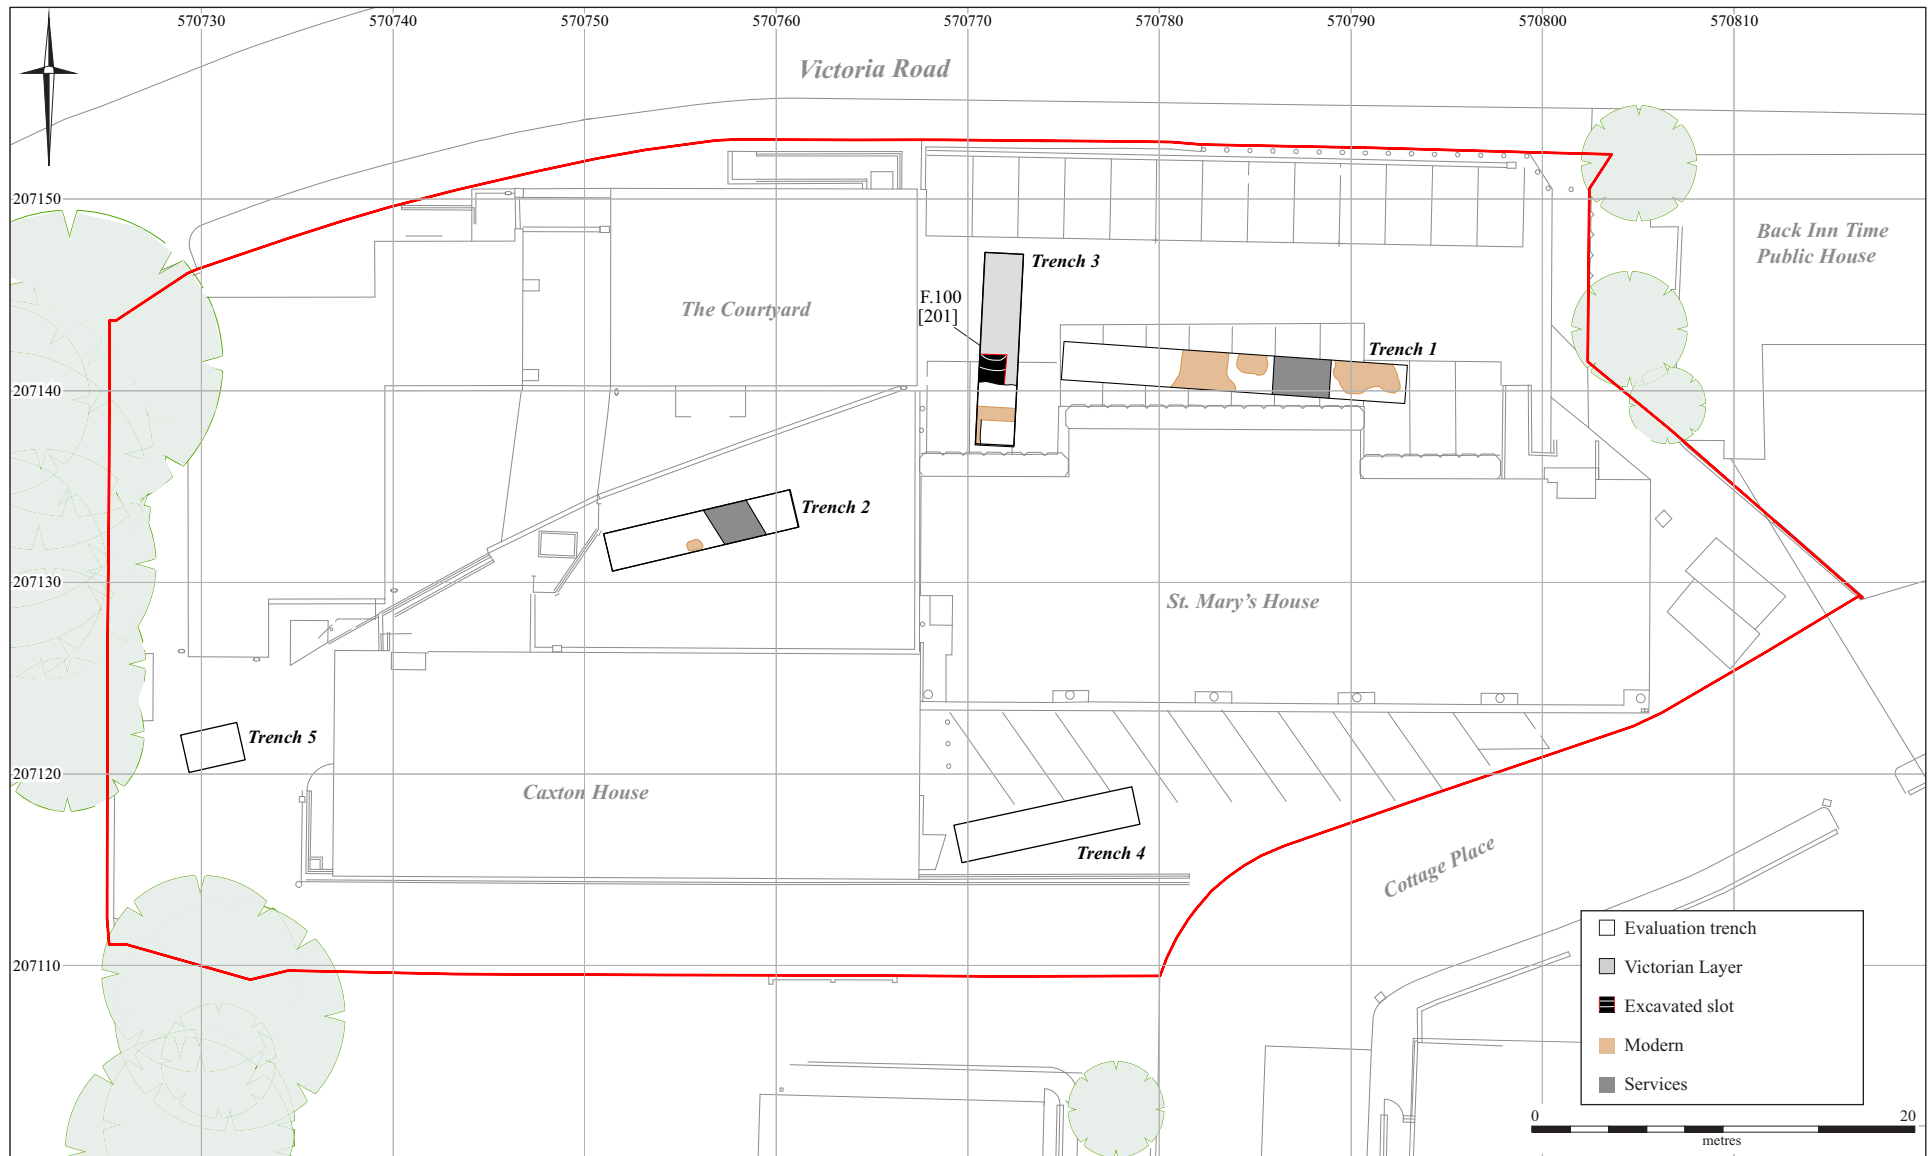
Figure 2. Trench Plan.

Five archaeological trenches totalling 50.3m in length (a 3.1% sample of the area) evaluated the PDA. These were placed in the available open spaces around the current office buildings taking into account the confines of the site and the location of known services, (see Figure 2).

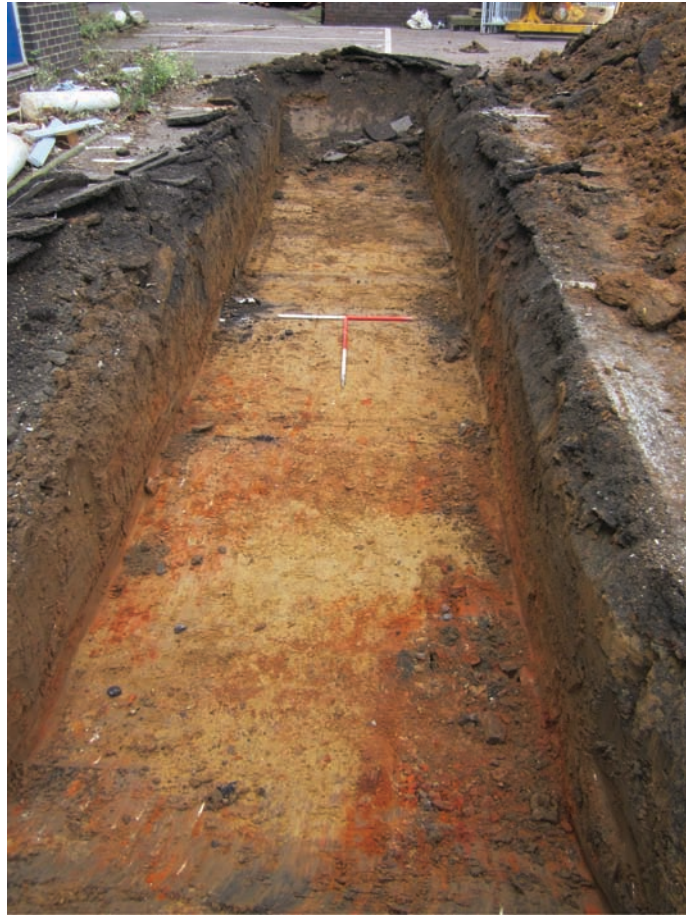
Figure 3. Photograph of Trench 1 looking West (above) and Trench 2 looking East (below).

Trench 1, in contrast, was heavily disturbed by modern activity, with a live service present in the eastern half together with a drain culvert. Also present were a number of large brick filled pits (see Figure 3) likely relating to the clearing of the site in the late 1970's and early 1980's.

Trench 1		
General Description	Orientation	E-W
Trench 1 contained several modern brick/rubble filled pits and a live service. No archaeological features or deposits were present.	Avg. Tarmac Depth (m)	0.30
	Avg. Made-Ground Depth (m)	0.48
	Avg. Subsoil Depth (m)	0.36
	Width (m)	2.00
	Length (m)	17.80

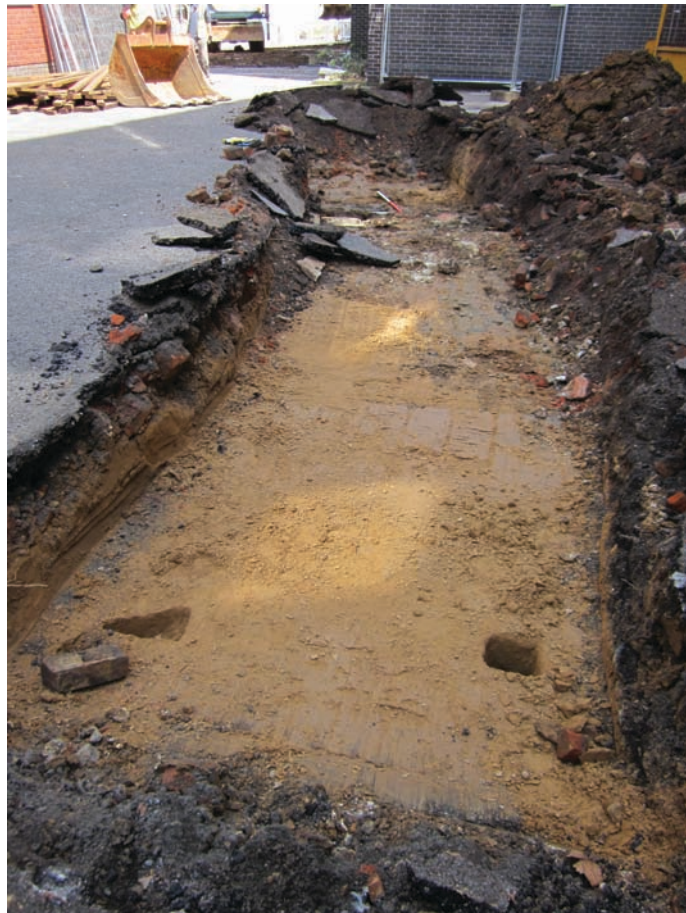
Due to the presence of a thick layer of reinforced concrete, and the confines of the site, Trench 5 was shorter than originally planned. However it demonstrated that this part of the site has been heavily truncated, with the concrete and underlying hardcore laid directly onto the Head Brickearth. Trench 2 identified a similar pattern, where the hardcore and tarmac had been laid directly onto the underlying geology with no evidence of any earlier deposits. This trench was also truncated by a live service and modern drains.

Trench 2		
General Description	Orientation	E-W
Trench 2 contained a live service and a modern drain. No archaeological features or deposits were present.	Avg. Tarmac Depth (m)	0.30
	Avg. Made-Ground Depth (m)	0.20
	Avg. Subsoil Depth (m)	N/A
	Width (m)	2.00
	Length (m)	10.00

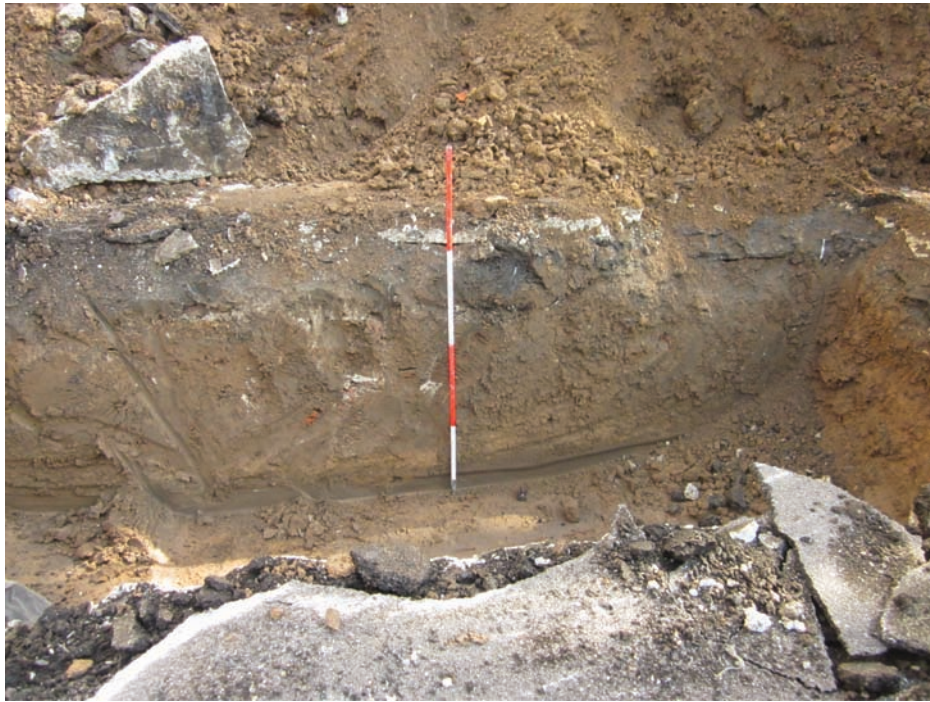
Figure 4. Photograph of Trench 3 looking North (above) and Trench 4 looking North (below).

Within the five evaluation trenches no archaeological features were identified. However, a layer of probable surviving plough soil containing Victorian artefacts including pottery, tile, tobacco pipe and animal bone was present within Trenches 3 and 4. This layer, consisting of mid brown sandy silt, was left *in-situ* in Trench 3 and partially hand excavated revealing a relatively shallow depth which increased

Trench 3								
General Description				Orientation		N-S		
Trench 2 contained a modern wall and a partially preserved Victorian layer containing moderate quantities of pottery, tile, animal bone and tobacco pipe.				Avg. Tarmac Depth (m)		0.30		
				Avg. Made-Ground Depth (m)		0.20		
				Avg. Subsoil Depth (m)		N/A		
				Width (m)		2.00		
				Length (m)		10.00		
Feature No.	Feature Type	Context No.	Cut/Fill	Length (m)	Width (m)	Depth (m)	Artefacts	Archaeological Period
100	Layer	200	F	-	-	-	BN, PT, TL, TP	Victorian
100	Layer	201	C	N/A	N/A	0.15m	-

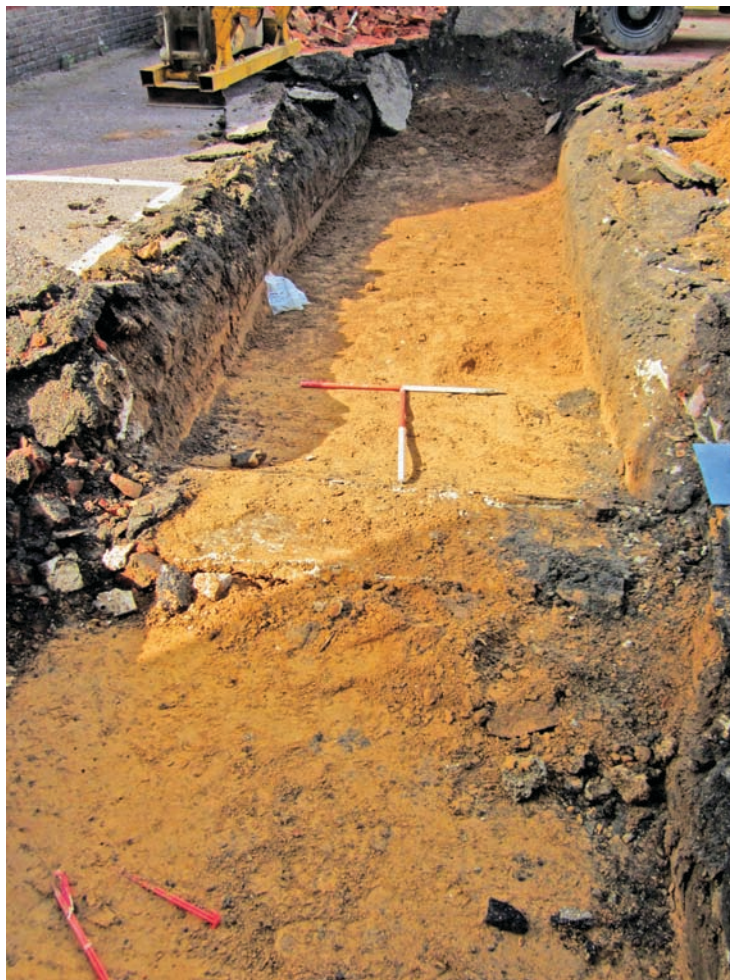
towards the northern end of the trench as the natural Head Brickearth sloped downwards. The layer was fully machined out in Trench 4 in order to investigate the underlying ground. It was shown to have a depth of upto 0.80m (see Figure 3) in this trench and contained moderate quantities of Victorian and more modern artefacts. Cutting into the underlying Head Brickearth were a number of plough scars likely dating to the Victorian or modern period as brick and tile fragments were present within them.

<b>Trench 4</b>		
<b>General Description</b>	<b>Orientation</b>	E-W
Trench 4 contained a similar Victorian layer as that seen in Trench 3. Also present were two probable plough scars. No other archaeological features or deposits were present.	<b>Avg. Tarmac Depth (m)</b>	0.10
	<b>Avg. Concrete Depth (m)</b>	0.14
	<b>Avg. Made-Ground Depth (m)</b>	0.30
	<b>Avg. Subsoil Depth (m)</b>	0.80
	<b>Width (m)</b>	2.00
	<b>Length (m)</b>	9.50
