Double Bank Lane, Sawtry, Cambridgeshire

An Archaeological Evaluation Assessment

July 2013

Report No. 1181
Event No. ECB 4004

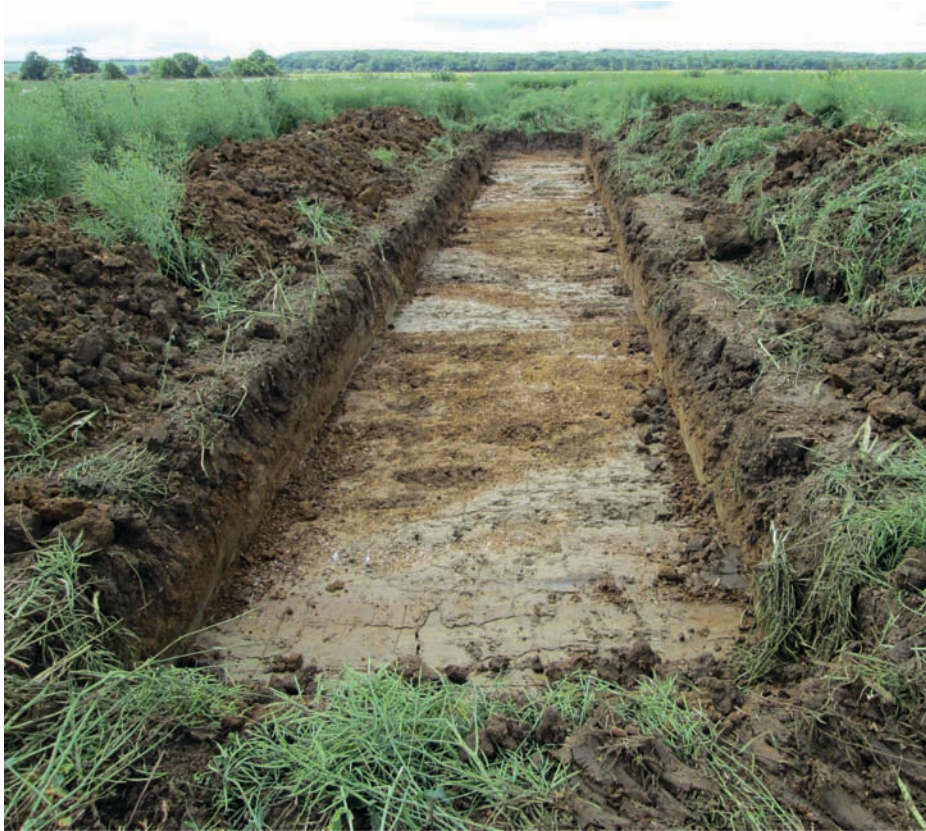
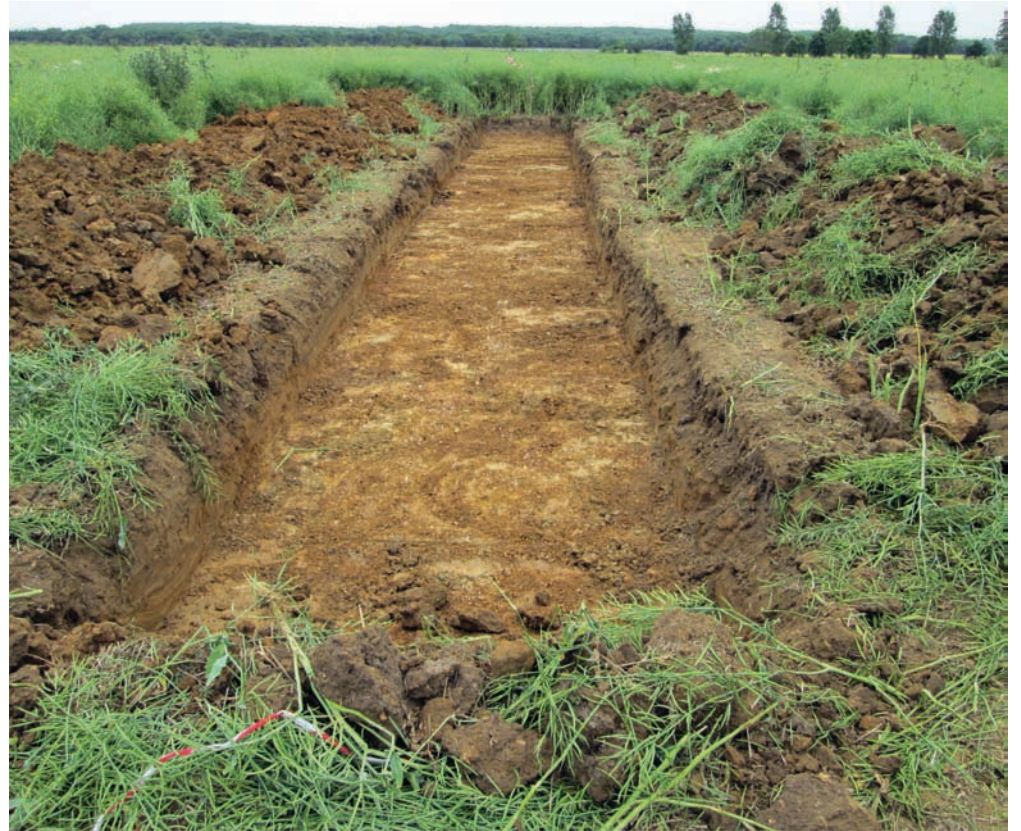
Figure 3. Trench 8, looking north (left), Trench 10, looking south (right)

Trench 8			
General Description		Orientation	N-S
Trench 8 contained a single field drain. No archaeological features or deposits were present.		Avg. Topsoil Depth (m)	0.33
		Avg. Subsoil Depth (m)	0.17
		Width (m)	2.05
		Length (m)	20.00

Trench 10			
General Description		Orientation	N-S
Trench 10 contained a single field drain. No archaeological features or deposits were present.		Avg. Topsoil Depth (m)	0.30
		Avg. Subsoil Depth (m)	0.20
		Width (m)	2.05
		Length (m)	20.00

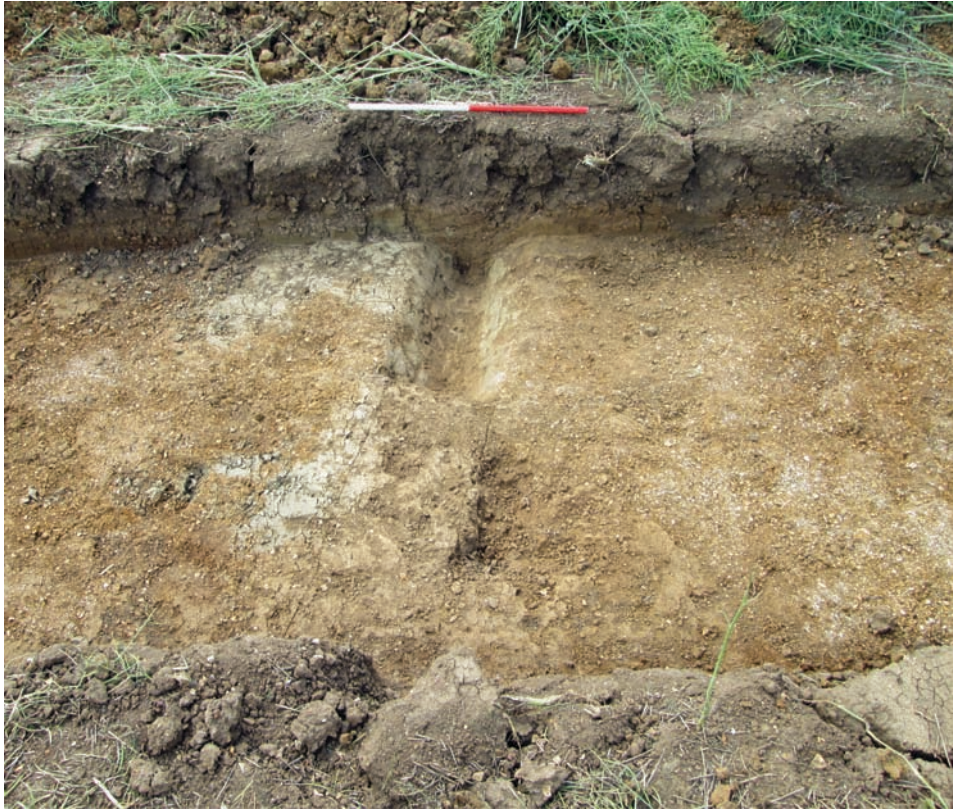
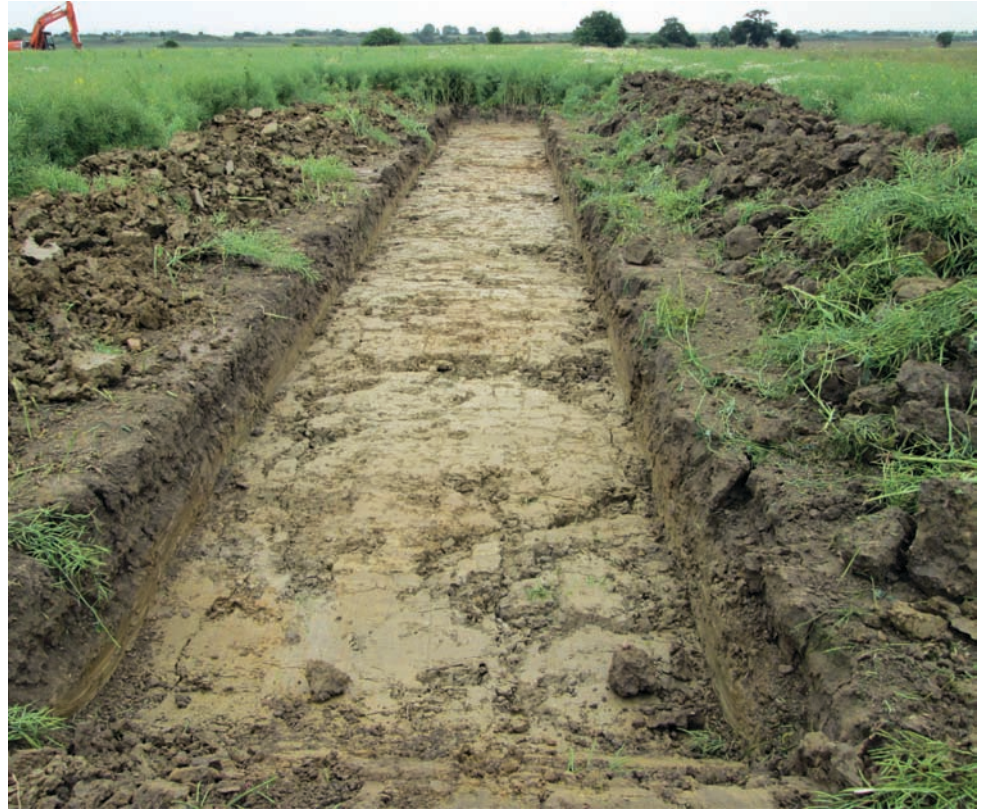
Figure 4. F.002 in Trench 13 (left), and Trench 24, looking east (right)

A total of three archaeological features were identified within the 25 evaluation trenches, (see Figure 2). These features included a small ditch in Trench 13 and two post-holes in Trench 23. Ditch **F.002** (see Figure 3) was infilled with homogenous mid brown clay with few inclusions and contained no artefacts. However, the ditch cuts from just below the topsoil layer suggesting it is dates no later than the post-medieval period. Of the two post-holes in Trench 23, one was excavated (**F.001**). This feature was infilled with dark grey/black clay silt and contained a steel screw and nail suggesting it is quite modern in date. The location of the two post-holes close to the edge of the field suggests they are probably part of a former fence-line. A number of modern field drains and plough scars were also identified within several of the trenches (see Appendix 6.1), however no residual artefacts were observed within any of these features.

Trench 13						
General Description					Orientation	E-W
Trench 13 contained a single small, shallow, undated ditch.					Avg. Topsoil Depth (m)	0.30
					Avg. Subsoil Depth (m)	0.17
					Length (m)	21.00
Feature No.	Feature Type	Orientation	Context No.	Cut /Fill	Artefacts	Archaeological Period
1	Ditch	-	102	F	None	Undated
1	Ditch	NE-SW	103	C	-

Trench 24		
General Description	Orientation	E-W
Trench 24 contained a single field drain. No archaeological features or deposits were present.	Avg. Topsoil Depth (m)	0.31
	Avg. Subsoil Depth (m)	0.21
	Width (m)	2.05
	Length (m)	21.00
