Hillside Park Caravan Site, Limekiln Lane, Baldock

Archaeological Monitoring and Recording

Cambridge Archaeology Unit University of Cambridge March 2014

Report No.1216

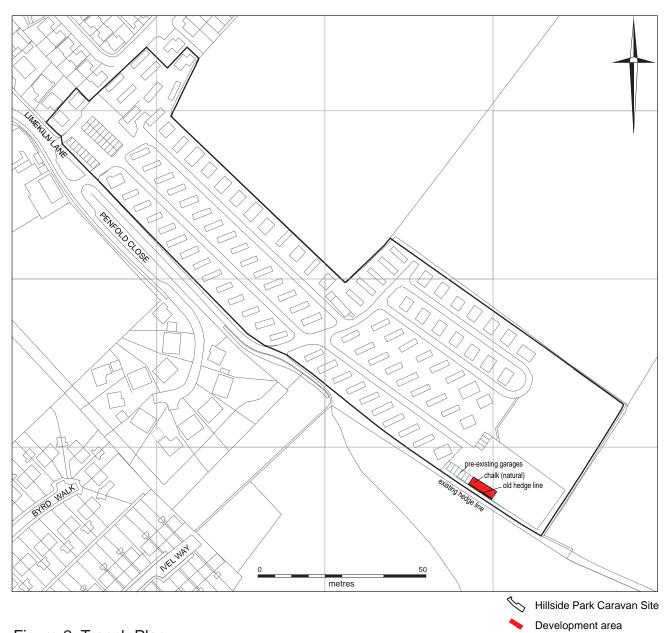
Figure 2. Trench Plan.

In total some $65m^2$ was stripped down to the top of the chalk, the area being investigated consisting of a 16.4m long by 5.5–6m wide NW-SE oriented rectangular strip adjoining the east side of the existing block of garages (Figure 2). The weathered top of the chalk was encountered at a depth of between 360-500mm below ground level.

On the north (or car park) side of this plot there was evidence for a considerable amount of truncation, with no topsoil or sub-soil present, but with 150mm of tarmac overlying 210mm of crushed red brick as foundations, this lying directly upon the truncated surface of (fresh) chalk. This same level of truncation continued southwards across the plot to a point just 2-3m north of the existing hedge line. Right up against the edge of this the section in the south-east corner of the plot was examined. This revealed 350mm of thin grey humic topsoil overlying 150mm of grey-brown subsoil, 50mm of dirty weathered chalk above the top of the solid chalk (at a depth of 550mm below ground level.

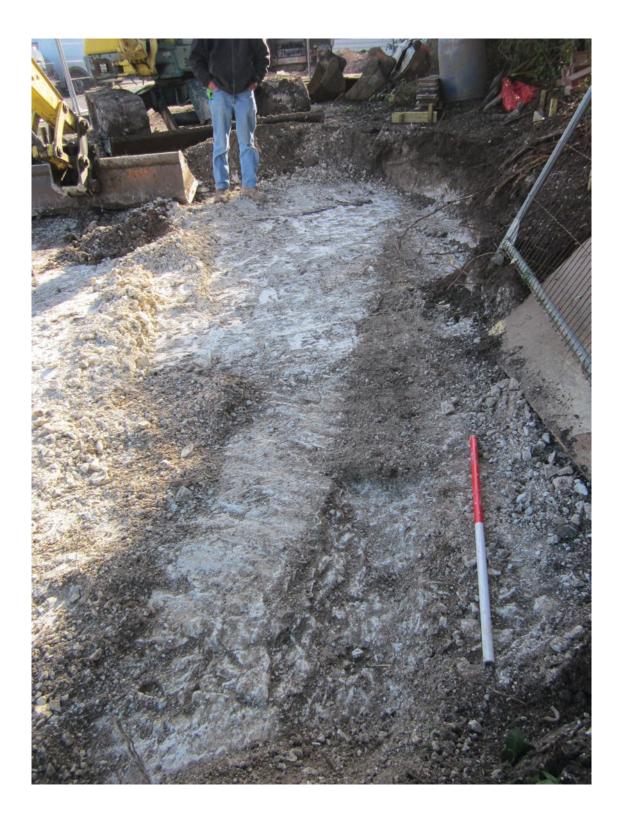
In terms of 'modern' features, a single hedge-rooting gully with sub-parallel sides 300mm apart and an uneven U-shaped base only 50mm deep was identified towards the eastern end (Figure 3). This could be traced eastwards for at least 9m, although its continuation westwards was assumed, parallel to and just 1.5m north of the existing hedge line. A single fragment of Postmedieval tile was encountered within the fill of this examined by means of a 1m long slot (Figure 4); the single fill here consisted of broken-up lumps of chalk (<50mm) detached from the base of this gully mixed with a loose grey-buff coloured chalky soil, small chalk inclusions and many pre-existing roots.

Figure 3. Photograph of modern hedge-rooting gully along RH edge.

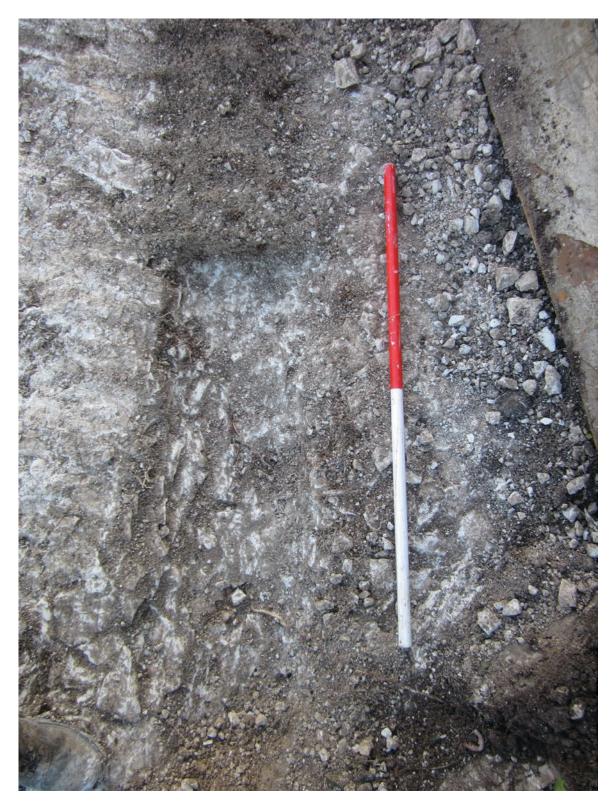
Figure 4. Photograph of 1m slot in cut into shallow gully.
