Elizabeth House, Chesterton, Cambridge

An Archaeological Evaluation

Elizabeth House, 1 High Street, Chesterton, Cambridge:
An Archaeological Evaluation

© **Cambridge Archaeological Unit**
University of Cambridge
May 2014
Report Number: 1234
Event Number ECB4028

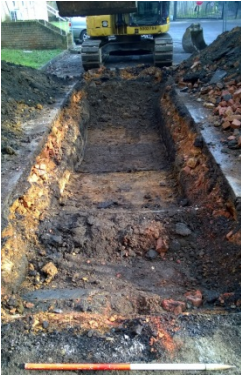
Trench 2

Orientation	NE-SW	
	Height at ground level (m OD)	8.06	
	Avg. Disturbance (m)	0.34	
	Avg. Topsoil Depth (m)	0.15	
	Avg. Subsoil Depth (m)	0.14	
	Total Depth of Trench (m)	0.63	
	Width (m)	1.5	
	Length (m)	6.4	
	General Description		
	At the southwest end of the trench a lead water pipe was encountered and the trench shortened as a result. Much of the trench was occupied by a strip quarry orientated northwest-southeast. At the northeast end was the corner of a square cut pit containing china and pig bone.

House, and was cut to fit in amongst a number of services and emergency exits. The remains of a large post-Medieval quarry was recorded that contained a number of fragments of 19th/20th century china and pig bones. Trenches 5 and 6 were set within the grass area, in a space between several trees and bushes, at right angles to each other forming an 'L' shape. At the southwest end of Trench 5 was the northern edge of a post-Medieval quarry pit that extended throughout much of Trench 6. Neither trench revealed any other archaeological features. Trench 7 to the southeast, and located within a gravelled area (the gravel overlying a dark and a sub-soil), also revealed the remains of a quarry at its southern most end, but no further archaeological features. Further quarrying was evidenced at the very northwest end of Trench 9 as the only feature encountered in the trench.

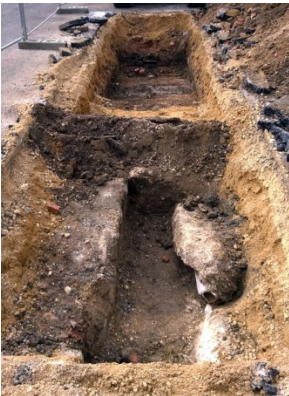
Orientation	NE-SW	
	Height at ground level (m OD)	8.15	
	Avg. Disturbance (m)	0.95	
	Avg. Topsoil Depth (m)	-	
	Avg. Subsoil Depth (m)	-	
	Total Depth of Trench (m)	0.95	
	Width (m)	1.5	
	Length (m)	9.4	
	General Description		
	At the northeast end of the trench was part of the foundation wall for a building and a clay pipe encased in concrete. East-west across the mid-point was an electricity cable observed by the yellow hazard warning placed above cables (no cable was exposed). At the southwest end of the trench was a cut feature that contained 20 th century material.

Trench 3 revealed traces of an earlier building with sections of brick foundation walls surviving below a layer of limestone rubble. In association with the foundations was a single clay drain that was most likely for the rain water runoff from the now demolished building. There were further disturbances in the trench that appeared to be the result of the removal of any debris when the building was demolished. Encountered in the centre of the trench was the yellow and black warning tape for buried electricity cables and so this section was not machined.

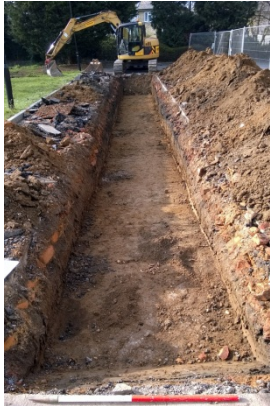
Orientation		NW-SE	
				Height at ground level (m OD)		7.99	
				Avg. Disturbance (m)		0.28	
				Avg. Topsoil Depth (m)		0.18	
				Avg. Subsoil Depth (m)		0.3	
				Total Depth of Trench (m)		0.76	
				Width (m)		1.5	
				Length (m)		18.8	
				General Description		<p>Three features were identified at the southeast end of the trench, one of which was excavated. The two unexcavated features were both discrete features (pits?) that contained articulated animal (thought to be pig) remains (burials?) that were accompanied by a white substance (lime?). They were most likely late 19th – early 20th century pig burials, within allotments or fields.</p>	
				Feature No.	Feature Type	Context No.	Cut/Fill/ Layer
1	Pit	1	Fill			Undated, associated with post-Medieval animal burials	
		2	Cut	0.55	0.14

Trench 4 was the only trench that contained discrete features, which were not interpreted as evidence of quarrying. Three pits were recorded, only one of which was excavated. This was a small pit, **F.1**, exposed at the edge of the trench and 0.55m wide and 0.14m deep. The pit contained mid-brown sand silt but there were no artefacts recovered from it. Within close proximity were a further two pits of similar size both of which contained articulated pig bones along with a white substance. This white substance may have been lime and the two features were interpreted as pig burials. Neither feature appeared particularly old with the intermixed soil a dark humic brown; as a result it was deemed best not to excavate these further.

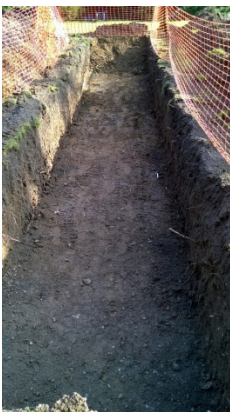
Trench 6

Orientation		NW-SE	
				Height at ground level (m OD)		7.88	
				Avg. Disturbance (m)		-	
				Avg. Topsoil Depth (m)		0.24	
				Avg. Subsoil Depth (m)		0.51	
				Total Depth of Trench (m)		0.75	
				Width (m)		1.5	
				Length (m)		8.6	
				General Description		<p>This trench was excavated within the grassed area and as such there was no disturbed (tarmac or concrete) ground. Most of the trench was dominated by a large post-Medieval quarry pit, with only a 2m wide area at the southeast end onto natural. It was cut adjoining and at right angles to Trench 5.</p>

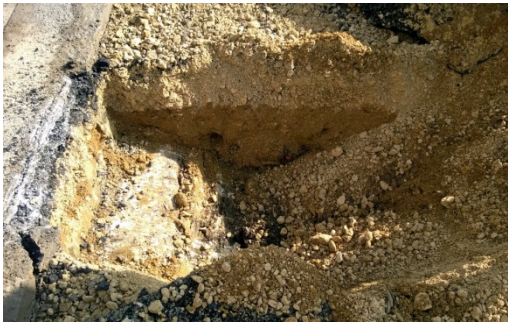
Orientation	
	Height at ground level (m OD)	8.22
	Avg. Disturbance (m)	
	Avg. Topsoil Depth (m)	
	Avg. Subsoil Depth (m)	
	Total Depth of Trench (m)	
	Width (m)	
	Length (m)	
General Description		
Trench 8 was started, with the tarmac cut ahead of the machine. However, when machining began a hard reinforced concrete was encountered directly beneath the tarmac and despite breaking through a small area the 360° machine was unable to cut the trench and it was abandoned unexcavated.

Trench 1 was to be located along the eastern wall of Elizabeth House at the rear of the building; however, it would have blocked off an emergency exit and so was not cut. After cutting the tarmac over Trench 8 a hard and compact concrete was encountered. It was possible to punch a very small machine bucket hole through it, but any attempts to lift it or break it further proved fruitless. As a result neither of these trenches was cut.

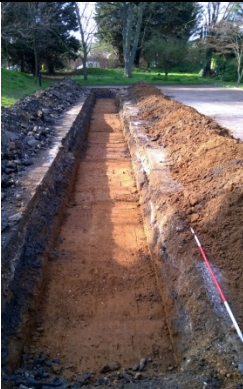
Trench 9

Orientation	NW-SE
	Height at ground level (m OD)	8.04
	Avg. Disturbance (m)	0.3
	Avg. Topsoil Depth (m)	0.17
	Avg. Subsoil Depth (m)	0.22
	Total Depth of Trench (m)	0.69
	Width (m)	1.5
	Length (m)	27
General Description		
The edge of a post-Medieval quarry was visible at the northwest end of the trench. No other features were present.
