Great Saint Mary's Church, Cambridge

Observations during internal alterations

July - September 2013

Report No. 1256
HER No: ECB4154

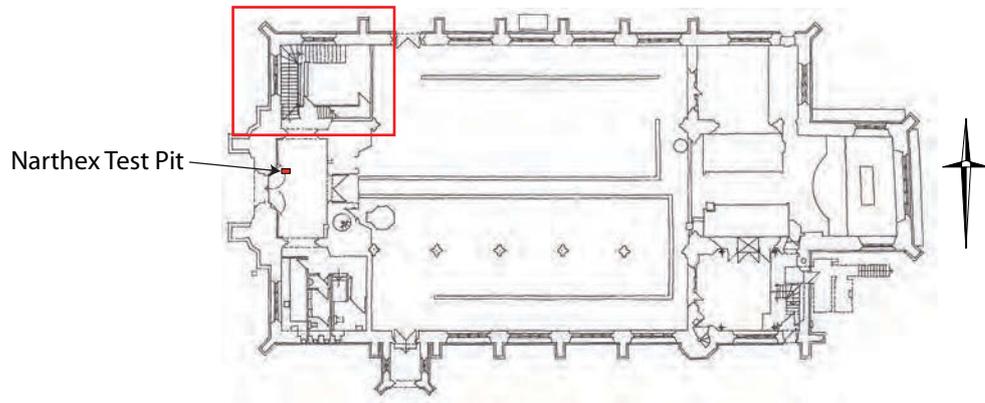
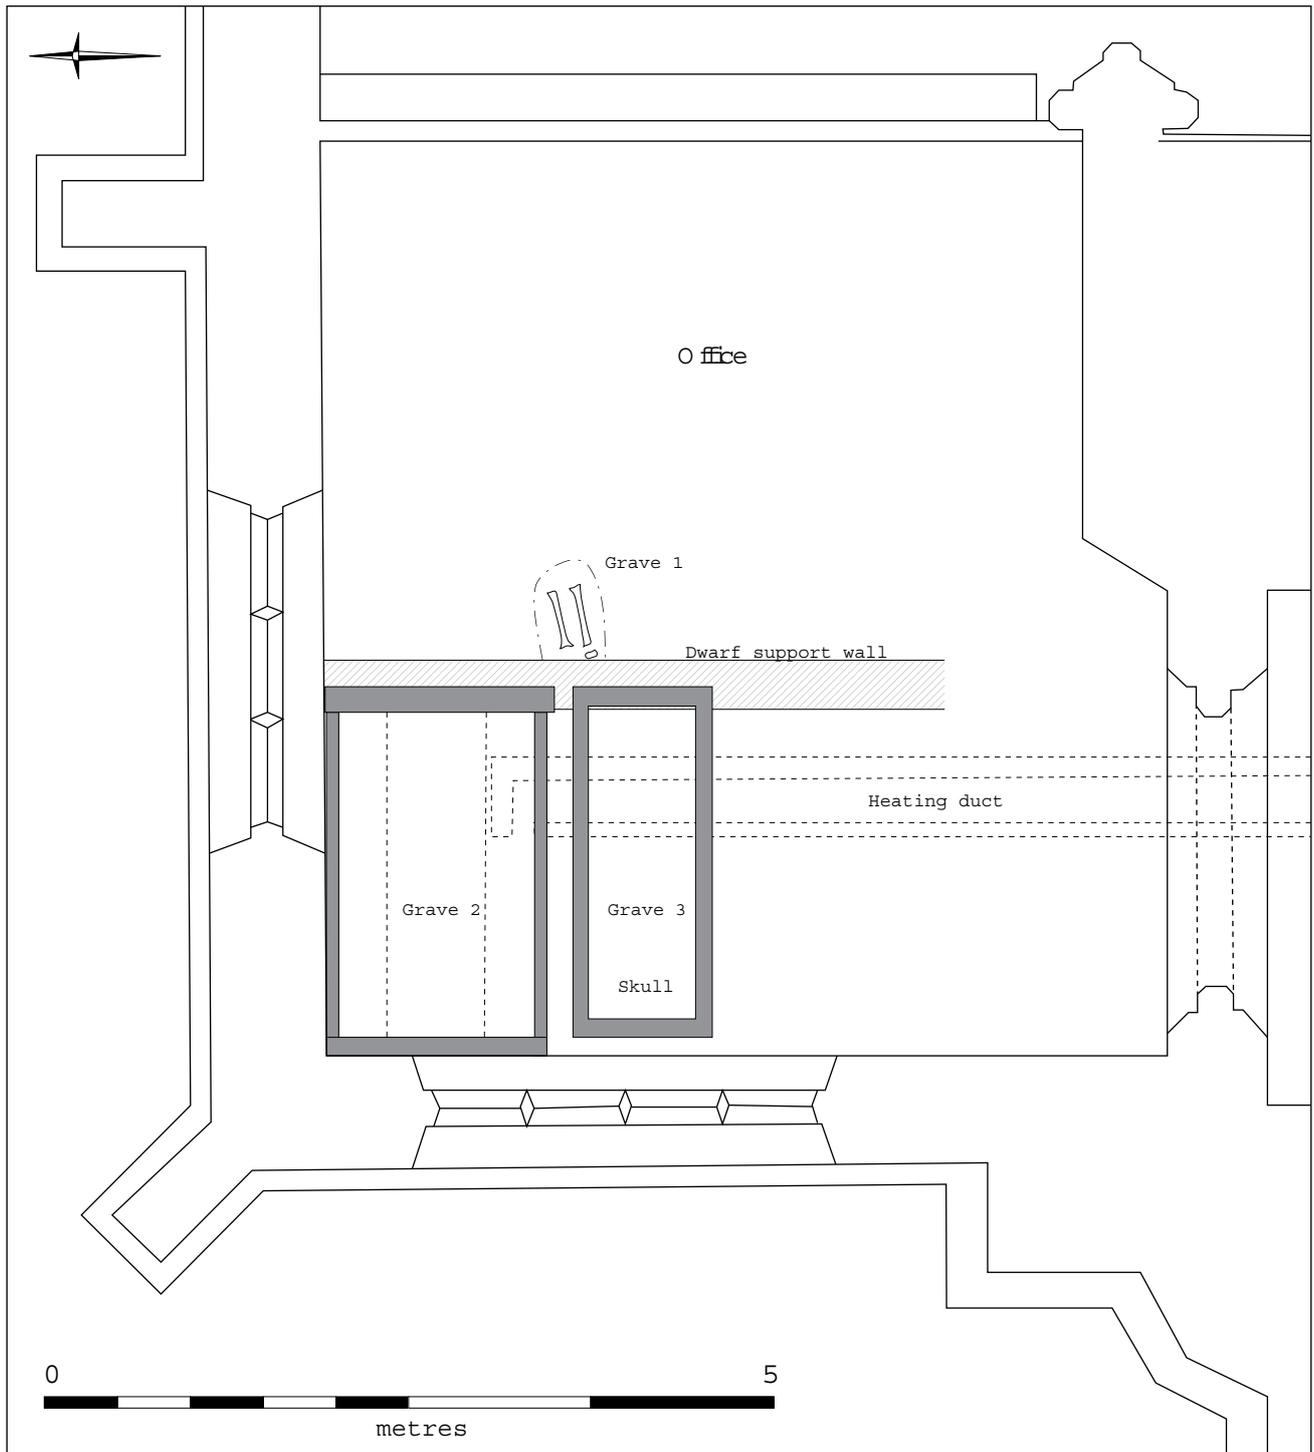
Figure 2: Location of Graves in the Office

On 19th April 2012 a stone was lifted in the Narthex on the line of the proposed door guide (see figure 2). The hole measured 0.60m west to east and 0.49m north to south.

Several visits were made between the 10th and 23rd of September 2013 whilst the raised wooden floor of what had been an office in the northwest corner (effectively the west end of the partitioned north aisle) was lifted and the ground beneath reduced to accommodate new heating pipes and for the floor to be reset at a lower level to match that in the Narthex.

During the works two brick lined graves were revealed together with what remained of a much earlier burial cut by the later ones. The decision was made, in association with the DAC archaeologist, that the human remains should be left *in situ*. All recording was subsequently made from ground level and without entering either of the brick graves, which would have compromised the burials observed within them. The removal of the barrelled roof of the larger of the two lined graves allowed the new floor supports to be inserted without further interference.

The subsequent exposure of the two brick lined graves immediately to the west (see below and figures 2 and 3) showed that very little more of the skeleton could have survived having been truncated toward the top of the femurs.

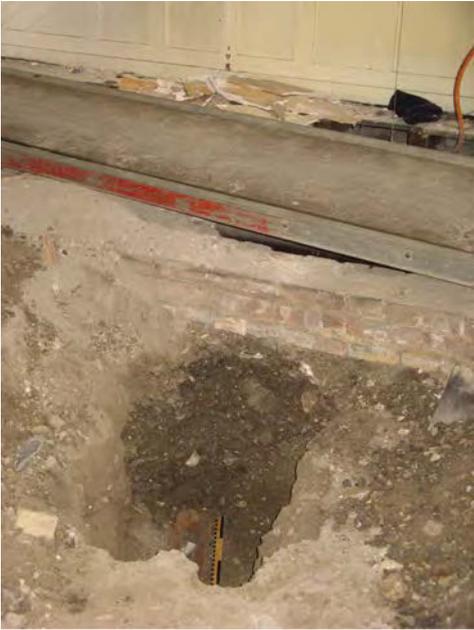
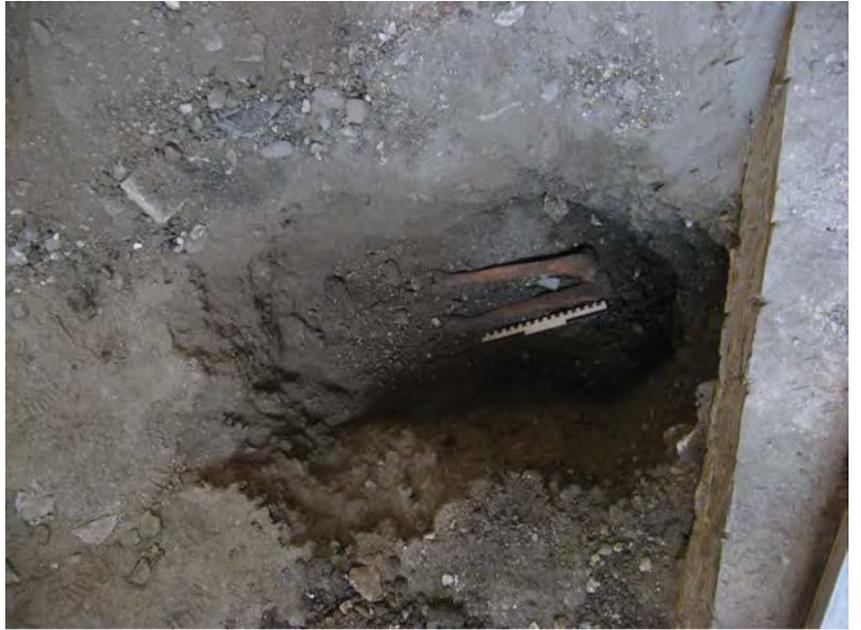
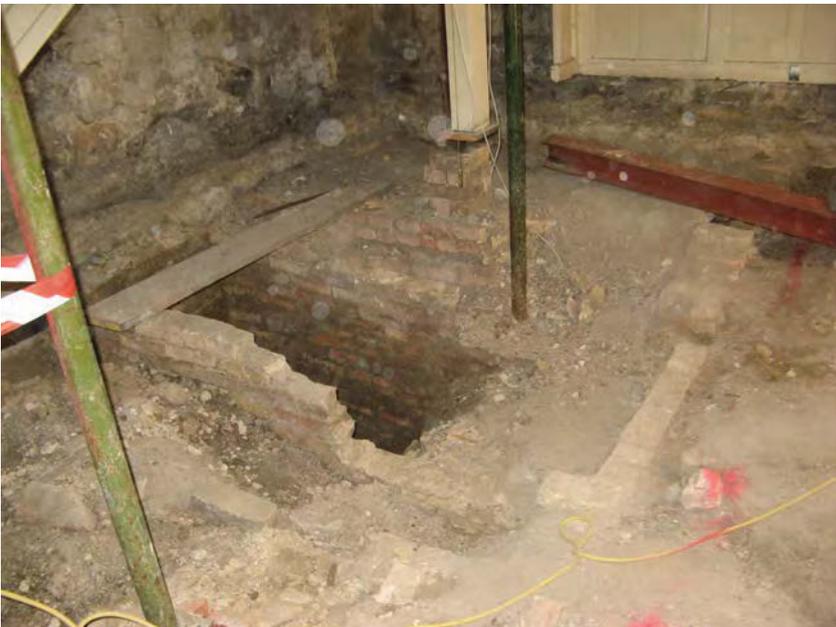
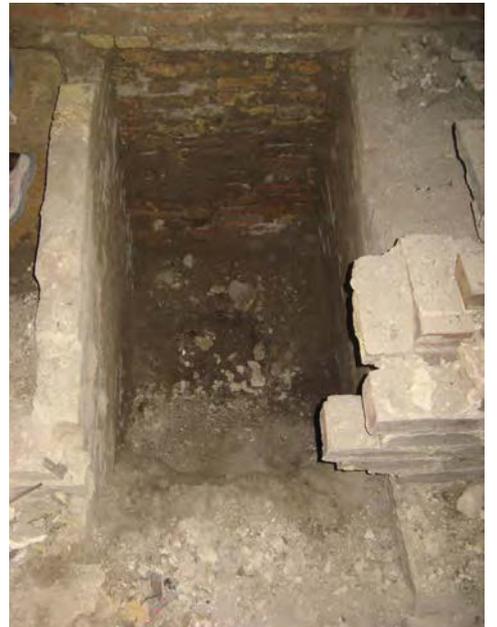
Figure 3: Graves 1 and 3

Human remains were encountered by the workmen at 0.80m below the floor whilst exploring a 'soft spot' within an otherwise compact deposit beneath the wooden floor. On examination it became clear that this loose material was not the original grave fill and that the burial had been disturbed at least once previously. The soft material was the backfilling of that earlier disturbance.

The skeleton, as observed, consisted of the two tibia of a single individual. The patella of the right leg was present, but not the left, nor apparently either of the fibula or any bones of the feet. Cleaning at the west end revealed the lower ends of both femurs indicating that the bones of the skeleton were in the correct anatomical position (and therefore this was a west to east burial as would be expected) but that the lower legs had been previously disturbed.

Grave 3 was a single brick lined grave immediately to the south of Grave 2, constructed from very similar bricks. Internally the void measured 0.72m north to south and 2.12m west to east. The original height is unknown as if it had a roof in the past this had subsequently been removed and the grave itself was backfilled with loose rubble soil. The brickwork of the existing heating duct ran immediately over the top and the insertion of this had presumably led to the disturbance and back filling of the grave.

The backfill, and damage to the upper courses of the grave, meant that on initial exposure it was not immediately apparent that it actually was a grave. Removal of some of the fill, however, exposed the top of a skull at a depth of approximately 1.60m below the upper level of brick. Having established that it was indeed a grave no further excavation was carried out. The exposure of the remains was not sufficient to establish whether a coffin was present, however there was certainly no lead coffin in the grave. It is most likely that a wooden coffin had been present but had not survived the passage of time and the earlier disturbance.

Grave 1 from the East

Grave 1 from the North

Grave 3 from the Southeast

Grave 3 from the East

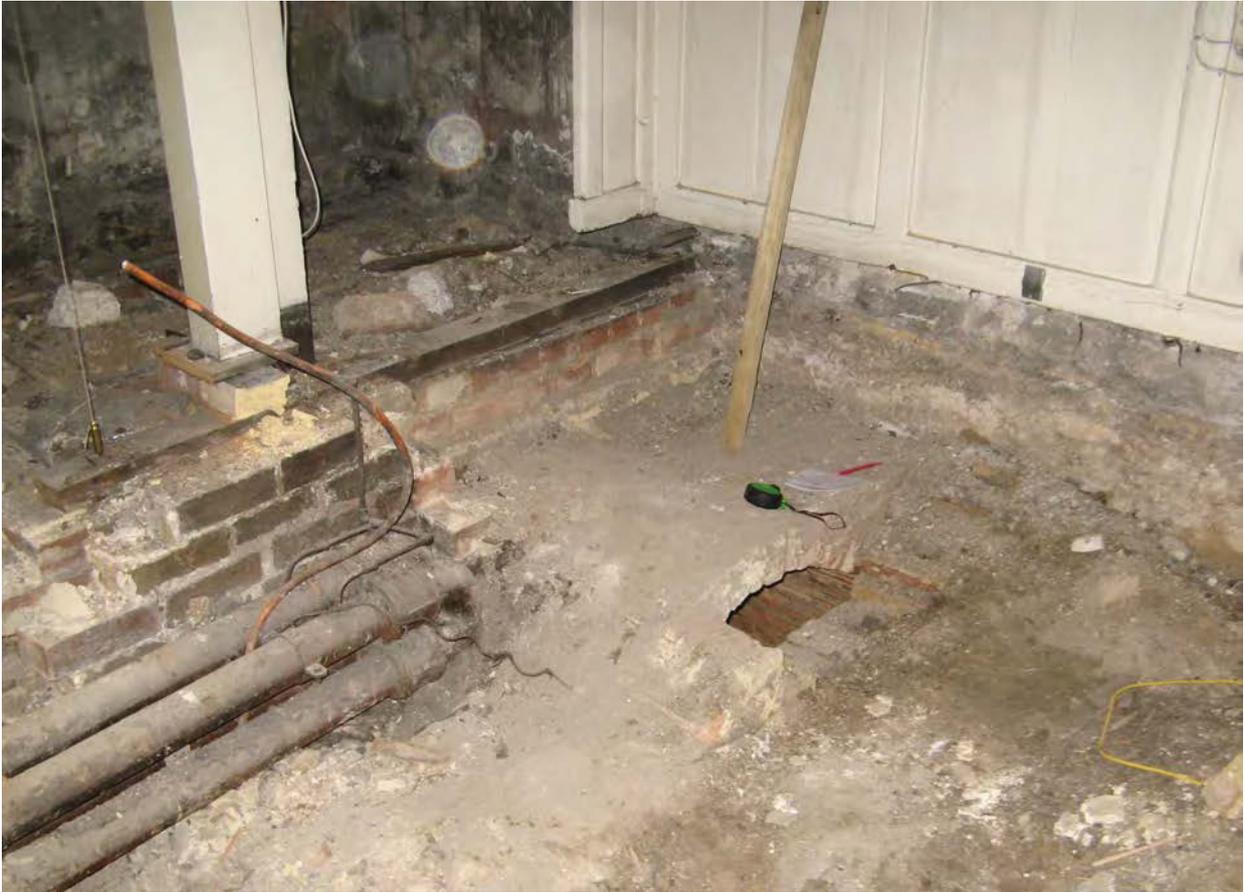
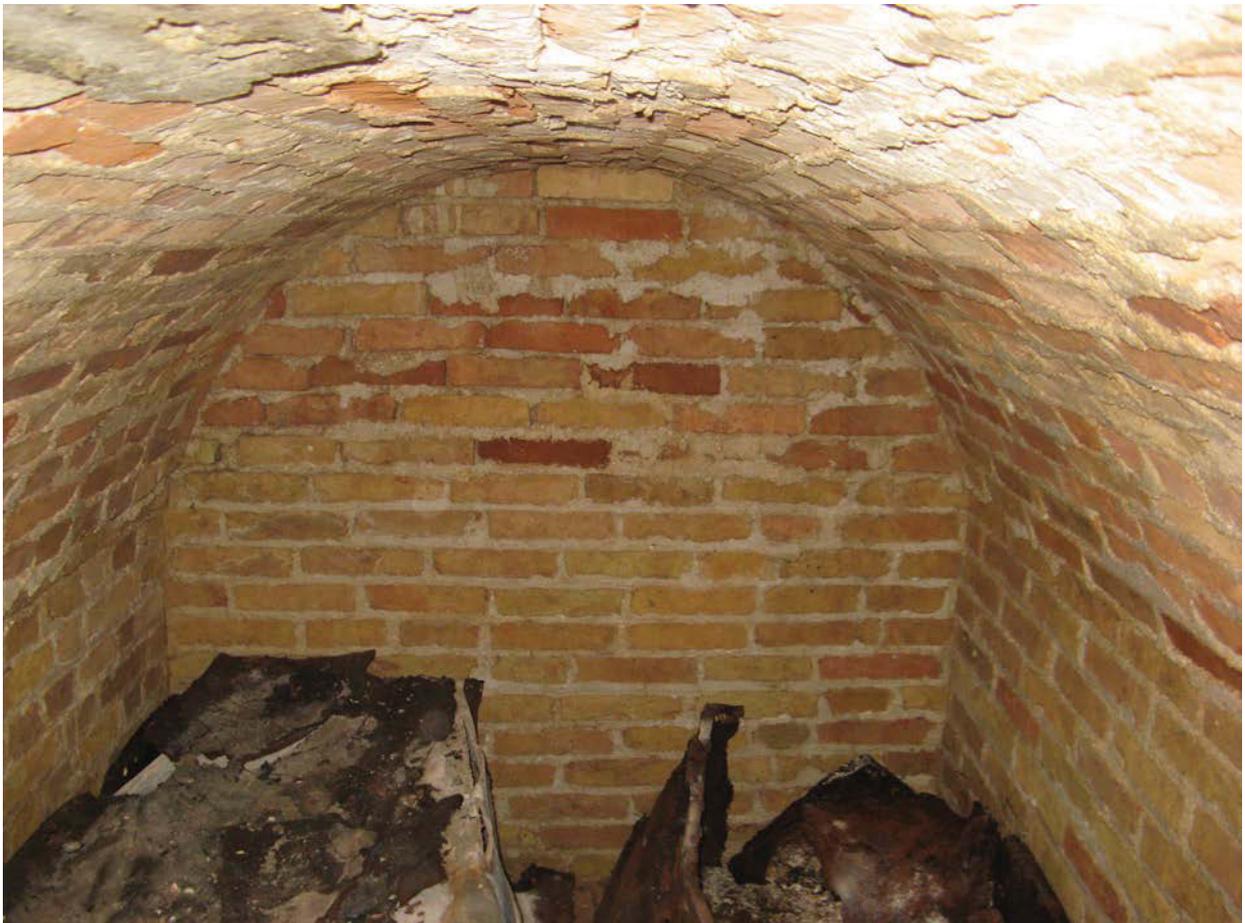
Figure 4: Grave 2 (1)

Grave 2 was a large brick lined grave or tomb in the extreme northwest corner of the narthex.

It was constructed from orange/pink unfrosted handmade bricks measuring 230 x 100 x 45mm (9 x 4 x 1¾ inches) set in a cream mortar. Internally the void measured 1.22m north to south, 2.07m west to east and 1.30m from the floor to the internal apex of the slightly arched roof.

Within the grave were two coffins; Coffin I on the north side, Coffin II on the south. Coffin I was of wooden construction with fragments of a fabric covering surviving in places although the overall condition was poor. Broad headed pins, which would have fastened the fabric in place, were visible as was an iron 'handle' on the southern side (figure 5). No human remains were visible in the coffin, but the shape indicated that this was, as might be expected, a west to east orientated burial.

Grave 2 from the Southeast

Grave 2 Interior from the East

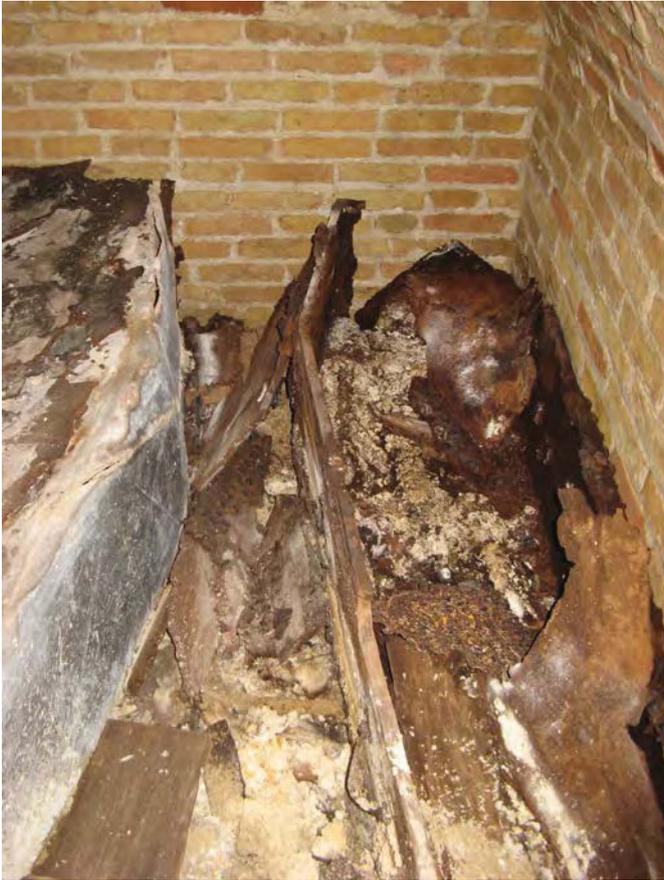
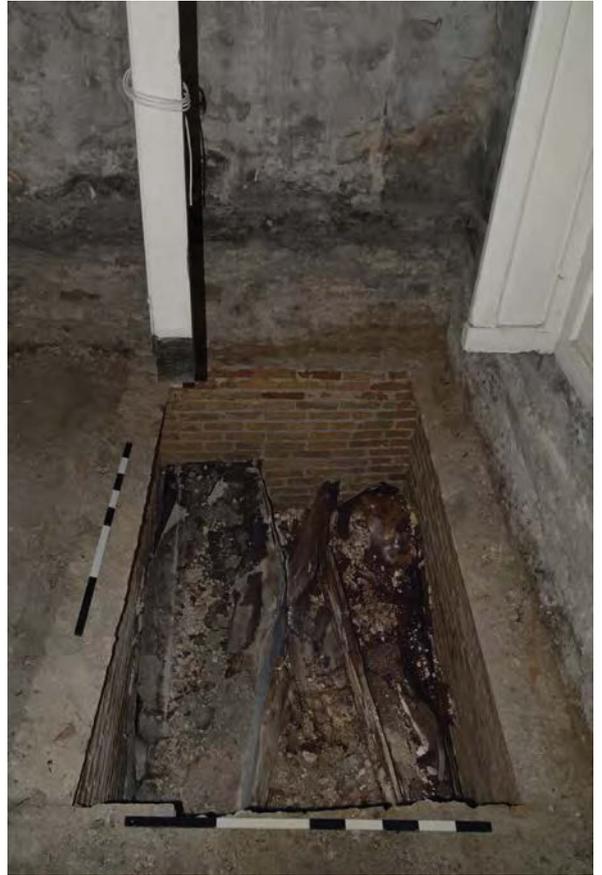
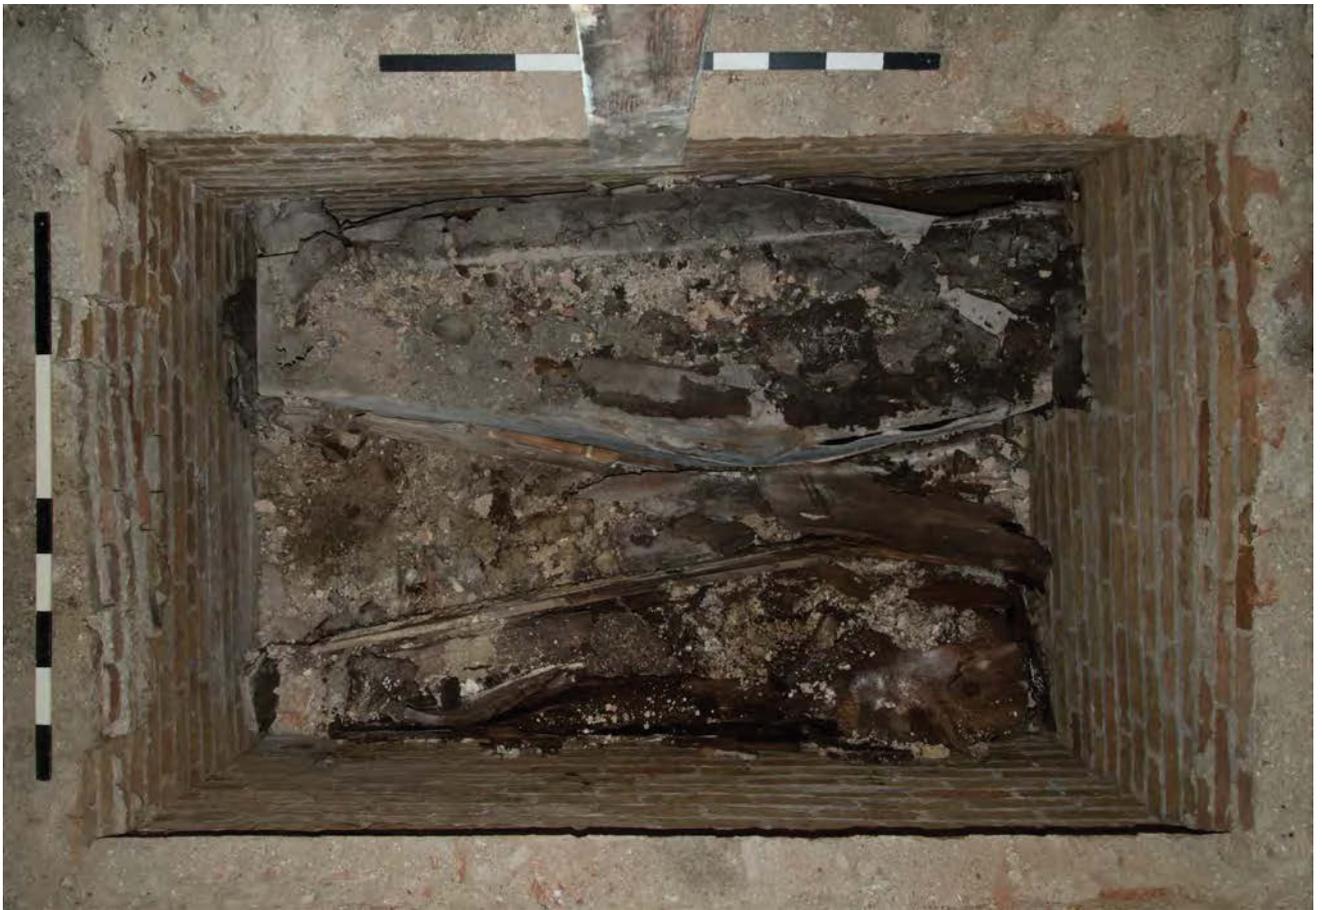
Figure 5: Grave 2 (2)

Coffin II was more elaborate. A badly decayed wooden outer shell was visible around a lead inner. It is possible that there was a further wooden coffin inside this, but it was not observable. It was not clear whether this coffin also had a fabric covering, but from what was visible it seems likely that it did not. No plaque or plate was observed and again the remains within were not visible. Given the form of the grave, most likely to be a family vault, it is reasonable to presume that the second occupant is a close relative of Mary's, most probably her husband.

Grave 2 Interior from the East Showing Coffin Grave 2 from the East after Removal of Roof

Grave 2 Interior from the North

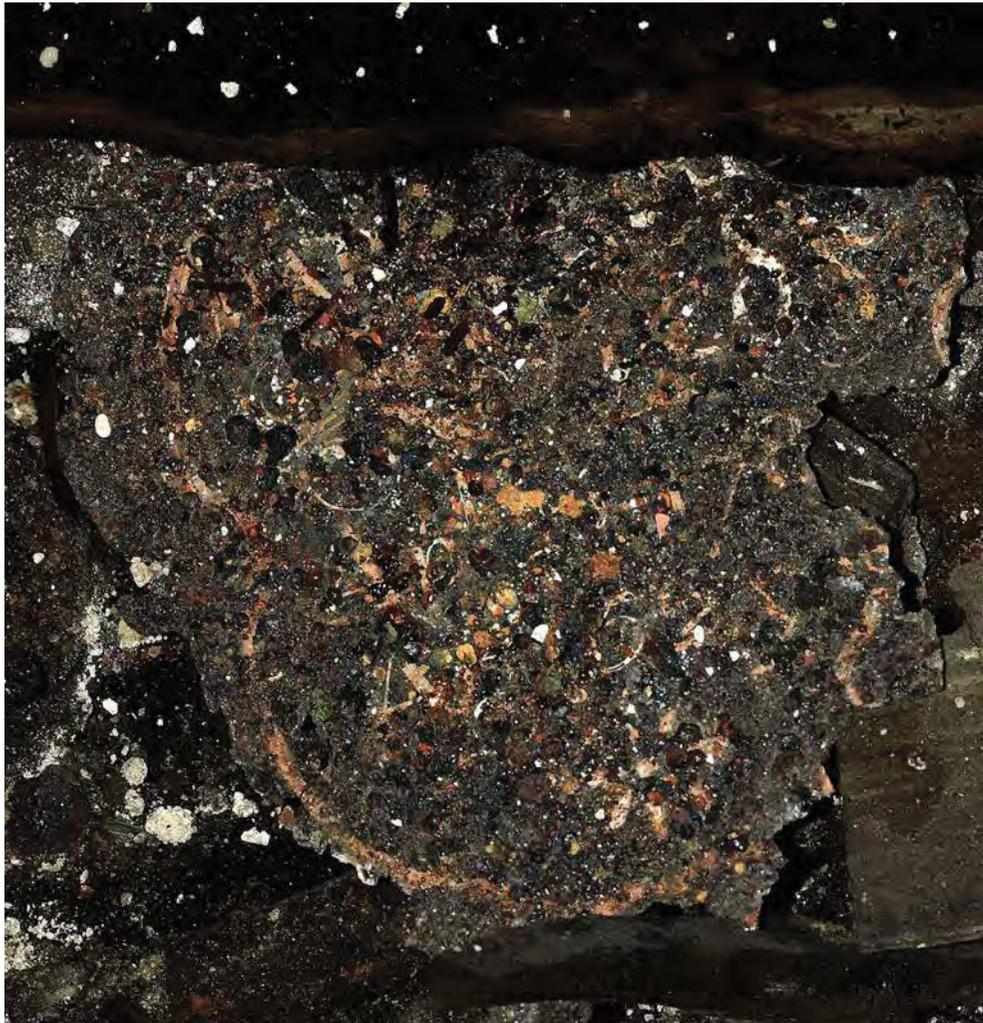
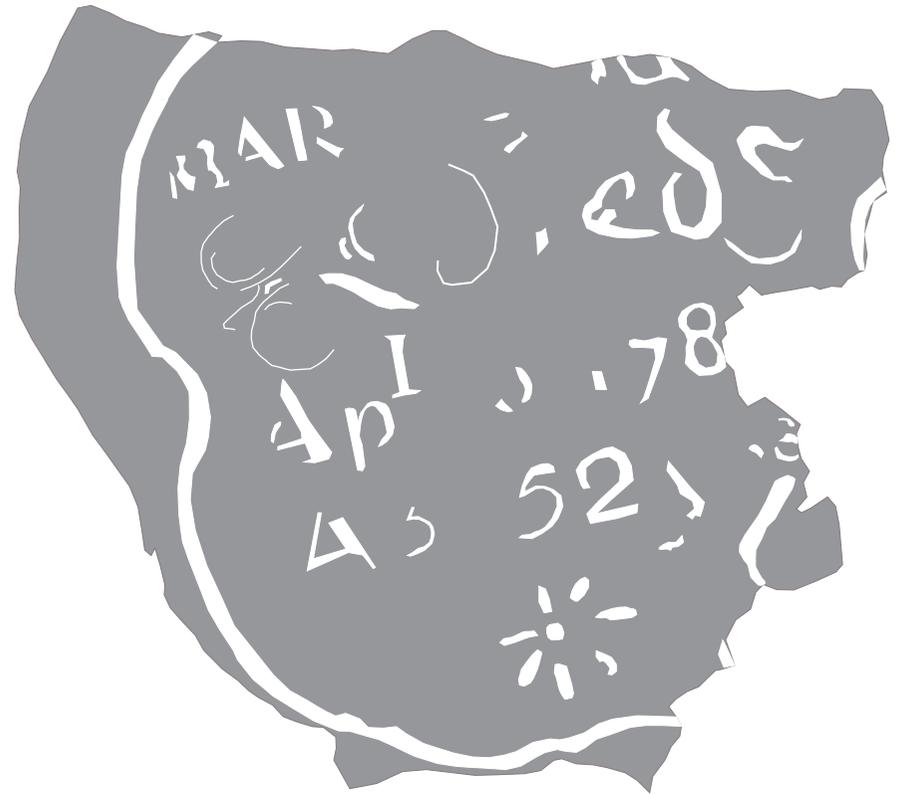
Figure 6: Cor Plate from Grave 2

Significantly there was a badly corroded coffin plate still in place in roughly the pelvic area of the coffin. It was not possible to make anything out on this *in situ*, but detailed photographs were taken and it subsequently proved possible to make out some of the painted lettering (figure 6).

MAR(Y?) (illegible)
died
Apl (?)0 178(?)
Ag(ed) 52 y(ear)s

Although it is not possible to identify the individual precisely, it does confirm the date of the burial as being late 18th century.

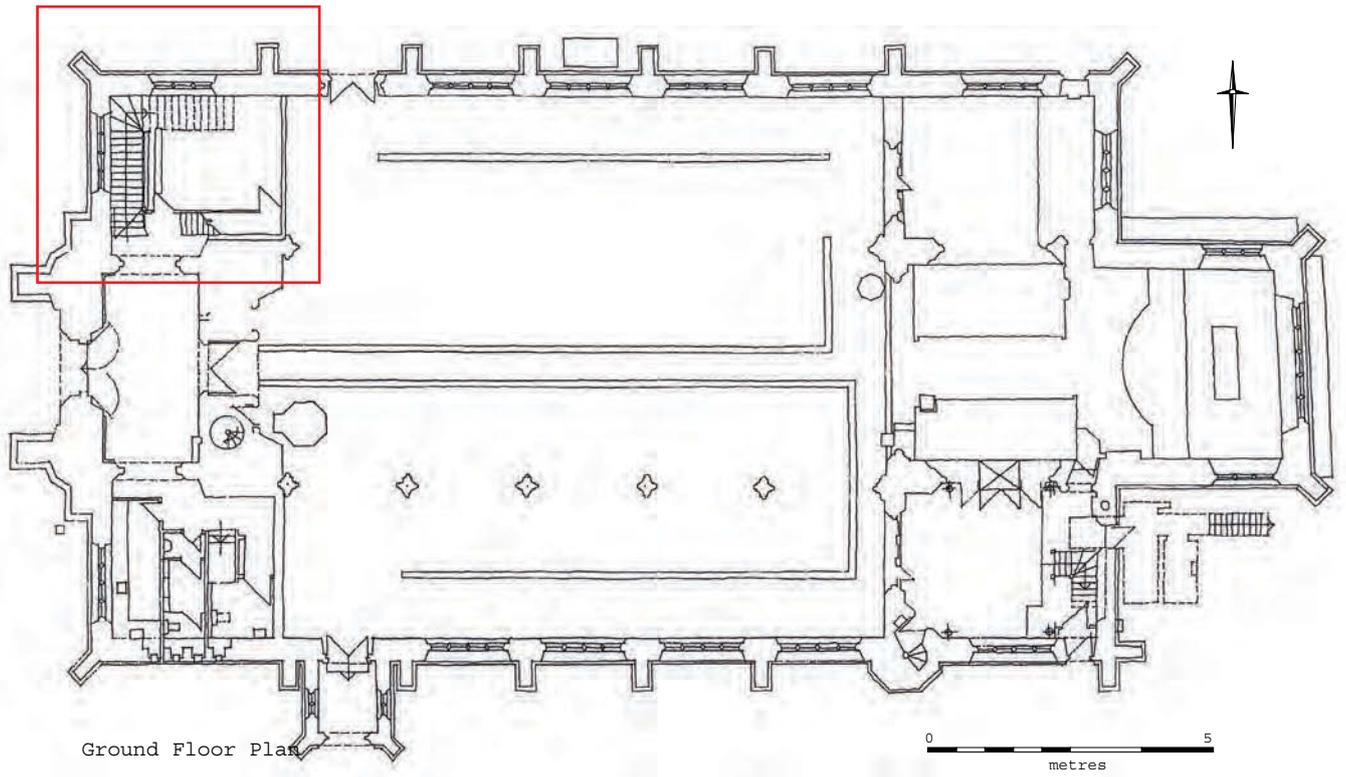
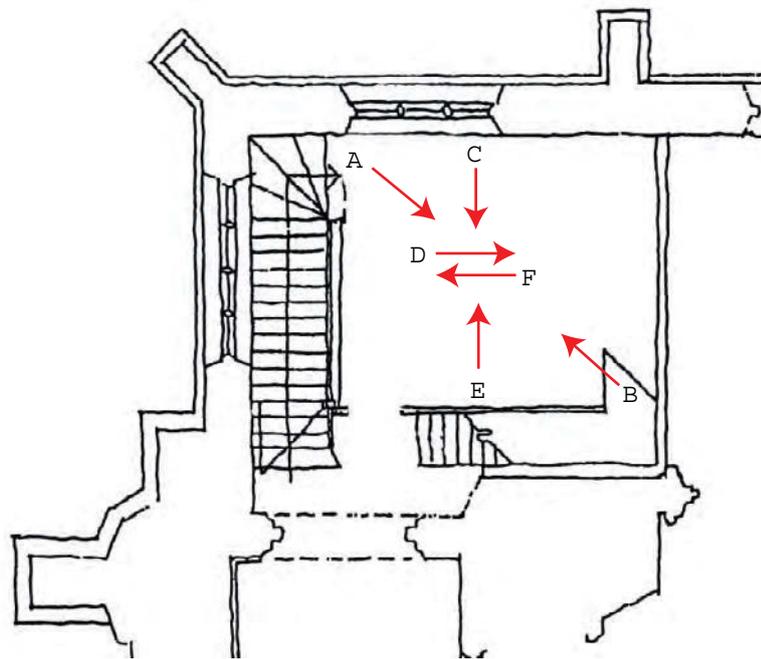
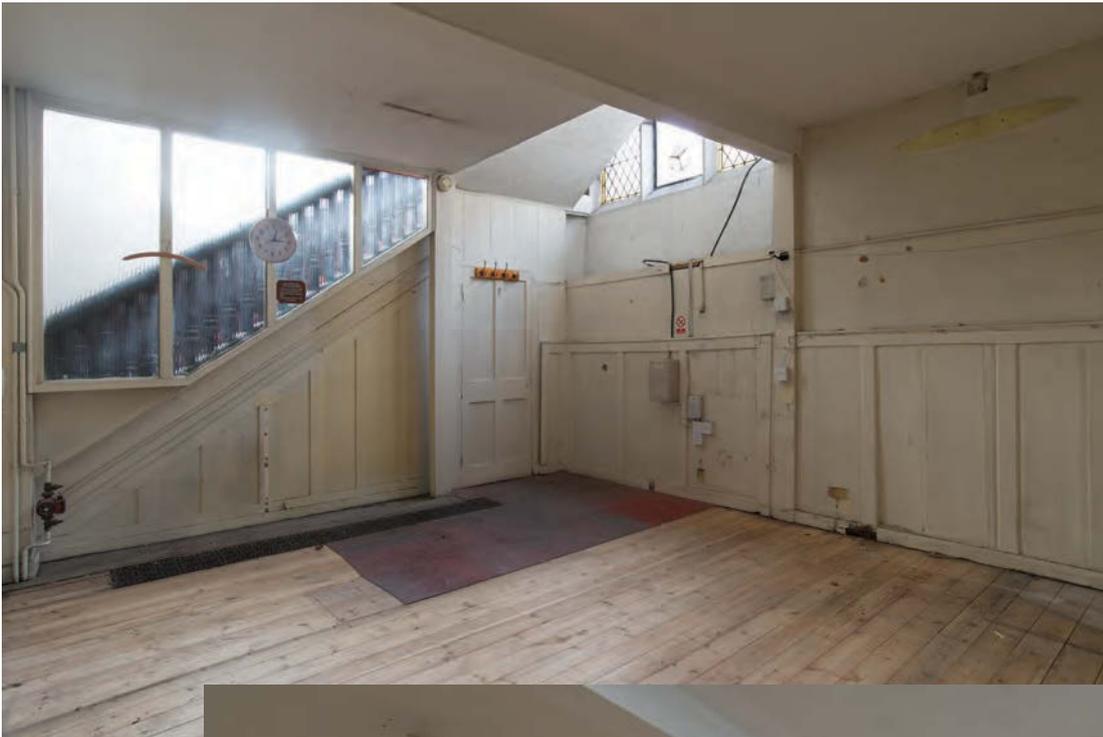
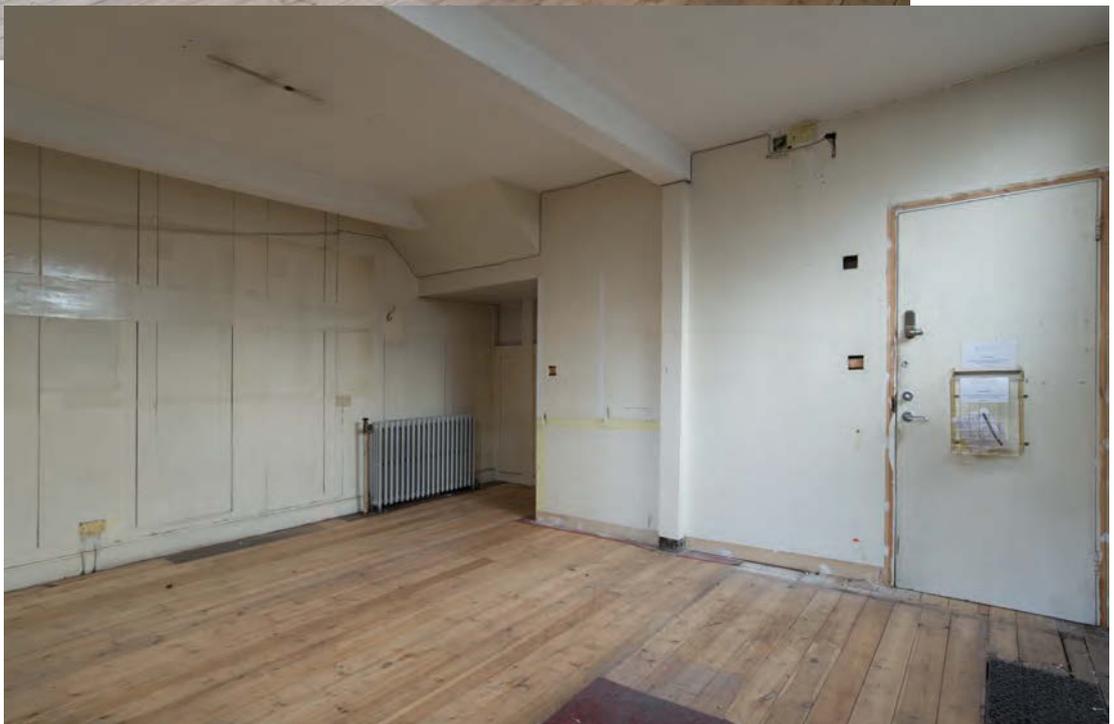
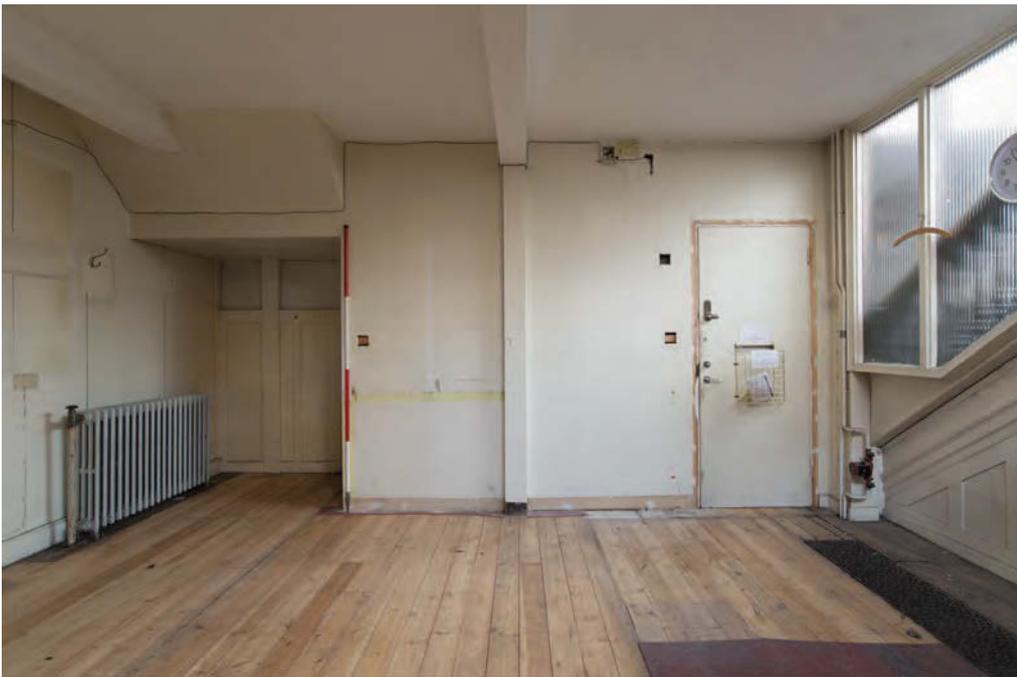
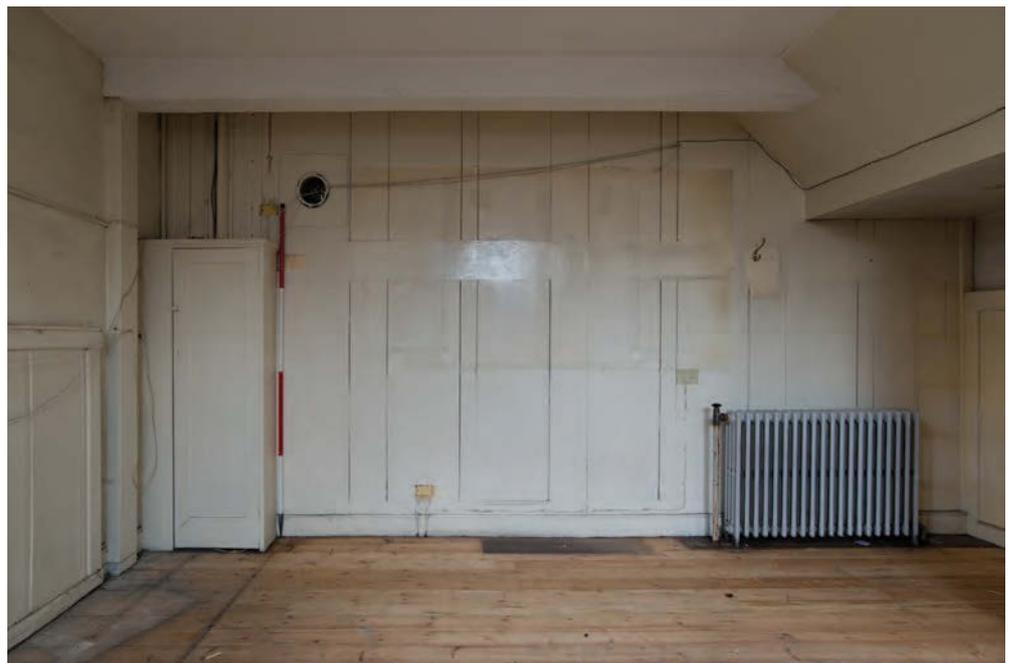
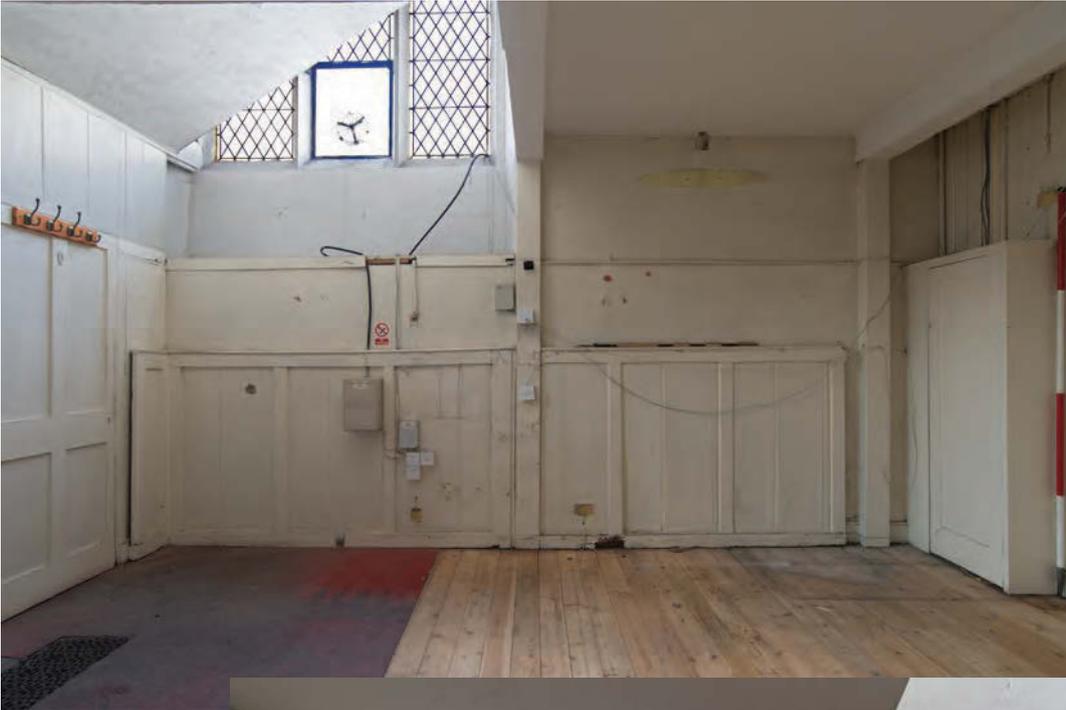
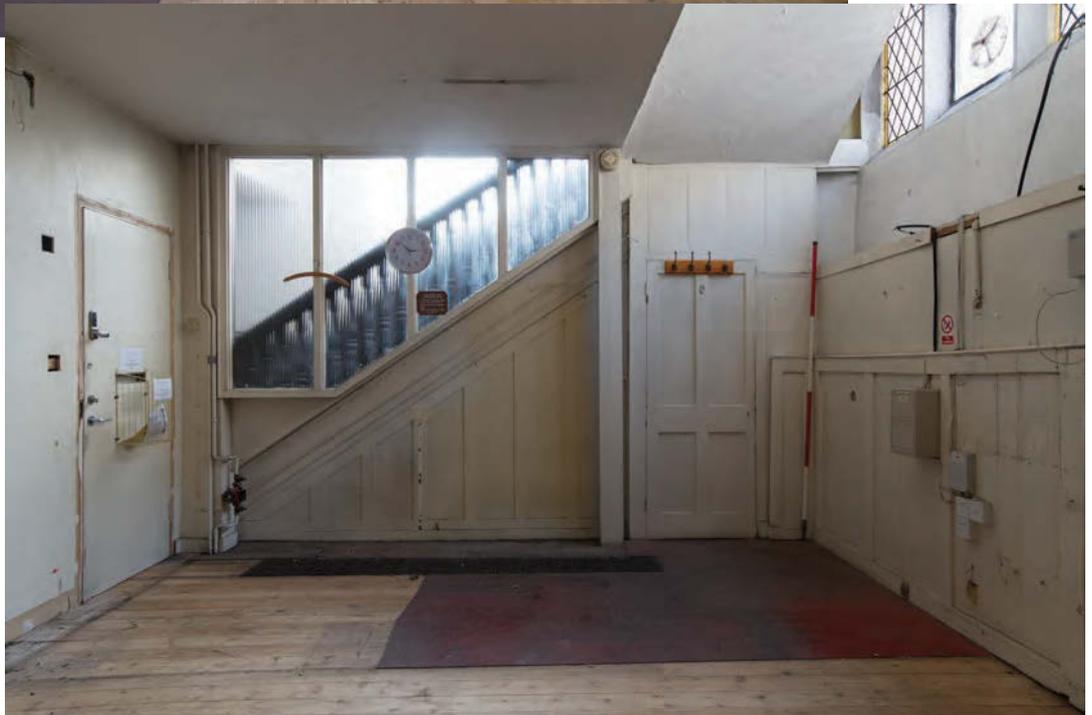
Panelling in the Northwest Office (figures 7-10)

The office area in the northwest corner of the church had been formed within the turret area adjacent to the tower inside the curve of the Gibbs staircase obscuring both it and two windows from view. Panelling was present on the north and east walls, but was different in appearance on each wall.

On the north wall the panelling extended to 1.25m high and consisted of six raised panels each 0.60m wide with 0.10m wide stiles set into upper and lower rails 0.10m deep. That the panelling is a secondary addition to the room is confirmed by the awkward cut partway through the fourth panel to fit around an RSJ support to the first floor office.

On the east wall the panelling extended from floor to ceiling, forming the partition dividing this space from the rest of the north aisle. The lower panels were 1.40m high with lower and middle rails 0.25m deep. The stiles alternated at 0.25m and 0.10m wide. The panel surface was flush with the rails and stiles. This panelling probably predates the later conversion to an office and may have been *in situ*, however, as figure 9 shows it is an awkward fit in the space and may equally have been a later insertion.

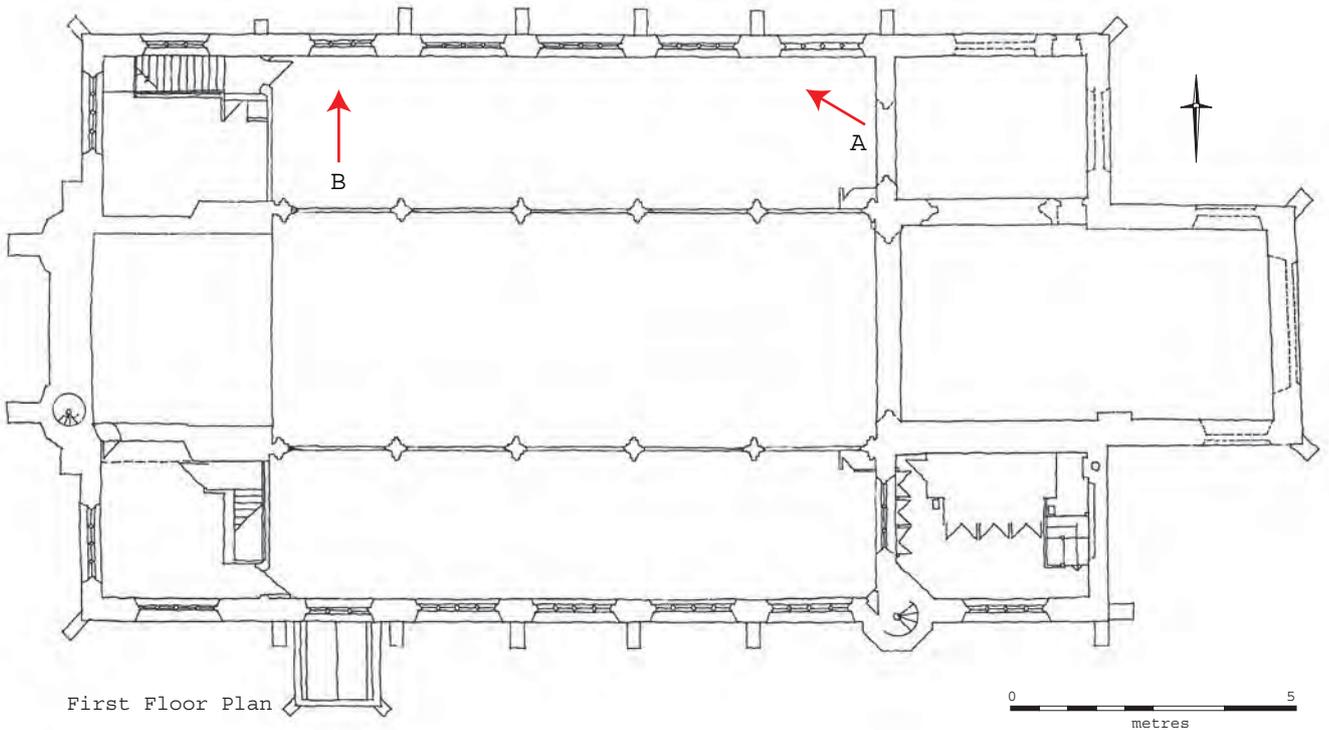
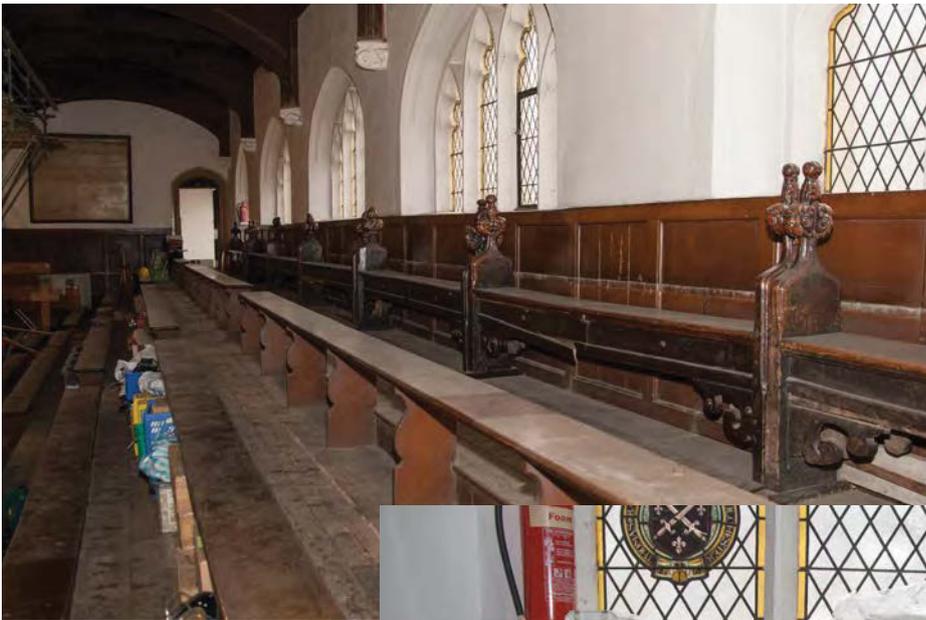
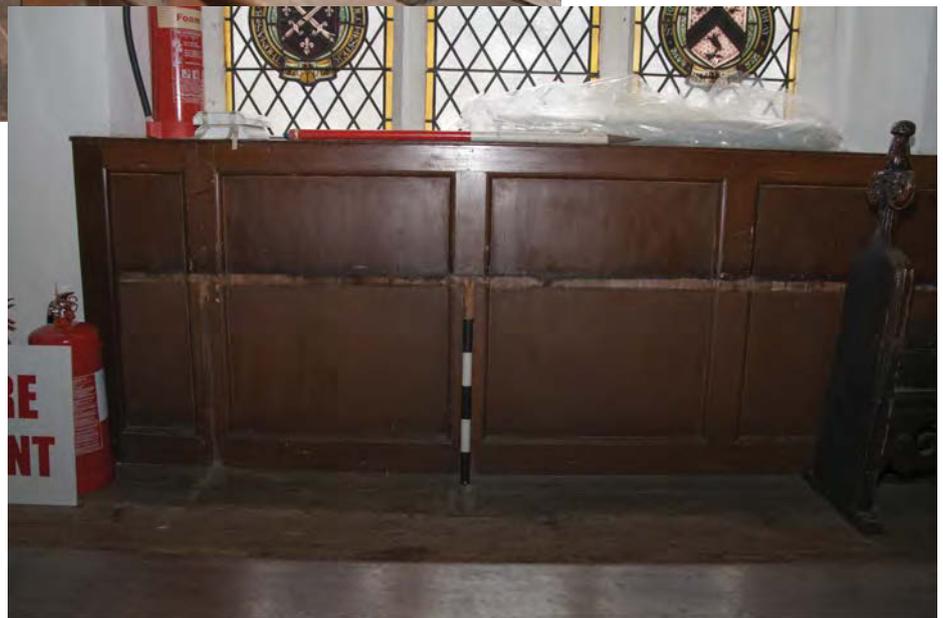
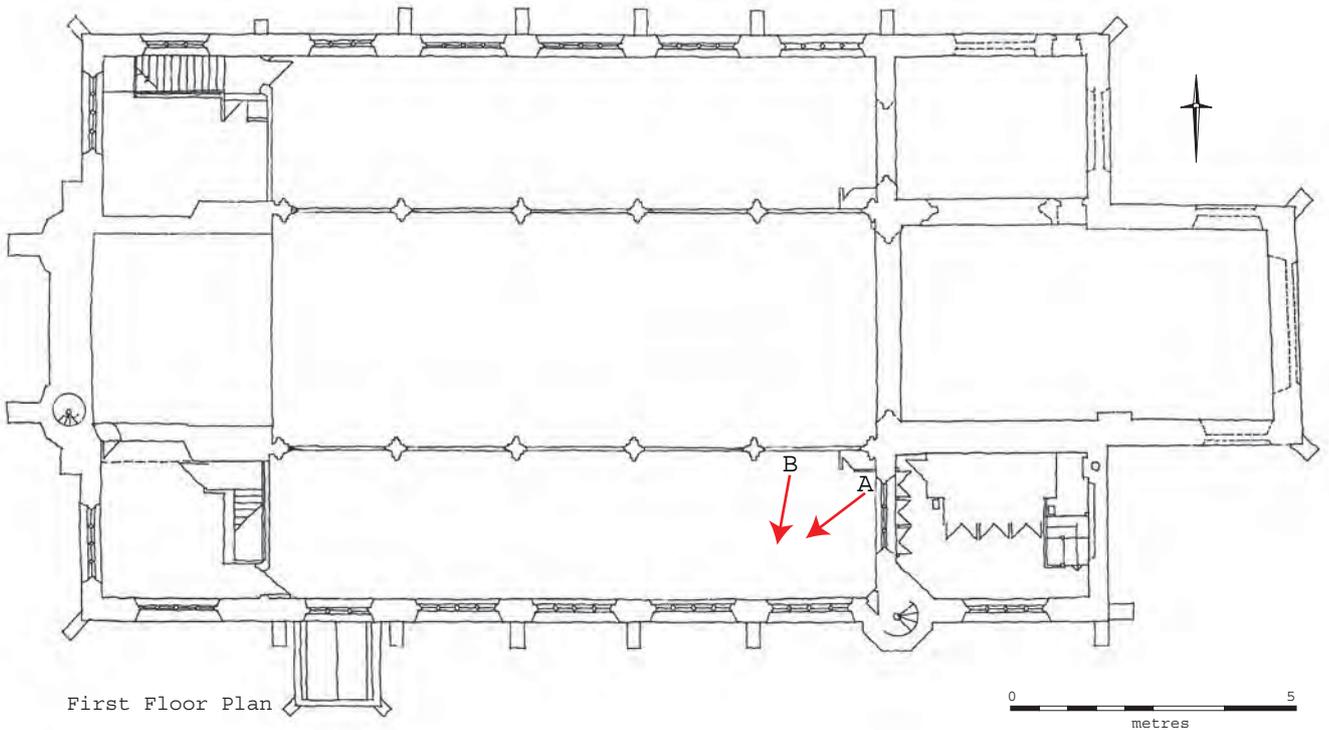
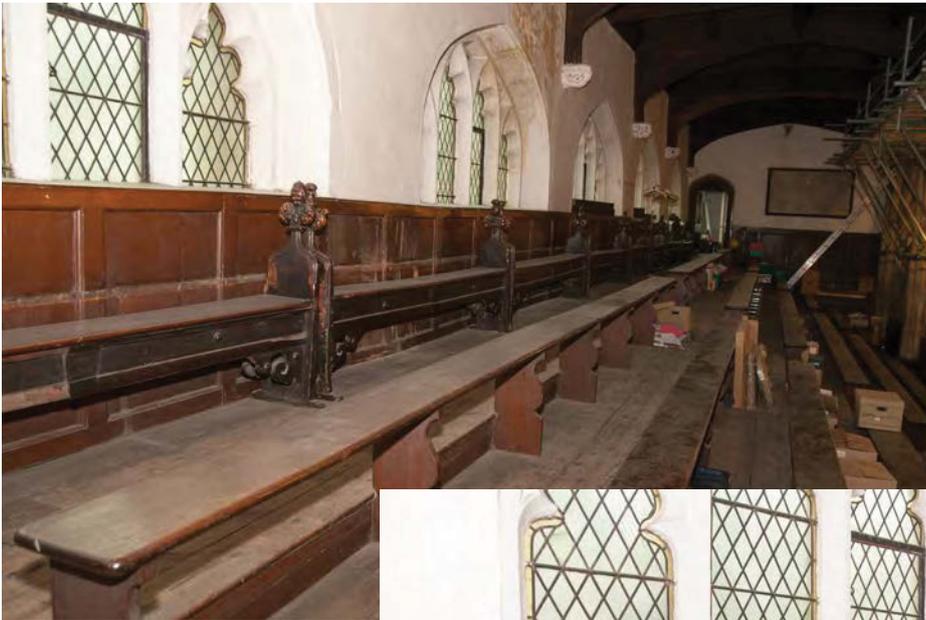
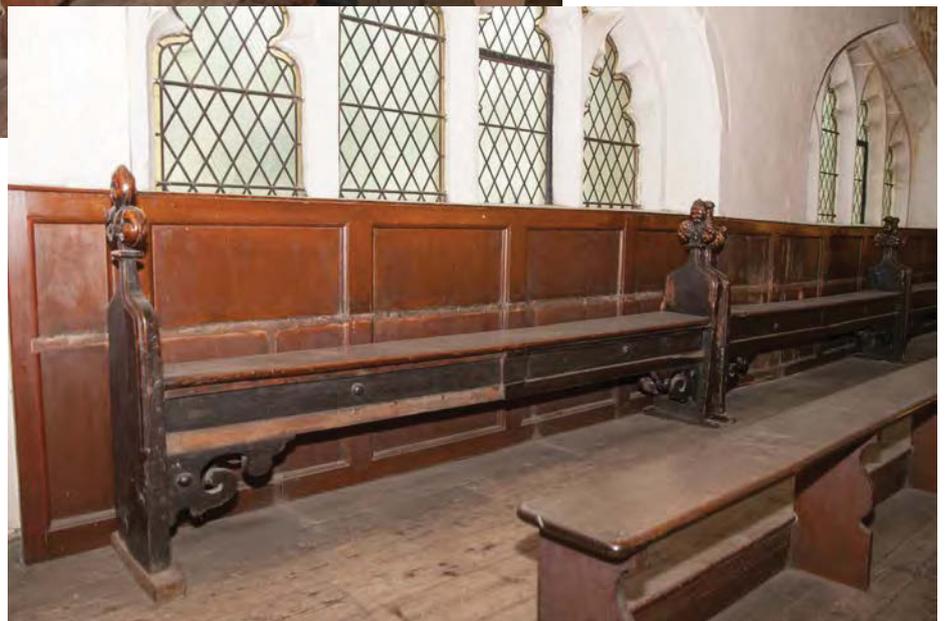
North and South Aisle Gallery Panelling (figures 11 and 12)

At the rear of the 1736 aisle galleries wainscot panelling extended along the full length on both sides. This remained *in situ* throughout on the south side, but was removed and reset on the north. The panelling was virtually identical on both sides with a typical panel measuring 0.68m wide with stiles 0.13m wide, the lower rail 0.12m deep and the upper rail 0.10m deep. Narrower panels were used at each end to fit. The panelling fits awkwardly across the windows reflecting its later addition to the structure, but there was not sufficient information visible to determine whether or not the panelling was contemporary with the construction of the galleries themselves.
