Great Saint Mary's Church, Cambridge

Observations during internal alterations

July - September 2013

Report No. 1256
HER No: ECB4154

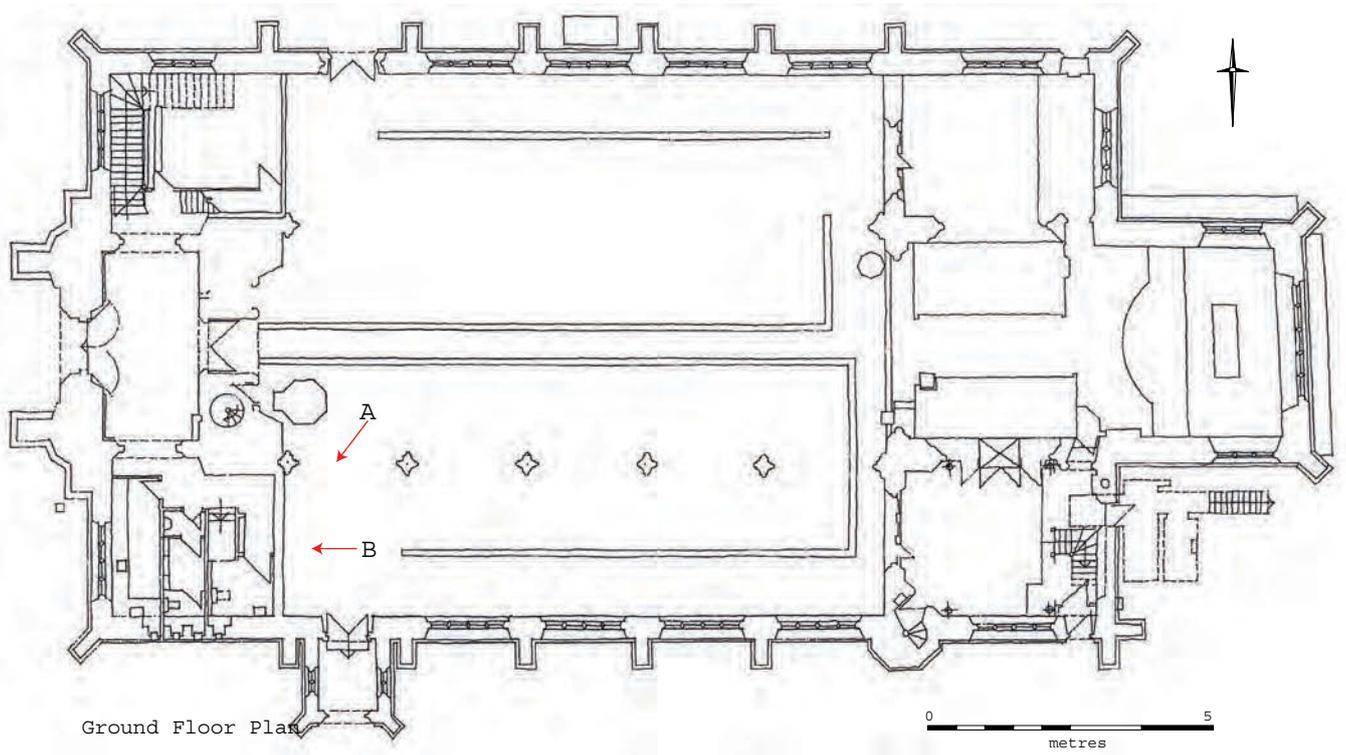
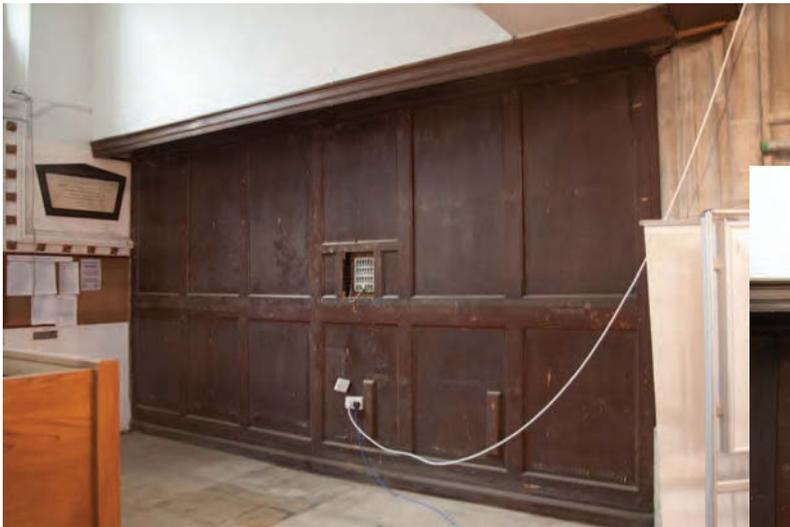
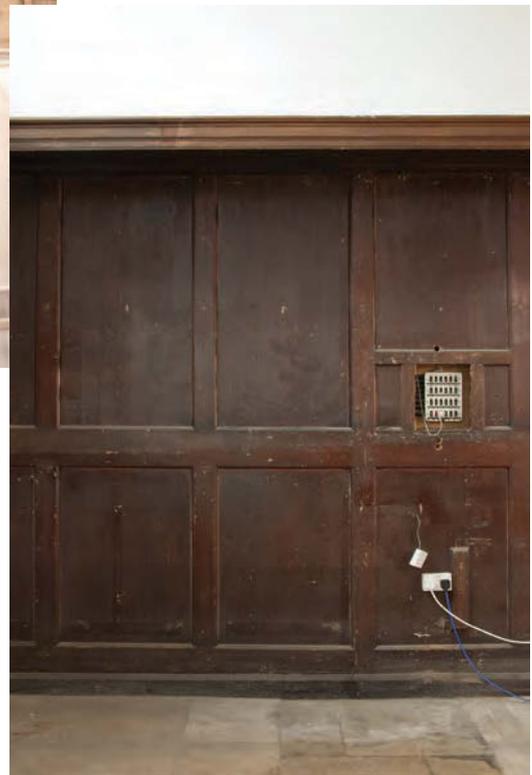
Figure 13: 20th Century Paneling and of Suite

Panelling at West End of South Aisle (figure 13)

Removal of cupboards at the west end of the south aisle revealed floor to ceiling panelling in dark brown stained wood. The panels were 0.68m wide with the lower section 0.92m high and the upper section 1.32m high. Stiles measured 0.14m wide, the lower, middle and upper rails all 0.21m deep.

The framework on which the panelling was set made it clear that the construction dated to the mid 20th century.

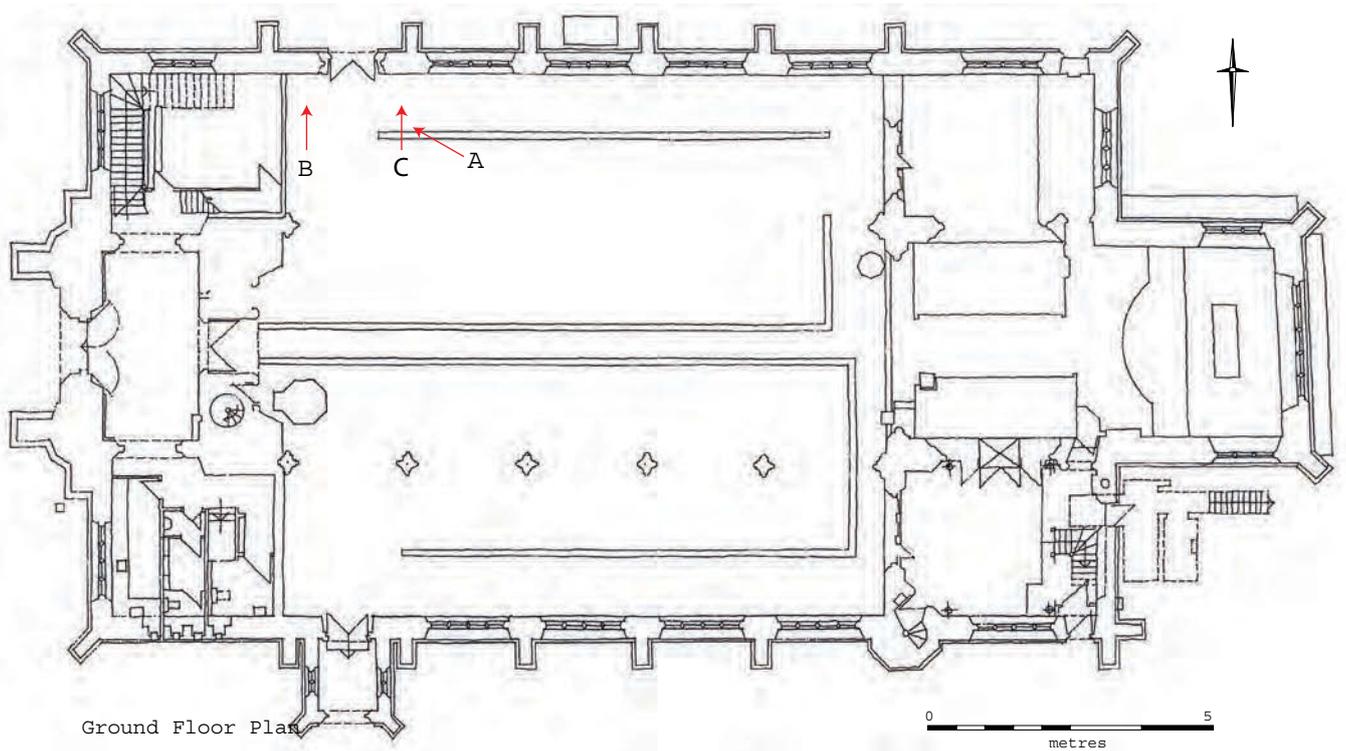
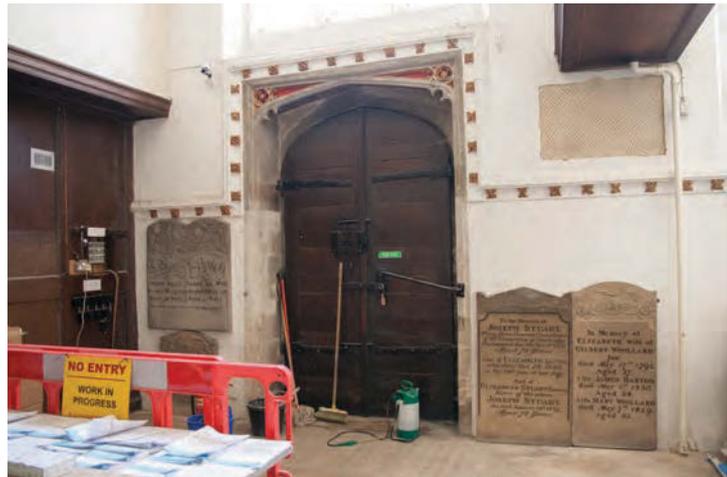
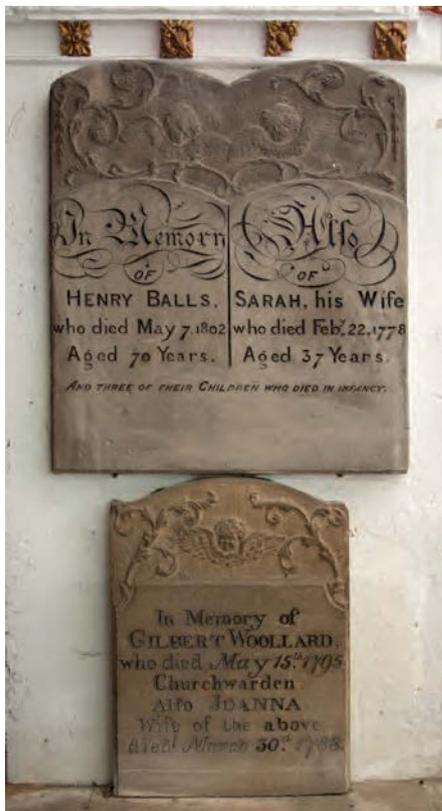
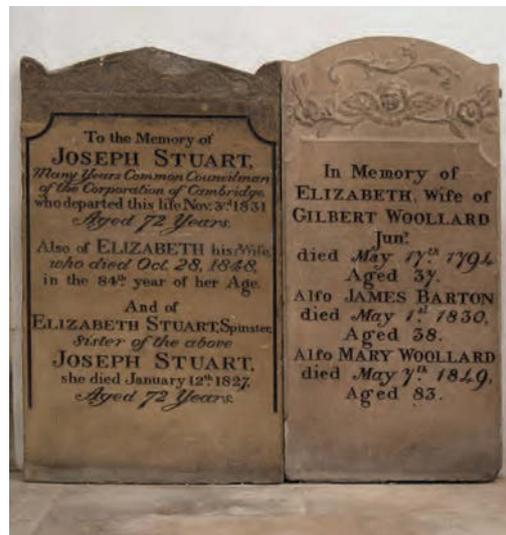
Figure 14: Memorials at the North Door

Wall Set Memorials by the North Door (figure 14)

Four wall-mounted memorials by the north door were photographed in their then positions as the new shop area would largely obscure them. The memorials appear to have been designed as outdoor gravestones, but the lack of weathering would indicate that they were never used as such.

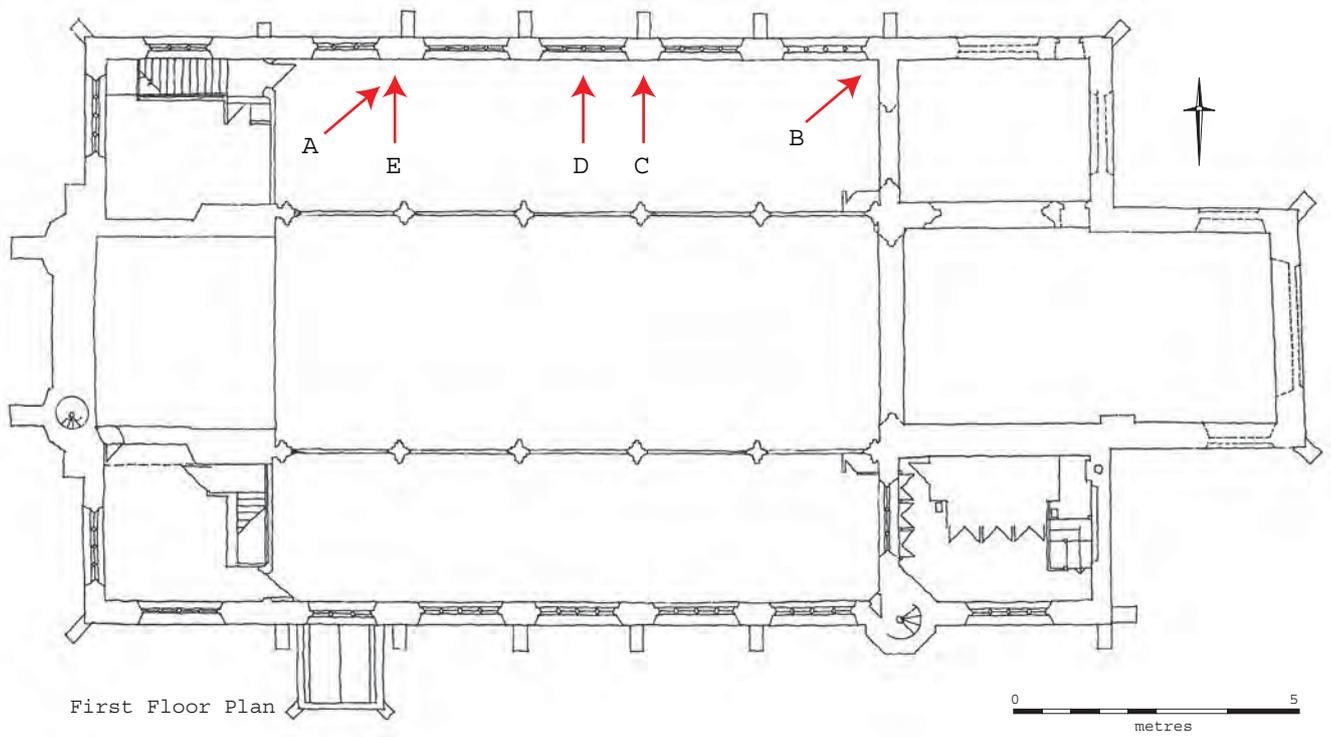
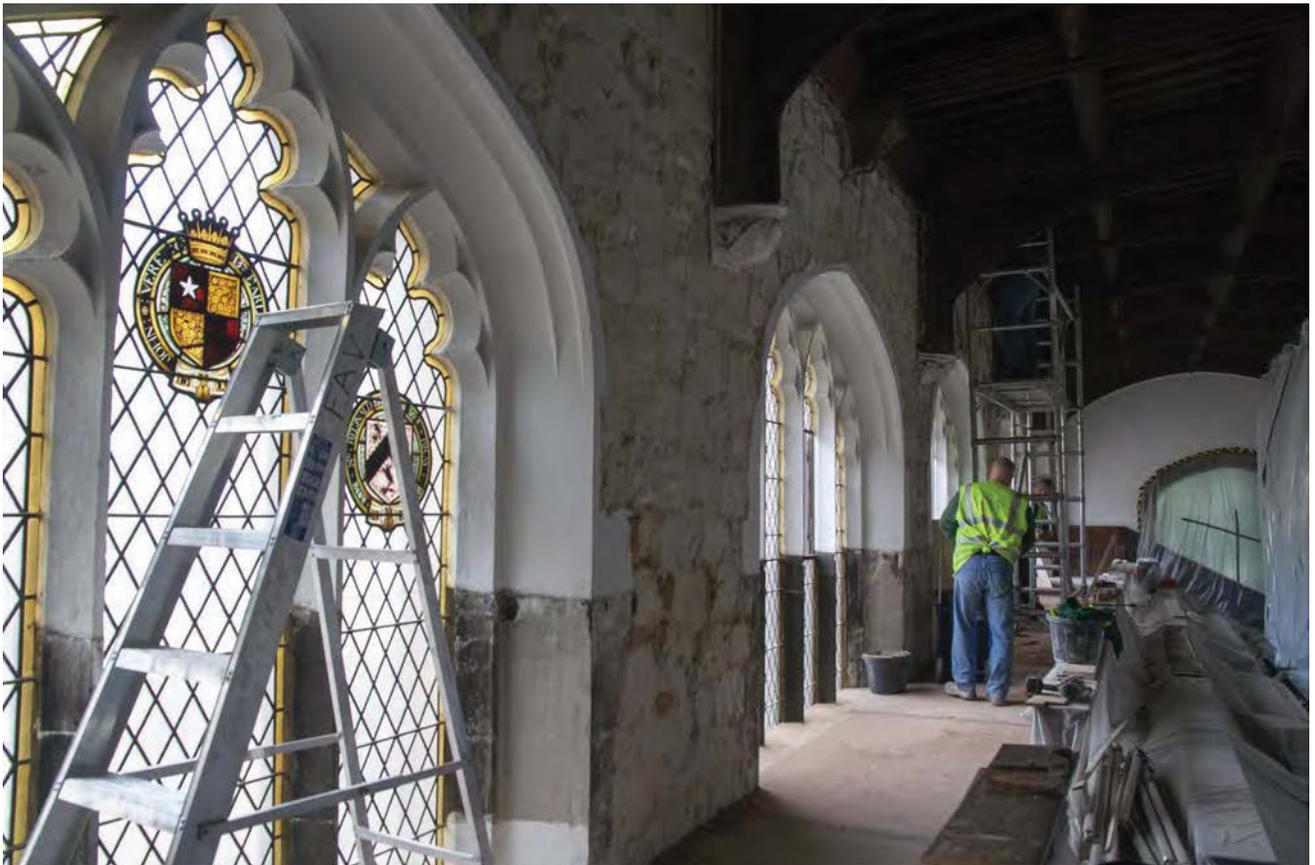
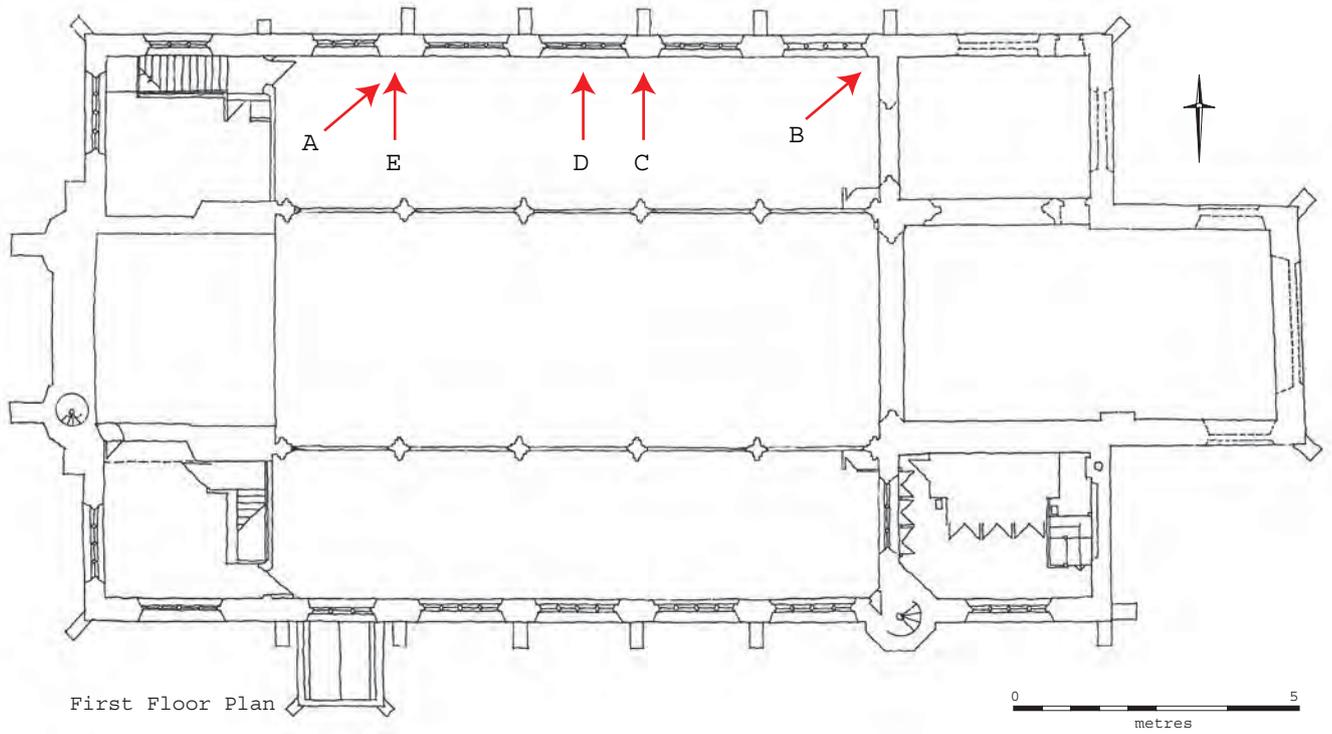
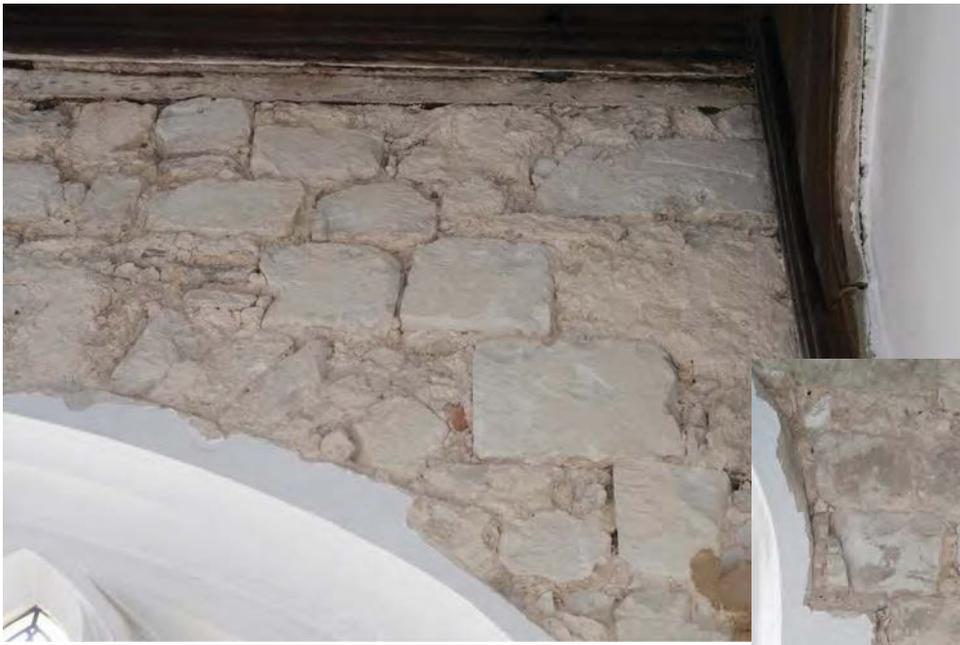
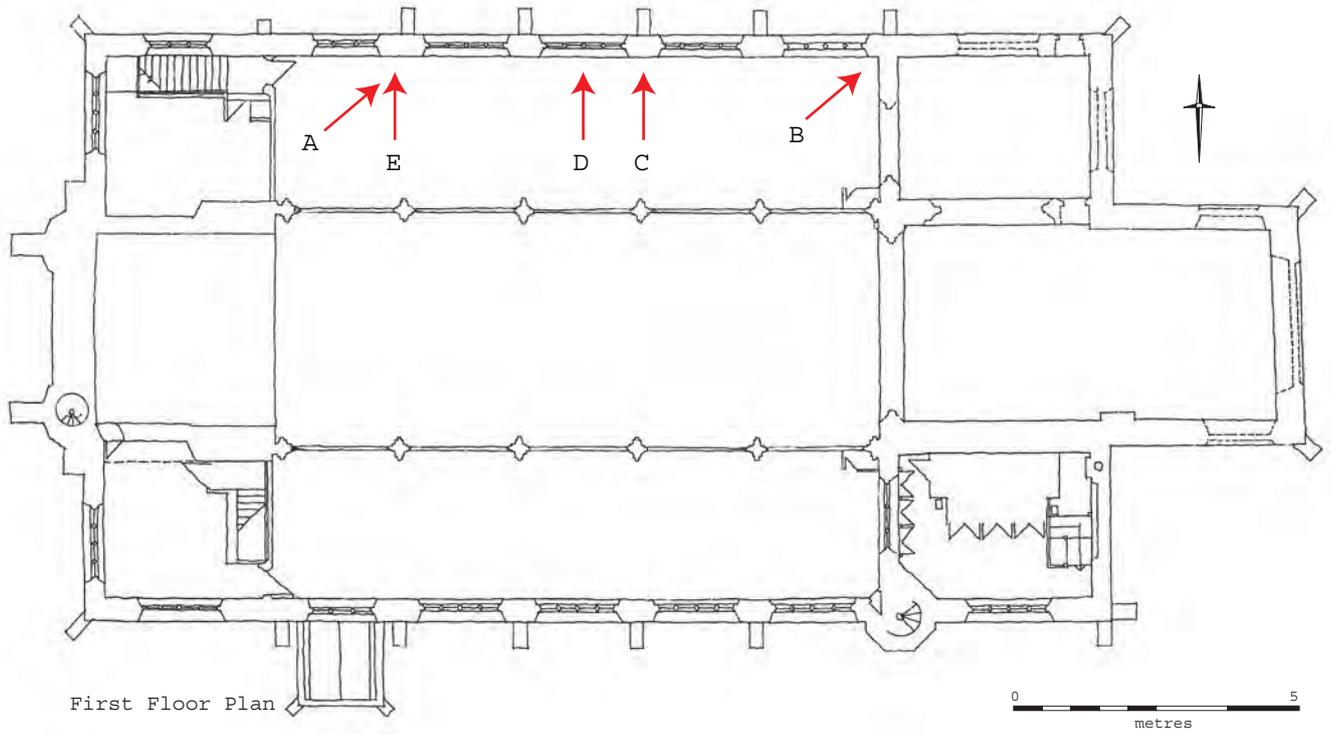
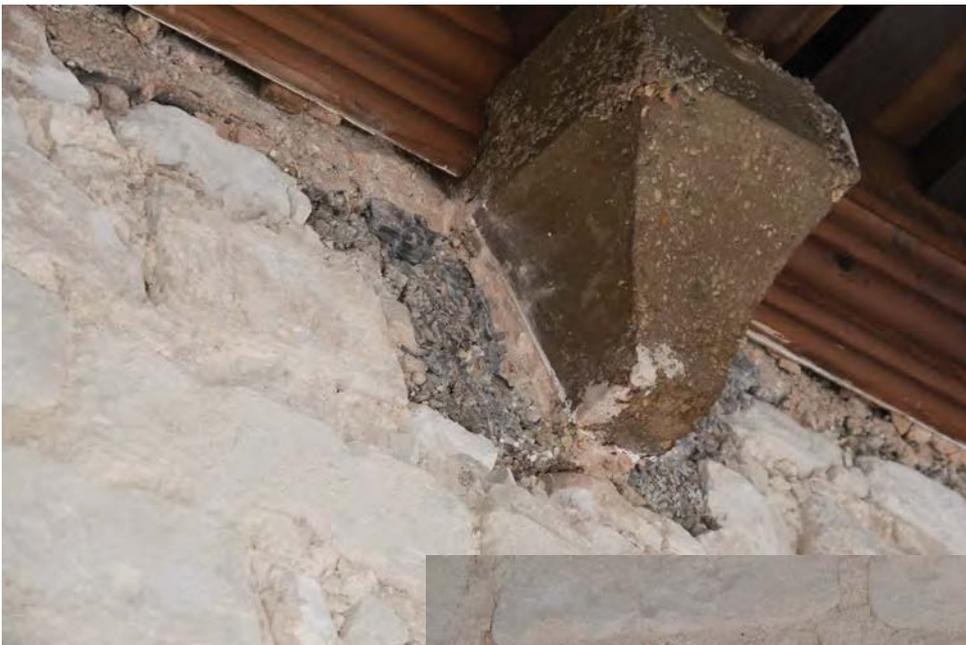
Stonework Revealed on the Upper North Wall (figures 15-17)

Following removal of the north gallery aisle panelling the plaster was removed from the wall surface revealing the block clunch facing of the wall below. Most of the stonework was cut into rectangular blocks of varying sizes infilled with smaller rubble. Only two pieces of reused stone were observed which may relate to the earlier church building, but which may equally derive from the masons yard and be unrelated.

Evidence of earlier (20th century) remedial and alteration work was clearly visible at the top of the wall in the form of inset concrete corbels to support the ceiling.
