# St. Mary's Church, Farcet, Cambridgeshire

## Archaeological Monitoring

**Archaeological Monitoring**

**Report No. 1263**

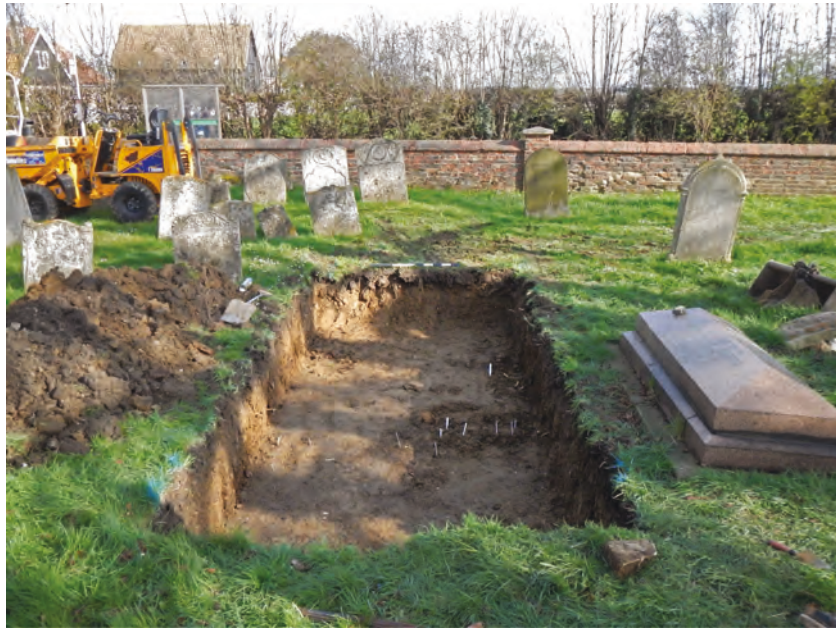
Figure 3. Soakaway 1 (top), Soakaway 2 (middle), and Soakaway 5, with 3 and 4 behind (bottom)

Within the southern sector of the cut frequent disarticulated human remains were recovered along with iron fragments and coffin nails. The material most likely originates from the disturbance of earlier graves by the cutting of new graves.

The first burial to be identified (Grave no 1a) was aligned in a north south direction and appeared to have been disturbed by the cut of a large sarcophagus immediately to the south of the grave. No obvious signs of a coffin or coffin nails were noted. Two further graves (Graves 1c and 1d) were noted aligned in an east west direction both with visible traces of a coffin and remaining coffin nails. The southern most grave (Grave no 1c) cut a small circular charnel pit (1b) that contained large quantities of disarticulated human remains including infants.

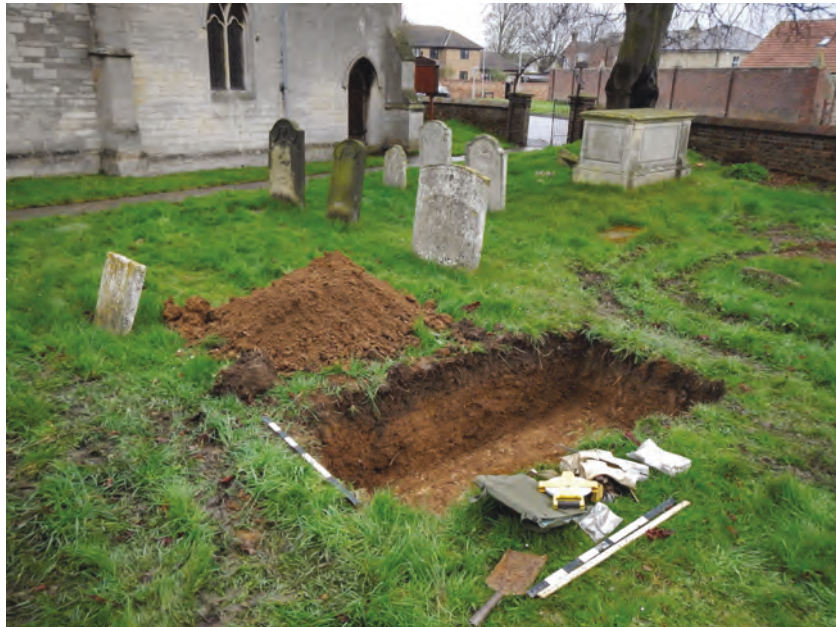
At the base of the cut frequent disarticulated human remains were recovered along with iron fragments and coffin nails. Cleaning of the surface revealed four partial grave cuts (Graves 2a, 2b, 2c, 2d) aligned in an east west direction. All the grave cuts exhibited traces of a coffin structure and remaining coffin nails. Further excavation was discontinued at this point. The two partial grave cuts (2a and 2c) in the western end of the soakaway pit are most likely associated with extant grave markers to the west of the pit.

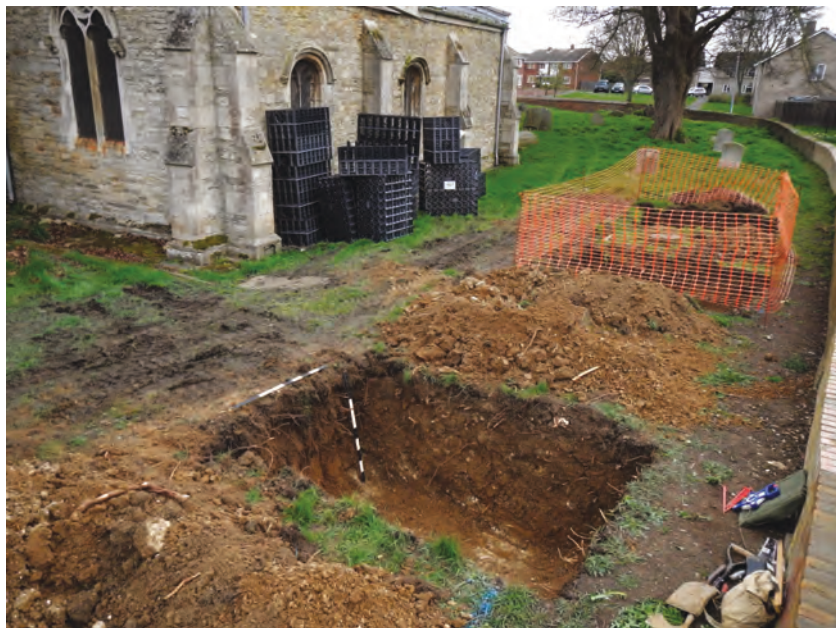
The ground at this point was disturbed by extensive tree rooting. No grave cuts were encountered.

At the base of the cut three partial grave cuts (graves 5a, 5b, 5c) were exposed aligned in an east west direction. All the grave cuts exhibited traces of a coffin structure and remaining coffin nails.
