Clare College, Cambridge

An Archaeological Evaluation

April 2015

Report No. 1286

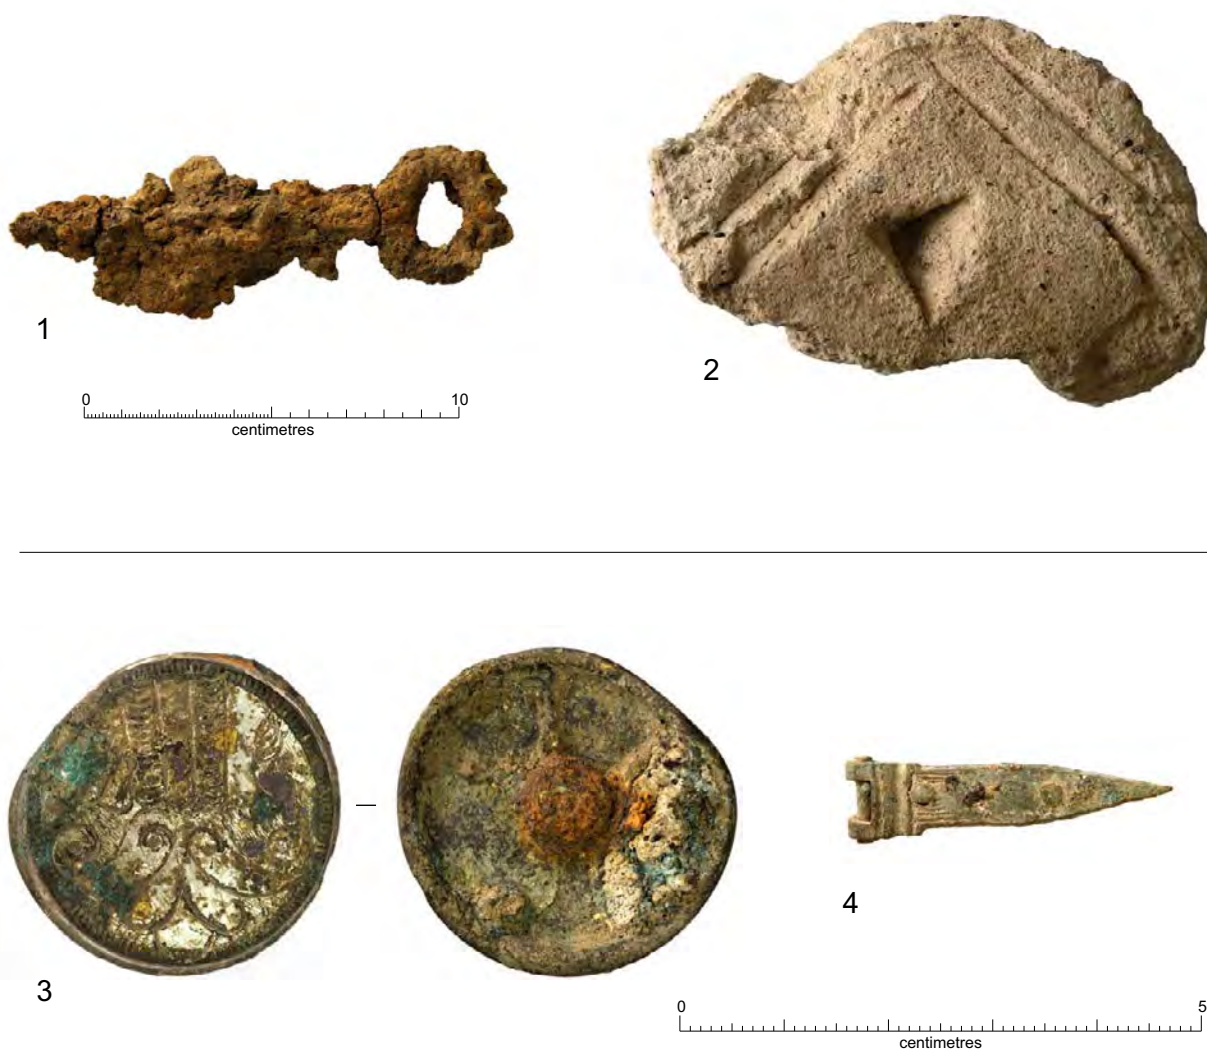
Figure 18. Photographs of selected finds

- 1) Iron key
- 2) Mortar with scored lines and lozenge
- 3) Decorated copper-alloy mount
- 4) Copper-alloy book clasp

The only Phase 2 ironwork was heavily corroded key of medieval form [433] (F.414) (see Figure 18.1), a large rectangular plate [315] (F.304) and an unidentifiable fragment.

F.406 [414]: a cast circular mount/fitting or cover of 28mm diameter, with traces of a central iron fixing to the reverse. The mount is silvered or tinned to the side and upper surface, with the latter decorated with engraved scroll work in the form of a stylised palm tree within a milled border. No parallels for this mount have been found within the published finds corpuses, and therefore its specific function cannot be ascertained. However, it is well made and decorative, and stylistically it most likely dates to the 16th or 17th centuries. Weight 34g.

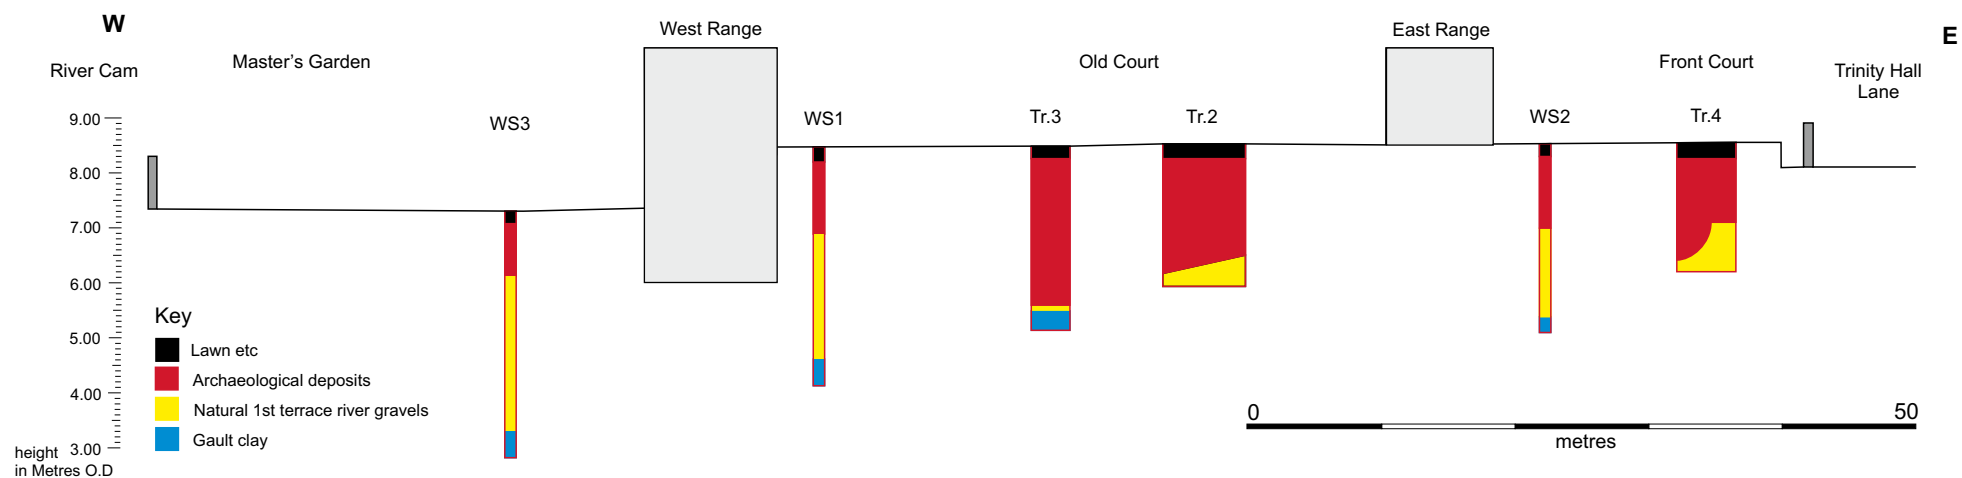
Figure 21. Plan with composite section of archaeological investigations, showing underlying deposits in area (NB vertical scale exaggerated)
