Mere View, Yaxley, Cambridgeshire

An Archaeological Evaluation

Cambridge Archaeological Unit
University of Cambridge

Report No. 1306

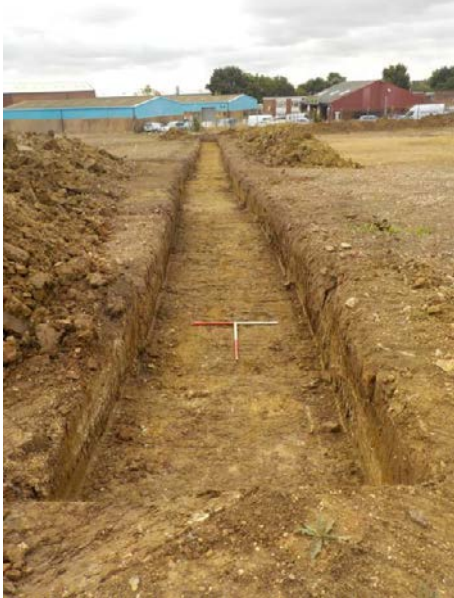
Trench 1			
Length (m)	60	Demolition Rubble (m)	0.10-0.15
Width (m)	1.80	Subsoil (m)	0.18-0.30
Orientation	E-W	Subsoil (colluvial) (m)	0-0.15
Features (n=0)		Shallow depth of colluvium appears in eastern extent. No finds. No features. 3 modern pipe trenches containing services and 1 land drain encountered.

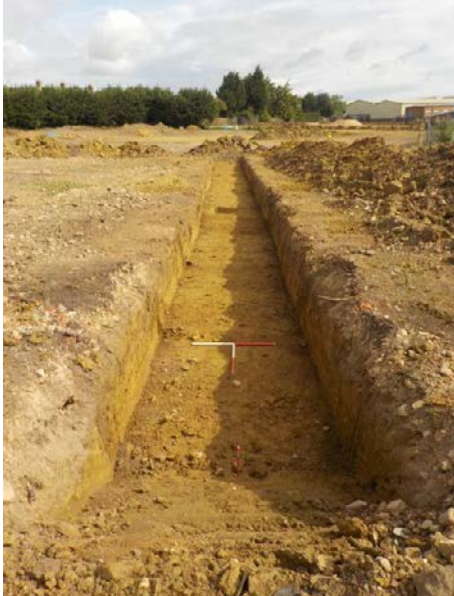
Trench 2			
Length (m)	34.50	Demolition Rubble (m)	0.10-0.15
Width (m)	1.80	Subsoil (m)	0.25-0.30
Orientation	N-S	Subsoil (colluvial) (m)	0-0.18
Features (n=0)		Shallow depth of colluvium appears in northern extent. No finds. No features. 1 modern pipe trench containing services and 1 modern pit encountered.

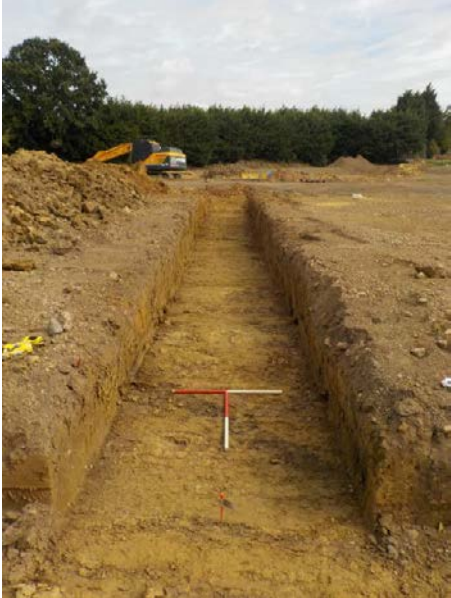
Trench 3			
Length (m)	20.50	Demolition Rubble (m)	0.10-0.15
Width (m)	1.80	Subsoil (m)	0.08-0.25
Orientation	N-S	Subsoil (colluvial) (m)	0-0.15
Features (n=0)		Shallow depth of colluvium appears in southern extent. No finds. No features. 2 modern pipe trenches containing services, 1 also in Tr1.

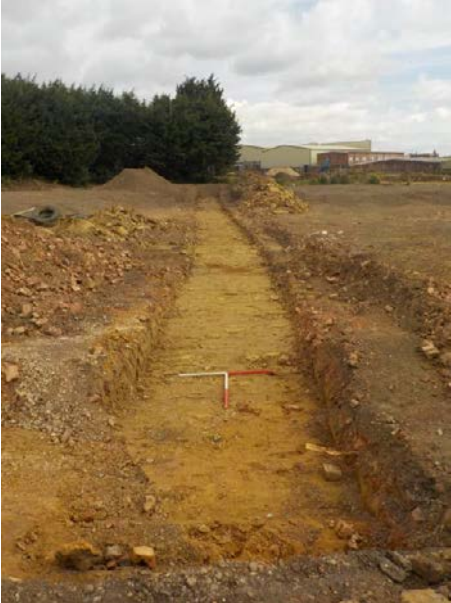
Trench 5			
Length (m)	46.50	Gravel dump (m)	0-0.80
Width (m)	1.80	Made Ground (m)	0
Orientation	NE-SW	Subsoil (m)	0
Features (n=0)		Rubble directly overlying geology. No finds. No features. 2 modern pipe trenches containing services, 2 modern land drains, plus 1 modern hydrocarbon contaminated pit feature with brick rubble same as rubble covering rest of site.

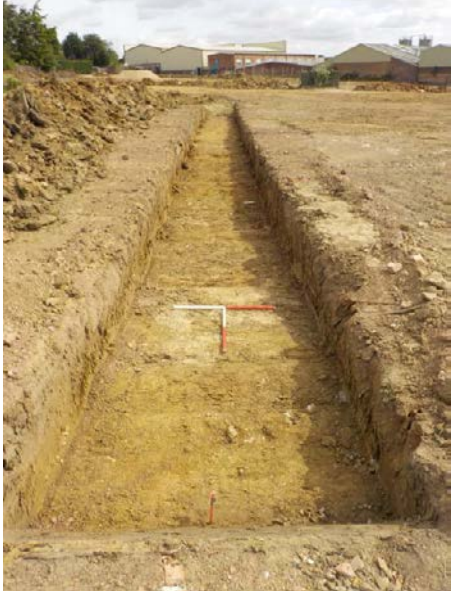
Trench 6			
Length (m)	35.50	Demolition Rubble (m)	0-0.10
Width (m)	1.80	Made Ground (m)	0
Orientation	NE-SW	Subsoil (colluvial) (m)	0.25-0.35
Features (n=0)		35m trench cut but backfilled to shorten length to 33m due to diesel contamination spilling in from modern culvert. No finds and no features. 1 modern pipe containing services and 1 land drain. Colluvial overlying geology in whole of trench area.

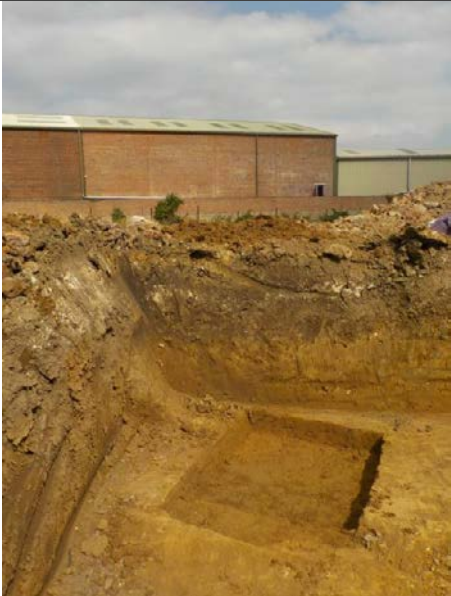
Trench 7			
Length (m)	40.00	Demolition Rubble (m)	0.10-0.30
Width (m)	1.80	Made Ground (m)	0.2-0.35
Orientation	E-W	Subsoil (colluvial) (m)	0->0.55
Features (n=0)		Colluvium over southern extent containing 1 piece of Med/Post-Med ceramic. No features. Test pit 1 dug to test for more finds and/or features but no results. Colluvial tested to full depth in Tr.8.

No archaeological features were identified in the trenched area. However, 3 sherds of Medieval/Post-Medieval ceramic were found in the presumed colluvial layer at the junction of Trench 7 and Trench 8. Two 1m x 1m test pits were hand dug through this

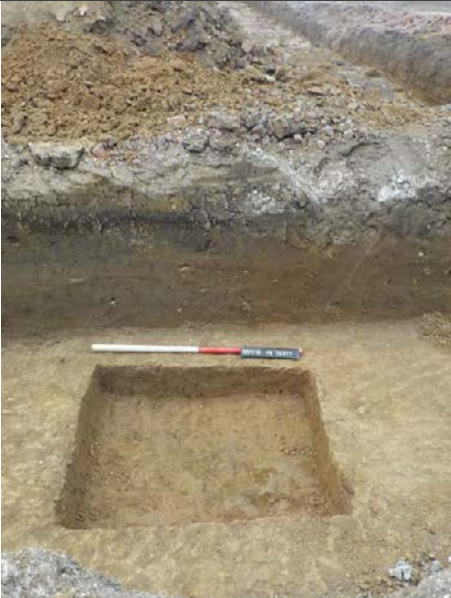
Trench 8			
Length (m)	16.00	Demolition Rubble (m)	0.10-0.20
Width (m)	1.80	Made Ground (m)	0.25-0.40
Orientation	N-S	Subsoil (colluvial) (m)	0.55-0.80
Features (n=0)		Colluvium present in whole extent of trench containing 2 pieces of Med/Post-Med ceramic and Med/Post-Med/Modern brick. No features. Test pit 2 dug to test for more finds and/or features but no results. Colluvial tested to full depth in Sondage 1 at southern extent of trench. Full depth 0.80m. Backfilled immediately for safety..

layer, neither of which produced artefacts and no features were present (Figure 2). The layer was then completely removed in the southern half of Trench 8 to investigate any possible features masked below but no features were encountered. In other trenches (Trenches 1, 2, 3, 6, 12) the colluvial layer contained no finds or features and was removed to show no features beneath.

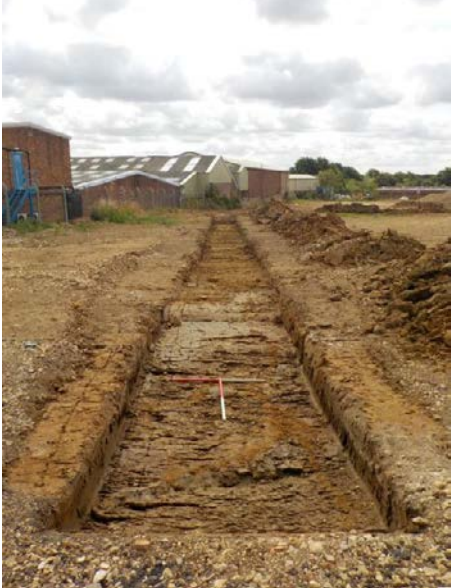
Trench 9			
Length (m)	40.00	Demolition Rubble (m)	0-0.10
Width (m)	1.80	Made Ground (m)	0
Orientation	NW-SE	Subsoil (colluvial) (m)	0
Features (n=0)		No finds. No features. Rubble directly overlying geology. 1 modern land drain, plus 2 small areas of modern hydrocarbon contaminated disturbance with brick rubble same as rubble covering rest of site, probably associated with demolition works.

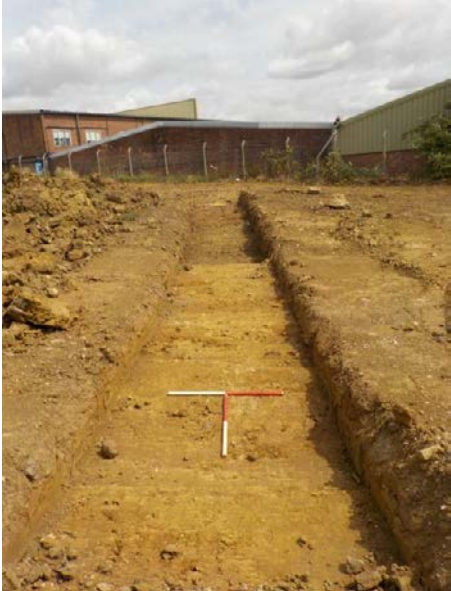
Trench 10			
Length (m)	19.00	Demolition Rubble (m)	0-0.10
Width (m)	1.80	Made Ground (m)	0
Orientation	NW-SE	Subsoil (m)	0
Features (n=0)		No finds. No features. Rubble directly overlying geology. 1 large area of modern hydrocarbon contaminated disturbance with brick rubble same as rubble covering rest of site, probably associated with demolition works. Machine tested to depth of 1.4m and immediately backfilled for safety.

Larger areas of modern redeposited material in Trench 10 and Trench 12 were tested via machine excavation in an attempt to expose the base of the disturbance. These excavations reached depths of 1.4m and 1.2m respectively but neither reached the bottom of the redeposited material before having to be backfilled for reasons of safety. It is highly unlikely that any archaeological features beneath these modern disturbed areas would have remained.

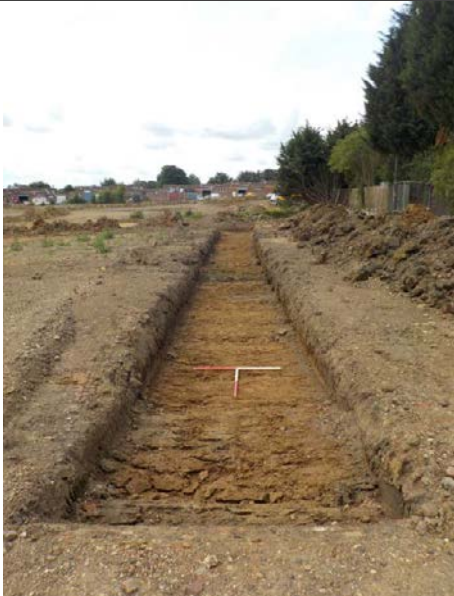
Trench 11			
Length (m)	30.00	Demolition Rubble (m)	0.10-0.20
Width (m)	1.80	Made Ground (m)	0.20-0.35
Orientation	NE-SW	Subsoil (m)	0
Features (n=0)	No finds. No features. 1 small area of modern hydrocarbon contaminated disturbance cut from surface with brick rubble same as rubble covering rest of site, probably associated with demolition works.

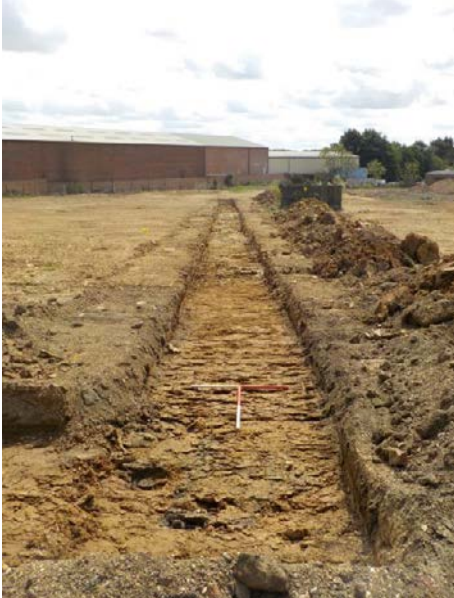
Trench 12			
Length (m)	70.00	Demolition Rubble (m)	0-0.10
Width (m)	1.80	Made Ground (m)	0.10-0.15
Orientation	NW-SE	Subsoil (colluvial) (m)	0-0.60
Features (n=0)	No finds. No features. 1 modern land drain, 3 modern pipe trenches containing services and 1 large area of modern disturbance tested to a depth of 1.2m. South-eastern 10m of trench exhibits gradually increasing depth of colluvium.
