**Archaeological Monitoring at Godolphin Cottage, Gog
Magog Hills Estate, Cambridgeshire.**

Cambridge Archaeological Unit
University of Cambridge
Department of Archaeology

January 2016

Report No.1322

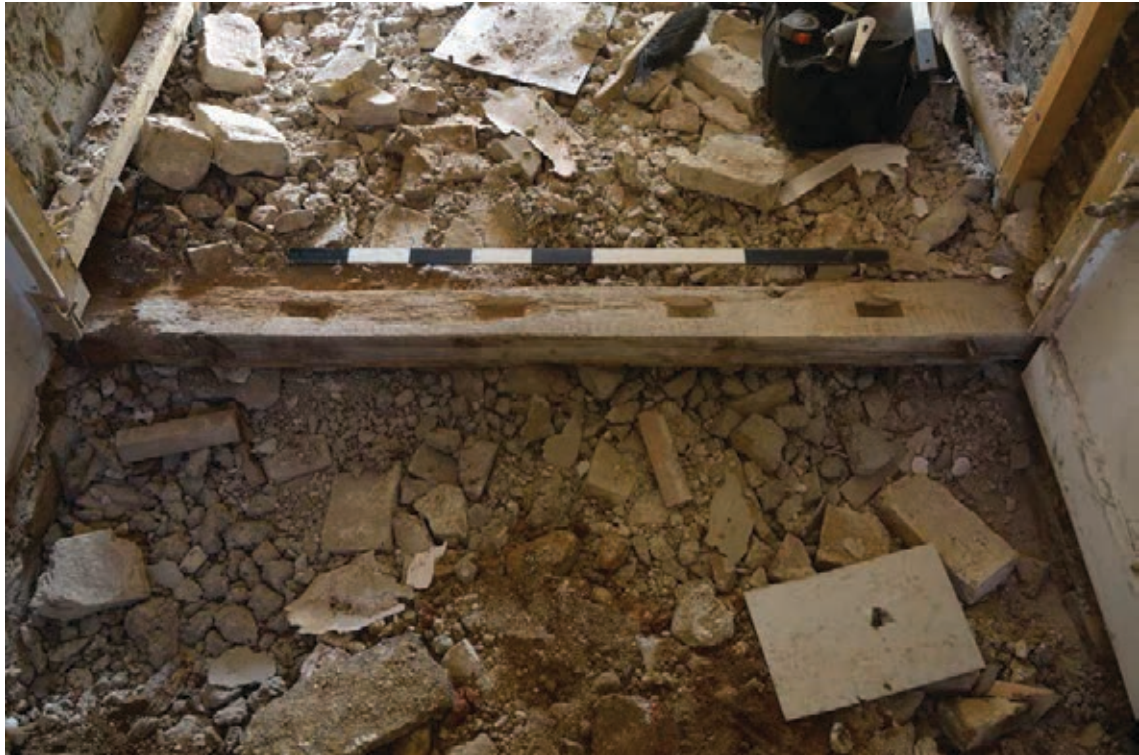
Figure 9. Wooden baseplate exposed in connecting corridor

Works in the area adjacent and to the east of the garage revealed traces of earlier internal divisions with remnants of a staircase base (fig 9) including a sill plate. Underlying these was a paved stone floor (fig 10) forming a front to back connecting corridor possibly part of the original Stable Block construction. Initial plans for the conversion of the Stable Block from 1957 (fig 5), show the internal divisions and staircase within the connecting corridor as well as the fireplace and chimney base attached to the east interior wall of the garage, their removal probably dates to this period. The internal divisions in the southern segment of the connecting corridor are described as a fuel store, during the works the original brickwork in this area was exposed and appeared to be coated in coal dust confirming its function as a fuel store.

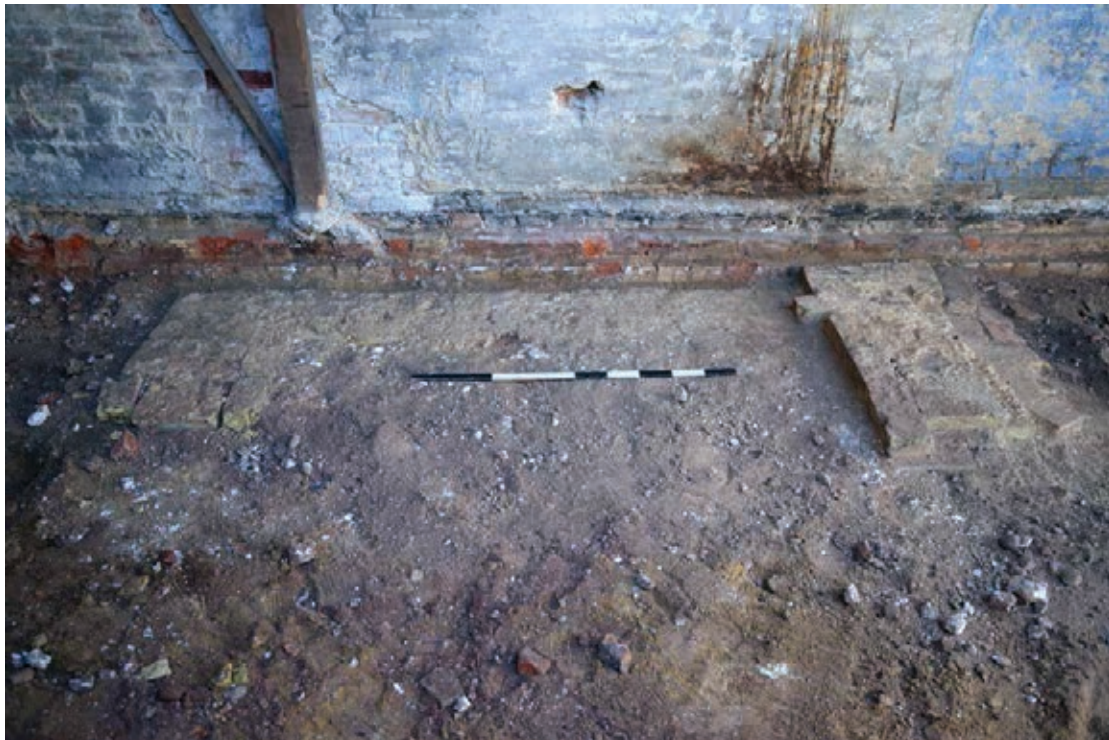
Figure 11. Remnants of Chimney base

00.30m (LOE) Top of yellow brick wall with pale sandy mortar exposed, with adjacent compacted reddish brown sandy clay surface with frequent small to medium sub rounded chalk inclusions. Latter stripping of the area revealed the brickwork to be the truncated base of a large chimney and fireplace butting up to the east wall.

The initial stripping of the ground in preparation for the works within the dwelling revealed structural remnants of parts of the buildings. The removal of the fireplace and chimney stack base (fig 11) exposed by the stripping were most likely the result of works done in the late 50's to convert the stable block into domestic dwellings, plans (fig 5) dating to the period show details of the fireplace and further internal divisions of the garage. The garage is located at the western extent of the former stable block. Internally there is a straight joint at the corner where the south elevation butts up to the wall suggesting the garage structure is a later addition to the 18th C. Stable block range. The soakaway (fig 12) uncovered in the north west corner of the garage lies in an unusual position in relation to the garage, with parts of it underlying the garage doorstep and west wall. Its placement suggests it predates the construction of the garage.

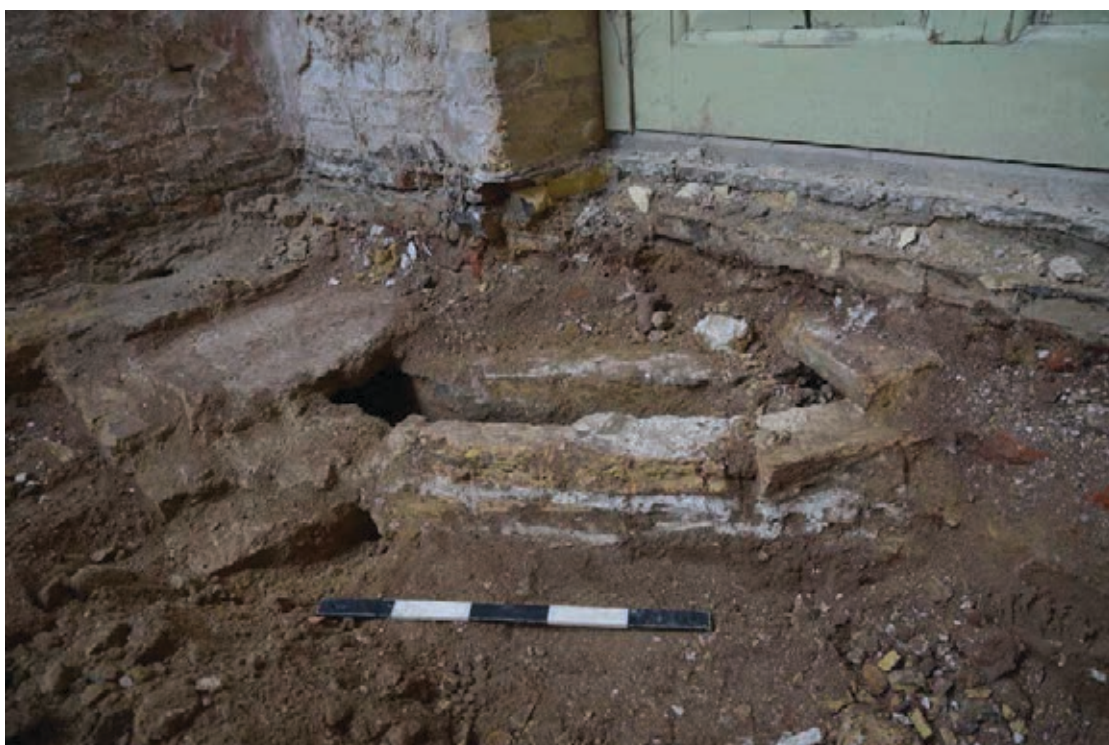
Figure 12. Drain serving soakaway in the north west corner of garage

00.30-0.80m (LOE) Within the northern segment of the test pit a yellow brick wall with pale mortar could be seen aligned approximately east to west (later stripping of the whole area revealed part of a soakaway structure). The rest of the test pit was filled with a yellowish brown silty clay with a moderate frequency of small to medium sub angular gravel inclusions gravel with occasional fragments of building debris, poorly sorted.
