Holy Trinity Church, Hildersham Cambridgeshire

Archaeological Evaluation and Monitoring

Cambridge Archaeology Unit University of Cambridge January 2016

Report No. 1319

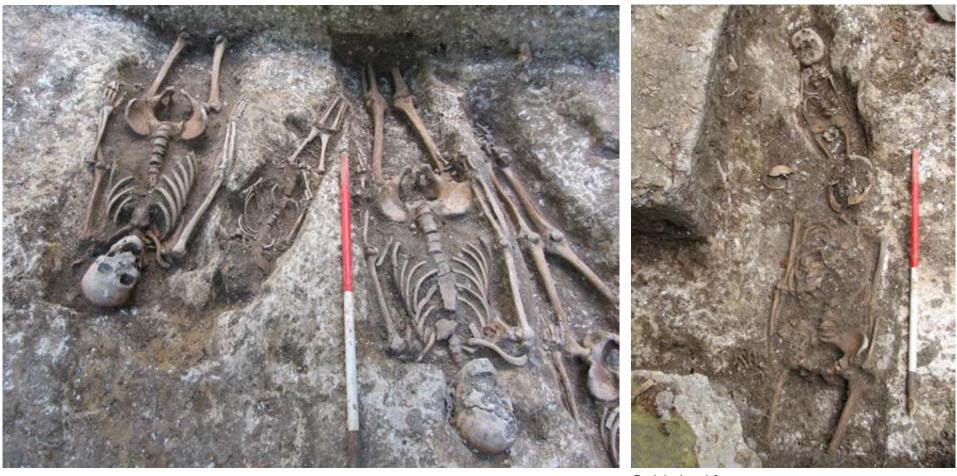
Figure 3. Photographs of burials within the north porch excavation area

Burials 9-12 Burials 4 and 6

sewn-up with thread(?); the evidence for this being seen in the form of cuts into the chalk moulded to fit the shape of the shoulders, neck and head, whilst tapering at the other end from the pelvis to the toes (see Burials 5, 10, 11-14+ Figure 3). However, four 'coffin-shaped' grave cuts were also noted (Burials 4 +6-8). Four sherds of 12th century (Early Medieval) pottery including St.Neots and Greyware types were recovered from the general area of the graves, with two sherds collected from the actual fill (019) of grave cuts, but bagged up as generic 'grave fill' finds. Another two sherds were re-deposited finds from the fill (020) of a Postmedieval pit (F.4) associated with an old soakaway. An earlier posthole (F.1) and pit (F.2) were encountered close to and just under the walls of the church (SEE Figure 2), thus it seems possible that they pre-date it; being loosely referred to here as 'Saxon/Medieval'? However, the latter assignation remains uncertain.

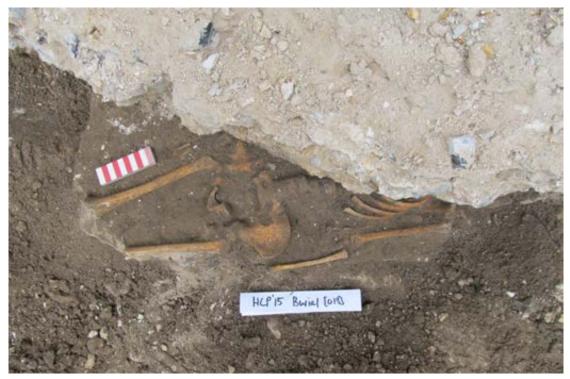
Burial 18

Without radiocarbon dating the skeletons, a precise date for these burials was impossible to determine. However, several factors point to them being Medieval. Burial 18 was that of a child lain below the flint and mortar hardcore/make up for the step of the north door, and this appears to have been truncated by the wall foundation itself. This indicates that this burial at least predates the construction of this church wall. Meanwhile the anthropomorphic shape of the grave cuts mimic that of Medieval stone coffins (such as those found at Bakewell, Yorks.). Such grave cuts are often seen within monastic graveyards, such as that of the Benedictine St Neot's Priory (Alexander in Horton & Wait 1990), the earliest burials in this style dating to between 1080-1200 AD (Glichrist & Sloane 2005).
