Archaeological Test Pits at the former Marconi Site (Selex plc) Chelmsford

An Archaeological Evaluation

May 2007

Report No.733

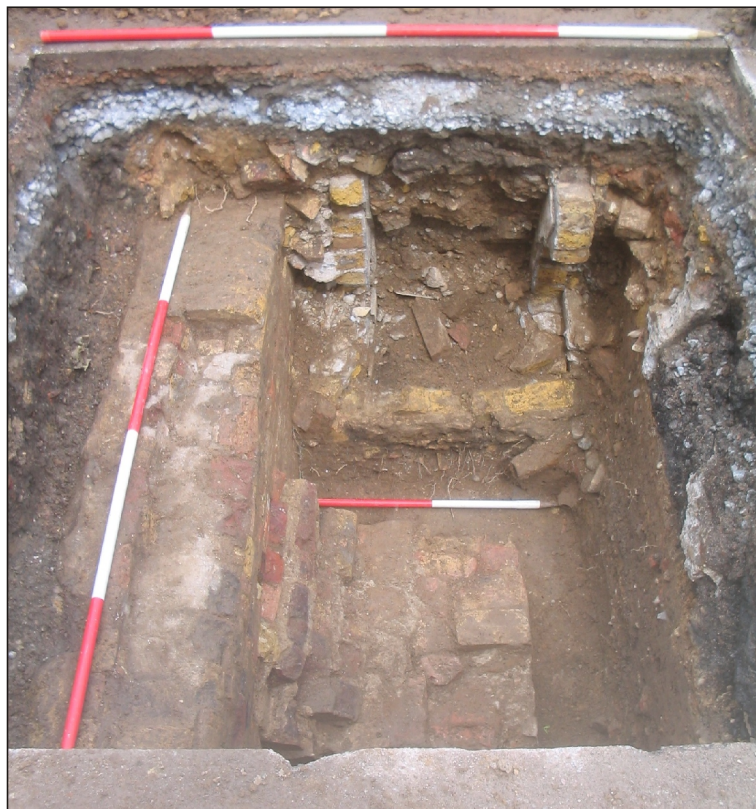
Figure 5. Plan and photograph of Test Pit 3. A corner of the foundations / cellar of T.D. Ridley's Steam Corn Mill

Natural (gravel or brickearth) was not reached due to the depth of building foundations encountered within this test pit. The truncation of the top of the gravels extended to a depth of almost 2.4m, at which point a further rubble or concrete foundation [17] was encountered, possibly serving as the base for a substantial Victorian brick foundation and supporting buttress. The latter sounding was excavated in the SW corner of the test pit using the 0.5m wide ditching bucket. At a higher level (from 1.6m to 1m below current ground level) this brick wall and buttress may have been part of the interior of a cellar (see Plan in Figure 5), whilst a later plaster-lined brick tank fed by a ceramic drain (0.20m diameter) abutted this on the north side, perhaps part of an adjacent building (see N section in Figure 6).

Excavation was carried out by hand to a depth of 1.2m, removing the rubble backfill and in places the garden soil infilling the voids within the brick structures. Fragments of clay pipe stems and Victorian pottery attested to the mid-late 19th century date of this backfill ([13] – [15]). Evidently this particular area of foundations or cellar was infilled at a relatively early date in the history of the mill's use. From the base of this backfill [15] a large sherd of glazed red earthenware (GRE) pottery was recovered, the latter possibly broken from a crock or jar. This was spot dated to the late 18th or early 19th century, and may have been locally redeposited. The fresh condition of this sherd suggests that the area interpreted as being open fields prior to 1844 might have been previously occupied.

The discovery within one of the test pits (TP3) of substantial Victorian brick foundations associated with T.D. Ridley's Steam Corn Mill provides a useful link with the recent history of the Townfield Street (western) end of the former Marconi site. Some details of recent archaeology such as the presence of charred timber found within the latter foundations could be corroborated directly with the oral testimony (given by long-standing employees at the works) of the 1969 fire that destroyed the disused mill following its use as a paint store, whilst the recognition of other features, such as an earlier road level in front of the mill (observed in TP13) and the discovery of a possible concrete anchor for one of the Marconi radio masts (TP2) could be interpreted using the existing historic photographic archive. In contrast to this, the former presence of 18th – 19th century brickearth quarries at the western end of the site was only suggested by the archaeology.
