Jesus College, Cloister Court

Archaeological Recording (Phase I)

Architectural Observations (Phase I)

Report No. 1380
ECB5245

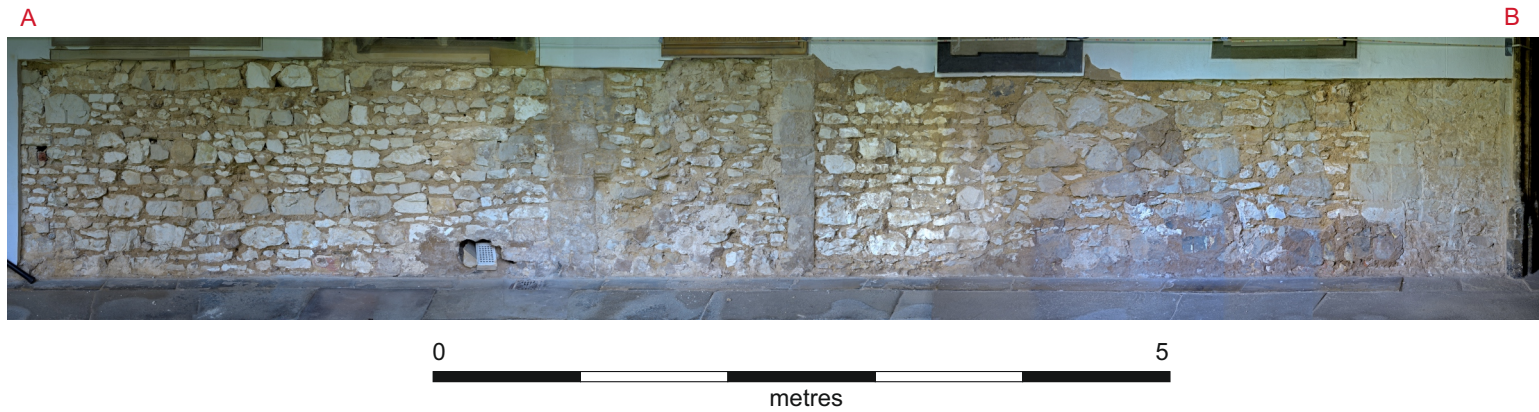
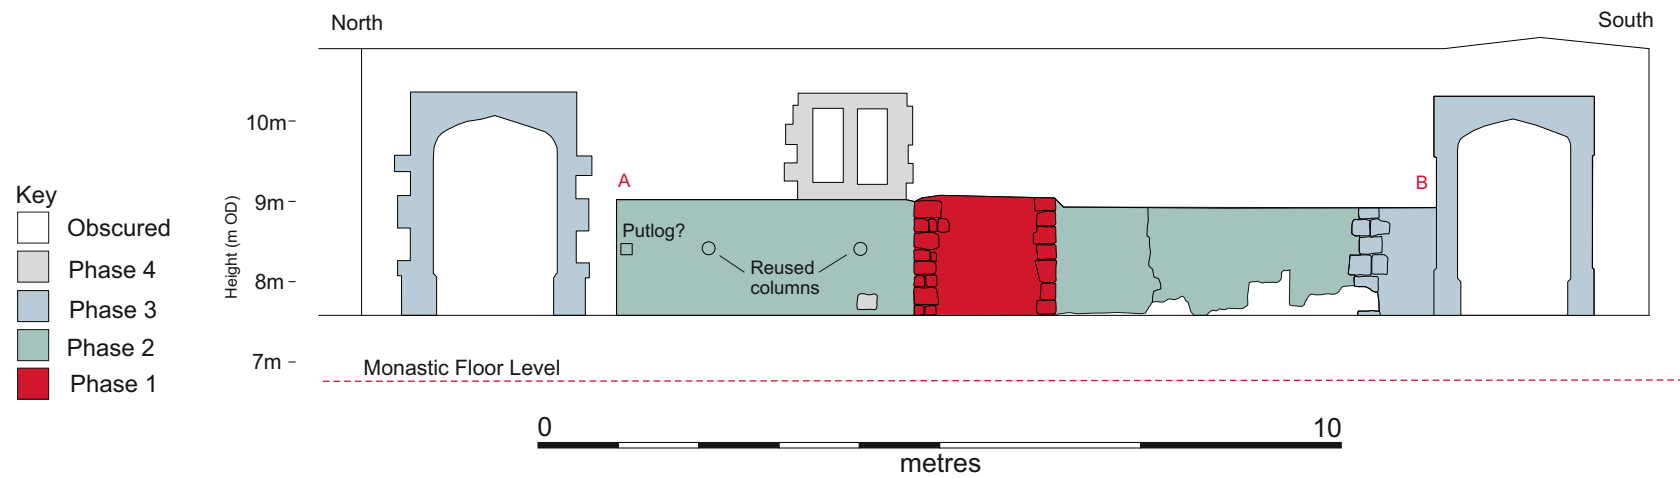
Figure 2. Elevation of east wall, showing phasing

In the eastern claustral range, the earliest fabric to be exposed comprised part of the north end of the medieval north transept (Figure 2). Here, vertical limestone quoining marked the outer face of a probable external buttress. Composed of well-dressed limestone ashlar blocks, measuring on average 300mm by 200mm by 120mm, the buttress appears to have originally stood detached from any neighbouring structure(s). 1.78m to the south, separated by a contemporary core of randomly coursed unworked clunch fragments bonded with semi-friable pale brown lime mortar, was a second set of vertical quoining. In contrast to its neighbour, however, these latter ashlar blocks were composed of clunch (measuring on average 220mm by 200mm by 180mm); a much less hardy material that is predominately restricted to internal use. The position of these particular blocks indicates that they mark the return of the interior face of the of the transept's north wall. This is intriguing, because it suggests that the wall did not originally return to the south at this point but was instead open in some form – either as a doorway, arch or colonnade – thereby permitting access to the transept from the cloister walk. Unfortunately, as the upper half of the render was not removed in this location, no further determination as to the nature of the original arrangement could be determined.

In the eastern claustral range, Phase 2 was represented by two walls that infilled what appear to have been previously open spaces to the north and south of the Phase 1 buttress (Figure 2). The date at which they were constructed is unclear, however; both may represent monastic developments, or alternatively one or both may relate to the subsequent conversion of the cloister for collegiate use. The northern wall, which infilled the exterior space between the end of the transept and the remainder of the east range, was the best constructed. It consisted of well-coursed but irregularly-sized clunch fragments – several of which clearly comprised reused moulded blocks, including two sections of small freestanding columns that were probably derived from a colonnade – that were bonded with concreted mid brown lime mortar. Further to the south, the second section of infill abutted the interior face of the transept's clunch quoined north wall. Two distinct builds were noted, although it is possible that they represent the use of different materials in the same construction. To the north, abutting the transept, the build was near-identical to that described above. Adjoining this to the south, however, the second build predominately consisted of larger, unsquared clunch fragments that were more irregularly coursed. It is possible that this change represents an infilled feature such as a door, although no trace of any jambs was identified and the door would have been unusually narrow for such a prominent location.

In the eastern claustral range, Phase 3 was represented by the addition of two stone-built doorways (Figure 2). That to the south, which was also associated with a partial rebuild of the transept wall

with good-quality clunch ashlar, has previously been associated with the conversion of the chapel for collegiate use (RCHM(E) 1959, 89-90). Its location indicates that it was inserted after the preceding north aisle was demolished, although it was not necessarily a primary element in the chapel's conversion. It is of simple perpendicular style, with a four-centred arch. The archway to the north, which provides access to Chapel Court, is extremely similar in design. It is however heavily weathered, somewhat unusual given its sheltered location inside the cloister walk, suggesting that it may have been moved here from elsewhere during Phase 4.

In the eastern claustral range, Phase 4 was represented by the addition of a small stone-built two-light window with square heads and simple mullions. This is most probably 19th century in date.

cloister to transept. Due to the limited scope of the exposure this interpretation remains highly conjectural, but the issue may be clarified somewhat when the upper portion of render is replaced. Also notable is the absence of an identifiable scar marking the return of the aisle adjoining the transept. It is possible that this was removed when the new doorway was introduced upon the church's conversion into a collegiate chapel (at B in Figure 2), although other interpretations could again be presented.

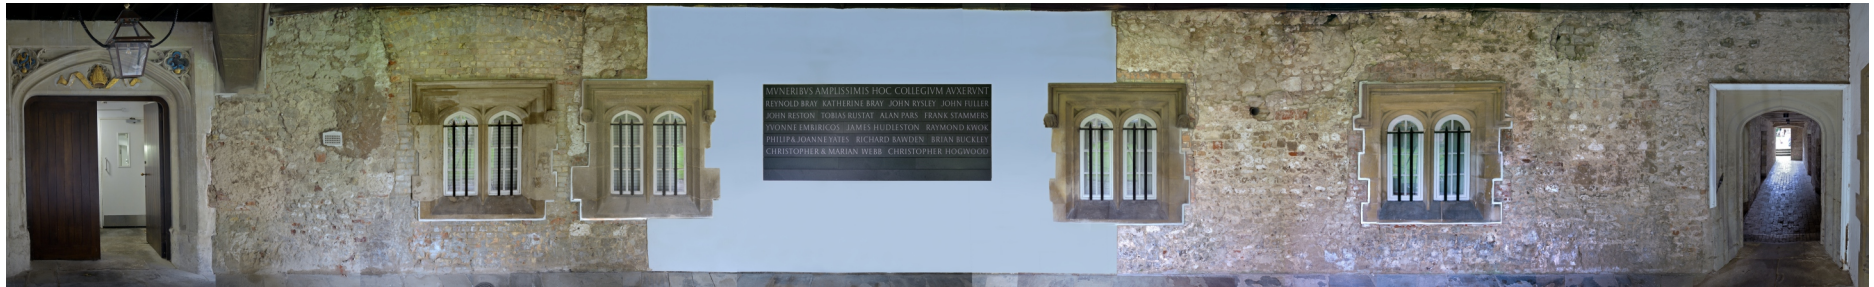
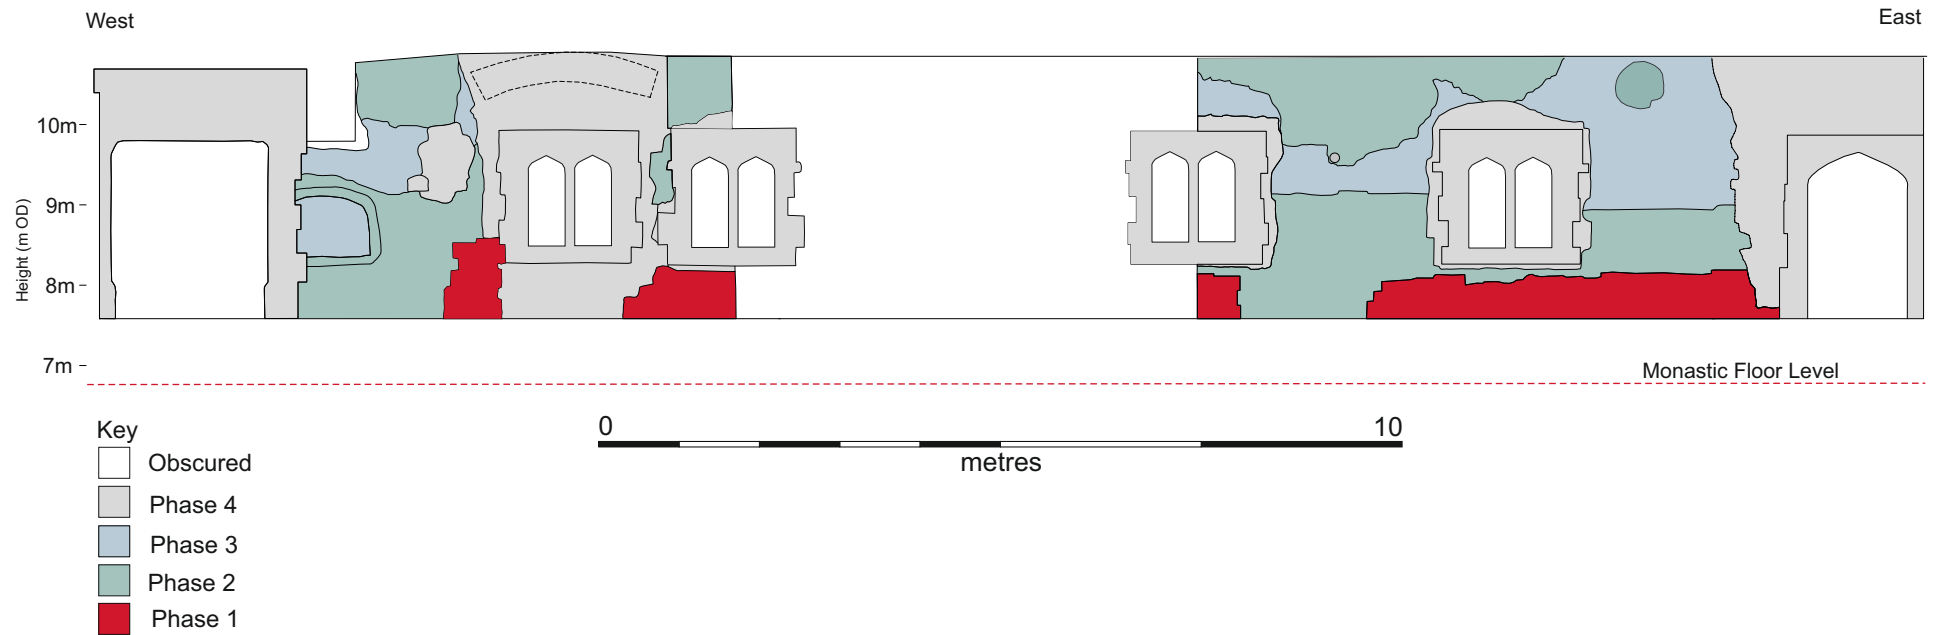
Figure 3. Elevation of north wall, showing phasing

In the northern claustral range, the earliest fabric to be exposed was again most probably monastic in origin. Here, along most of the base of the wall, several courses of well-laid clunch ashlar blocks, measuring on average 300mm by 200mm by 170mm, were present (Figure 3). A break measuring 1.72m wide was noted 7.0m from the range's east end; given its size and location, this may potentially represent a robbed and infilled doorway. Overall, this build survived to a maximum height of 0.98m above the present floor level (8.45m AOD), which is approximately 1.84m above the original monastic ground height (see Figure 3). It is notable that as well as their stratigraphic position at the base of the sequence, all of the Phase 1 elements were distinguished by their relatively high build quality.

In the northern claustral range, Phase 2 was principally represented by an extensive wall that utilised the preceding Phase 1 remnant as its foundation. This build, which was composed of moderately well-coursed small clunch fragments (measuring on average 180mm by 120mm by 100mm) with occasional patches of handmade red bricks (arranged as headers) and flat-laid peg tile, all bonded with tenacious off-white lime mortar. This fabric is very likely to represent Alcock's extensive alterations of the late 15th century (see further Evans *et al.* 1998, 96-102). In addition, one intriguing contemporary feature located towards the west end of the range comprised a brick-built opening composed of plain chamfered bricks forming a simple arch mould (Figure 3). The bricks themselves were handmade in a dark red fabric and measured an average of 45mm thick, while the opening measured 0.72m high and approximately 1.08m wide (although it was later truncated by the addition of a Phase 4 doorway). Whilst open to interpretation, the opening appears most likely to have functioned as a service hatch associated with the hall that occupied the north range after its conversion into a college. It was originally plastered both internally and externally, thus obscuring its constituent bricks from view.

In the northern claustral range, Phase 3 was principally represented by an outer skin that was applied to the preceding Phase 2 college wall. Composed of flat-laid handmade red brick fragments (measuring 45mm thick) and unworked clunch fragments, with the addition of occasional flat-laid Collyweston stone and green-glazed ceramic floor tile fragments, this skin appears to have been applied in order to protect the earlier structure and provide a solid key for additional coats of render. Given its constituent materials, it is likely that this additional skin was applied during the 16th or 17th centuries (although it could conceivably date as late as the 18th century). Portions of this material were removed when the external render was chipped away as part of the ongoing remedial works. Also occurring during this phase, the Phase 2 brick-built service hatch was blocked up using a single skin of dark red to pale pink bricks that measure 220mm by 110mm by 45mm in size. This blocking was then coated with off-white lime mortar that has been keyed in a diamond pattern to facilitate the addition of render to the wall face.

In the northern claustral range, more extensive fenestration, along with two further doorways, was introduced during Phase 4. These changes are again most probably 19th century in date (probably extending into the early 20th century). Of the four windows, the westernmost was associated with the most extensive alterations. Here, the surrounding wall fabric had been replaced with pink and yellow machine-made bricks (measuring 220mm by 110mm by 65mm in size) that were bonded with mid-brown sandy mortar. A brick-built relieving arch had also been introduced above the window, which was itself stone-built with two lights, each having a four-centred arch, and a perpendicular hood moulding. Three further windows of near-identical design were also present, although these had been introduced with less impact upon the preceding fabric. In each instance, they were infilled around with modern machine-made bricks. Of the two doorways, the easternmost was the oldest. Its insertion was associated with a partial rebuild of the north range wall using irregularly-coursed unsquared clunch, with some reused ashlar blocks and occasional handmade red brick fragments. The easternmost doorway was both larger and more recent. Although copying the prevalent perpendicular design, it is more highly decorated and is clearly associated with a significant alteration of the north range's layout.

Finally, additional information pertaining to the north claustral range was also uncovered. During monastic times this range housed the refectory on the first floor, with probable store rooms below. Subsequently, the structure was converted into the college hall. Within the exposed elevation a portion of the original monastic fabric was identified, surviving at most 1.95m above the initial ground surface (see Figure 3). Evidence of the later collegiate conversion was also revealed, including a brick-built opening that probably functioned as a hatch permitting food and drink to be introduced ready for serving in the hall. Later modifications included the addition of an outer rubble skin and several phases of fenestration. Overall, it is clear that the results of this work make an important contribution to the architectural history of the site. As subsequent phases of remedial work expose additional portions of the college's historic fabric, a valuable opportunity will be presented to increase this understanding still further.
