# New Court and Master's Garden, Corpus Christi College, Cambridge

## An Archaeological Investigation

© **Cambridge Archaeological Unit**  
UNIVERSITY OF CAMBRIDGE  
Department of Archaeology  
November 2017

**Report No. 1385**  
**ECB 5308**

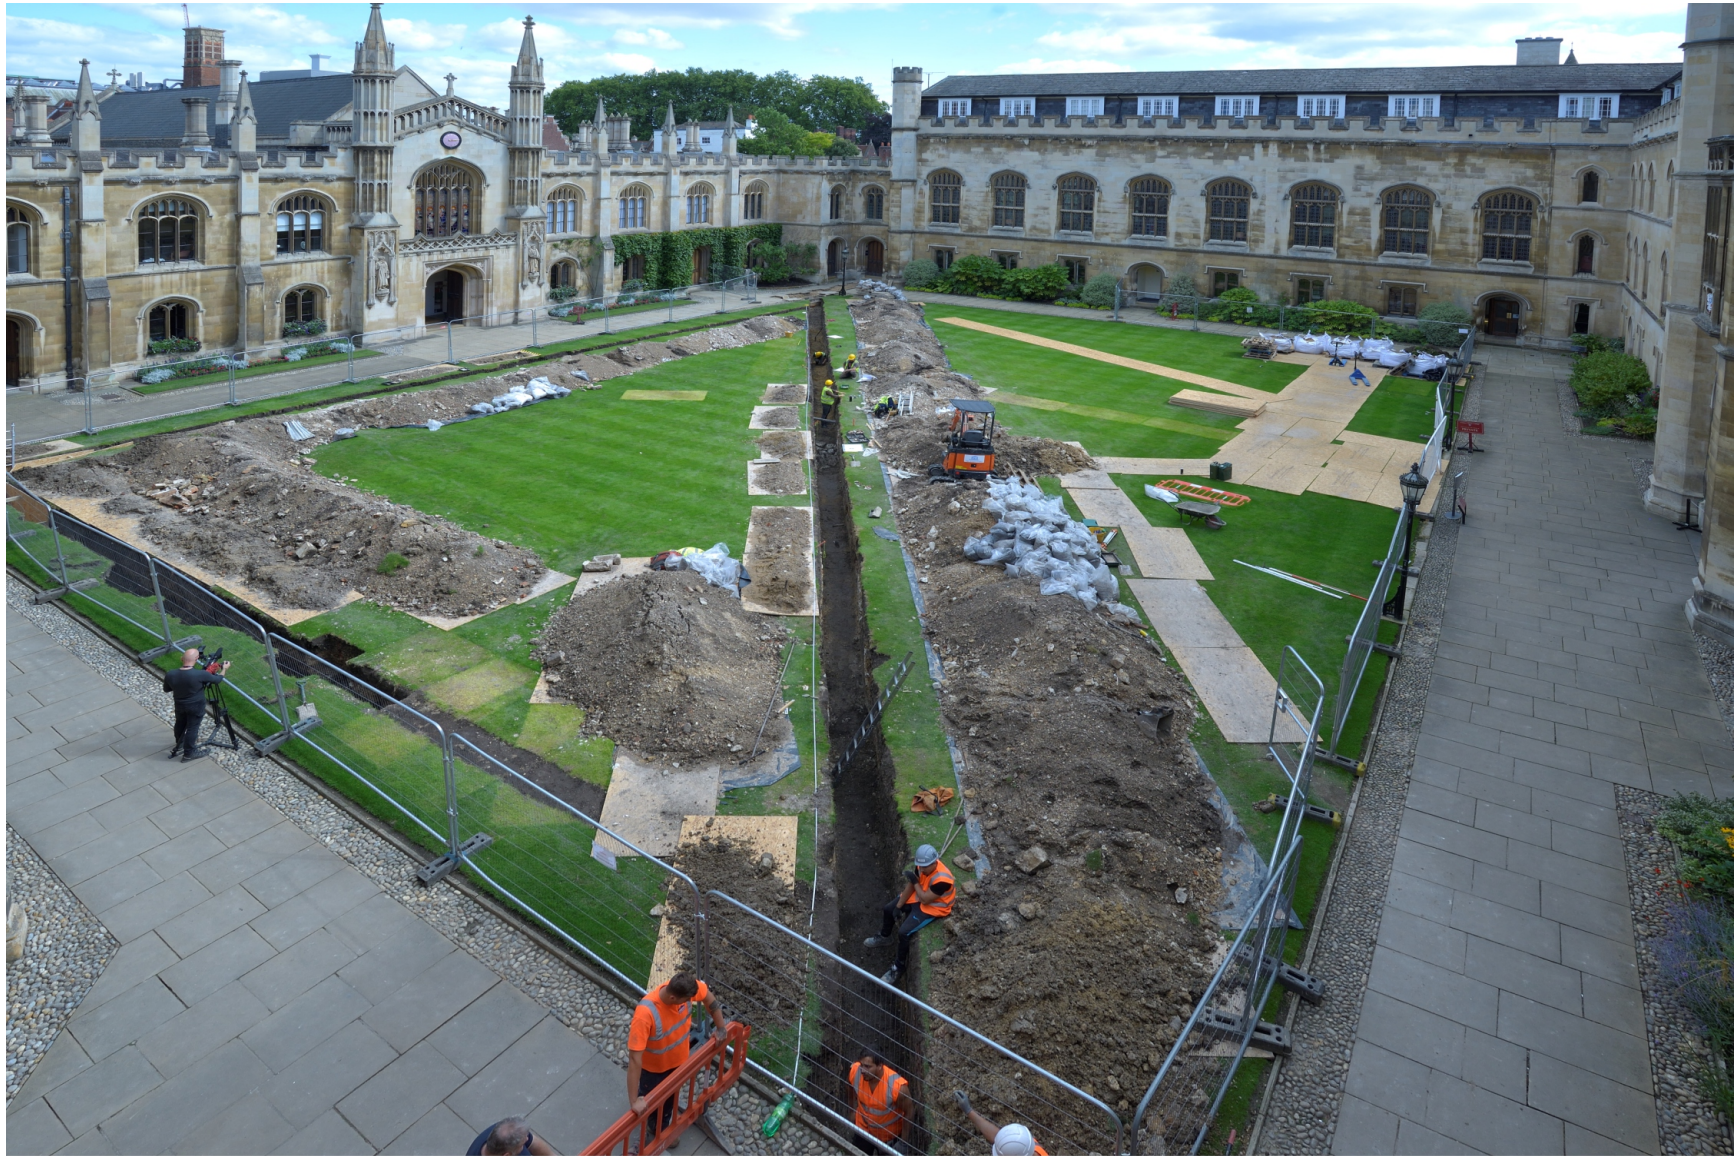
Figure 2. View across New Court, facing southeast, showing the extent of the trenching

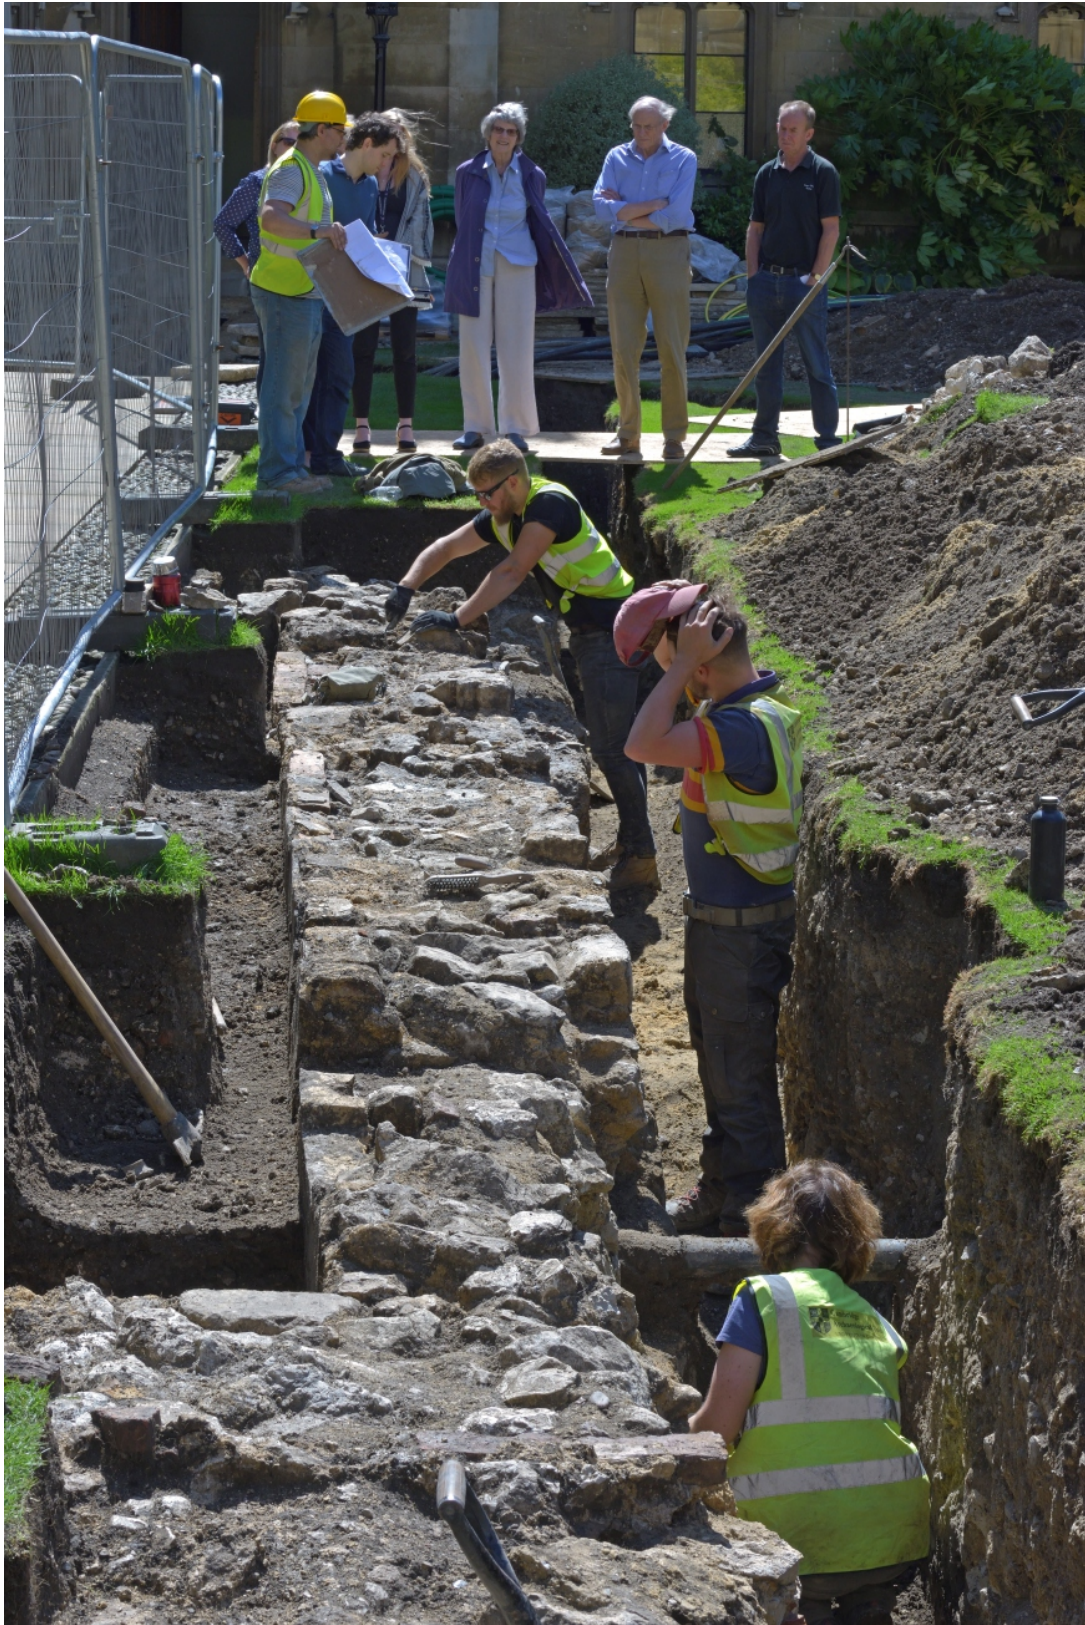
Figure 3. The investigation in progress, with the west wall of the former chapel exposed in the foreground as a guided tour is in progress (view facing south)

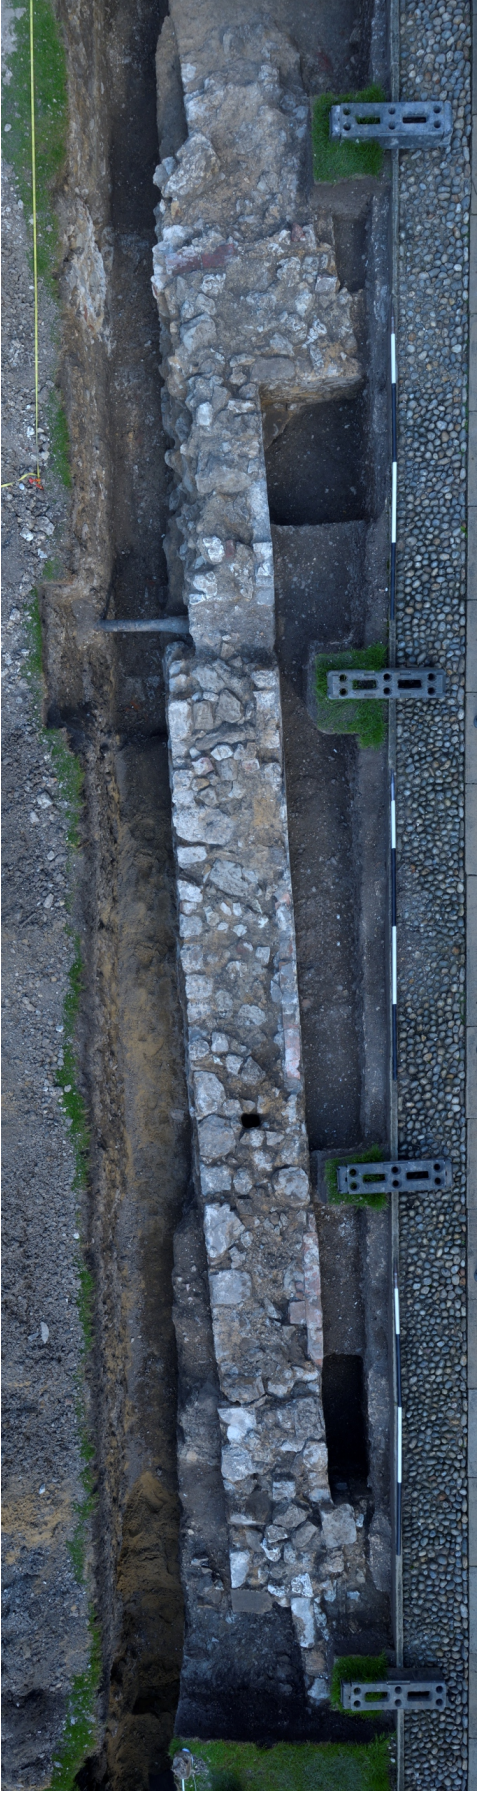
Figure 9. The uncovered remnants of the former chapel's west wall, viewed vertically (right), with a plan of the excavation (top left) and the trench overlaid upon Willis and Clark's reconstruction (bottom left)

During the initial phase of cleaning and recording the sections of the service trench in New Court, a substantial masonry wall was identified towards the northern edge of the site that predominately lay beyond the limit of excavation. From its scale and location, this was identified as a likely remnant of the former chapel. Consequently, the decision was made to hand-strip an additional area, running parallel to the trench, in order to more fully expose the chapel's remains and also to assess the degree of preservation present outside the area of recent disturbance. All identified structural remains were preserved in situ and carefully reburied once the investigation was complete.

The identified portion of this structure comprised the west wall of antechapel (Figures 9-10). Although partially clipped by the insertion of the service trench, and truncated by an earlier water pipe, the chapel was otherwise excellently preserved. The highest surviving portion of the structure was encountered at 9.87m AOD, only around 0.12m below the present lawn surface, while the walls were consistently upstanding to around 0.50m. This high degree of survival indicates that the general ground level of New Court was *raised* rather than *lowered* in 1823 when the site was cleared. The hand-stripped area was continued until the returns of both the north and south walls were identified and test pits were then dug in the two interior corners in order to establish the original floor level (which lay at 9.32m AOD). The clunch-built footings of the chapel's walls continued below the limit of excavation.

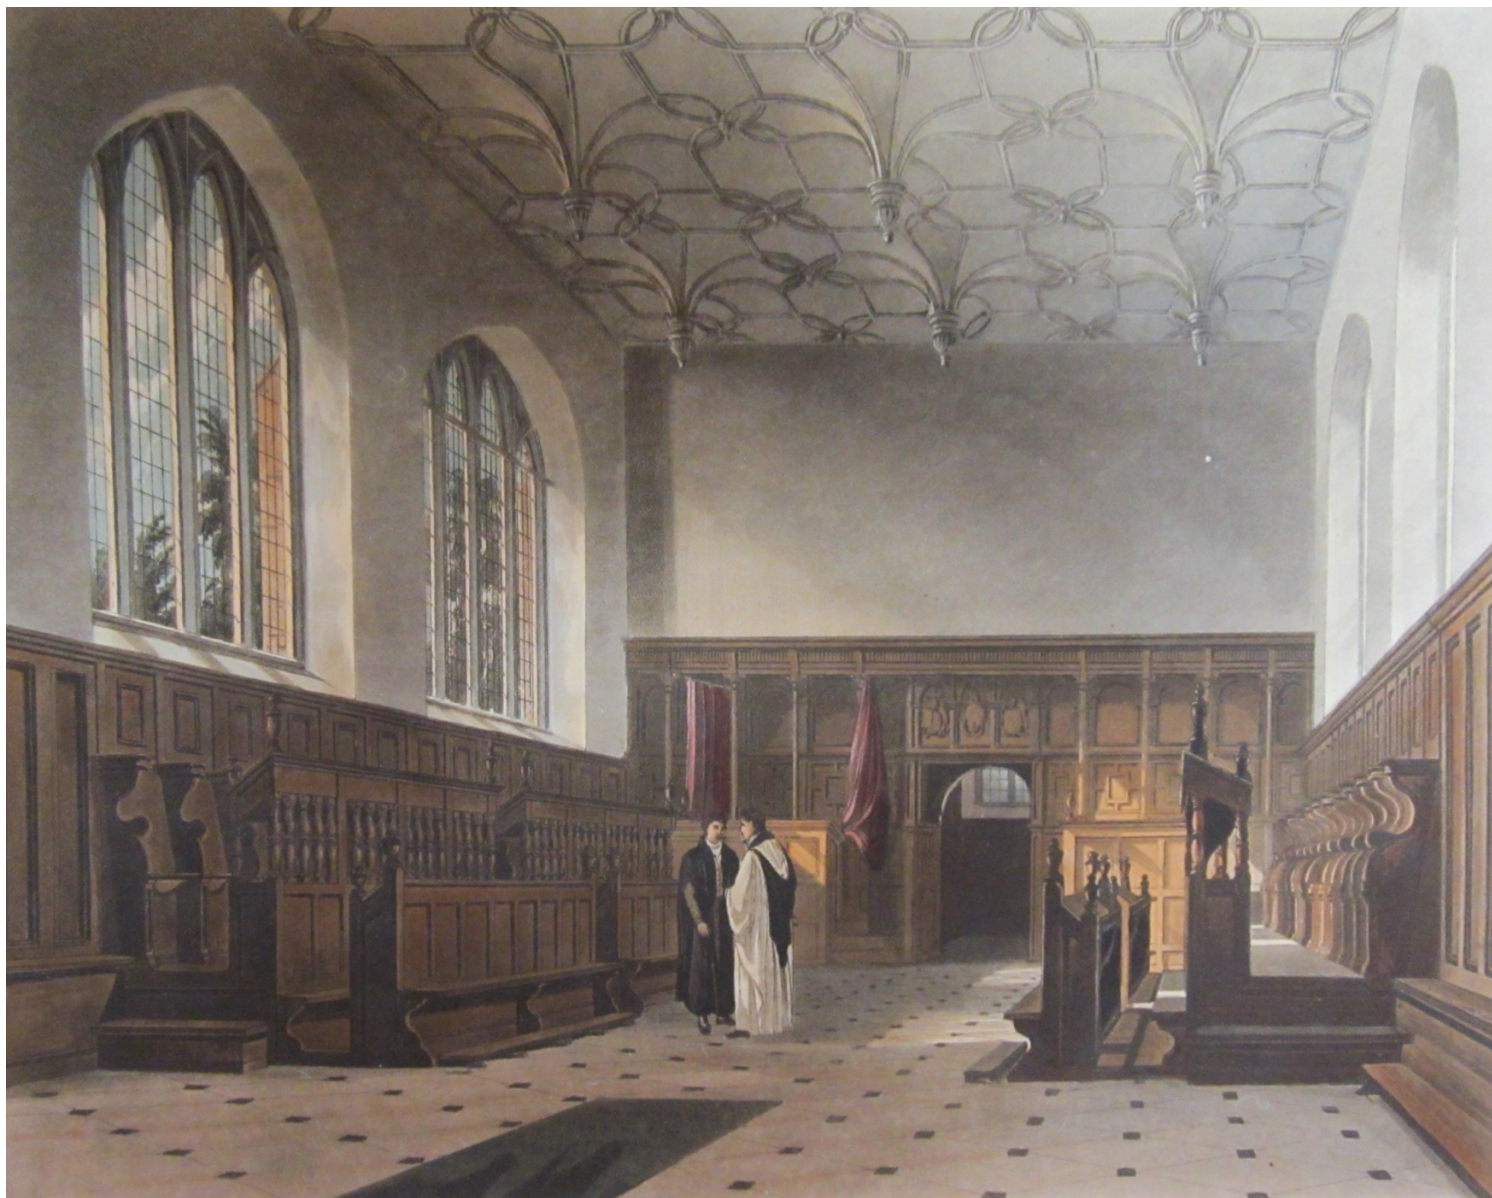
Figure 12. A view of the chapel's interior looking from the chancel across the choir, with the antechapel in the background, published in Combe 1815

Construction of the new chapel began in 1578/9 and was completed in 1584 (Willis & Clark 1886 vol I, 289-97). Its principal benefactor was Sir Nicholas Bacon, Lord Keeper of the Great Seal of England, who donated £200 pounds towards its erection; an endowment that was initially intended to cover the entire cost of the project, although in the event it fell short by some £450. Usefully, a substantial number of documents survive in the college archive pertaining to both the design and construction of the chapel, many of which have been published in summary form (Sandeem 1962). Amongst these documents are plans detailing both the chapel's proposed form, prior to the commencement of work (Figure 10), and the blueprint of the design as it was actually constructed (Figure 10) as well as the original mason's proposal for the entrance porch to the antechapel (Figure 11). In addition, the historical accounts provide considerable information pertaining to the materials that were used in the building's construction – such as various dissolved monasteries from which much of the building stone was salvaged – along with details of the individuals who were employed in building it. The chapel's interior was depicted in an early 19th-century print (Figure 12).

The walls themselves, which measured 0.78m wide, were constructed with a clunch and reused masonry core faced with irregularly-coursed Barnack ragstone to create an uneven, textured appearance. They were bonded with pale yellow lime mortar. On the southwest corner of the chapel, two courses of dressed limestone quoining also remained in situ (Figure 13). Internally, in the northwest corner of the antechapel a single remnant of the original flagstone floor remained in place (Figure 13), the rest of the flagstones having been robbed (see Figure 12 for a depiction

The chapel's modest external appearance was wholly suited to its location. The porch was accessed via the southern end of Small Court, along a narrow gap formed by the east end of the former bakehouse (Figure 8). From this position, the remainder of the building was obscured from view by the wall of a yard flanking the Master's Lodge. Since the chapel's southern and eastern walls were located in the lodge's garden, and its eastern wall in the Stable Yard, the porch was the only portion of the structure that was visible to the incoming congregation. Internally, the decoration was more elaborate but still relatively restrained; the distinction between the choir and chancel, for example, was maintained via fittings, such as the choir stalls – which were modelled after those in St John's College chapel (Willis & Clark 1886 vol. I, 294) – rather than being defined architecturally (as visible in Figure 12).

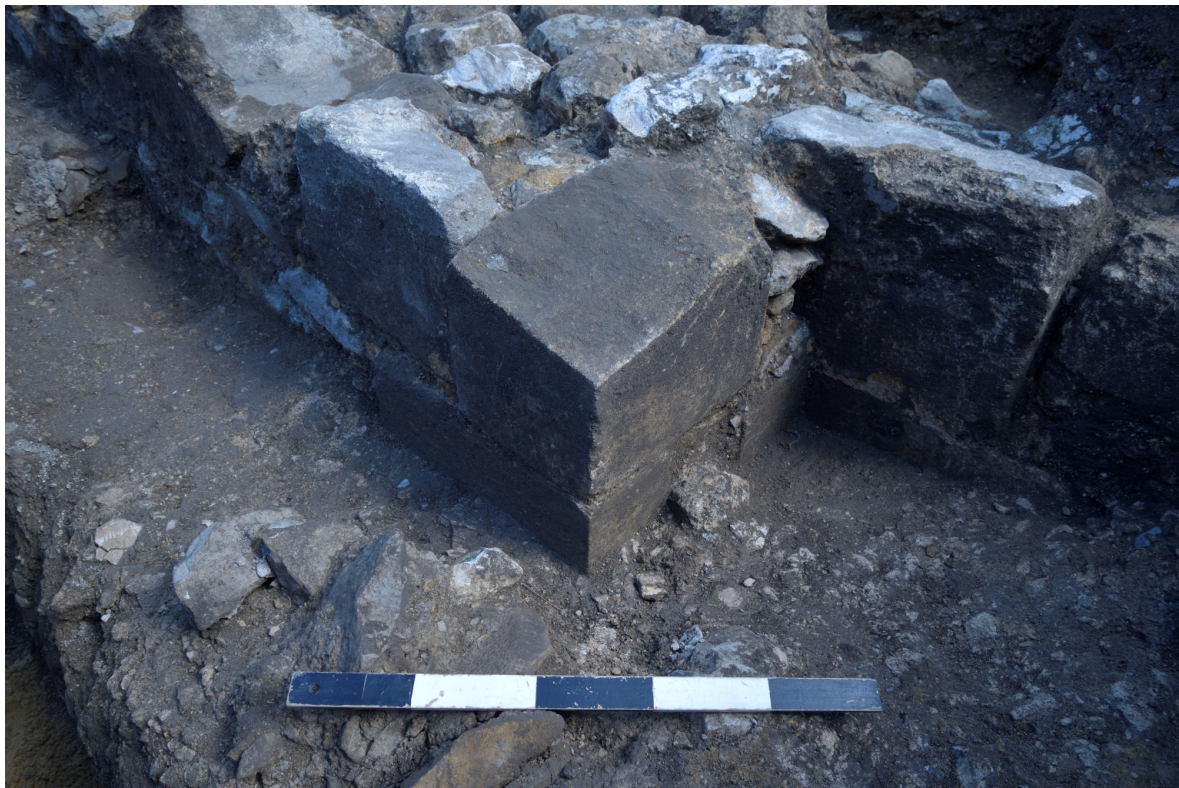
Figure 13. Photographs of the former chapel, showing; a fragment of the original flagstone floor and internal rendered walls (top, facing northwest) and ashlar quoining on the building's exterior southwest corner (bottom, facing northeast)

of the floor as it appeared in the early 19th century). The internal walls of the antechapel had been rendered (Figure 13), concealing a single skin brick repair that extended along much of the eastern face of the west wall. Comprised of pinkish red handmade bricks, this repair was most likely 18th century in date. In 1815 the walls of the antechapel appear to have been wainscoted (Figure 12), and this alteration may thus have been associated with the panelling's introduction.

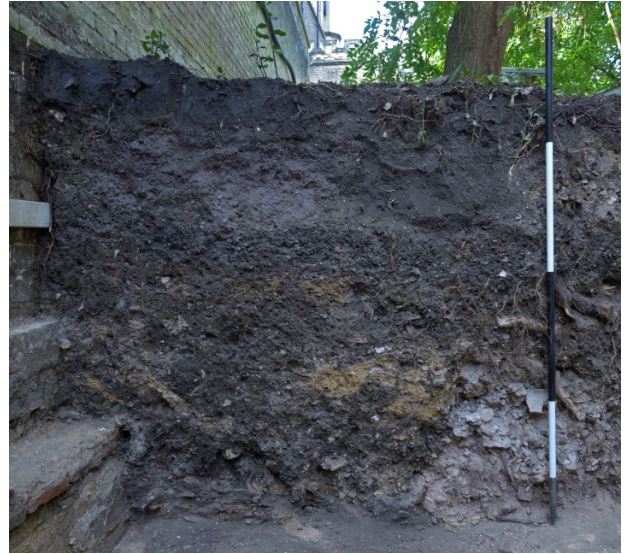
Figure 15. The Tudor tennis court, showing a plan of the present investigation (bottom left) and the location of previous investigations overlain upon Willis and Clark's plan (bottom right), as well as a section and photograph of the recent trench (top)

The earliest structural element encountered during the course of the investigation comprised brick wall remnant [2009] (Figure 15). Composed of handmade red Tudor bricks, this wall – which survived to a height of 9.21m AOD – had been rendered on its interior face. Given its location, it is highly likely that it formed part of the tennis court's western wall. Abutting [2009] was the remains of a robbed tile surface ([2008]). The tiles themselves were composed of a coarse red fabric and measured 8 inches square, with their upper surface lying at 8.87m AOD. Where they had not been robbed they were largely overlain by coarse mortar layer [2007], which probably comprised the bedding for a second tiled floor, since removed.

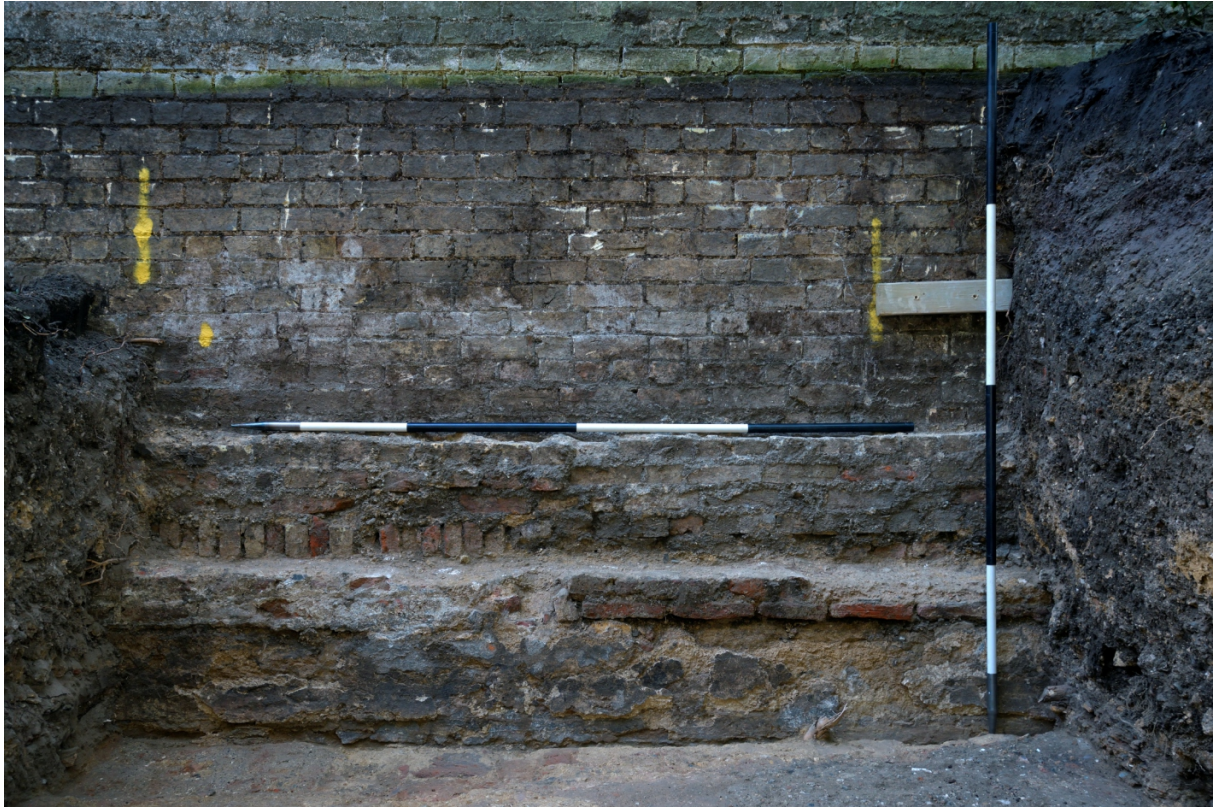
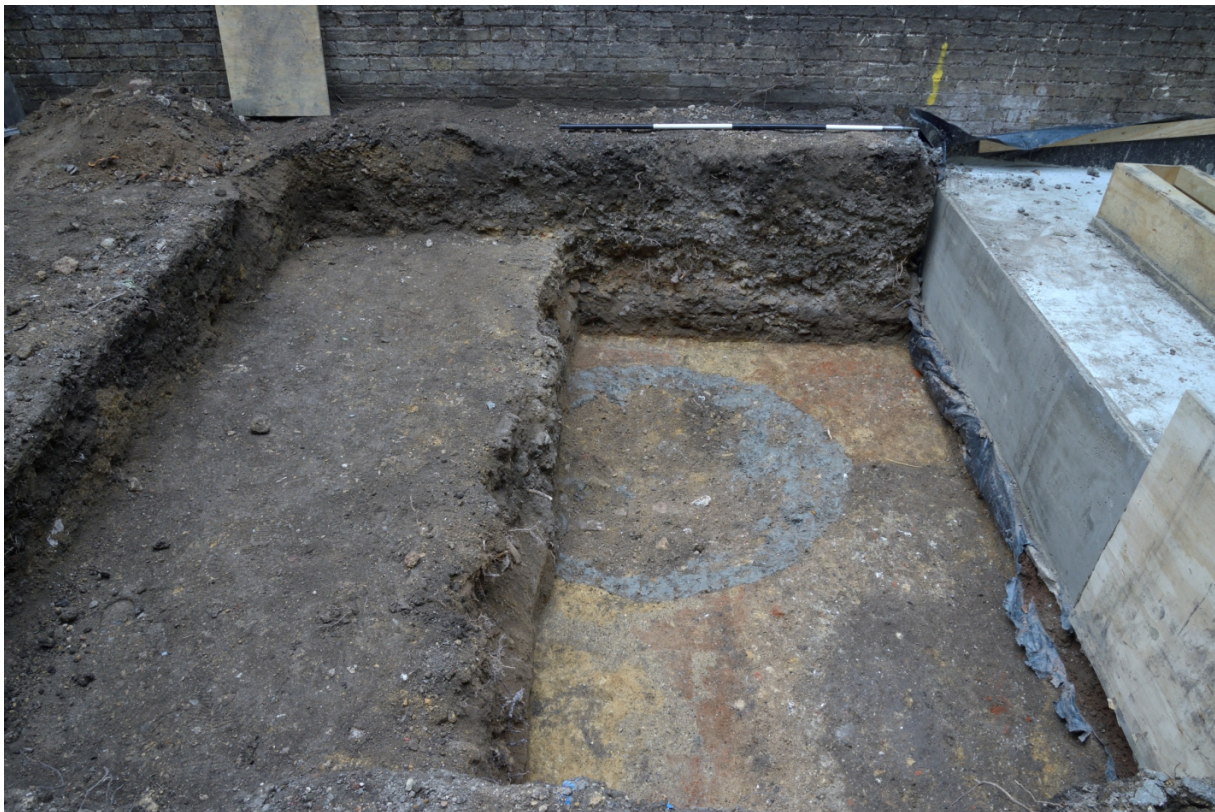
Figure 16. Photographs of the former tennis court, showing the original brick wall with attached render that was used as a foundation for the current boundary (top, facing west-southwest) and the backfilled well cut through a mortar surface (bottom, facing west-southwest)

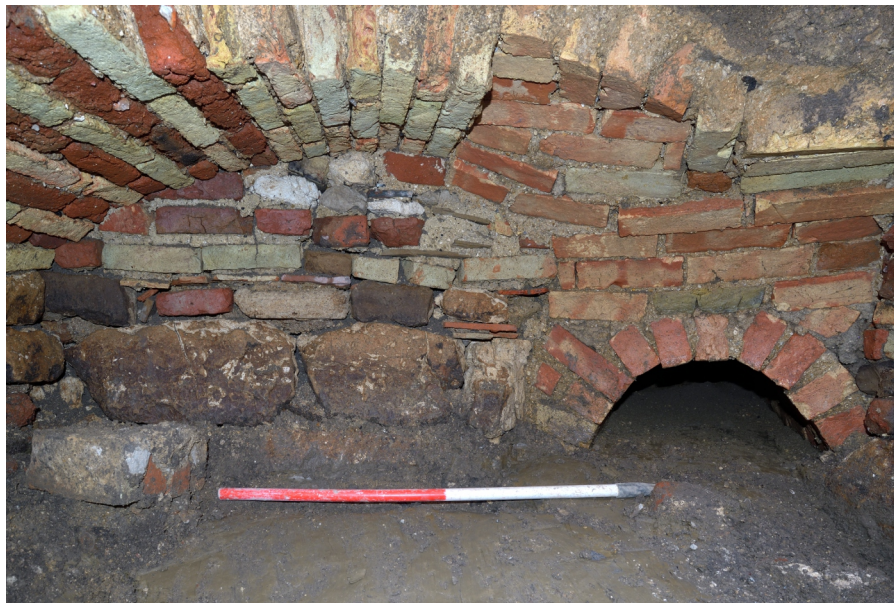
Figure 17. The stone and brick-built soakaway in Small Court, showing a section across the feature (right), a photograph of its interior (top left, facing north) and a plan of its location (bottom left)

Small Court comprised the area lying immediately to the south of Old Court prior to the construction of New Court (Figure 8). This small courtyard was bounded to the south by the former bakehouse (Area II), to the east by the Master's Lodge and to the west by the Dolphin Inn (Area V). Crossing this courtyard also comprised the only means of accessing the chapel. Unfortunately, due to the presence of a series of earlier services that had been backfilled with loose sand, the portion of the investigated trench in this area was highly unstable. Although the majority of its sections had collapsed, a substantial stone and brick-built structure with a vaulted roof was nevertheless identified. Consequently, the area surrounding this structure was shored up and made safe to enter and the investigation focused exclusively upon this discrete portion of the trench (Figure 17).

A repair had been made to the roof of the vault at some time during the 18th century ([1136]), and the structure was heavily altered in 1823 when an arched yellow brick culvert was introduced ([1137]) by removing a portion of the original wall and roof (Figure 17). This soakaway nevertheless remains a very well-built example of its type. It is likely that some form of access hatch was originally provided, so that regular maintenance could be undertaken.

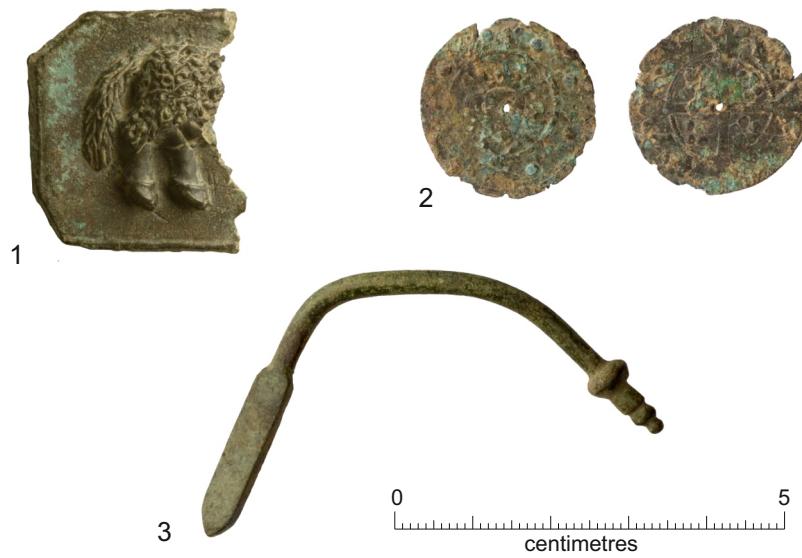
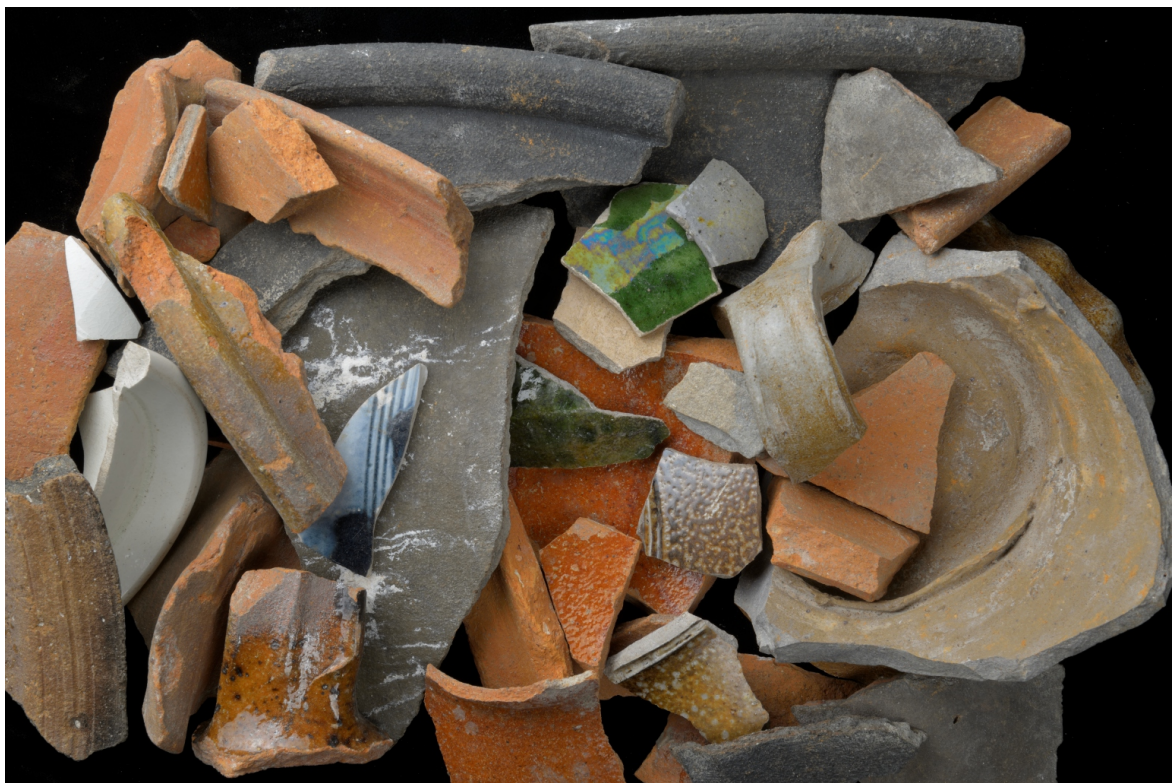
Figure 21. Copper alloy artefacts, including a blinker or saddle brass (1), a pierced English jetton of c. 1321-44 (2) and a post-medieval fitting or spatula (3); with, below, the multi-period ceramic assemblage recovered from a cubic metre sample of upcast spoil

A small metalwork assemblage was recovered from this site. In the first instance, three copper alloy items, weighing 28g, were present (Figure 21). They comprise:

[1174], Area IV: Copper alloy jetton, English, c. 1321–44. Obverse: sterling head with portrait of English silver pennies of classes 15c and 15d. Reverse: long cross patonce with rosette of pellets in each angle and crown in each angle of the border. 22 mm diameter, 0.71 g (corroded, central piercing).

[2006], Area III: A fragment of copper alloy cast blinker or saddle brass, which when complete would have been rectangular with chamfered corners and a raised image of a sheep. Measures 30 x 26mm, weight 20.86g. Late 18th or early 19th century.

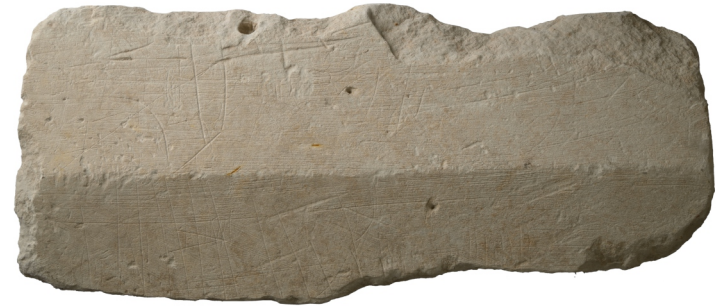
2

[1172], Unstratified (Figure 22.2): A broken and heavily abraded fragment of moulded clunch; most probably originally part of a door jamb or window mullion. It is notable for the quantity of incised graffiti that is present on both surviving faces, although no clear figurative design or legible lettering could be discerned. It measures 375mm long, 162mm wide and 84mm deep.
