St. Andrew's Church, Oakington, Cambridgeshire

Archaeological Monitoring January 2017

Report No. 1427

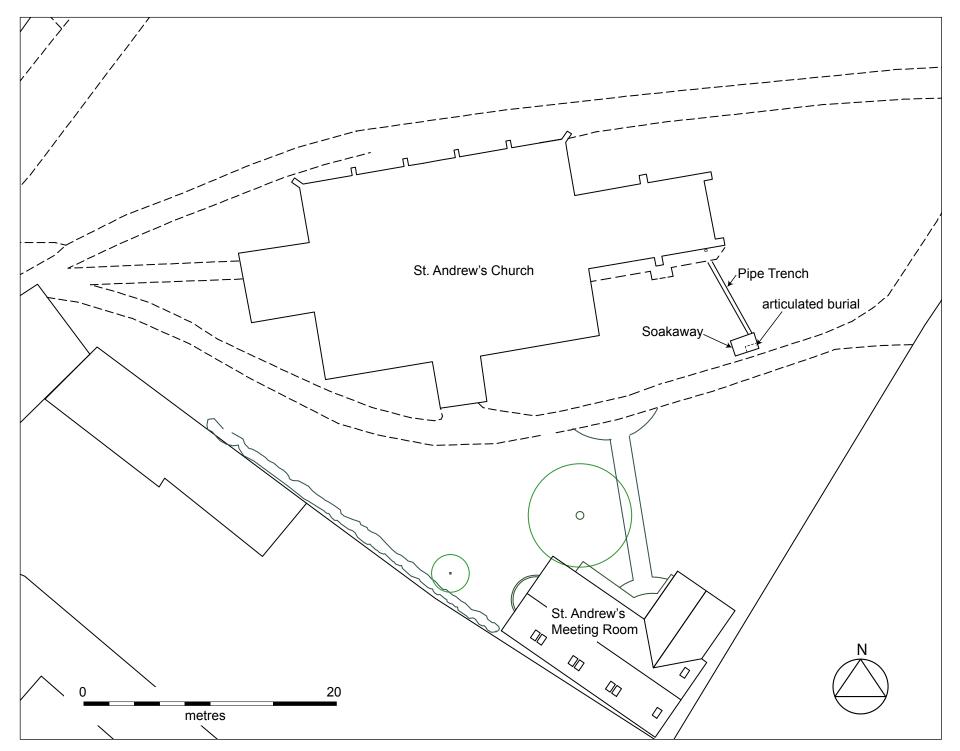
Figure 2: Pipe Trench and Soakaway Location (base data from survey provided by Brian Page)

A pipe trench and a single soakaway pit were excavated and monitored, the results are as follows:

Dimensions: Length 7m x width 0.30m maximum depth 0.30m orientated north-northwest to south-southeast.

Dimensions: Length 2.10m x width 1.40m depth 0.80m, orientated roughly east to west.

The pit was located at the southern end of the pipe trench, close to the churchyard path.

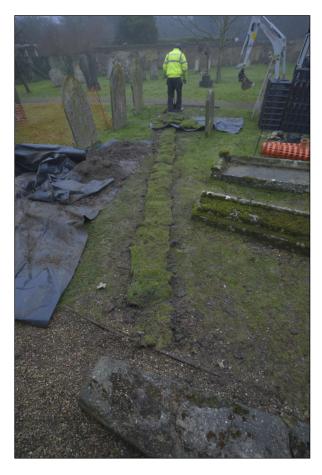
The pipe trench commenced at a point approximately one metre south of the east end of the church at a point that served the downpipe coming from the south side of the roof.

0.00-0.10m: The topsoil comprised of a very dark grey sandy clay loam with a moderate frequency of small to medium sub—angular gravel inclusions, poorly sorted.

0.10-0.30m: The underlying subsoil and redeposited grave soil, very dark grey sandy clay with a moderate frequency of small to medium sub—angular gravel inclusions, poorly sorted.

No articulated human remains were encountered in the pipe trench.

Figure 3: Backfilled Pipe Trench from North

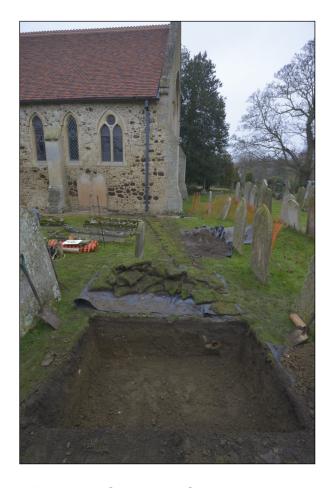
At a depth of 0.70m articulated human remains were partially exposed in the southeast corner of the soakaway pit. Excavation revealed the lower torso, pelvis and upper leg bones of an adult skeleton in a supine position with arm bones aligned parallel to the body aligned in a west - east direction. The skeleton was moderately well preserved.

At this point deeper excavation was discontinued to avoid further disturbance of any *in situ* burials and the pit was extended westwards to the same depth. Gentle probing of the ground revealed further articulated remains to the west and north of the uncovered remains suggesting the likely presence of further intact burials.

The soakaway pit was extended horizontally at a sufficient depth that would avoid any further disturbance of burials and achieve the specified volume for the function of the soakaway. The exposed remains were covered with a protective material and the grave fill replaced. No articulated burials were disturbed.

Figure 4: Expanded Soakaway Completed
