The Old Cattle Market, Royston, Hertfordshire

An Archaeological Evaluation

September 2007

Report No. 786

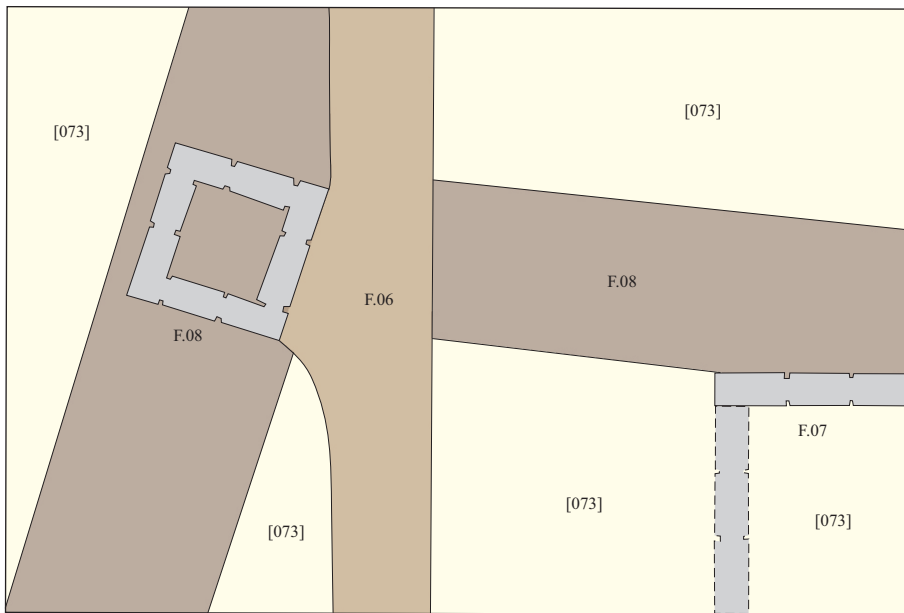
Figure 4: Trench 2, all features

Brick Foundation F.07 is 'L' shaped in form, though it extends beyond the limits of trench 2 in two directions. Cut [062] extends 0.80m+ west-southwest to east-northeast and 0.62m+ north-northwest to south-southeast; it is 0.14m wide and 0.26m deep with vertical sides and a relatively flat base. Within it was constructed [060], a single-skin brick foundation comprising reddish yellow bricks 230mm by 110mm by 60mm bonded with mid to dark grey lime mortar. Only one course survives. Deposit [061], a layer of firm brown silt with very frequent chalk fleck inclusions 0.26m thick, was packed around it. No datable material was recovered. **F.07** cuts **F.08** and is overlain by [072].

Service Trench F.08 is 'T' shaped in form, and is situated in trench 2. Cut **[068]** is 2.58m+ long from north to south and 2.11m+ long from east to west. It is 0.66m wide and 0.45m+ deep with steeply sloping to near vertical sides – the base was not reached. The salt-glazed ceramic pipes that were initially inserted into this cut were connected at their point of intersection by brick-built drain/manhole **[066]**, which was 0.54m square and constructed from unfrosted red bricks measuring 230mm by 110mm by 50mm bonded with an extremely firm mid grey waterproof mortar. It was 0.62m+ deep. The area above the pipes was then backfilled with **[065]**, a deposit of moderately well compacted off white natural chalk with occasional pale brown silt lenses 0.45m+ thick. Finally, when the services went out of use in the late 19th or early 20th century, manhole **[066]** was backfilled with deposit **[067]**. This consisted of CBM and concrete fragments intermixed with occasional gravel inclusions. **[065]** contained a sherd of late 19th century Refined White Earthenware. **F.08** cuts **[073]** and is cut by **F.07**.

Service Trench F.06 is of irregular, sub-linear form and is oriented east-northeast to west-southwest. It is situated in trench 2. Cut [064] is 2.00m+ by 0.36m in extent and 0.55m+ deep with steeply sloping to near vertical sides – the base was not reached. It was backfilled with deposit [063], a deposit of moderately compacted off white chalk with occasional pale brown silt lenses that is very likely to contain a ceramic service pipe towards its base. [063] contained six Codd bottle fragments dating to the late 19th/early 20th century; at least two vessels are represented, and fragmentary embossed lettering indicates that they once held soda/mineral water. **F.06** cut [071] and is overlain by [070].

Layer [070] extends beyond the limits of trench 2 in every direction. It is comprised of firm mid grey concrete with very few inclusions 0.10m thick. [070] represents the reinstatement of the concrete floor surface of the cattle market after the insertion of service trench **F.06**; it did not contain any datable material. It overlies **F.06** and is beneath [069].

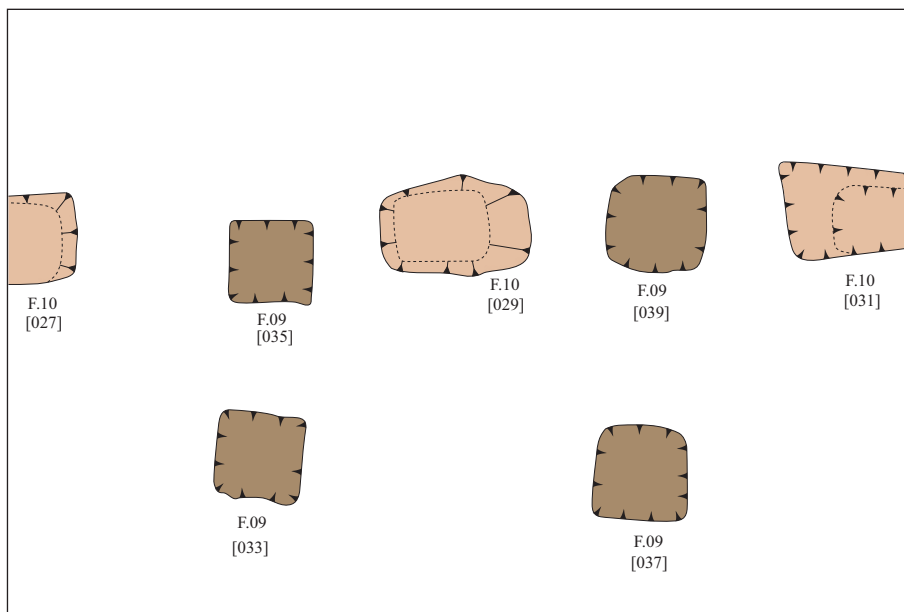
Figure 5: Trench 3, all features

Postholes F.10 are sub-rectangular in form, with the long axis of each aligned north-northwest to south-southeast. They are located in trench 3. Cuts [027], [029] and [031] vary between 0.50m and 0.22m+ in length, 0.32m and 0.29m in width and 0.50m and 0.49m in depth. Each has steeply sloping to near vertical sides, often with a partial step towards the bottom, and a relatively flat base. The initial fills, [026], [028] and [030], consist of deposits of firmly compacted mid to pale grey silty clay that contained occasional chalk and rare charcoal fleck inclusions. Central postpipes [077] to [079], which vary between 0.13m by 0.11m in extent and between 0.50m to 0.49m in depth, consist of deposits of loosely compacted dark to very dark brown silty clay with frequent brownish grey concrete fragment inclusions. Towards the base of each pipe was a small amount of dark brown degraded wood, indicating that the posts had not been entirely removed. [028] contained a sherd of late 19th century Refined White Earthenware, and a fragment of a mid 19th century or later green glass bottle with push-up. The postholes that comprise **F.10** cut natural and are overlain by layer [026].

Robber Cuts F.09 are sub-square in form, and are situated in trench 3. Cuts **[033]**, **[035]**, **[037]** and **[039]** vary between 0.28m by 0.27m in length and breadth and between 0.24m and 0.26m in depth. Each has steeply sloping to near vertical sides and a relatively flat base. Their fills, **[032]**, **[034]**, **[036]** and **[038]**, comprise deposits of loosely compacted mid to pale grey silty clay with occasional chalk and rare charcoal fleck inclusions. None of them contained any datable material. **F.09** cut **[024]** and are overlain by **[023]**.

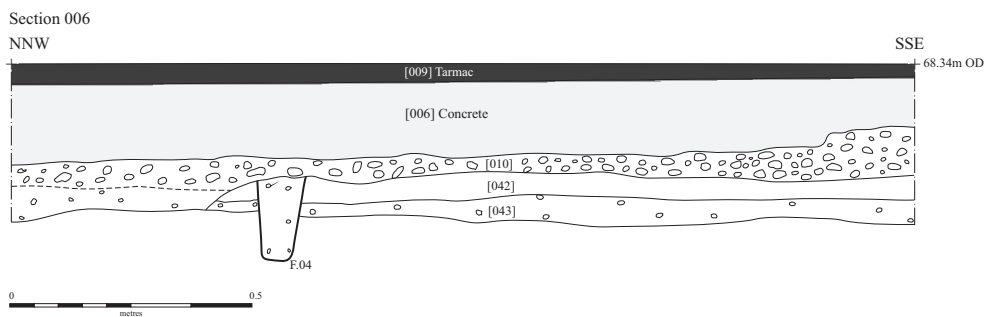
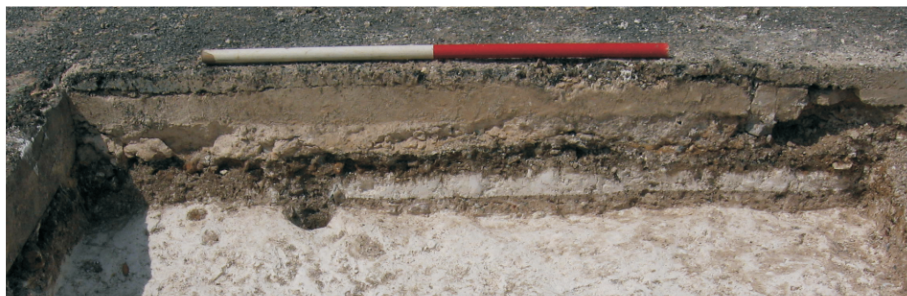
Figure 7: South-southwest facing section of Trench 1

These layers clearly derived from, and were affected by, processes of natural erosion. They were thus best preserved on the lower part of the natural slope at the northeast end of the site (see Figure 7), though the fact that they survived at all is most probably due to their being almost immediately sealed beneath the earliest stage of the cattle market structure in the early 19th century. This is confirmed by the recovery of late 18th/early 19th century pottery from **[043]**. The occurrence of such material clearly indicates a human presence, albeit probably only an occasional one, prior to the erection of the first structure on the site. This may relate to less formalised auctioneering activity such as that thought to have occurred at around the same time at the nearby site on Fish Hill, though the limited survival of the deposits obviously precludes definitive interpretation. If any earlier material had ever been present on the site, it has clearly been entirely denuded prior to the area becoming sealed.

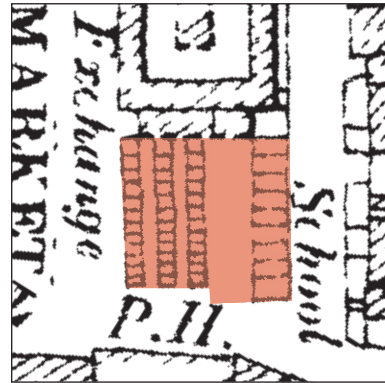
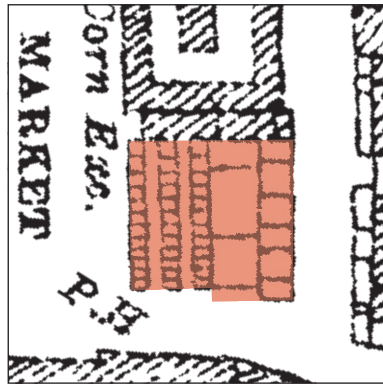
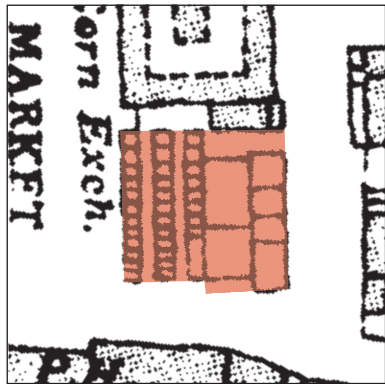
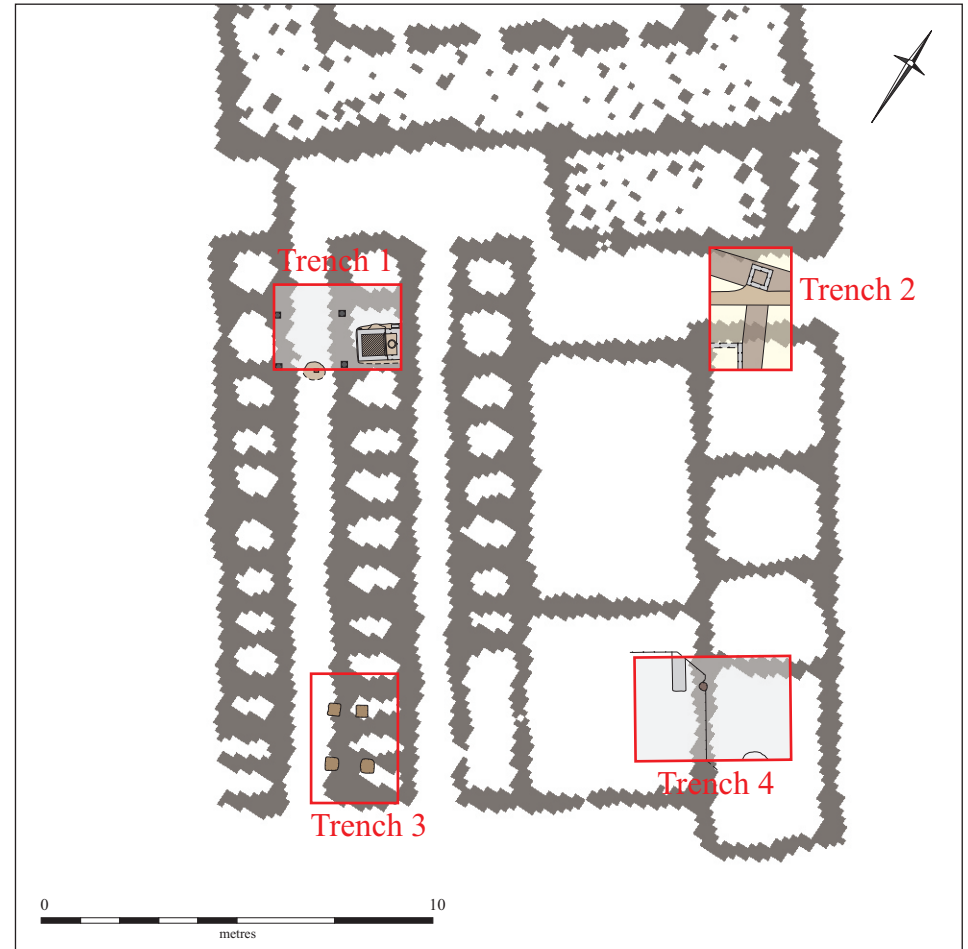
Figure 9: The cattle market over time

The earliest phase of the cattle market is most likely to have been constructed when the adjacent Corn Exchange was erected in 1829, though as noted above auctioneering may well have been conducted on the site in a less standardised form before this date. The evidence uncovered during this evaluation clearly indicates that in its original form the cattle market comprised an earth-fast timber structure, though its exact layout remains unclear. By the time the first edition 1:2500 Ordnance Survey map was published in 1887-88, the first map of sufficient resolution to show the internal layout of the building, these timbers had been levelled and the long-lived concrete structure established; this is consistent with the date of material recovered from the backfilling of postholes **F.10**. The next significant development, which comprised the insertion of lowered floor area **F.13**, occurred between the first revision of the OS map in 1902-03 and its second revision in 1926-27. As Figure 9 clearly demonstrates, the third revised edition provides a very accurate plan of the layout of the cattle market in its final, most developed form. The livestock pens, represented archaeologically by **F.09** and **F.03**, are clearly visible, as also is the lowered area of

The exact date at which the cattle market went out of use is not clear. The stalls are still visible on the third revised 1:2500 scale OS map of 1938-52 (see Figure 9), but are no longer present on the subsequent 1982 revision; this is consistent with the gradual decline of the livestock industry in Hertfordshire during this period. It is likely that the car park was established quite soon after the cattle market was abandoned, which suggests that it has been in use since at least the early 1980's. It has clearly been resurfaced a number of times, lending support to this interpretation.
