St. Bene't's Churchyard, Cambridge

Archaeological Monitoring

December 2019

Report No. 1439

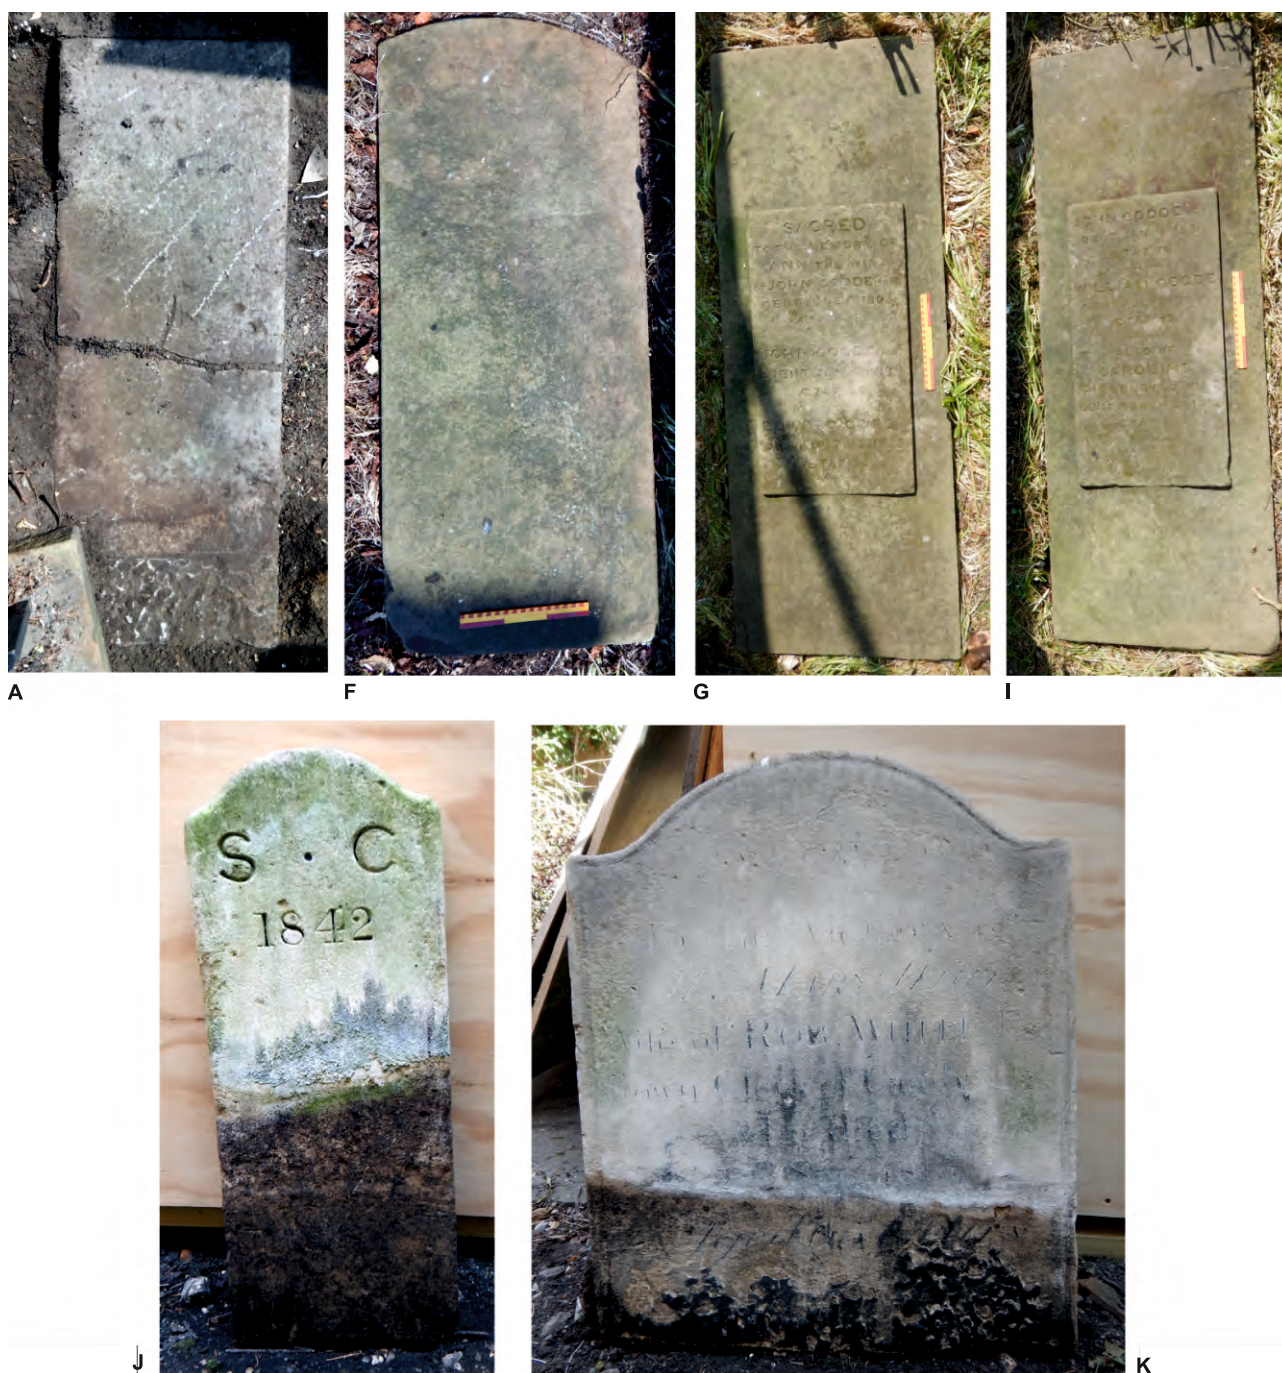
Figure 4. Exposed grave slabs and headstones: Stones A, F, G, I, J and K

Stone A: this stone was lifted by the contractor, there were no associated underlying features (Figure 4). The stone had previously been partially obscured and is 1.64m by 0.62m with the lower 0.24m unfaced and only crudely shaped. There was no discernible inscription on either face.

Stone F: this stone was lifted by the contractor, there were no associated underlying features (Figure 4). The stone was largely plain, although there were a few faint traces of decoration near the top of the stone.

Stone G: this stone was lifted by the contractor, there were no associated underlying features (Figure 4).

Stone I: this stone was lifted by the contractor, there were no associated underlying features (Figure 4). Inscription: JOHN COODE ^{SEN.} / OBIT JAN 11 1831 / ÆTAT 76 / WILLIAM COODE / OBIT July 11 1831 / ÆTAT 52 / ALSO OF / CAROLINE / HIS BELOVED WIFE / OBIT MARCH 31 1852 / ÆTAT 64

Stone J: this stone which must have previous been standing upright in the open area was moved by the contractor, its precise position was not recorded but there were apparently no associated underlying features. It must have been moved in the mid/late 19th century, although it is possible it was replaced close to its original location (Figure 4). The stone was small, 0.64m by 0.25m, and largely plain with the inscription S • C / 1842.

Stone K: this stone which had previous been standing upright in the open area was moved by the contractor, there were no associated underlying features and it must have been moved in the mid/late 19th century although it is possible it was replaced close to its original location (Figure 4). The stone proved to be broken and was 0.81m+ by 0.66m. The inscription reads: SACRED / TO THE MEMORY OF / M^{RS} MARY WHITE / WIFE OF ROB. WHITE ESQ / TOWN CLERK OF CAMBRIDGE / WHO DIED / ?? SEPT 1813 / AGED ?? YEARS. Robert White became town clerk in 1788 and held the post until he died. A Robert White married Mary Missen at St. Vigor's, Fulbourn, on 13 Mar 1793.

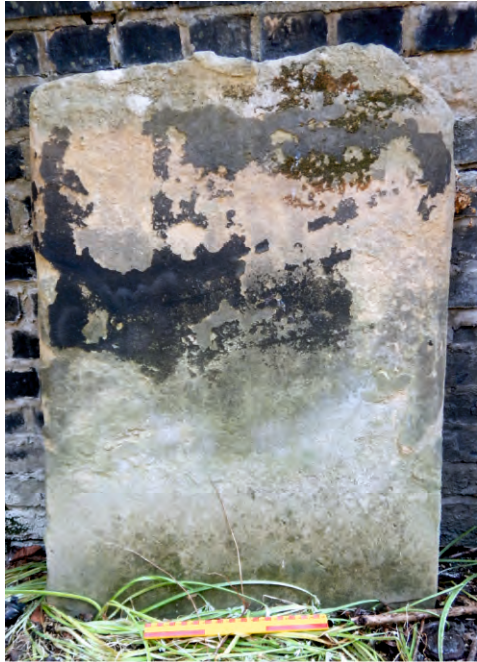
L

Stone L: this stone was placed upright against the eastern wall of the graveyard (Figure 5). 0.94m by 0.68m, inscription illegible.

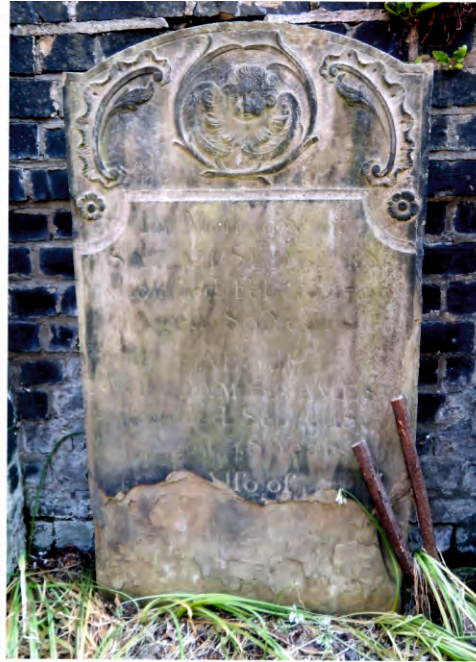
M

Stone M: this stone was placed upright against the eastern wall of the graveyard. 1.14m+ by 0.65m (Figure 5). It has ornate decoration and the inscription reads: IN MEMORY OF / SARAH SUDBURY/ who dies Feb 19 1799 / Aged 89 Years / Also of / WILLIAM GRAVES / Who died Sep^r. 19 1800 / Aged 48 Years / Also of / ??

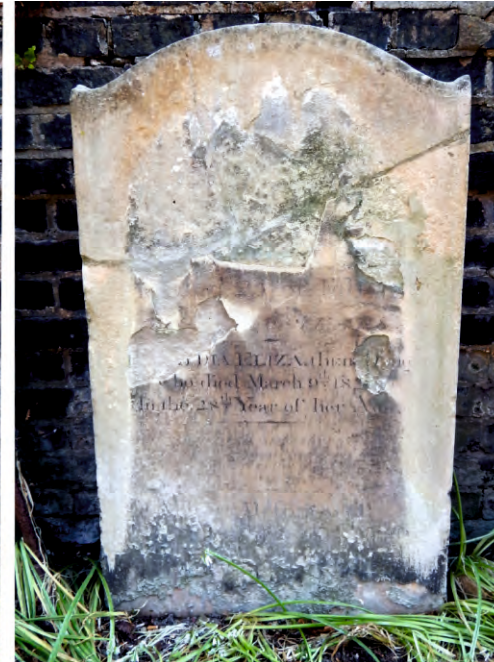
N

Stone N: this stone was placed upright against the eastern wall of the graveyard (Figure 5). 1.12m+ by 0.68. The inscription reads: ?? / ??DLA ELIZA. Their daughter / who died March 9th 183? / In the 28th Year of her Age.

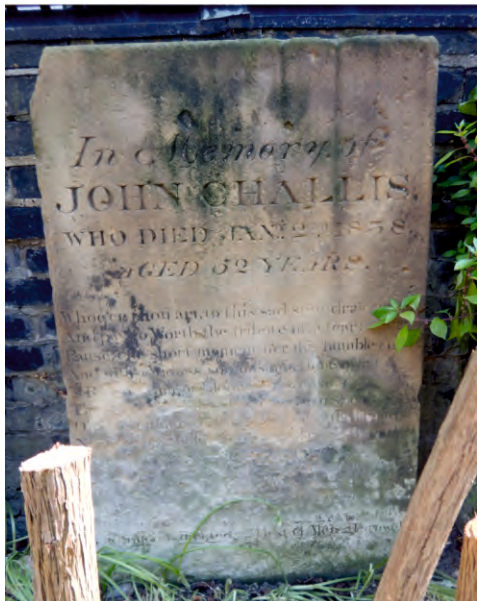
O

Stone O: this stone was placed upright against the eastern wall of the graveyard (Figure 5). 1.16m+ by 0.76m. The inscription reads: In Memory of / JOHN CHALLIS / WHO DIED JAN^y 22nd 1838 / Whoe'er thou art, to this sad spot drawn by / And pay to Worth the tribute of a tear: / Pause one short moment o'er this humble stone [continues for 10 more lines]

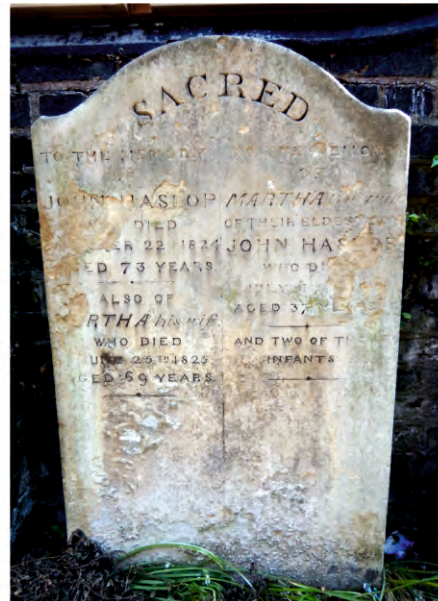
P

Stone P: this stone was placed upright against the eastern wall of the graveyard (Figure 5). 1.21m+ 0.75m. The inscription reads: SACRED / TO THE MEMORY / OF / JOHN HASLOP / ... DIED / ?? ER 22 1824 / AGED 73 YEARS / ALSO OF / MARTHA his wife / WHO DIED / JULY 25th 1829 / AGED 69 YEARS / MARTHA the wide / OF THEIR ELDEST SON / JOHN HASLOP / WHO DIED / JULY 15th ?? / AGED 37 YEARS / AND TWO OF THEIR / INFANTS

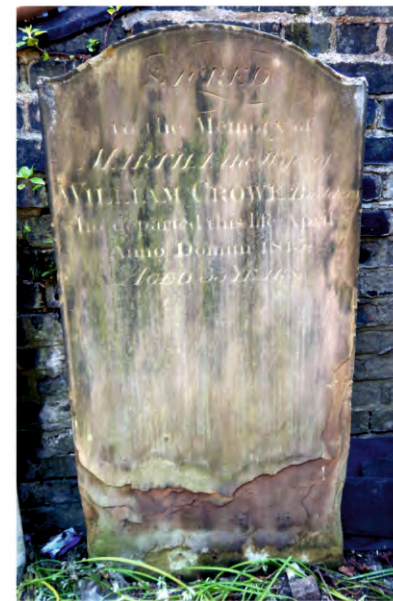
Q

Stone Q: this stone was placed upright against the eastern wall of the graveyard (Figure 5). 1.28m+ by 0.66m. The inscription reads: SACRED / to the Memory of / MARTH the Wife of / WILLIAM CROWE Builder / who departed this life April 9th / Anno Domini 1813: / AGED 33 YEARS

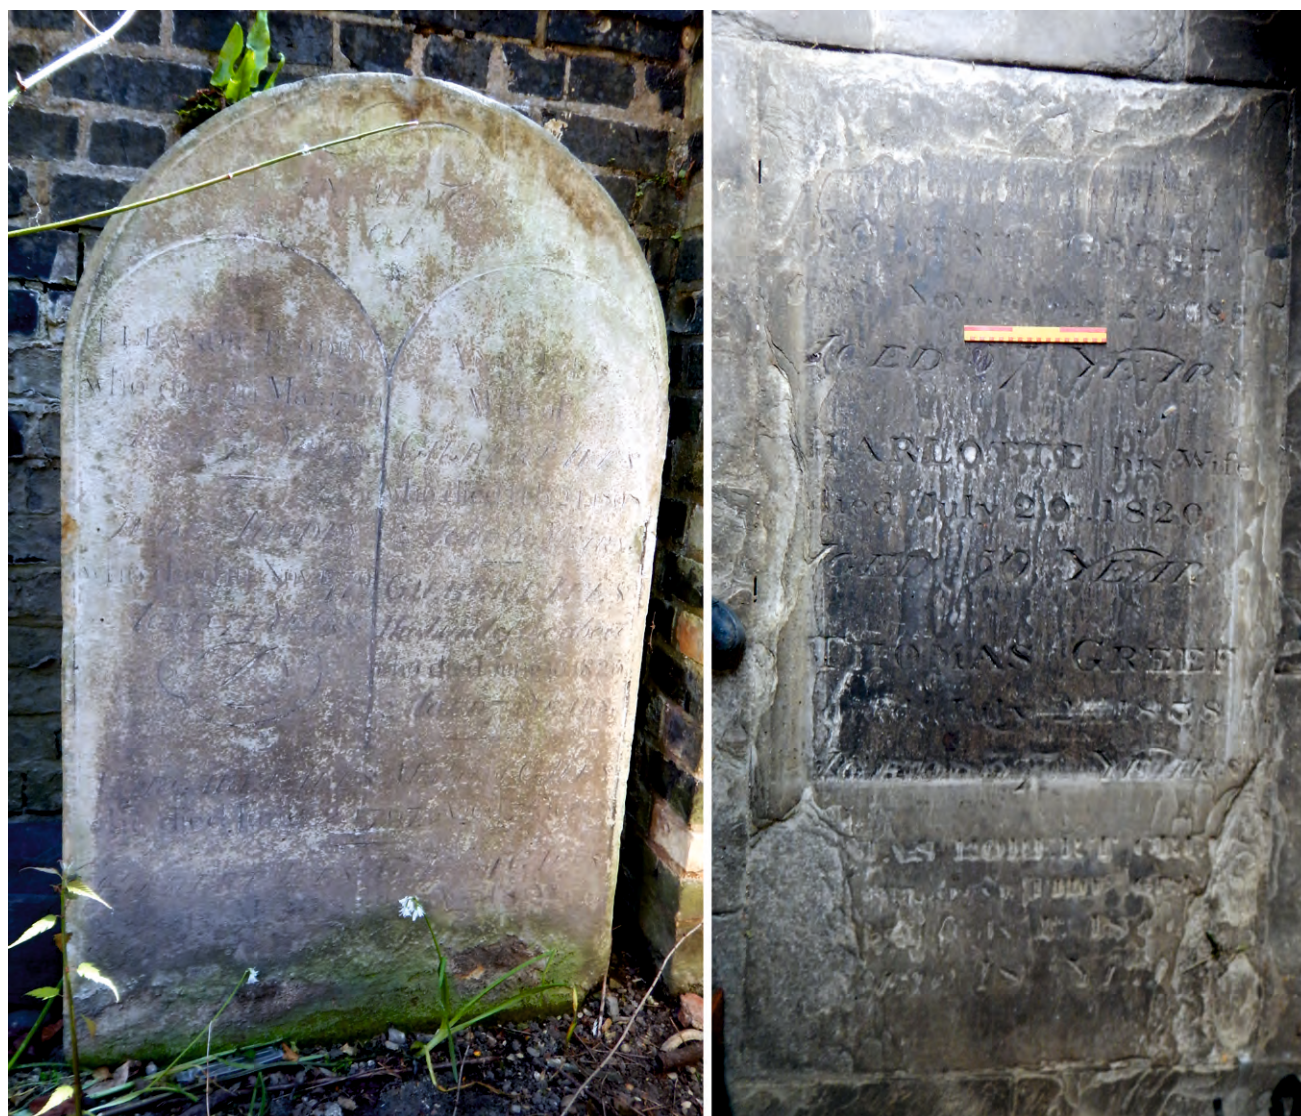
Figure 6. Exposed grave slabs and headstones: Stones R and S

Stone R: this stone was placed upright against the eastern wall of the graveyard (Figure 6). 1.37m+ by 0.84m. The inscription reads: IN MEMORY OF / ELEANOR THODEY / who died in Mar 1799 / Aged 73 YEARS / Jane THODEY / who died in Jny 1799 / Aged 71 YEARS / ANN LEES / Wife of / GILBERT LEES / who died Feb 2 1808 / Aged 60 YEARS / GILBERT LEES / Husband of the above / who died June 16 1826 / Aged 72 years / MARGARET LEES wife of G. Lees / Who died June 2 1797 Aged 7 years / GILBERT LEES ?? / ??

Stone S: this stone, which is lying flat in the northern porch of the church, was lifted by the contractor (Figure 6). This revealed no associated features, the stone is 2.14m by 1.12m.

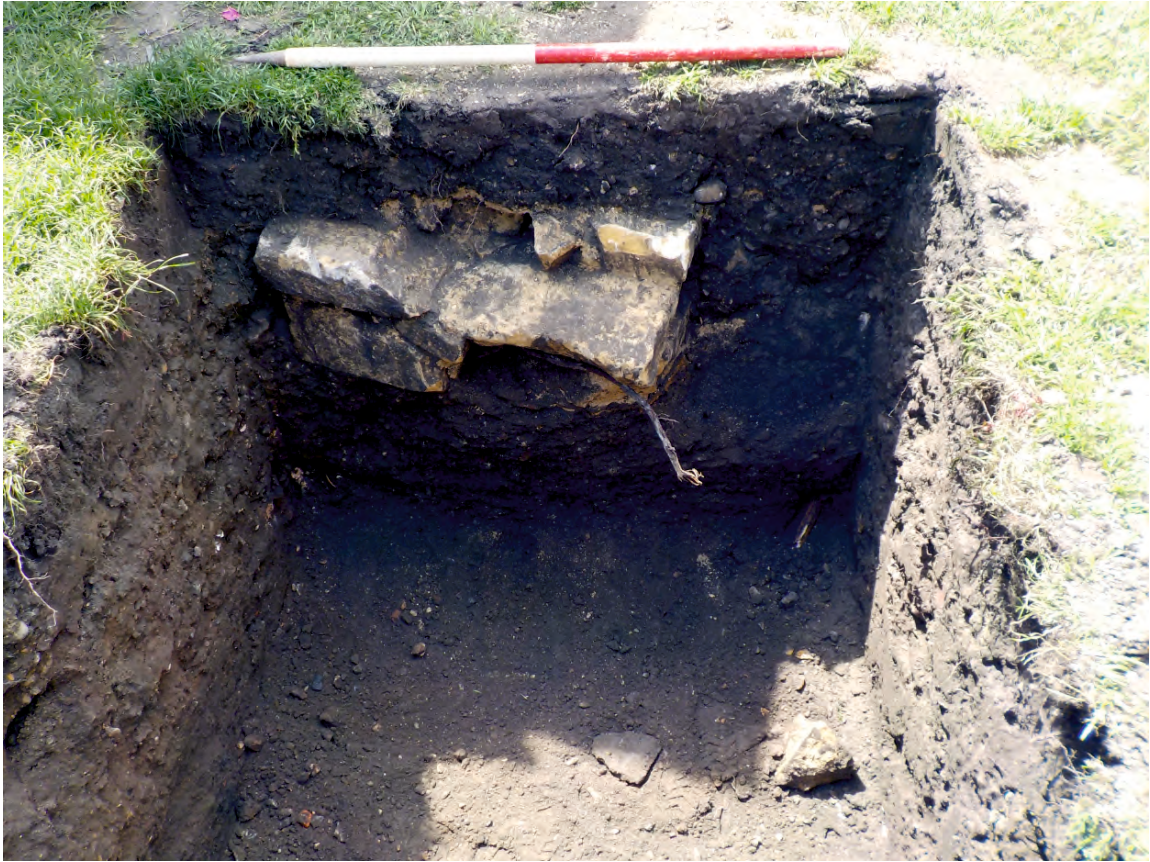
Figure 7. Soakaway 2 with Structure 1, facing east

Soakaway 2 was located to the west of the existing pathway between Bene't Street and the churchyard (Figure 7). It was 1.32m by 1.27m in extent and dug to a depth of 1.1m. The uppermost deposit was a loose black sandy silt topsoil [400] that was up to 0.10m thick. Beneath this, there was a square or rectangular foundation Structure 1 [406] cut [407] constructed from three courses of mortared sandstone blocks, which was 0.71m by 0.31m+ in extent and 0.30m deep (Figure 7). Structure 1 presumably represents some form of minor 19th or 20th-century footing for a churchyard feature of some kind. Beneath this was [404] a loose and friable coarse brown sandy silt, which was 0.60m thick and contained disarticulated human bone. Under this was [405] a loose and friable dark grey sandy silt with frequent gravel that contained disarticulated human bone, tile fragments and charcoal.

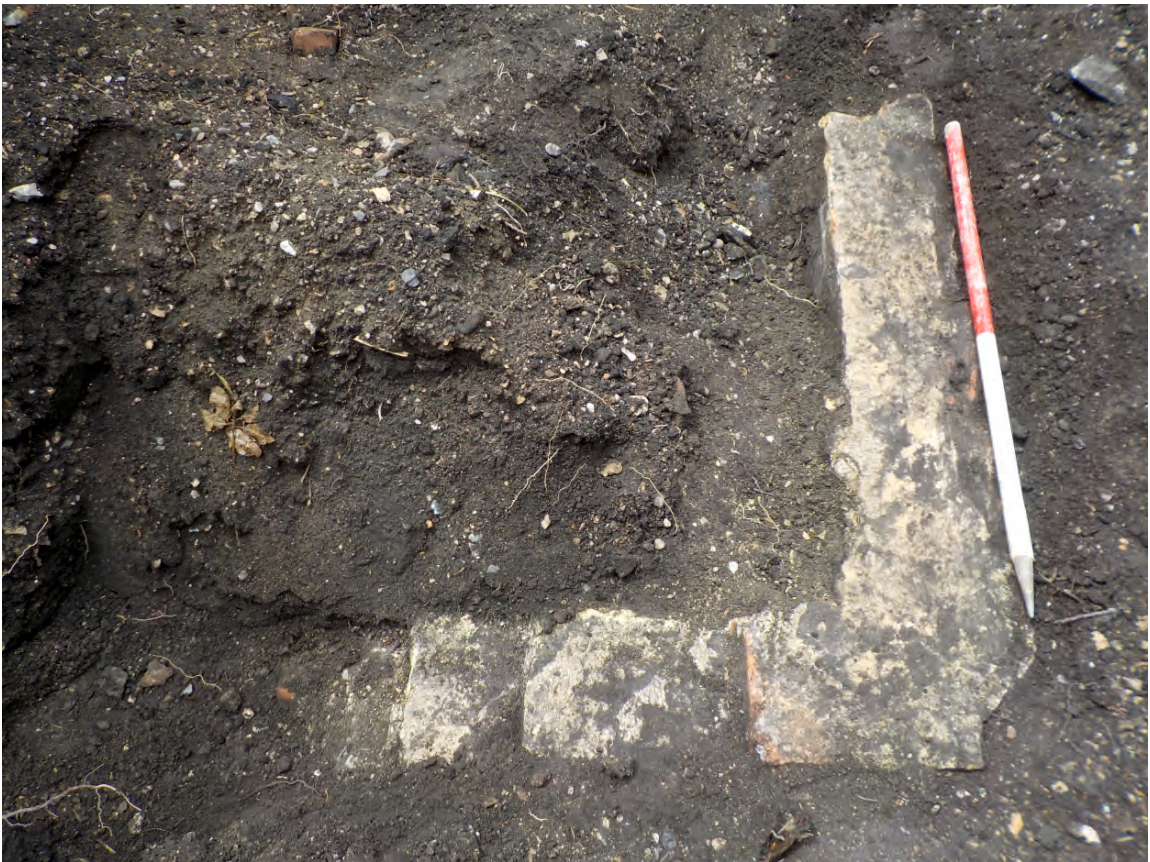
Figure 8. Wall 1, facing west.

Located to the northeast of the northeastern buttress of the church porch was an L-shaped wall foundation Wall 1 (Figure 8). Although truncated at both ends this wall survived for a length of 1.3m west–east and 1.0m north–south and was over 0.4m deep. The bricks and mortar indicate a 17th or 18th century date for this feature, which was truncated by the construction of the current north porch in 1853. Wall 1 probably represents an earlier north porch depicted on plans of 1688 and 1798.

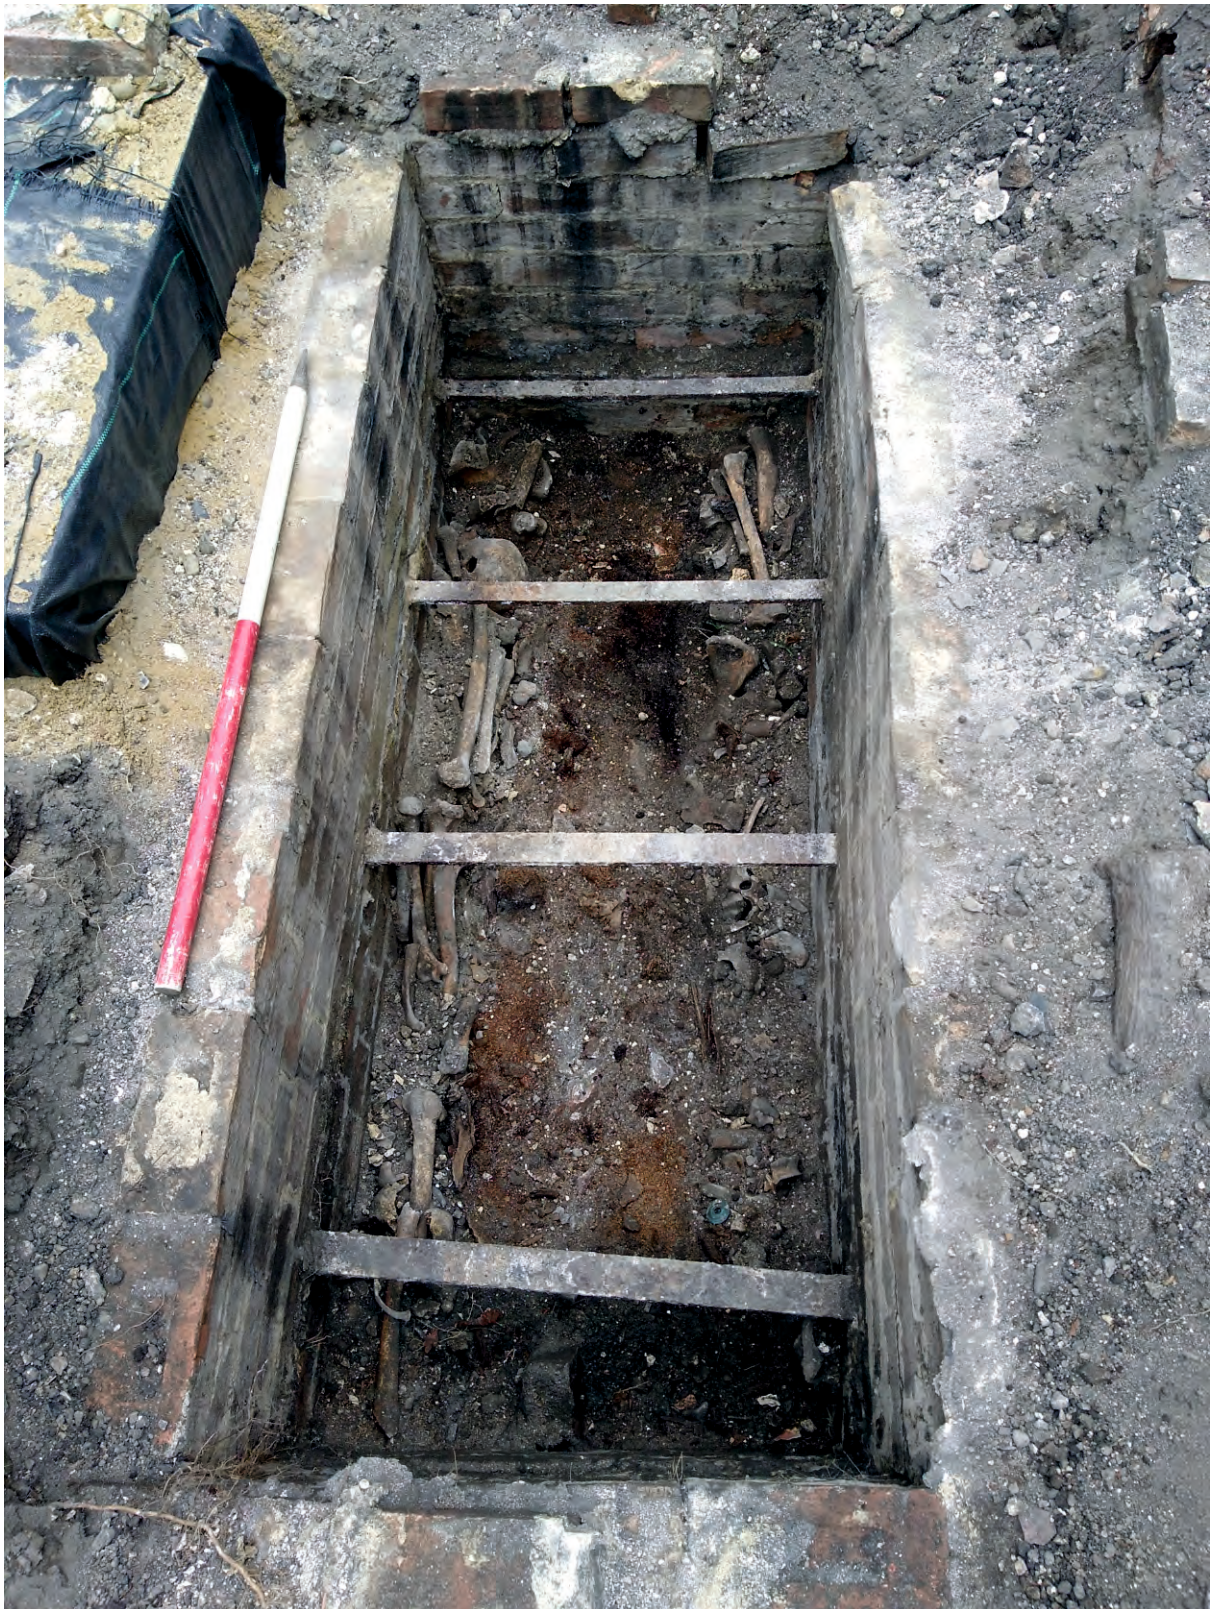
Figure 9. Vault 1 after removal of roof and clearance of debris, facing west

A 19th-century brick-built rectangular arched burial vault was identified to the east of Wall 1 (Figure 9). This vault comprised an arched roof [414], which appeared to have been removed and reinstated several times, and walls [415]. The vault was 2.05m long by 0.95m wide, with the uppermost 0.8m of the walls exposed. Four 0.04–0.05m wide iron cross beams [416] for supporting a coffin were visible and some collapsed human bone and coffin furniture was also discernible. The bricks of the vault were in a red fabric 220mm by 105mm in size and 70mm thick with a shallow frog. They were not machine made and the fabric was not levigated (reduced to a fine powder or smooth paste).

There were remnants of a decayed wooden coffin [408] c. 3.2m long by 0.7m wide with a considerable quantity of disarticulated human bone to either side of it [409], representing the remains of at least two adults. These deposits were cleaned and recorded but left in situ as they would not be disturbed. A fragmentary iron coffin plate with no legible surviving inscription

visible. A copper alloy disc and some ironwork that were present may be coffin fittings. These items were photographed but not removed from site. Disarticulated human bone from the two soakaways was bagged, labelled and reburied in Vault 1.

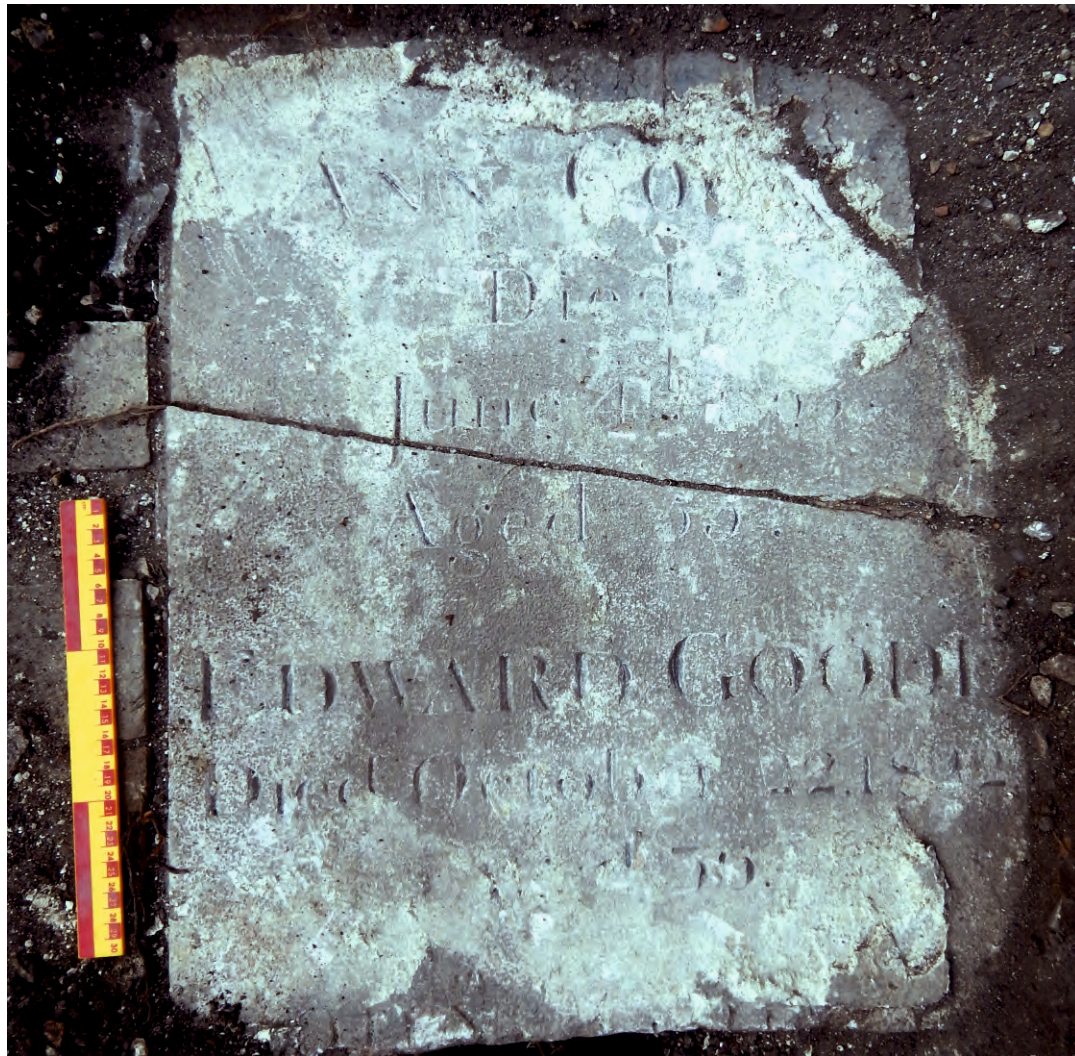
Figure 11. Buried Slab 1, facing north

Buried at a depth of *c.* 0.3m was a broken north–south aligned grave slab (Figure 11). Clearly not *in situ* it was 0.76m+ high by 0.58m wide and 70mm thick. Part of the slab was covered in mortar suggesting that it had been reused as a base for some later feature in the cemetery. The slab was undecorated and had the inscription:

ANN GO[ODE]
Died
June 4th 180[?3]
Aged 55.
EDWARD GOODE
Died October 22 1822
Aged [?3]6.

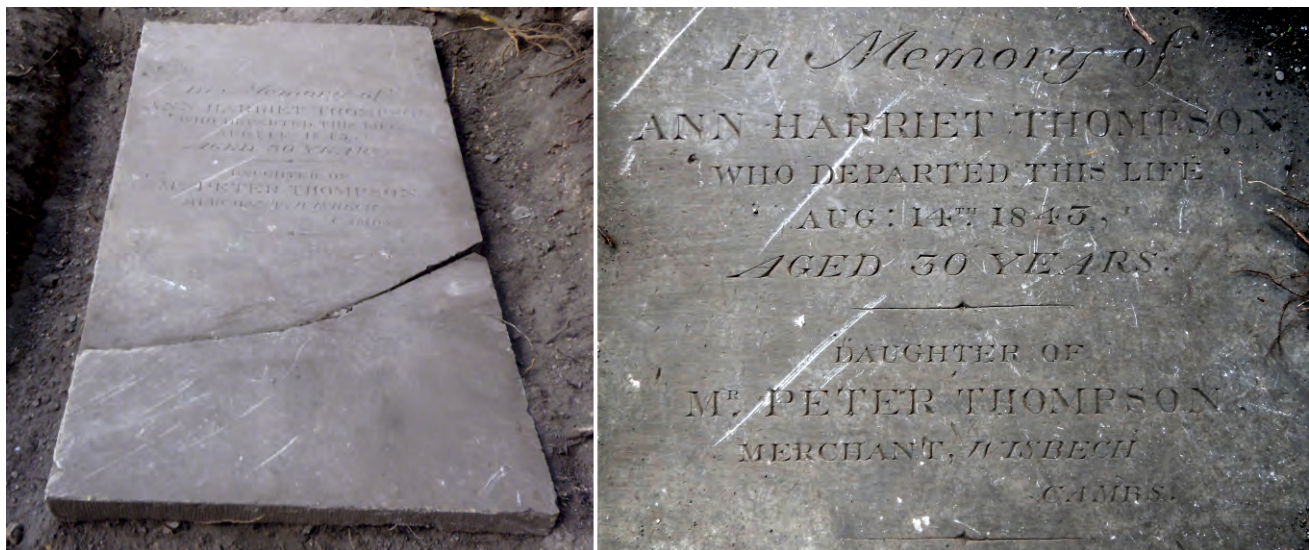
Figure 12. Buried Slab 2 plus detail of inscription, facing west-southwest

Buried at a depth of *c.* 0.4m was a west–east aligned slab that was 2.05m long, 1.075m wide and 0.10m thick (Figure 12). The slab was undecorated and had the inscription:

In Memory of
ANN HARRIET THOMPSON
WHO DEPARTED THIS LIFE
AUG : 14th 1843
AGED 30 YEARS

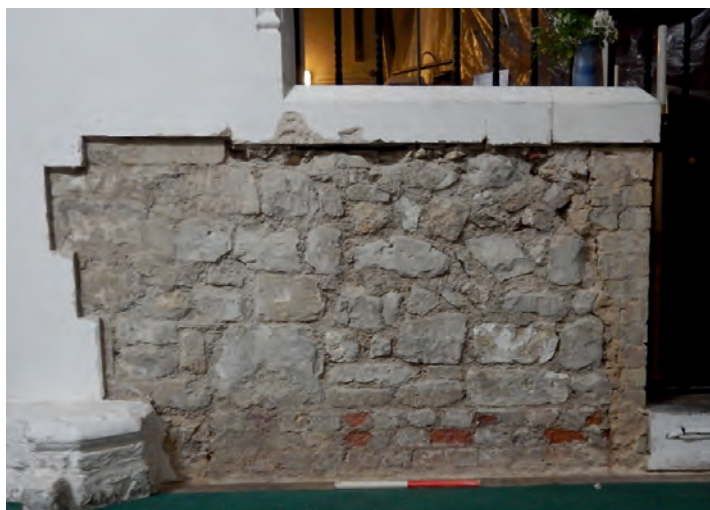
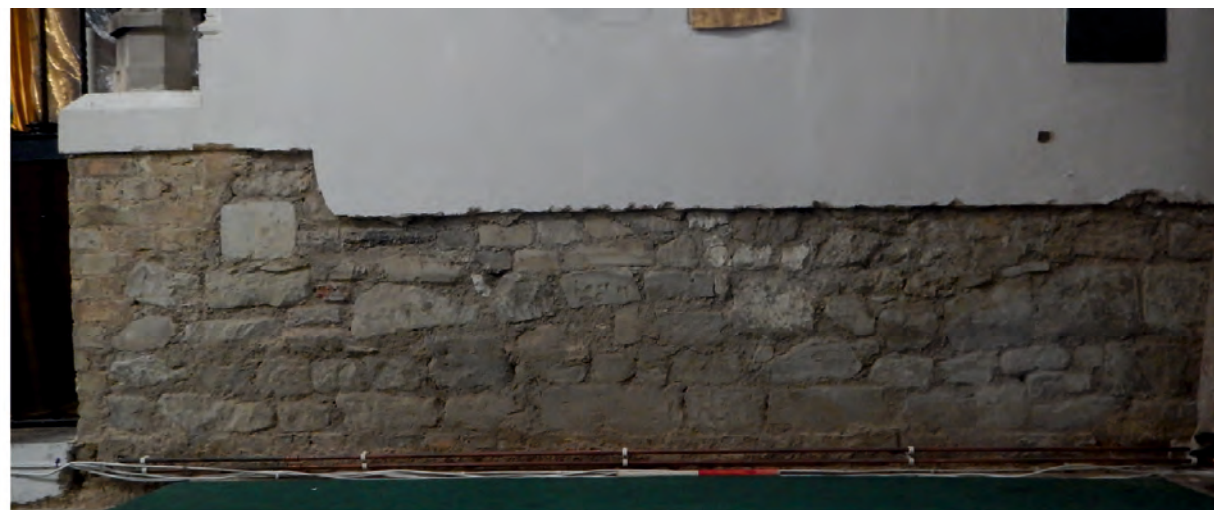
1

Inside the chancel wall plaster was removed from the lower portion of the walls as it was failing due to damp. The exposed stonework was examined and a photographic record made (Figure 13). No blocked features, reused architectural mouldings etc. were revealed.

Northern chancel wall: this wall was stripped to a height of 1.18m above floor level (to the west of the organ entrance) and between 1.18 and 0.84m (to the east of the organ entrance). This revealed that the wall was largely composed of clunch, this was quite mixed in character with a mixture of squared and faced blocks and smaller fragments set in a pale brownish grey sandy mortar. The overall impression of the character is that at least some of the clunch was reused. There was also some limestone blocks and handmade red bricks, which were *c.* 55mm thick. The entrance to the organ had been rebuilt in 19th-century yellow brick.

Figure 13. Exposed interior walls of chancel; 1, northern wall, western and eastern portions. 2, southern wall, eastern and western portions

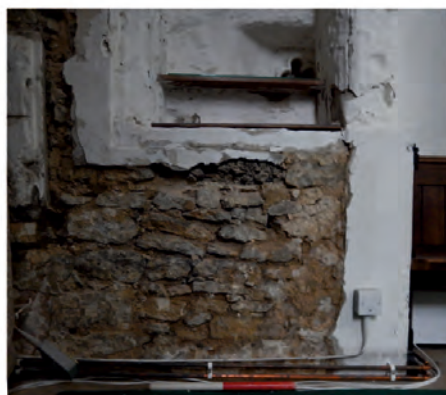
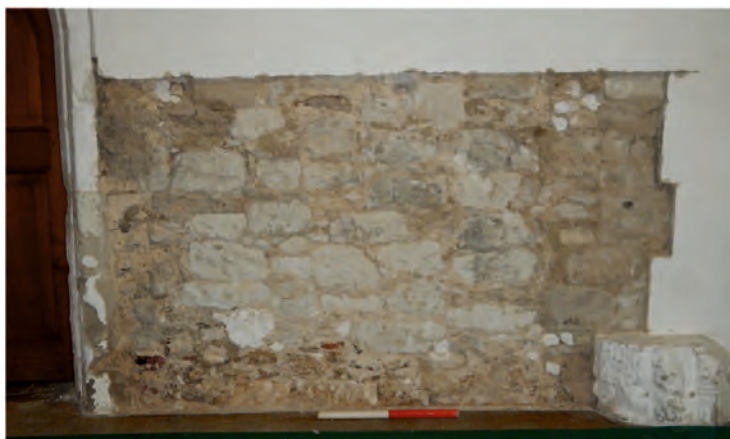
2

Southern chancel wall: this wall consisted of two distinct sections. To the west of the entrance to the vestry it was stripped to a height of *c.* 1.20m above floor level. The wall was of similar character to the northern and eastern chancel walls, although the clunch was more uniformly of larger blocks and no red brick was present. To the east of the entrance to the vestry the plaster was stripped to a height of *c.* 0.76 above floor level, although limited areas above this were also stripped. This wall contained no clunch or brick and the limestone used was narrower than elsewhere and was not squared or faced. The limestone was set in a less firm orangey brown sandy mortar.

The northern and eastern chancel walls are believed to date to after 1830 and the observations support this. The southern chancel wall is supposedly of 12th century date, the observations

suggest that this is probably true of the section to the east of the vestry entrance but indicate that the section to the west of the vestry entrance is of different later construction and may even be 19th century.
