THE TOILYARD, KIRTLING, CAMBRIDGESHIRE

An Archaeological Evaluation

© **Cambridge Archaeological Unit**
University of Cambridge
November 2008

Report No. 853
CHER No. ECB3081

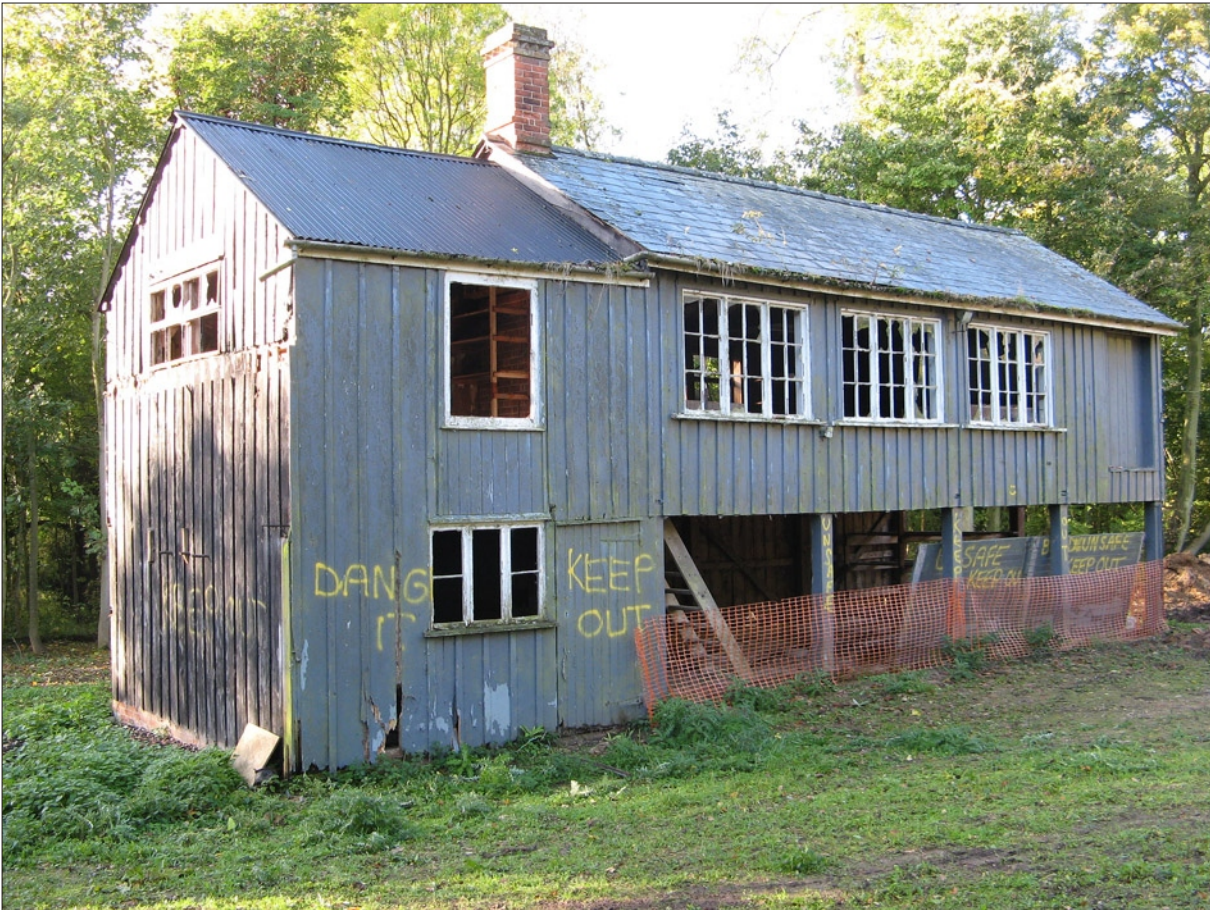
Figure 3: The Toilyard Building from the northeast

The site is situated about 500m to the west of the village of Kirtling and 350m southwest of Kirtling Tower. Extending over c. 2300 sq metres, this is the location of the former Kirtling Estate Toilyard which consisted of a two-storey weather-boarded structure, timber framed with a tiled roof, and later extensions to east and west clad in corrugated 'tin' sheeting. The extensions have recently been removed for safety reasons. The remaining structure is probably later 19th century and has planning permission for conversion to a dwelling.

The sawmill is typical of structures that would have at one time been distributed across a chiefly agricultural working landscape. The standing building on the site is constructed entirely from sawn timber and it is likely that the material for it was processed on this site at the mill. There is no evidence to indicate how the sawmill was powered.

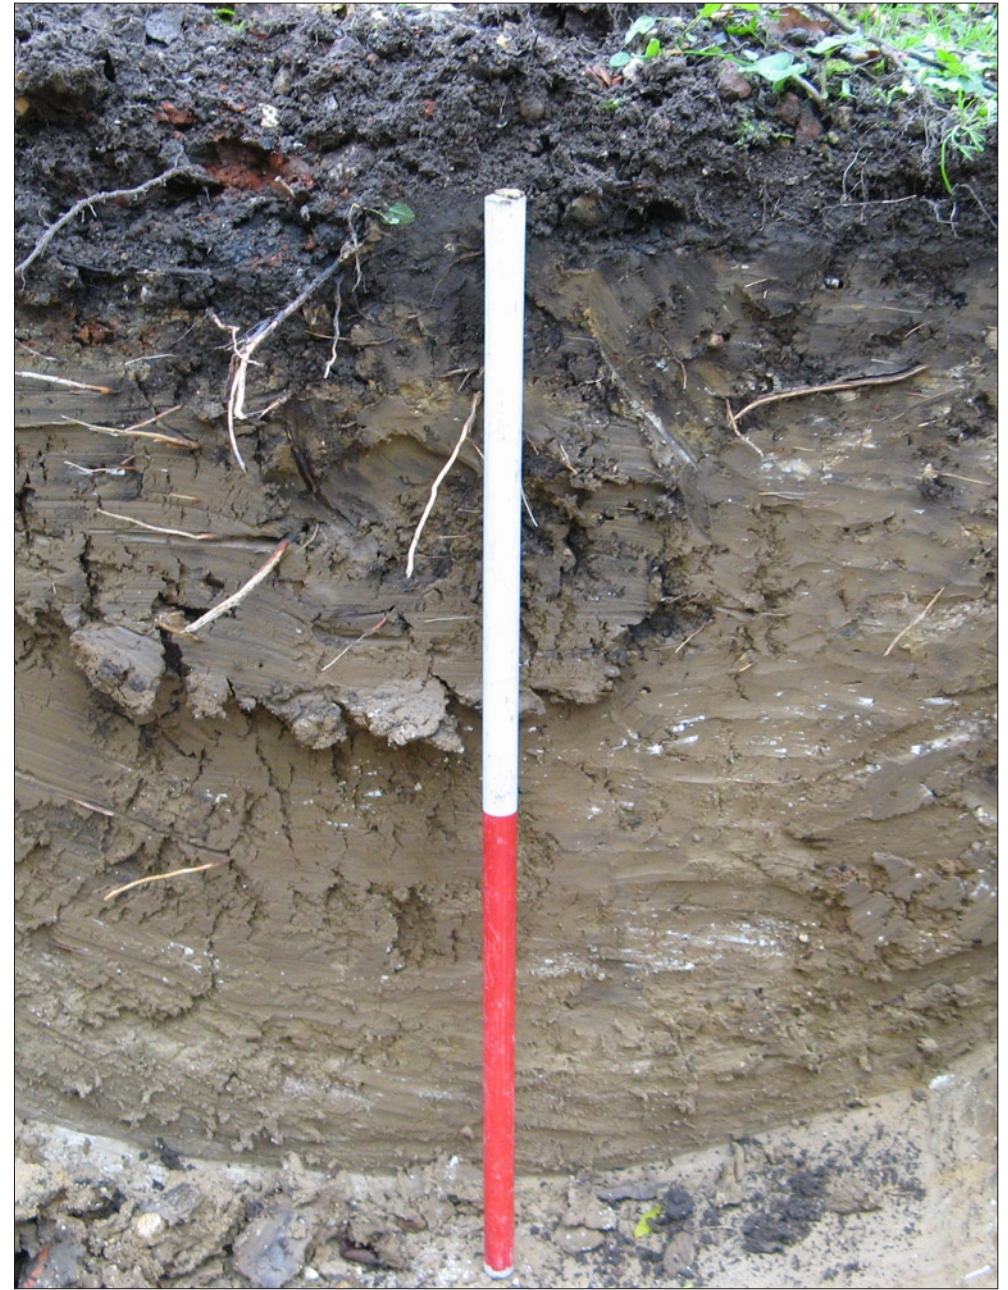
Figure 7: Redeposited clay above natural in Trench 1

Initially it was thought that the clay of C might be natural. There was, however, flecks and slightly larger pieces of brick or tile throughout. It is apparent that in this part of the site everything above the clean clay marl natural is redeposited.

Natural was a soft pale brown clayey marl with patches of a chalkier marl showing through. The only feature observed was a modern posthole with wood still visible.

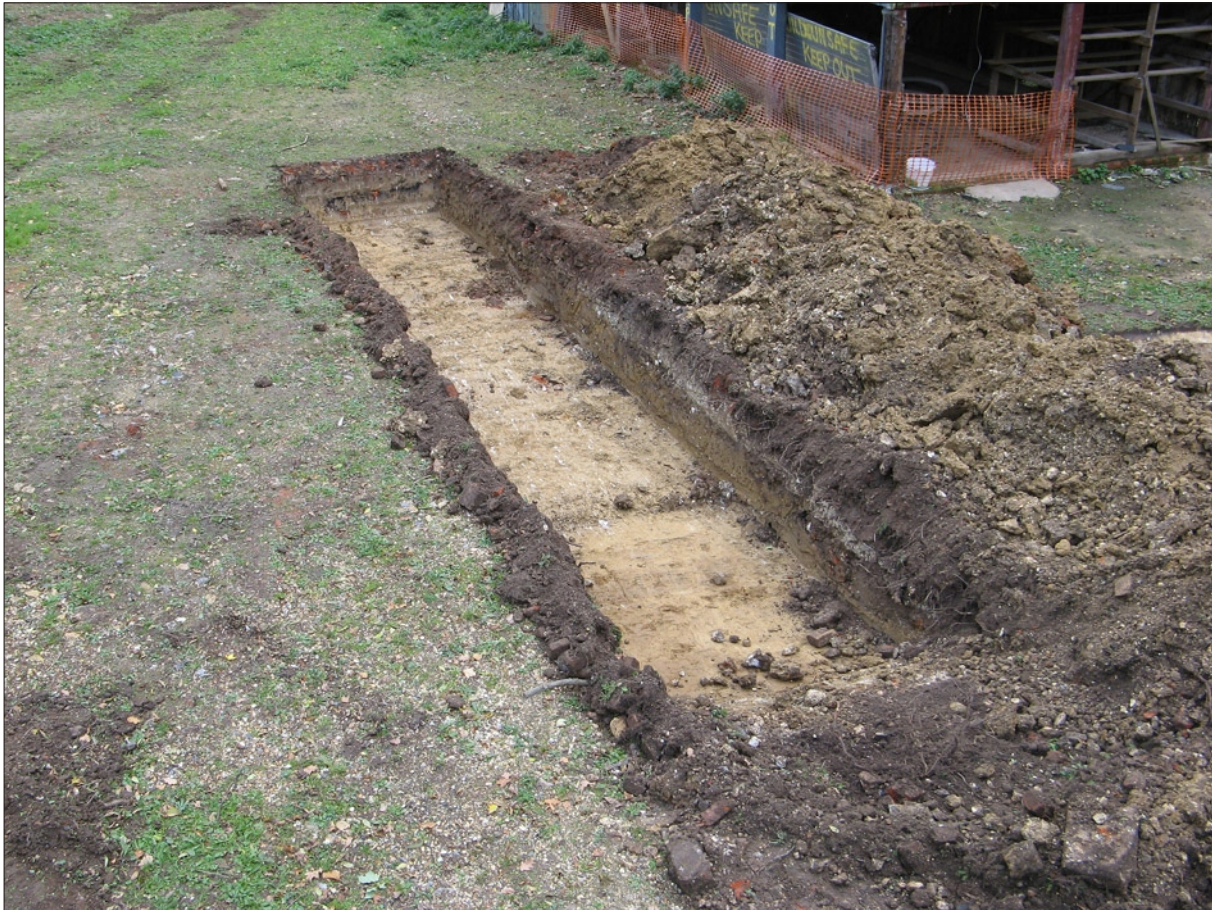
Figure 8: Trench 3

At the east end of the trench, at a depth of 0.40m, was a compact bitumen surface approximately 0.03m thick. This extended for about 0.44m to the west, but ended about 0.08m short of the north edge of the trench. This may have been a deliberate yard surface but may equally have been an area of spillage from the bitumen treatment of wood in the toilyard. Sealed beneath the bitumen layer were a small pit and a posthole, both demonstrably 20th century in date. Other than a broken ceramic field drain at the base no other features were observed in the trench.
