Moat Farm, Alburgh, Norfolk

Archaeological Monitoring and Recording

Report No. 934
Event No. ENF125011

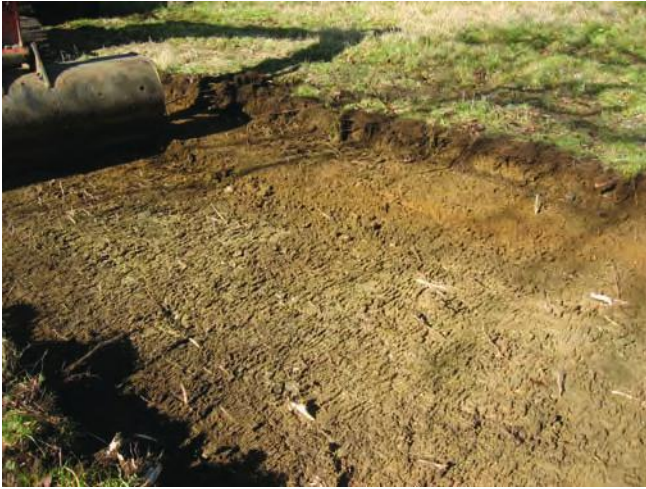
Figure 2a. Gravel layer associated with old driveway (natural clay can be seen in foreground)

The trench did not reveal any archaeological features, and was largely void of any material culture, although remnants of the old driveway were continuously exposed along the northern side of the trench from the road to the house. This original drive constituted two distinct layers; a bright orange, coarse sandy matrix containing small, sub-angular gravels (Figure 2a), overlain by a layer of large flint cobbles, which survived only in two small patches adjacent to The Street and the existing house (Figures 2b and 2c).

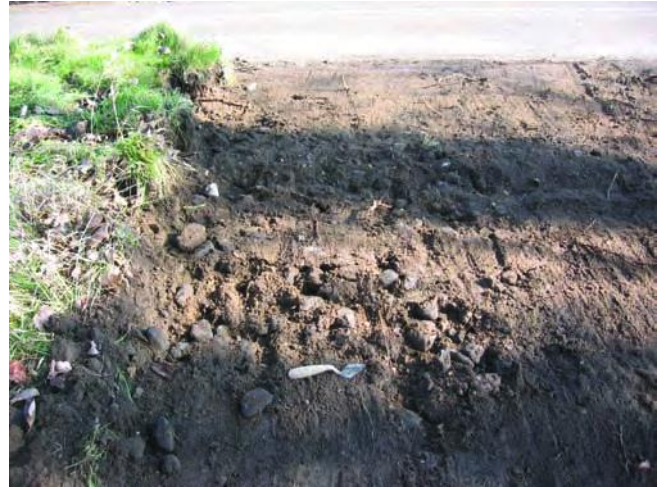
Figure 2b. Remains of cobbles associated with the old driveway adjacent to the street

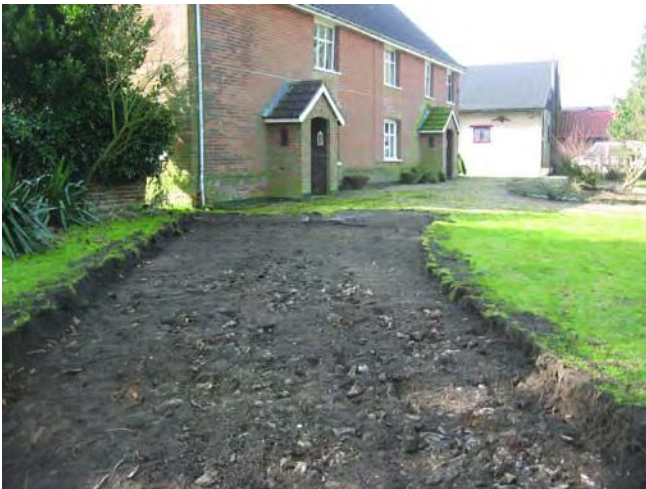
Figure 2c. Remains of cobbles associated with the old driveway adjacent to the farmhouse

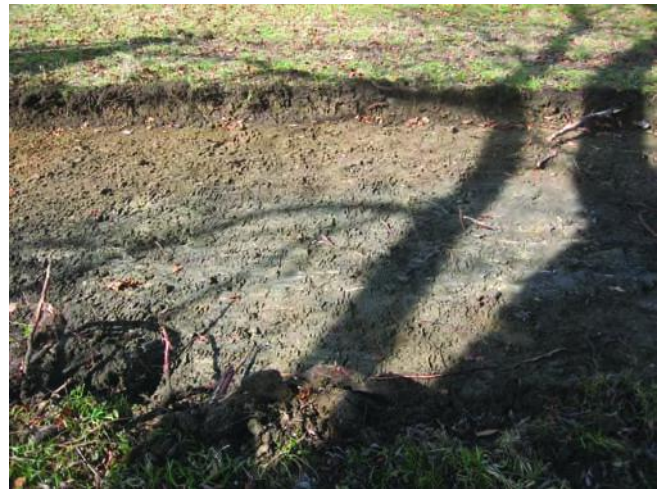
Figure 2d. Deposit resulting from moat cleaning

Adjacent to the northeast moat arm, the ground had been disturbed by the construction of a drainage pipe leading in to the moat, confirmed by the present owners to date from the last 20 years. An area of mixed soils was noted just west of this pipe, identified as the by-product of cleaning out the moat (Figure 2d). The deposit was a soft, dark blackish-grey slightly sandy, silty clay (a combination of topsoil and silts

dredged from the base of the moat) and contained an assortment of late 19th century and early-mid 20th century material. The finds included brick, tile, ceramic and china fragments, scraps of foil, pieces of bitumen and a complete, but damaged, enamelled iron milk/water jug, (probably dating from the 1940s). The mixture of material demonstrates the moat's use as a natural rubbish pit over the last 150 years. Unfortunately, no material pre-dating the late 19th century was found in this deposit.
