**Roddymoor Mill House  
Hassall  
Cheshire East**

**Archaeological Evaluation**

**Report No. Y350/18**

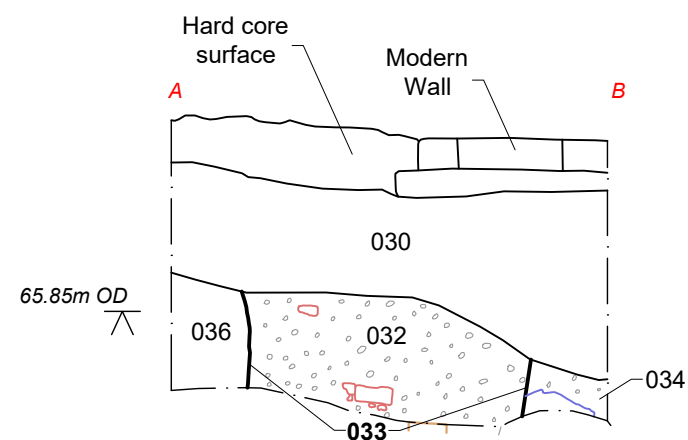
Figure 2.1 - West-facing section of Trench 2

Channel 033 was located towards the centre of the trench (Figs. 2.1 and 4.7). It was orientated north-west to south-east, had vertical sides and measured 1.4m wide, and cut through both 034 and 036. It was exposed to a depth of 0.6m, but further excavation to reveal its base was prevented due to health and safety concerns over the depth of the trench as a whole, and the presence of a single timber laying in the centre of the channel which continued into both edges of the excavation. The fill of this channel was mid grey, silty clay with abundant pebbles and brick fragments (032).

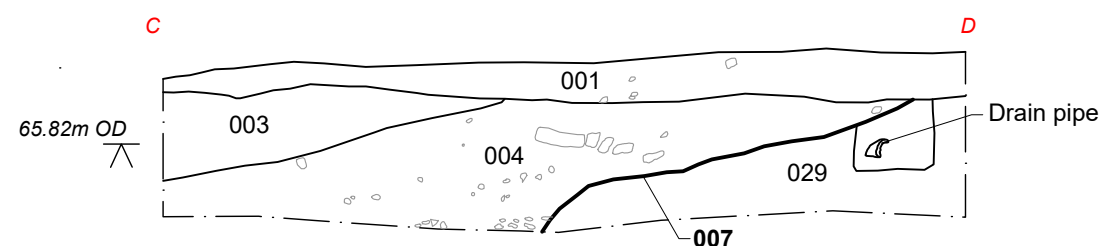
Figure 2.2 - West-facing section of Trench 3

Towards the northern end of the trench was a construction cut (007; Fig. 2.2). This feature extended 5.5m to the northern end of the trench and was recorded as having gently sloping sides towards the former mill building. Its full depth exceeded 3m as recorded in the north-facing section of this trench, which abutted the south-facing elevation of the former mill building. The material filling it (004) was dark black-brown silty clay with frequent brick fragments and stones.

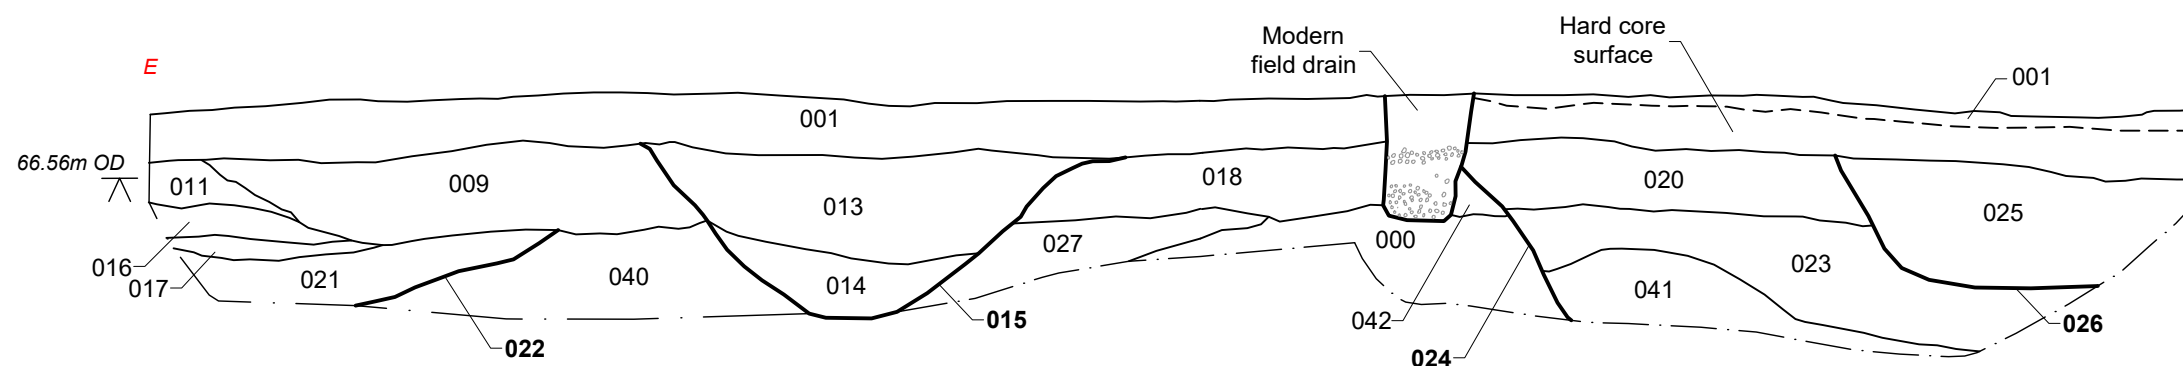
Figure 2.3 - North-facing section of Trench 4

Trench 4 contained dumped layers of backfill material within the former mill pond, and three cut features (015, 022, 024) (Fig. 2.3 and 4.10).

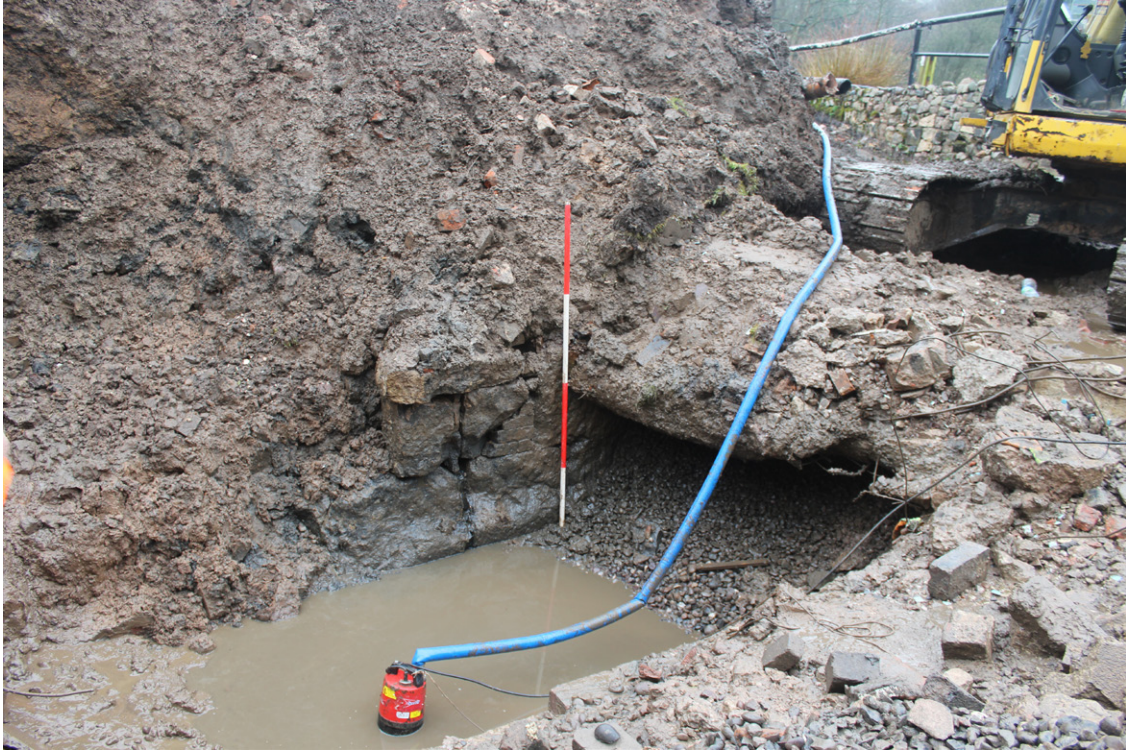
The stone wall (046) was identified in the south-west corner of Trench 1, and survived to a height of 1.09m up from the flagstone floor (Fig. 4.1). It appeared that the stone wall formed the foundation for the brick walls of the mill. Abutting its north-facing elevation was the later concrete slab to support the swimming pool, as well as a flagstone floor (045) which lay buried under the sorted pebble hardcore onto which the concrete slab had been poured. These flagstones were only briefly visible as the hardcore was removed by the excavator, due to water ingress (Fig. 4.2). Each flagstone measured approximately 0.8m by 1m.

Fig. 4.1 - North-facing elevation of Wall 046, in Trench 1, facing south-west

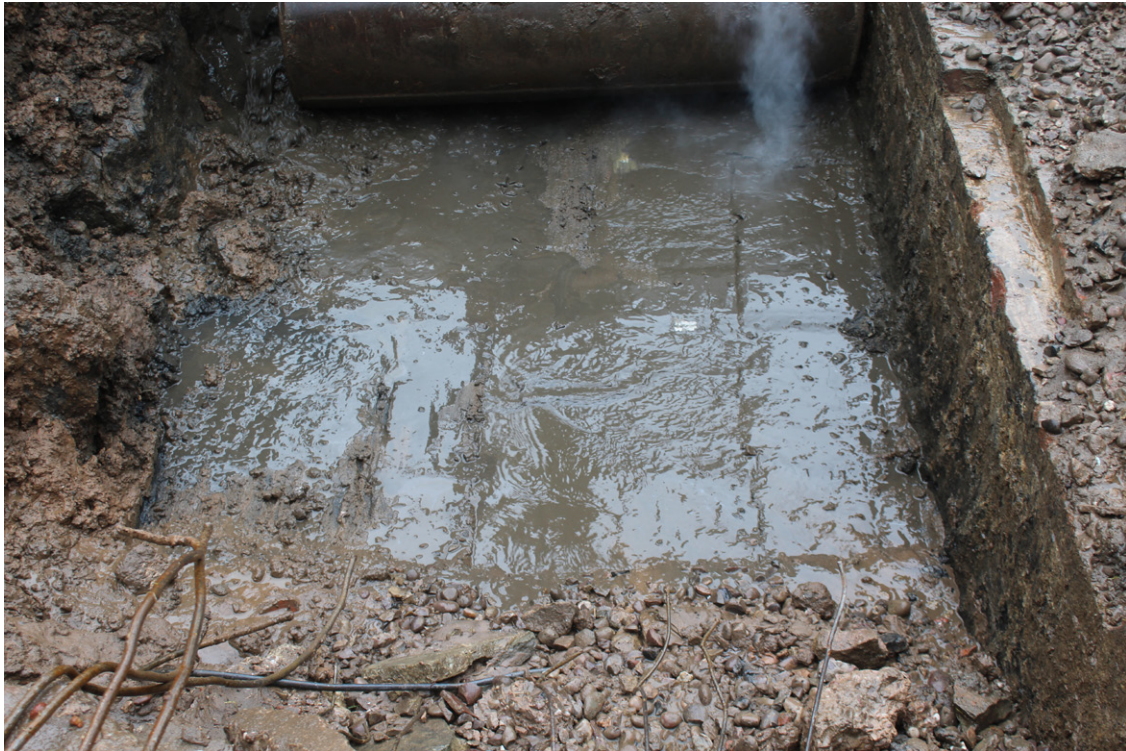
Fig. 4.2 - Flagstone Floor 045 visible as the mechanical excavator agitated the overlying water

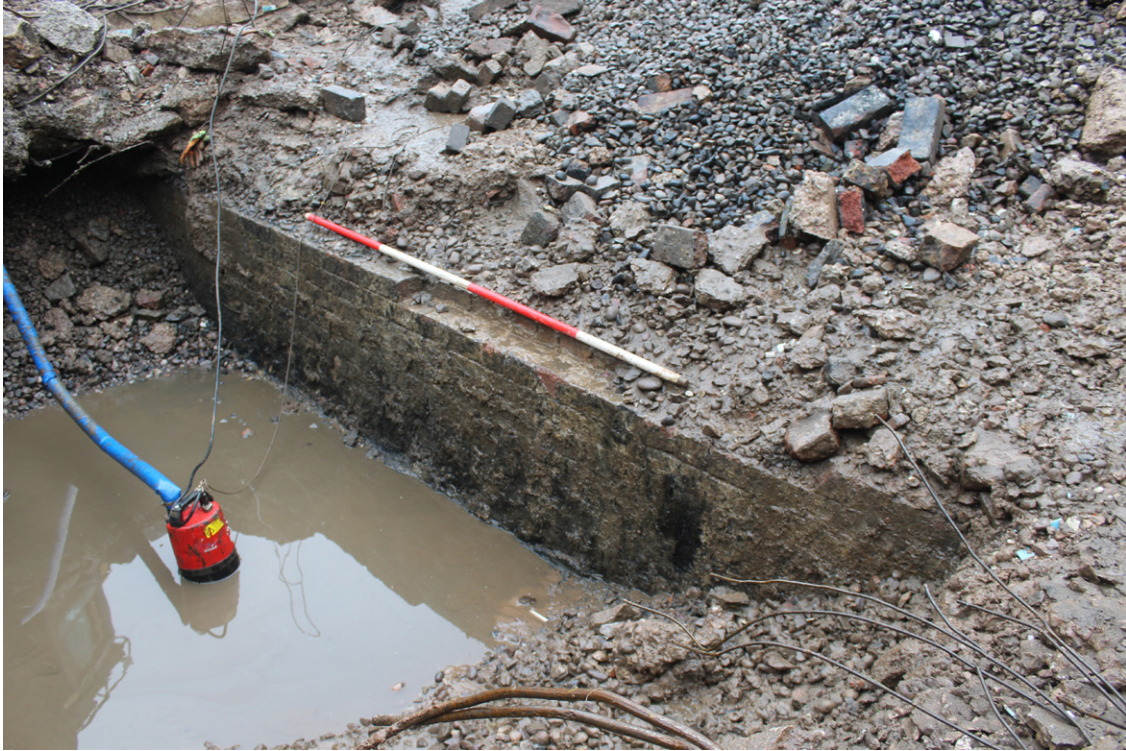
A brick wall (044) had been built on top of the flagstone floor and survived to 9 courses high (Fig. 4.3). It is unknown as to whether this is a brick support strut for the later construction of the swimming pool, or an alteration to the space defined by the stone-walled structure.

Fig. 4.3 - South-facing elevation of Brick Wall 044, in Trench1, facing north-west.

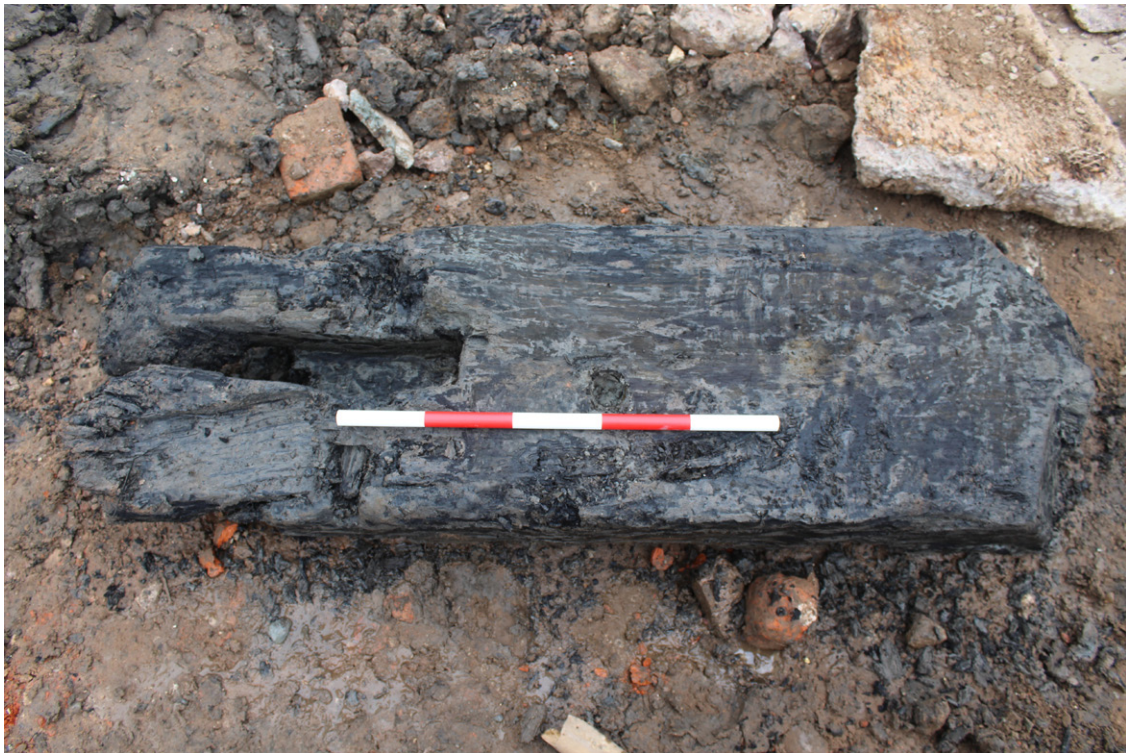
The base of Trench 2 was reached in a sondage at its southern end, which extended to 2.5m below the concrete slab (67.23m aOD) to reveal water-derived deposits consisting of thin layers of pale blue-grey silts and clays (043). This deposit was also identified at the northern end of Trench 2 at 1.87m below the concrete slab. It contained the remains of timbers (Fig. 4.4), which appeared to have been dumped.

Fig. 4.4 - Timber extracted from Deposit (043)

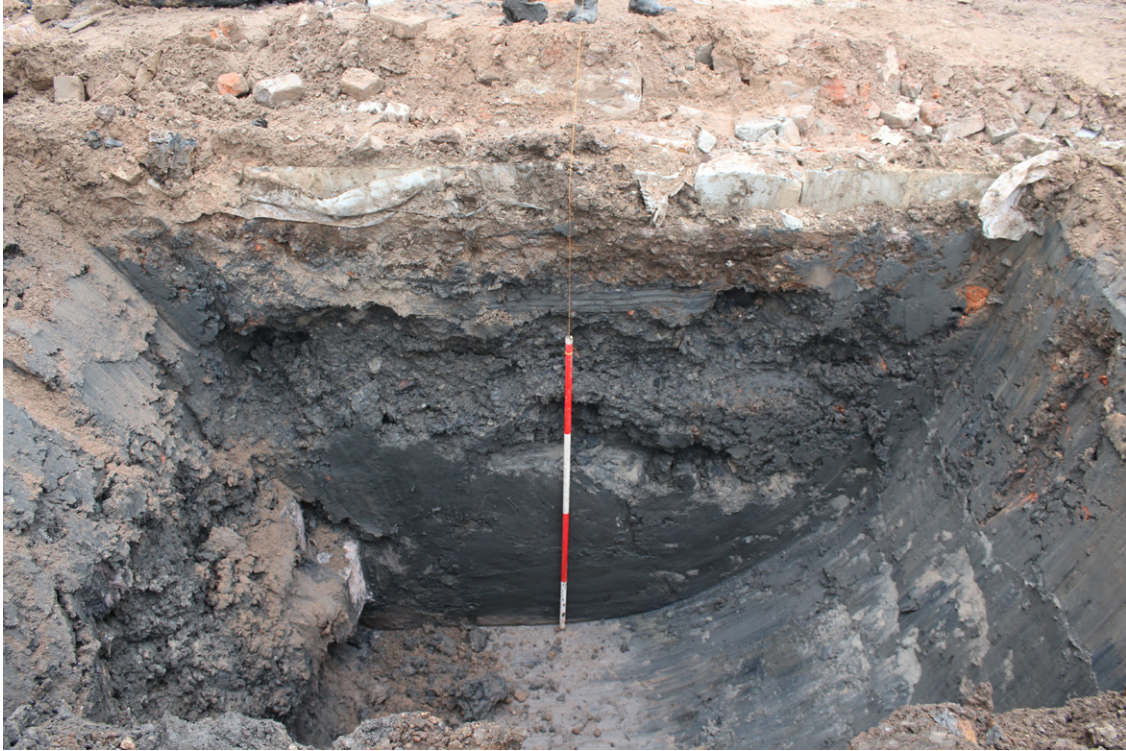
Deposit 034 measured 1.45m in depth, becoming shallower towards the north (Fig. 4.5). Its depth was recorded through the excavation of a sondage. It consisted of mid blue-black silty clay with occasional small to medium sub-rounded stones. Towards the bottom of Deposit 034, at the interface with 043, were three substantial faced stone blocks (Fig. 4.6) with mason's drag, metal fittings and bolts. These were contained within deposit 034. Two of the recovered stones showed signs of later disturbance in the form of having been pecked in an attempt to break them up and remove them, possibly for the insertion of a modern service (039), with each block subsequently having had concrete poured on them.

Fig. 4.5 - West-facing section of south end of Trench 2 showing Deposits 036 with faced stone in section, overlying Deposit 043, and underlying Deposit 030

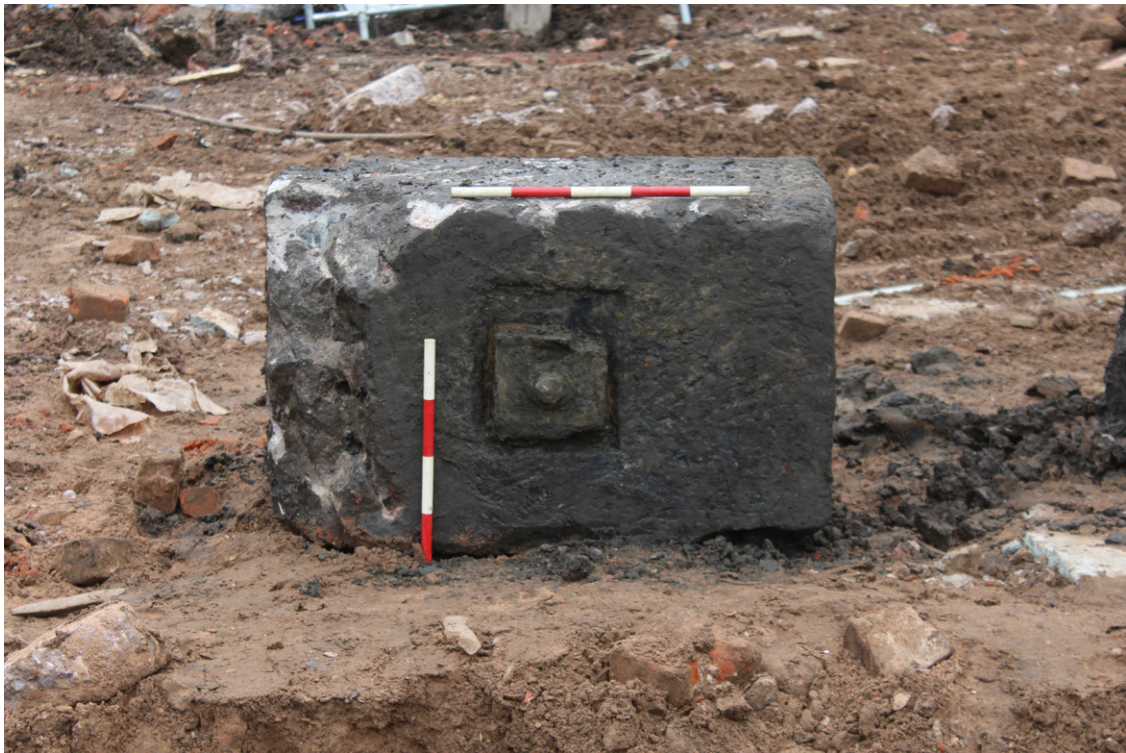
The stones found in deposit 043 at the base of Trench 2 were dressed, designed for a purpose, most likely a machine base to anchor mechanisms within the mill. These dressed stone blocks were found within an alluvial-type deposit along with preserved wooden timbers. They were clearly not in situ and are likely to be from the original mill. Peck marks on one stone showed that there was an attempt to remove them from the deposit they were found in when a modern service was inserted, likely during the later refurbishment of Higher Roughwood Mill and installation of the swimming pool.

Fig. 4.6 - Faced stone with bearing attachments, extracted from Deposit (036)

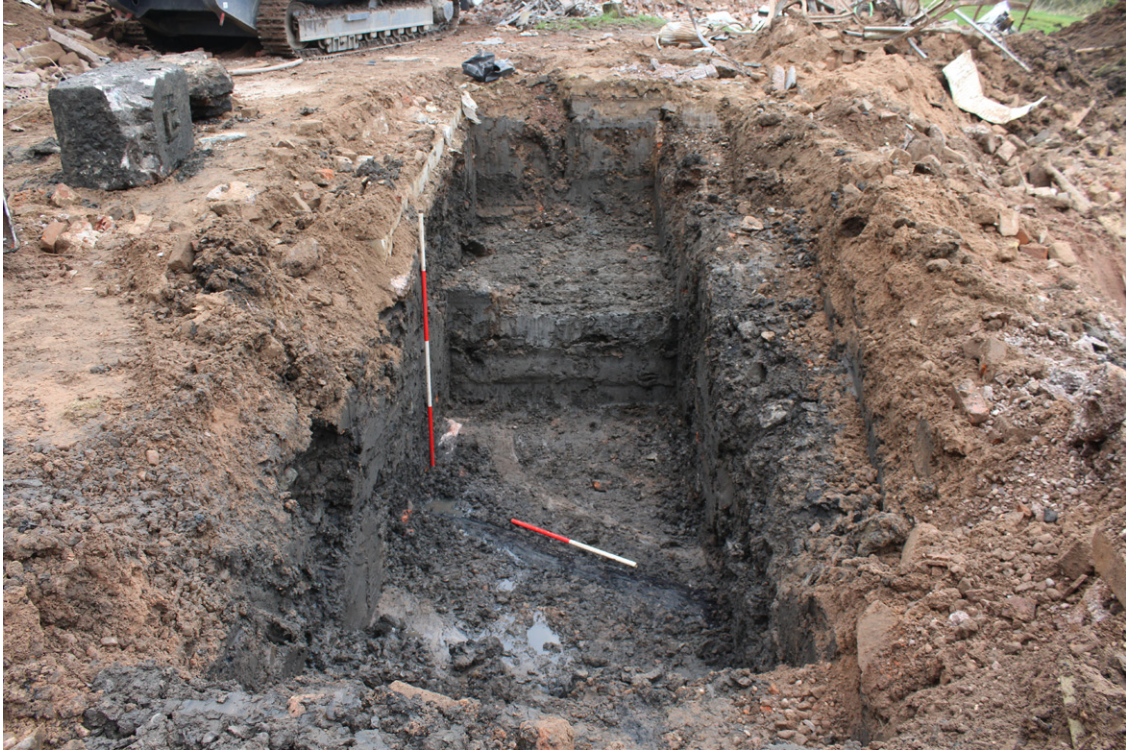
Fig. 4.7 - Trench 2, facing south, showing Channel 033

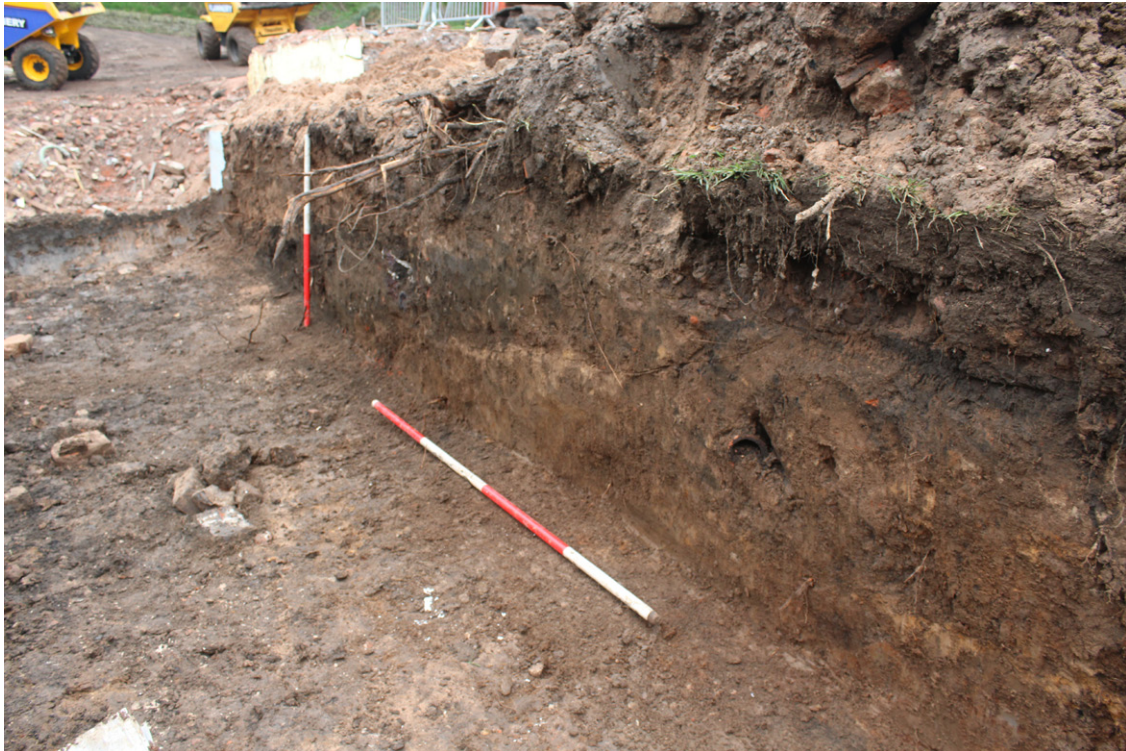
Fig. 4.8 - W-facing section of Trench 3

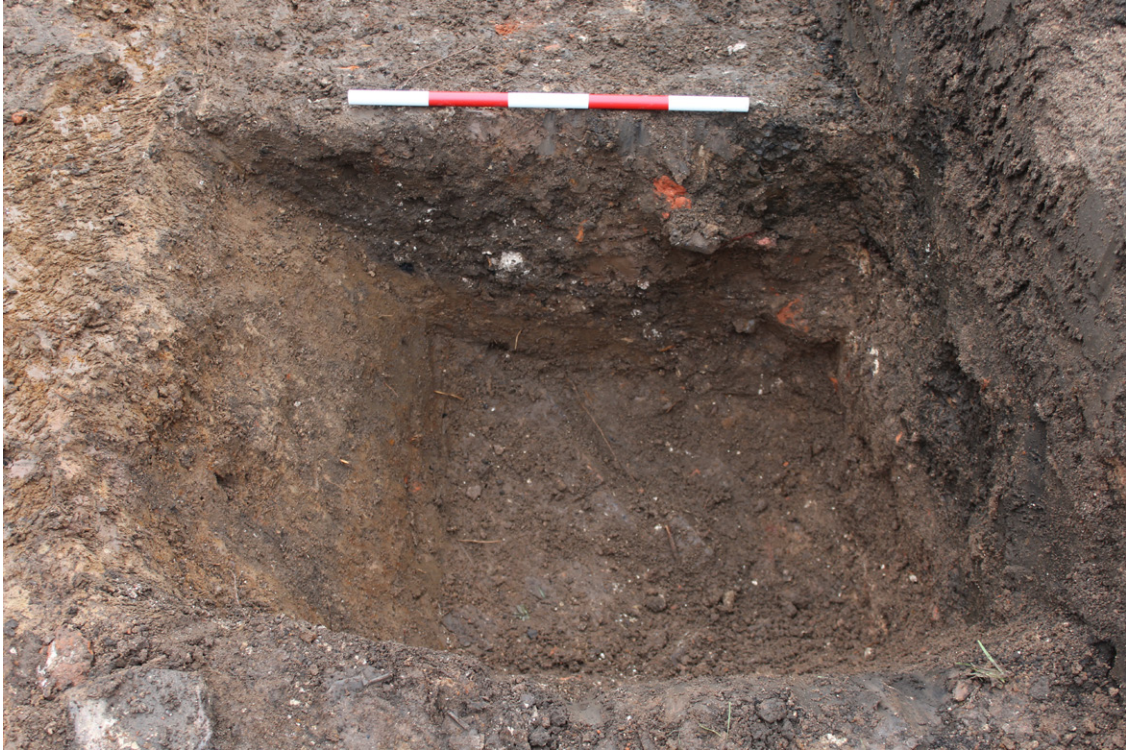
Ditch 005 was identifiable as 0.9m wide, continuing south beyond the limit of excavation and with a depth of 0.45m (Fig. 4.9). Further excavation at depth was not achievable due to the safety concerns mentioned above and because of the instability of the ground at the northern end of the trench due to the demolition of the mill wall. The ditch was filled with 19th century rubble (006).

Fig. 4.9 - Trench 3, N-facing section of 005

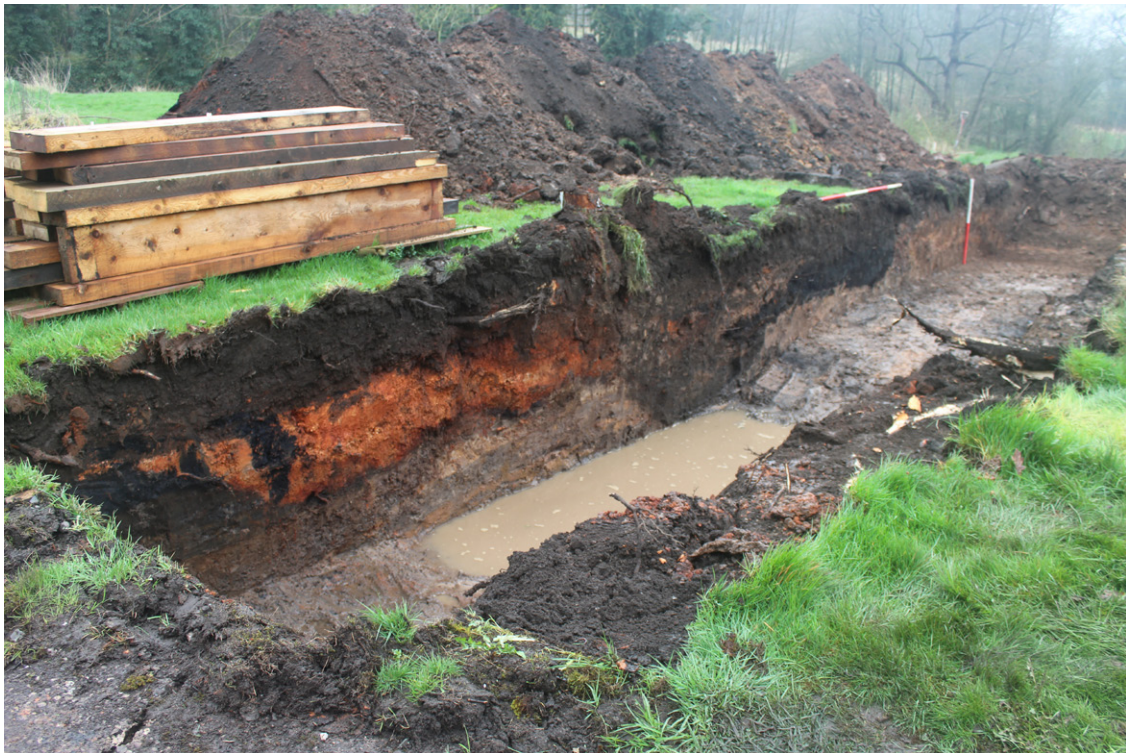
A layer of bright orange and black silty clay (009, 011, 018) overlay the re-deposited natural (040/027) and the fill of (022). This deposit was 0.54m in depth and was a bright yellow-orange clay silt, which became very black and charcoal-rich towards the east (011) and west (018) (Fig. 4.10) and forms a thick layer of made ground.

Fig. 4.10 - North-facing section of Trench 4, facing south-west

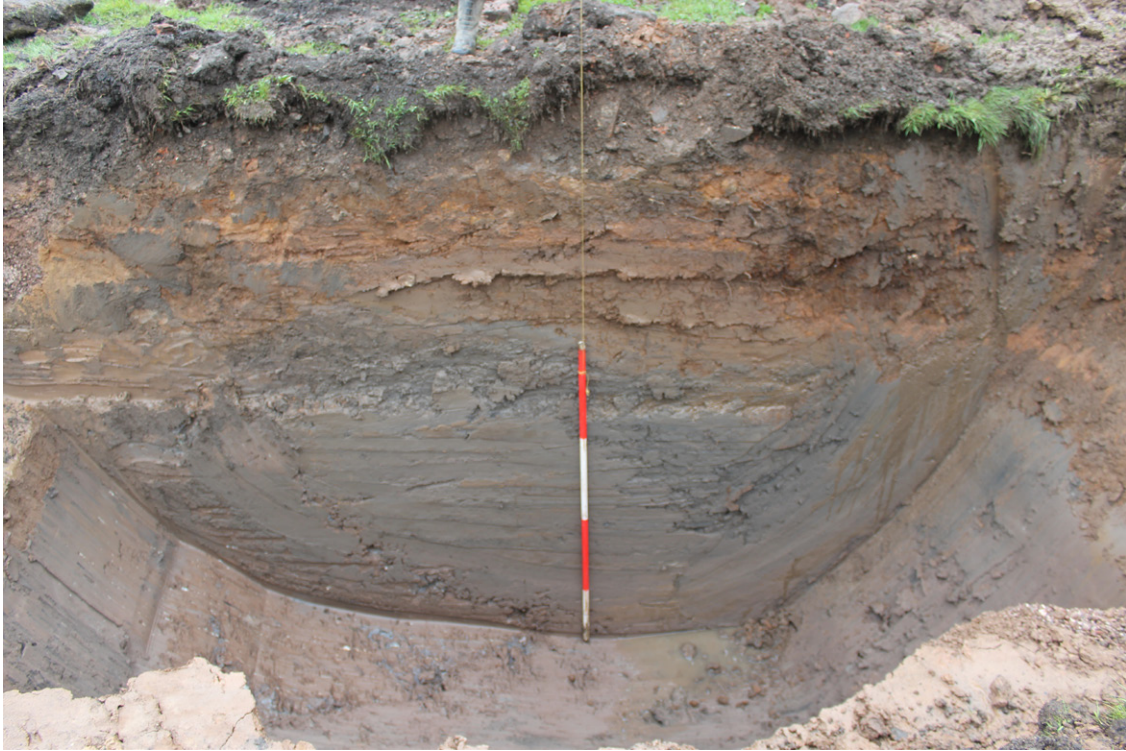
Feature 024 was located at the western end of the trench and appeared to be on a north-south alignment, continuing in both directions beyond the edges of the trench. It measured 2.78m in depth, a depth determined by the excavation of a sondage at the end of the trench, but appeared to be getting deeper towards the west (Fig. 4.11). This feature consisted of fairly steep sloping sides and a concave base. This feature was initially filled by a compact layer of mid grey sandy clay (041) with very occasional small stone inclusions and was otherwise fairly sterile. Overlying this was the secondary fill (023); a layer of mid-light grey-brown sandy clay with a slight silt component and small pebble inclusions. A tertiary fill was also recorded, of mottled light orange-brown to light-mid grey silty clay (020).

Fig. 4.11 - North-facing section of Feature 024, Trench 4
