Minor Archaeological Services Call-Off Contract Mavisbank House, Midlothian (PIC156)

New Access Road, Fencing and Drainage
Installation, Watching Brief, March 2019
Report No. HES-PIC156-2019-01

**New Access Road, Fencing and Drainage Installation
Watching Brief, March 2019**

Report No. HES-PIC156-2019-01

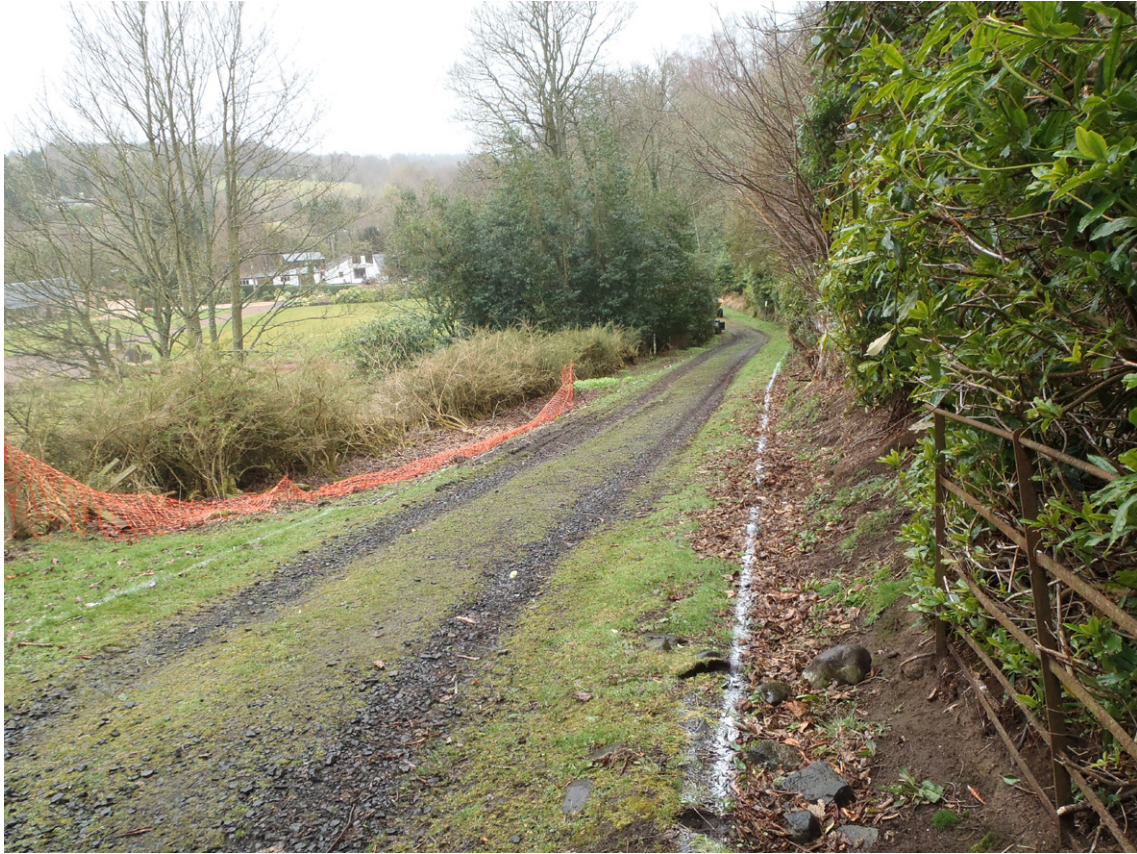
Fig. 3: Pre-ex shot of road surface.

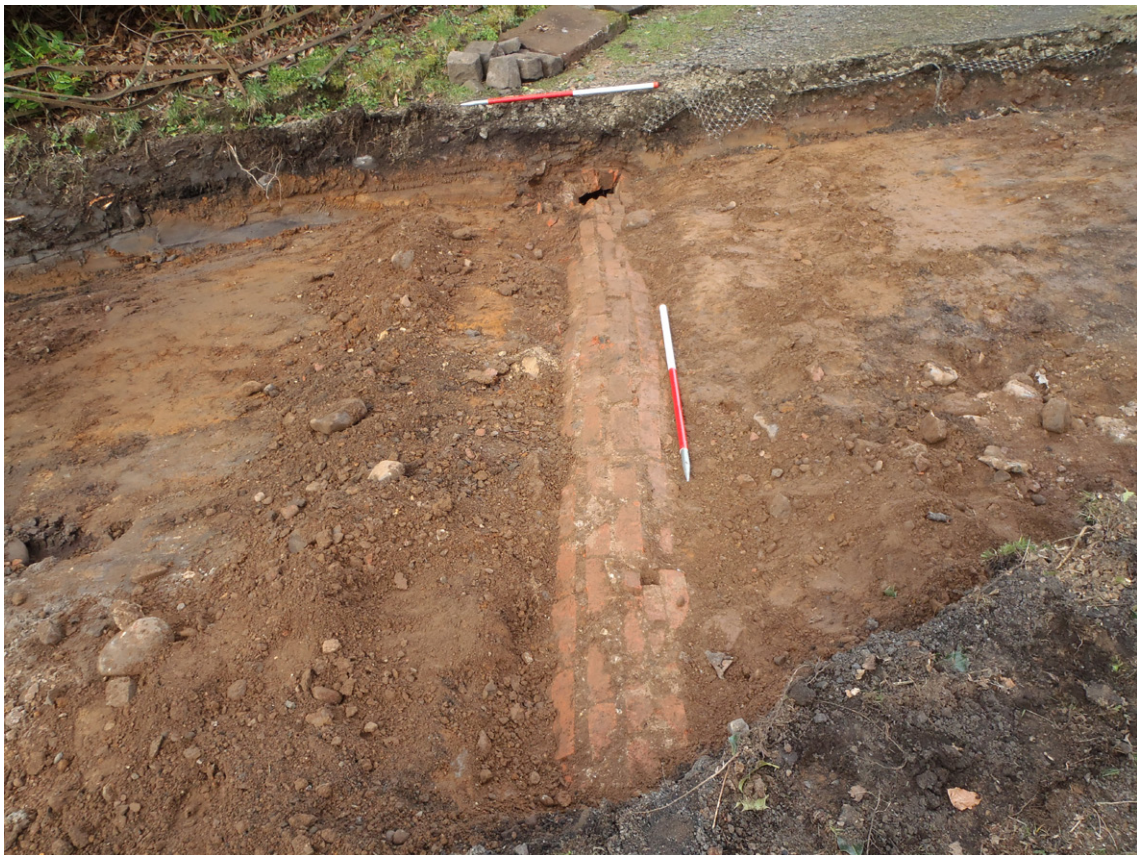
At the north most end of the stripped area an arched brick culvert (**006**) was uncovered, aligned NW-SE (Fig. 4). The feature measured 4m in length and 0.5m in width. A break at its N end allowed the internal diameter of the culvert to be measured, at 0.4m, and its outer diameter was 0.6m. The structure was made of red unfrogged bricks, bearing no stamps or makers marks, bonded with mortar. Based on the shape, colour, and lack of any markings on the bricks, it can be concluded that the feature is Victorian (Suddaby, I. Pers. Comm.).

Fig. 4: Post-ex shot of exposed brick culvert (006).

As agreed with HES, the culvert and sump were left in situ and covered with a steel plate prior to upfilling for the new road, and the gully was also left in situ and covered with terram prior to upfilling for the new road.

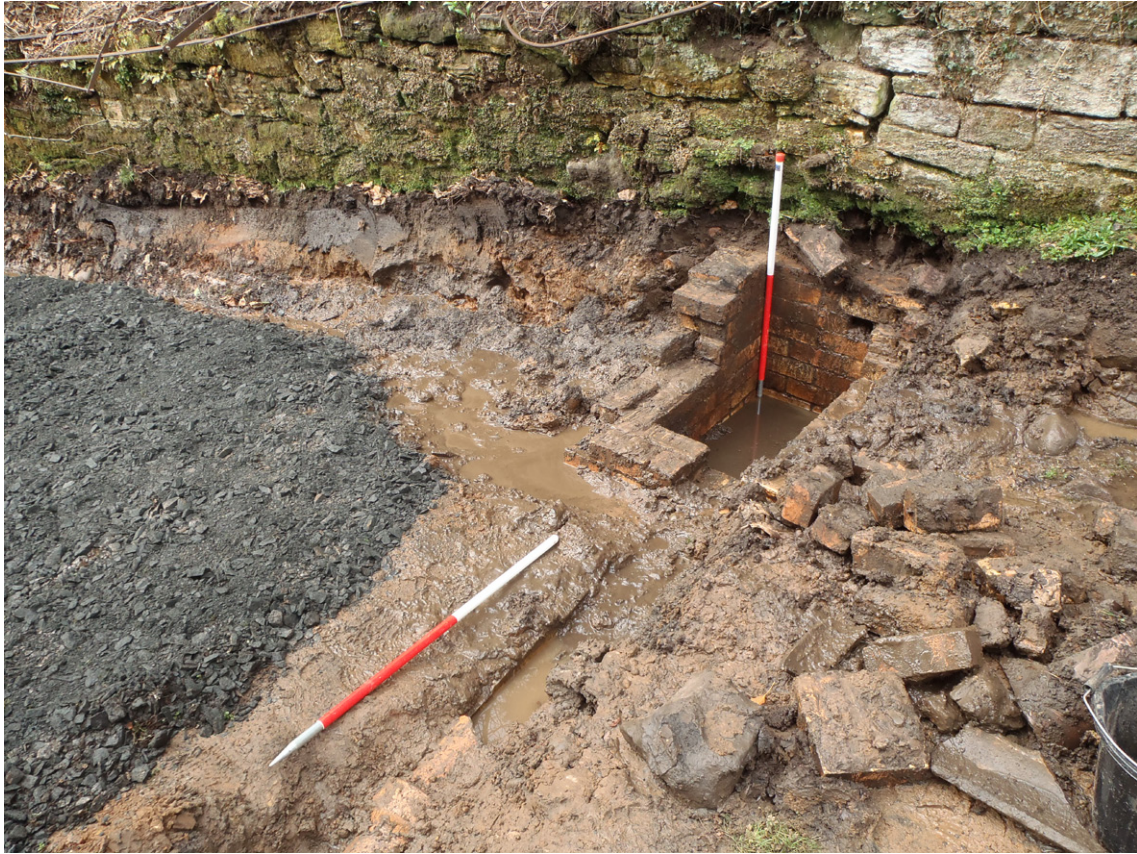
A 7" glazed ceramic pipe (015), which continued under 009 and 010 to the east, connected to a brick drainage sump (013) to its west (Fig. 5). The ceramic pipe and drain were no longer live. The sump (013) measured 1.3m by 0.95m, with a depth of 0.8m. It was two bricks thick and eight bricks tall. The base of 013 was brick-lined as well and the drain hole was located in the western wall of the feature, the opening obstructed by stones. The bricks used were a variation on the "WHITEHILL" bricks used for 018, as these bore the stamp "○VITEHIL○" (with a circular stamp at each end of the name). On closer inspection it was clear that the circular stamp did not obstruct the last 'L' but was made in this way without the second 'L' (Suddaby, I. Pers. Comm.). After excavation and recording of the feature was finished, all removed or fallen off bricks were put back in the base of (013), as discussed with HES.

Fig. 5: Post ex shot of (013) and (015).

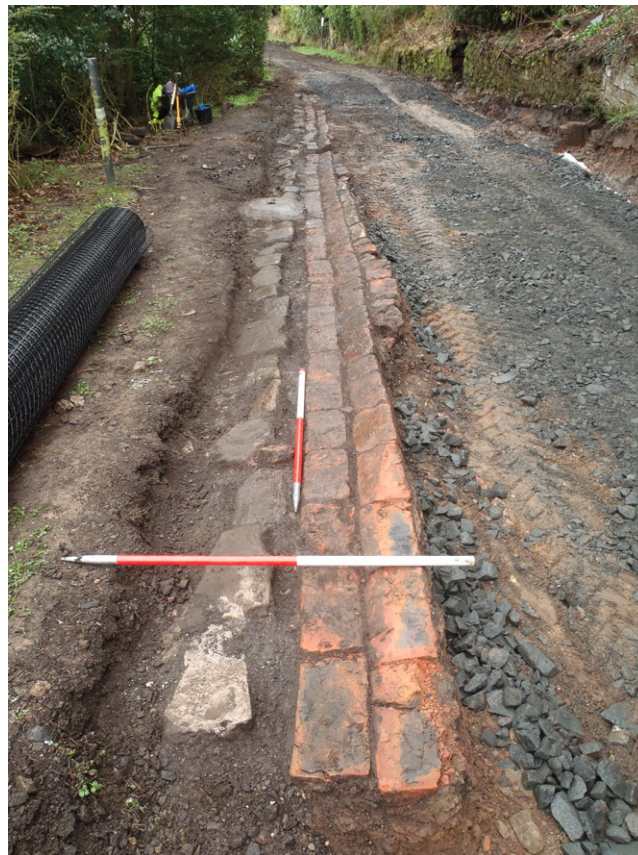
South of **006**, on the eastern edge of the road, a c.30m long brick gully (**009**) was uncovered, with a stone kerb (**010**) on its eastern side (Fig. 6). The gully was made of a double row of bricks (0.4m wide), laid end to end and slightly pitched towards each other to form a gully. The bricks were unfrogged, with no makers mark or stamps, again suggesting it to be Victorian (Suddaby, I. Pers. Comm.). The condition of the feature was variable: some bricks were more damaged than others, and during excavation it was noted that the bricks were quite fragile. A section of the feature had an additional line of more modern frogged bricks, stamped with "NIDDRIE" (circa mid 1920s) and "WHITEHILL" (unknown), along its western edge (**018**). The feature becomes more fragmentary to the south.

Fig. 6: Post-ex view of (009)/(010).

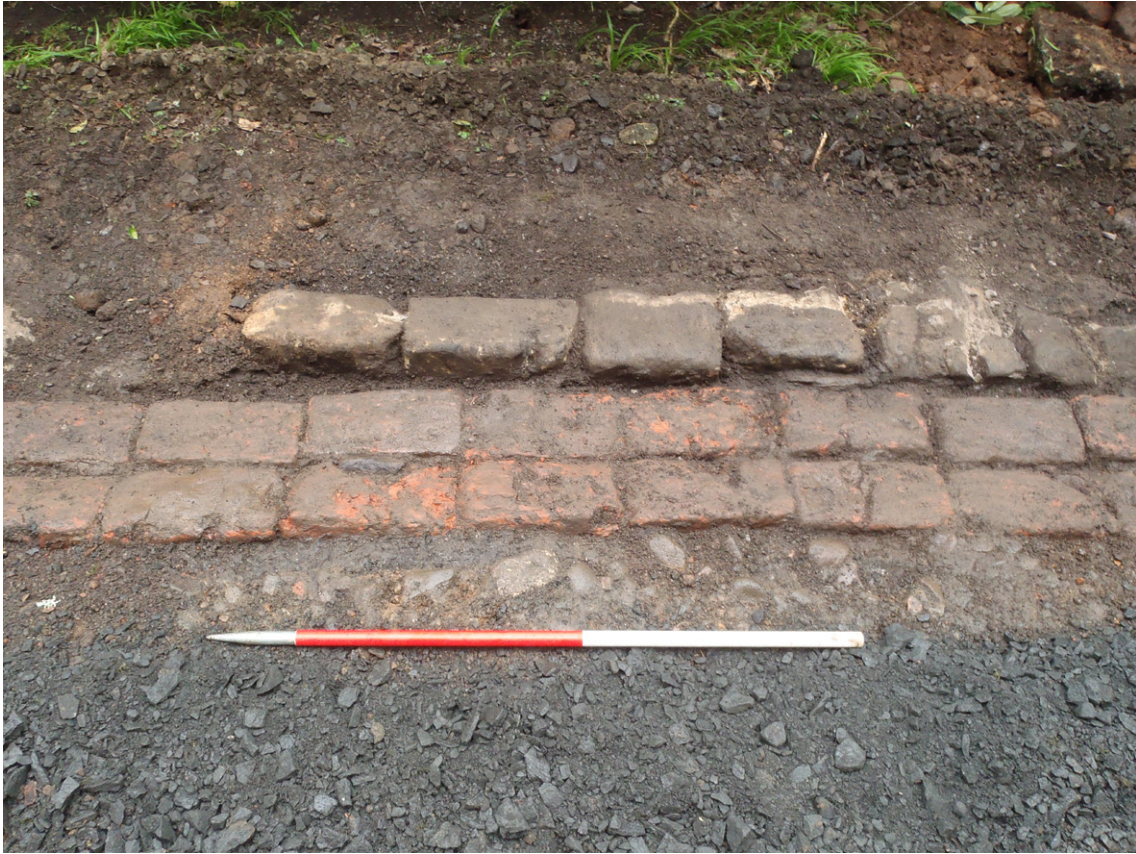
At its southern most end, **009** sits on top of a surviving fragment of the assumed

original road surface (016) (Fig. 7). It measured 3m long by up to 0.5m in width, and was a compact deposit of stones of various sizes. This surface was concluded to be part of the old road to Mavisbank house. This was the only remains of the original metalled road surface within the watching brief area.

Fig. 7: Post-ex shot of (009)/(010) with (016) in view.

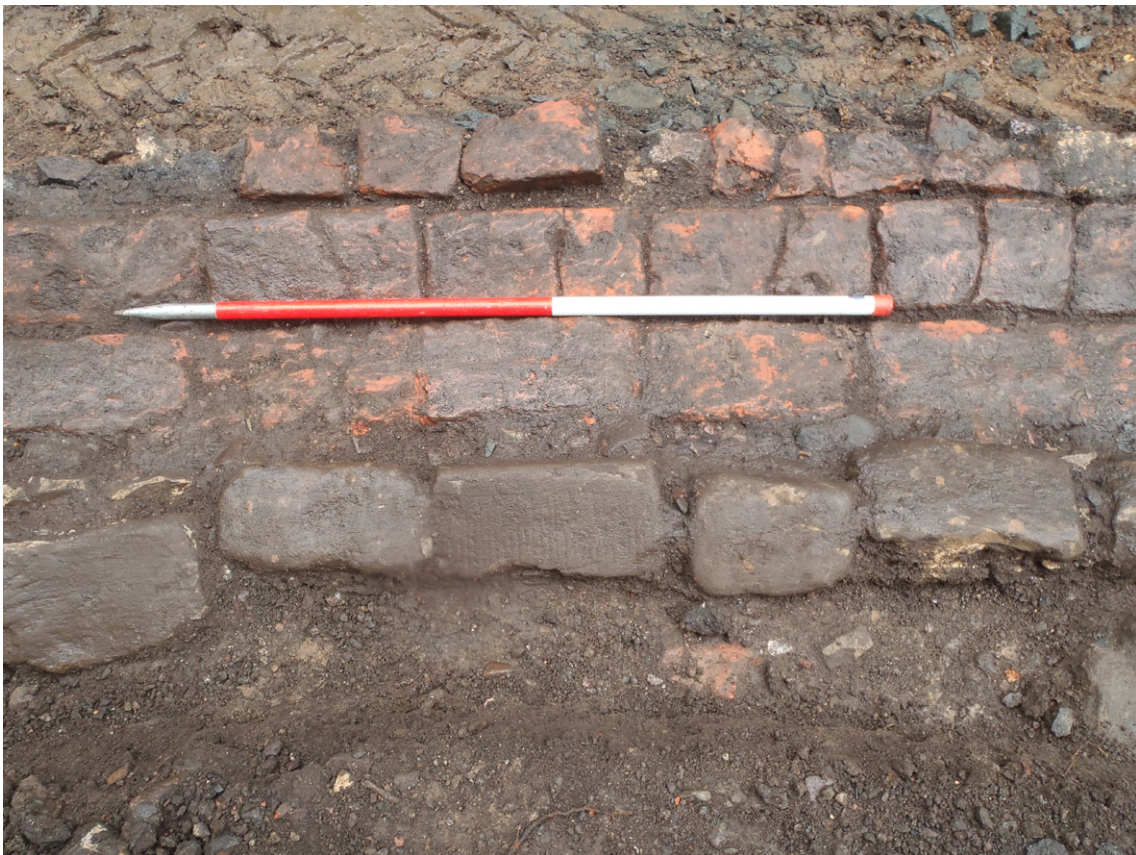
Parallel to **009** and on its east side was a stone kerb (**010**), which appeared to be contemporary to the brick gully. The kerb was 17.5m long and c.0.3m wide, made of stones of varying sizes, with a few dressed stones visible along its length (Fig. 8). There were several gaps with missing stones. A concrete block with a cut-out for a metal fitting (**011**) was present within the kerb, possibly for a metal fence post.

Fig. 8: Plan view of (009)/(010) with focus on one of the dressed stones.
