Former Eon Works
Eyre Lane
Sheffield,
South Yorkshire

Archaeological Strip, Map and Record and
Watching Brief

Report No. Y352/18

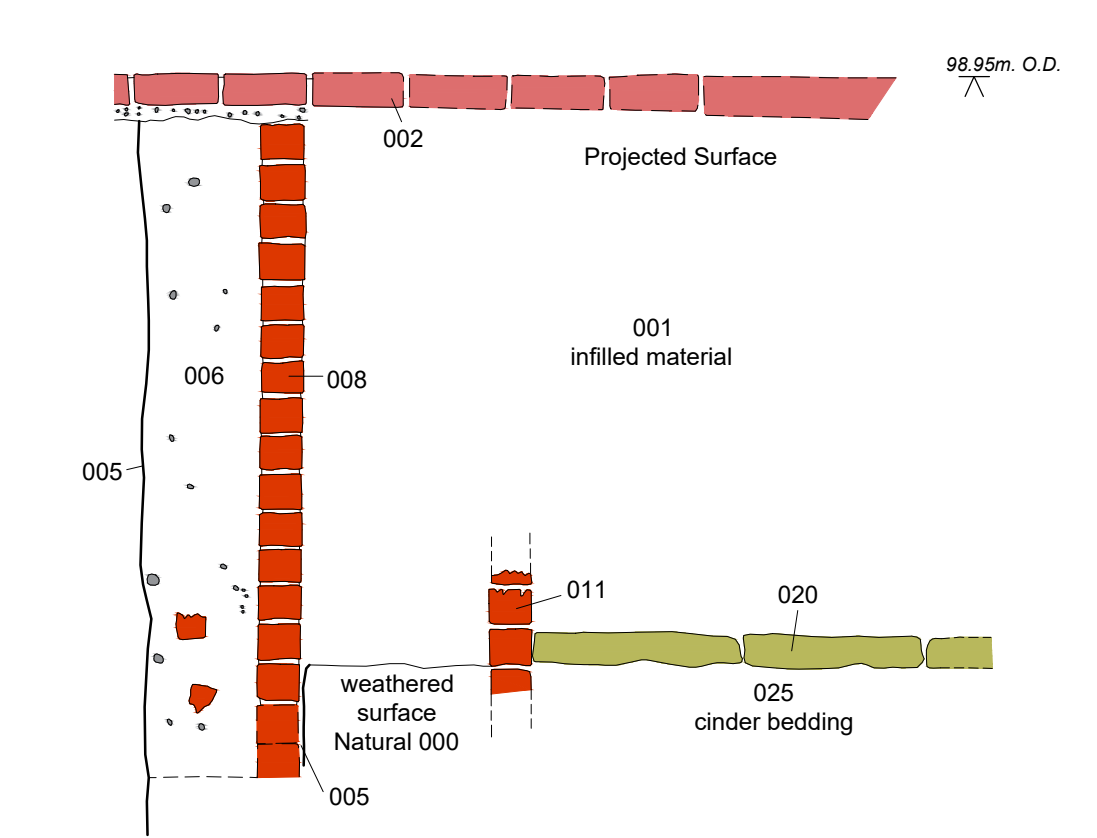
Fig.4a - South-west-section of Construction Cut 005, as recorded in Cellar 3 North (No.84 Eyre Lane)

The cellars each contained flagstone floors; four of the flagstone surfaces were exposed: Floor 017 at the west of Cellar 1; Floor 018 at the east of Cellar 2; and floors 020 and 021, at the east and west of Cellar 3 (Fig. 4a), respectively. The eastern half of Cellar 1 could not be exposed due to the limit of excavation. The floor at the west of Cellar 2 had been removed prior to the strip-and-map, possibly during the insertion of the later brick foundation wall for the garage. The flag stone surfaces were each bedded on a 0.05m thick deposit of granular cinder material, Deposit 025 was laid directly on to natural clay. Where flagstones had become dislodged or had been removed the cinder bedding was visible.

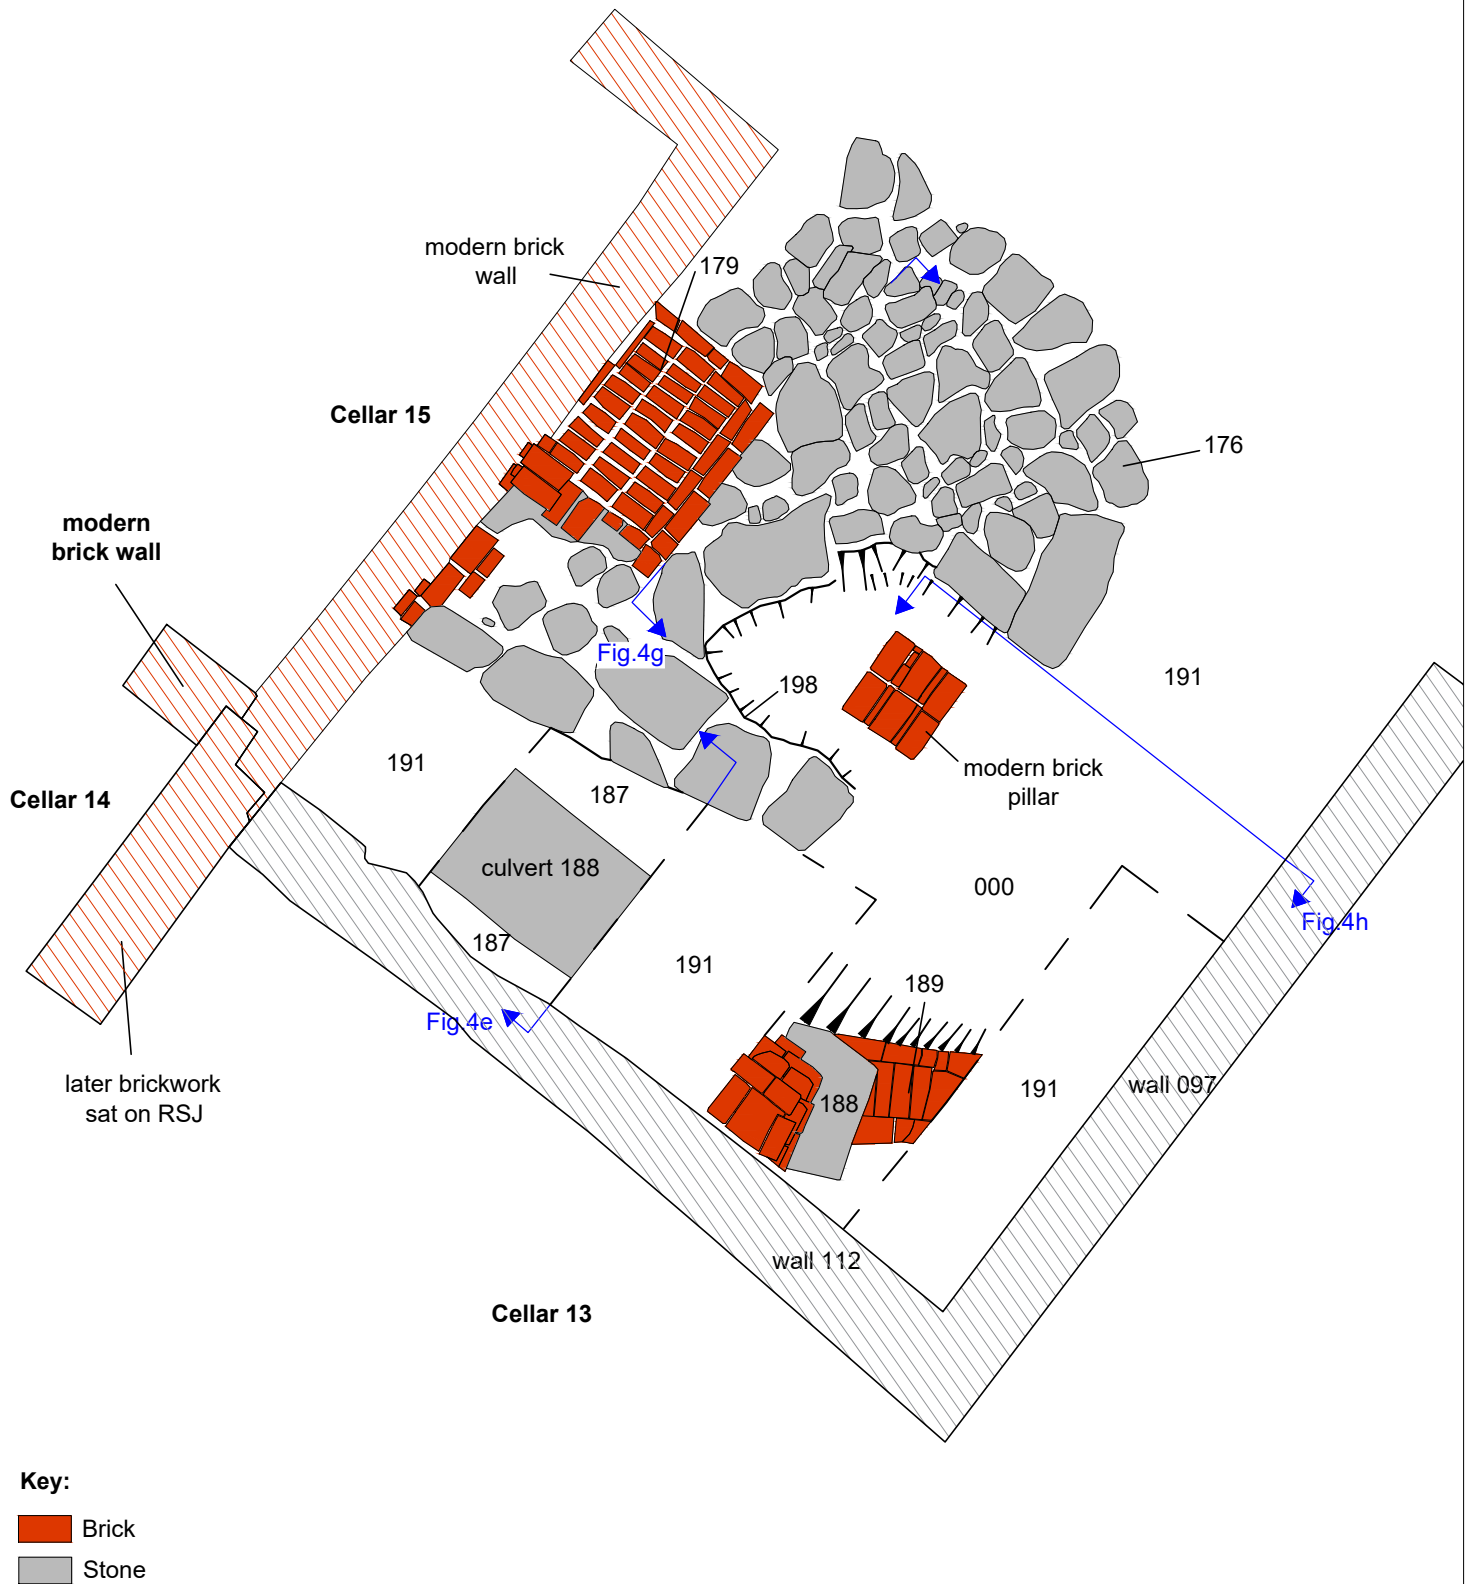
Fig. No:
5

Title:
Plan of the foundations of Oven Structure following removal of Brick Surface 174 and Brick Wall 171

A series of investigative slots were hand dug through the oven structure. The brick oven surface comprised a single course of bricks sat on a thick sandy lime mortar (174) that were bedded on to a composite stone surface, Deposit 175 (Fig. 7.18). The stone surface comprised loosely compacted well sorted sub-angular sandstones and cobbles (Fig.5). The stones were bedded within a loose sandy mortar-rich deposit. The exterior of the circular stone surface was defined by a ring of larger stones forming an external circular foundation ring (176) that the weight of the main walling of the overlying brick oven would have sat on. The ring of large stones would have provided a foundation for the weight of the overlying brick structure (171) that rested on the brick surface (174).

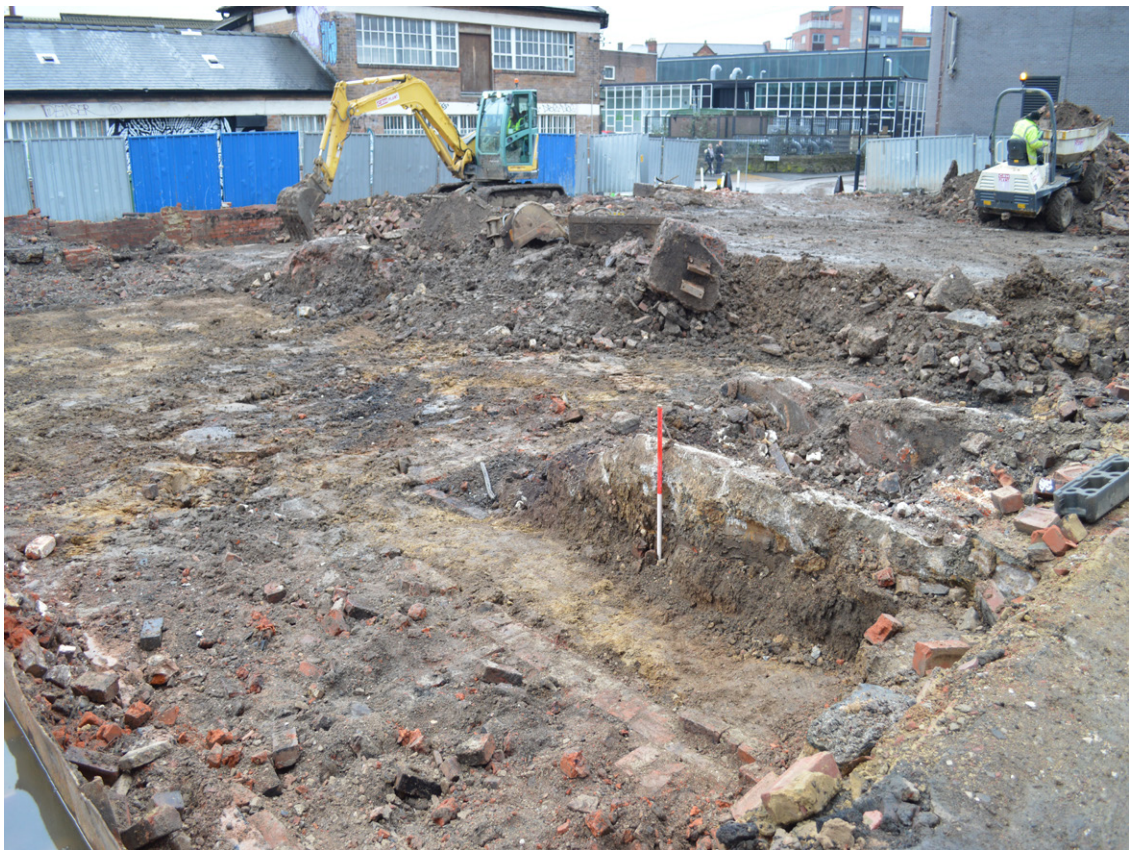
Fig. 7.2: General shot of site facing south, across the location of Court No.12, following the removal of the rubble from the Eon Works

Following the removal of the concrete slabs and overlying deposits, the excavation revealed the sub-surface surviving elements of the former structures on site, namely the cellars and foundation walling (figs 7.2 and 7.3).

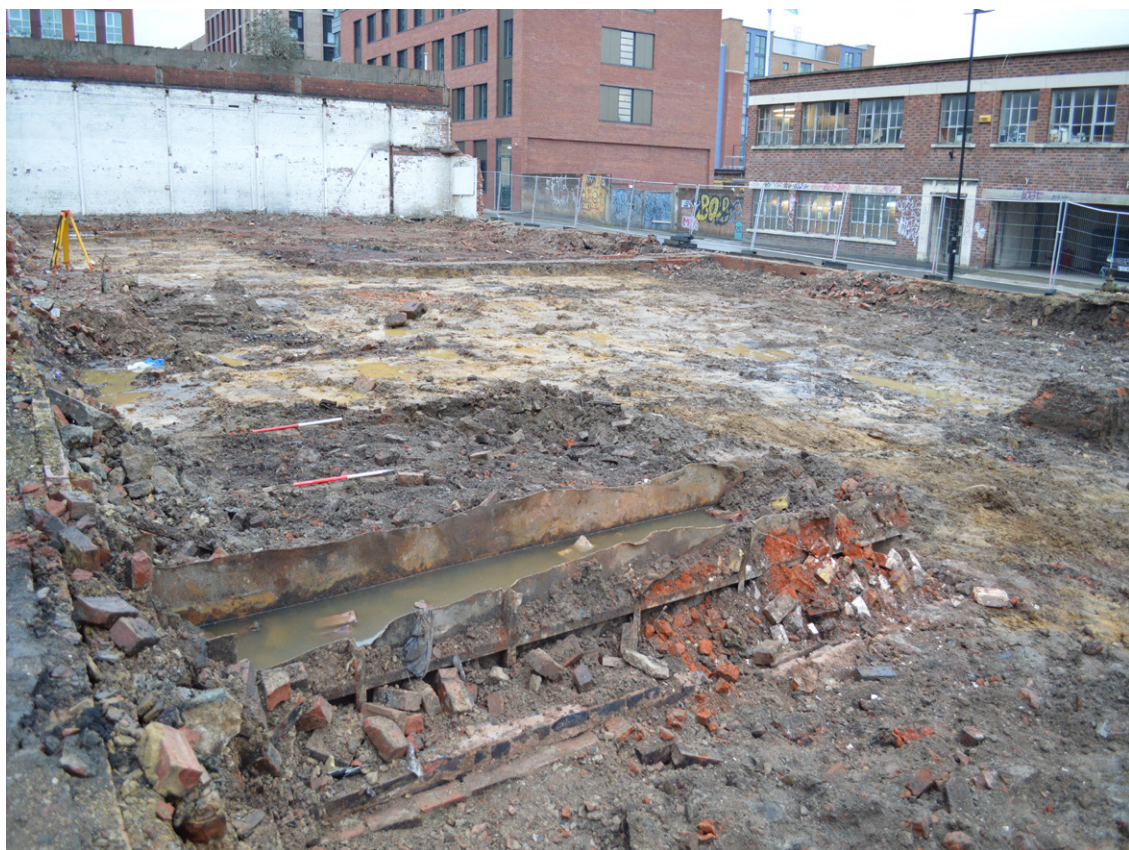
Fig. 7.3: General shot of site facing east following removal of the Eon Works

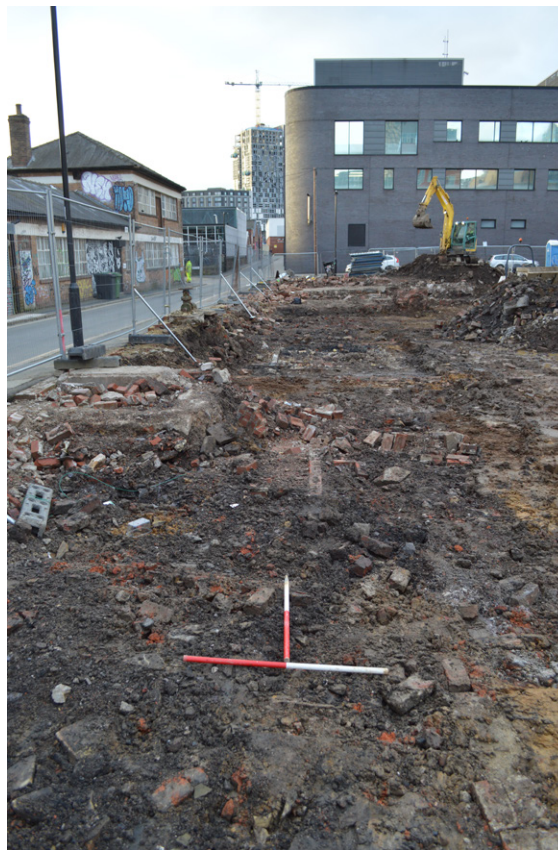
Fig. 7.4: General pre-excitation shot of site, looking along Eyre Lane (south-west facing)4

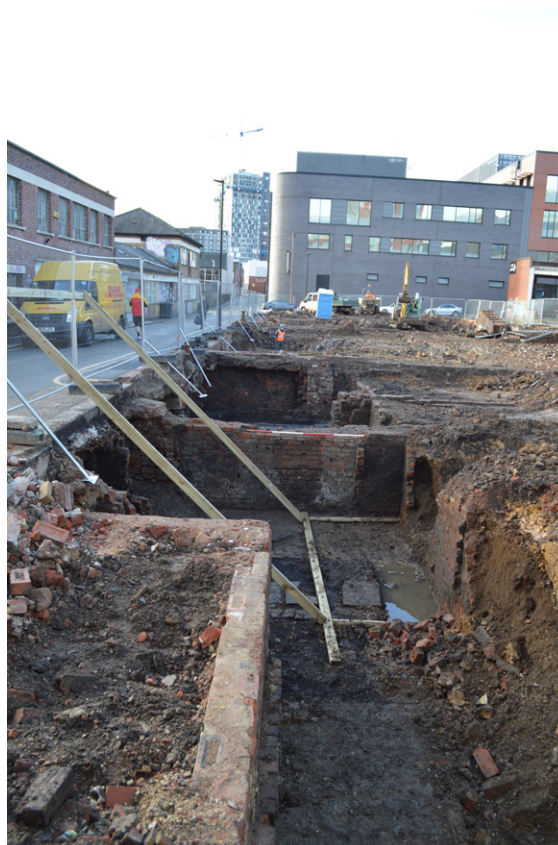
Fig. 7.5: South-west facing shot, with Cellars 1, 2 and 3 in the foreground

Cellars 1, 2 and 3 were exposed at the east corner of the site. The three cellars were in a row on the Eyre Lane frontage, on a north-east to south-west aspect lengthways. The cellars were defined by two lengthways walls that ran north-east to south west: a front wall (009) and a rear wall (008). The north-east end of the cellar was not fully investigated due to the proximity of the boundary wall of the adjacent property, and a modern brick wall foundation that had been sunk into corner of the site (Fig. 7.5). The cellars were filled with demolition debris and rubble from the collapse and demotion of the former buildings (003).

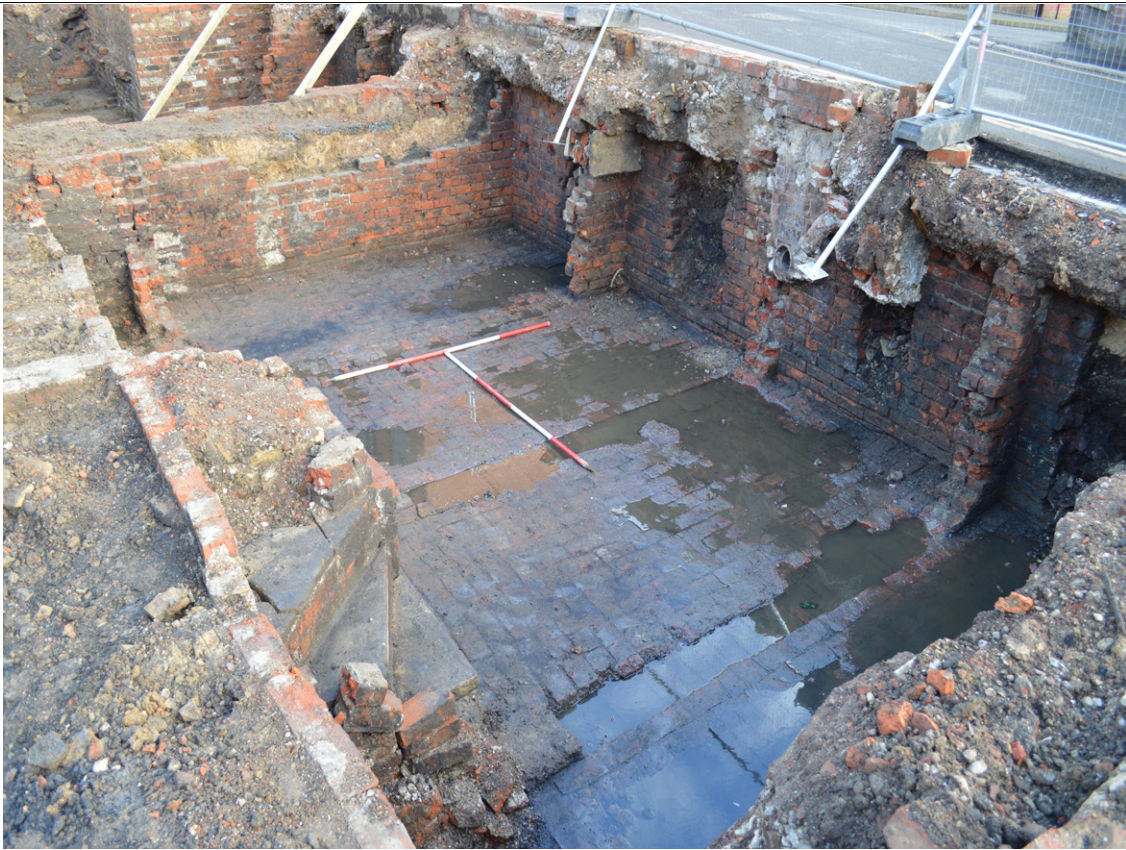
Fig. 7.6: General shot of Cellars 4 and 5, facing east

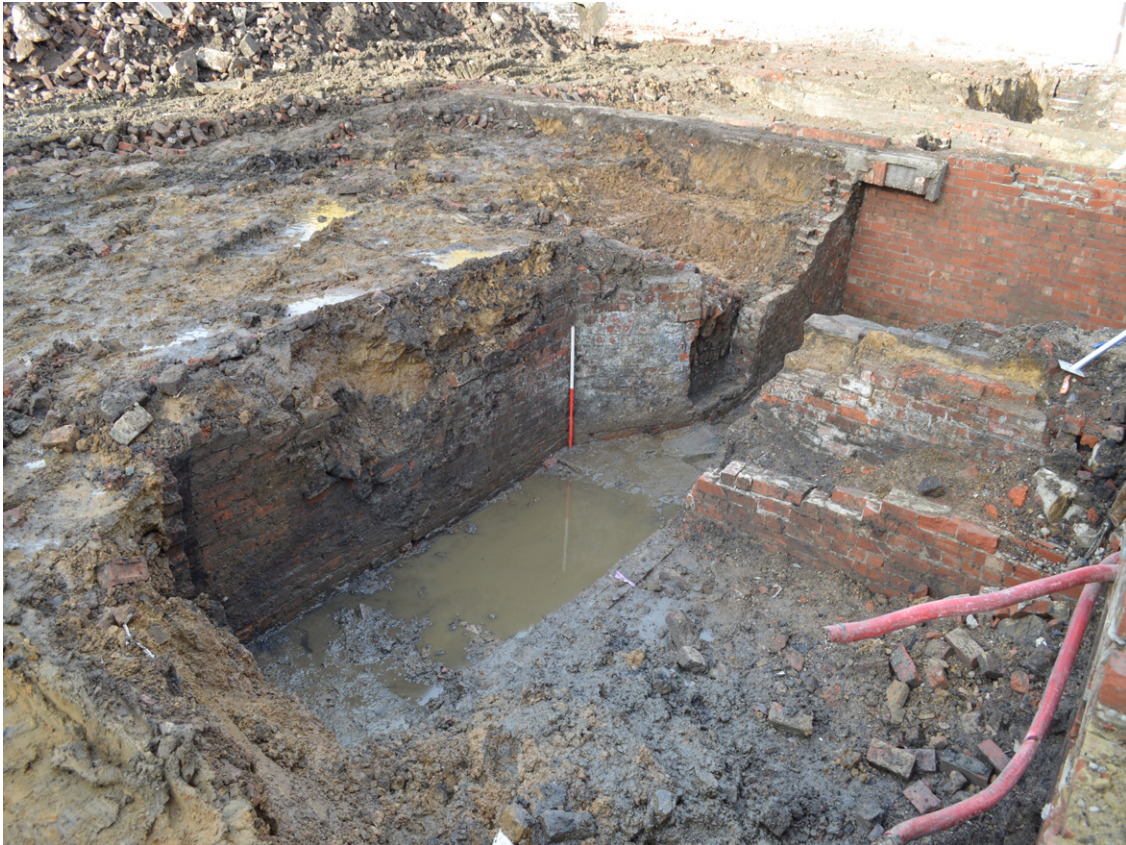
Fig. 7.7: North-facing shot of No.90 Hallam Lane (Cutlery Works cellar) facing north. Modern sub-station footings to right of shot

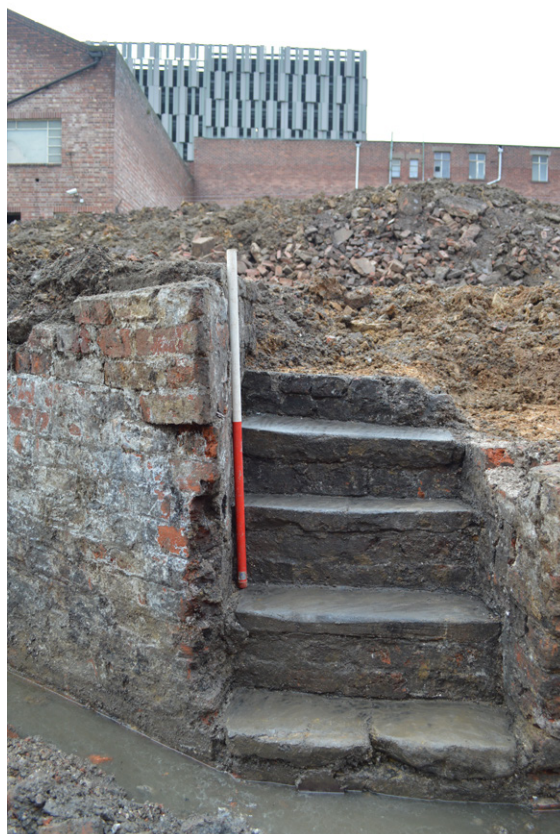
Fig. 7.8: Staircase 078 in Cutlery Works cellar, facing north-west

A relict staircase was present in the rear wall. Staircase 078 was built at the west corner of the north-east room, immediately before the sloped opening between the two rooms. The staircase comprised the lowest four steps of a flight of stone steps that were sat on brick risers of one-to-two courses of bricks, laid in stretchers and bonded with a coarse sandy-grey mortar (Fig. 7.8). The staircase was built into a small stub of a stairwell wall (049) that survived to a height of 1.30m, roughly fifteen courses. At some point the stairwell had been bricked up very loosely by unbonded bricks, presumably to prohibit access to the cellar. By removing the bricked-up stairwell, the full surviving extent of Staircase 078 could be recorded.

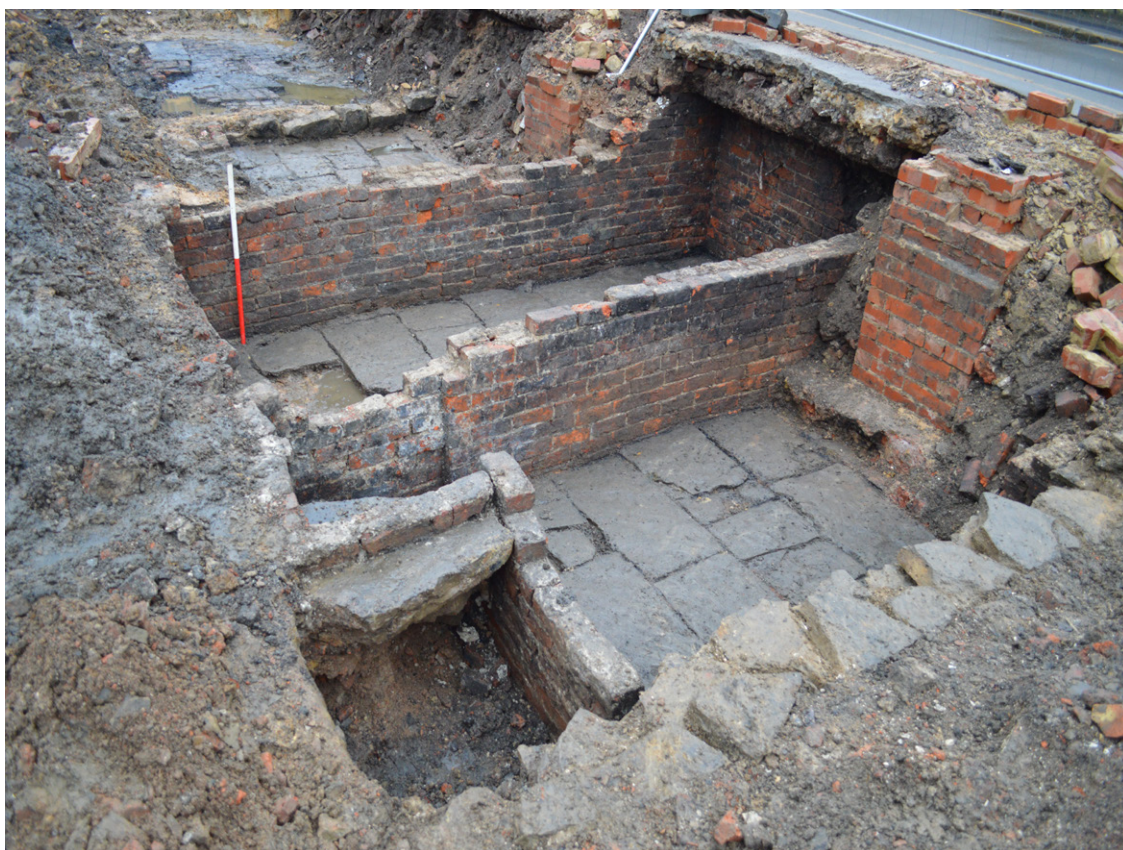
Fig. 7.9: General shot of Cellar 8 remains (upstanding in brick) and Cellars 7 and 6 in the background

The adjacent cellar to the south-west was Cellar 8, which was located beneath No. 98 Eyre Lane and served both the overlying property and the rear property: No. 1 Court 12. More of masonry remains of Cellar 8 were intact, compared to the adjacent Cellar 7. Cellar 8 had been filled with Deposit 066. The cellar had walls that survived to a height of 1.00m, 11 brick courses. The exterior walls of the cellar were Wall 064 to the north-east (the party wall with Cellar 7), the rear wall, 063, and the south-west wall, 062. The cellar was divided down the middle by Wall 065, a double skin brick wall that defined the two cellar rooms to serve the front and rear property, respectively (Fig. 7.9).

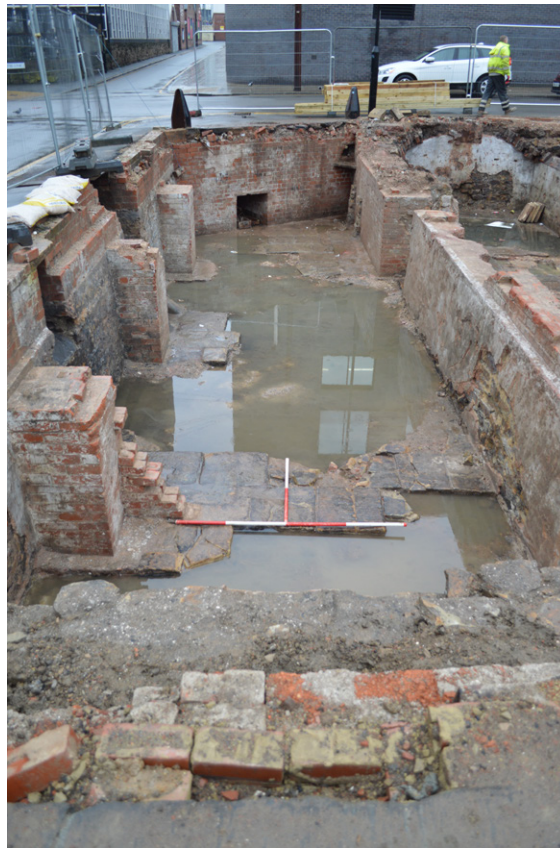
Fig. 7.10: General shot of Cellar 9 facing south-west

Cellar 9 was the main cellar of the Royal Hotel. It was rectangular and fronted Eyre Lane and the corner of Earl Street. It was on a north-east to south-west aspect at the end of Eyre Lane. The cellar was defined by a rear wall (087), a front wall (084) and a north-east wall (083). The original Earl Street frontage wall was obscured by later brick work associated with the Eon Works. The floor surface comprised sub-angular sandstone flags sat on natural clay (088). The front wall of the cellar (084) contained a coal chute (085) and a barrel run (086) (fig.7.10 and 7.11). The rear wall contained the opening to Cellar 10.

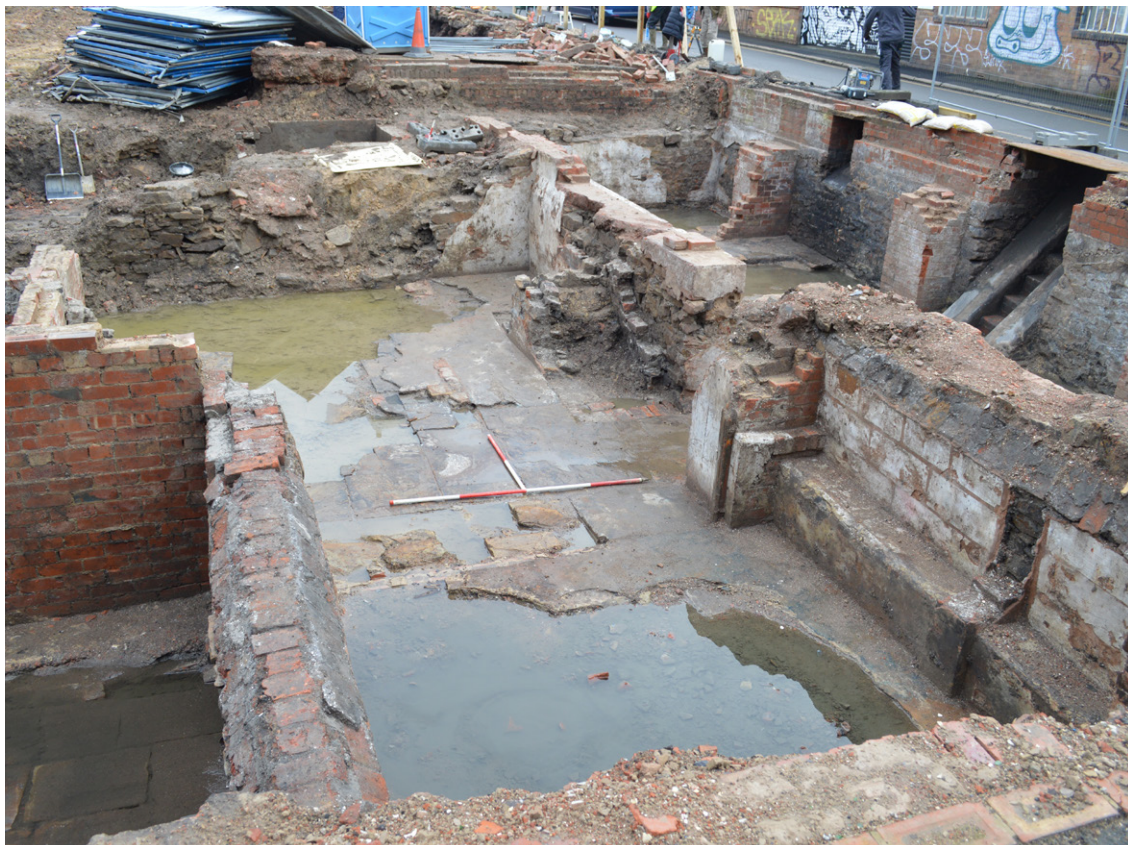
Fig. 7.11: General shot of Cellars 10 and 11 facing east

Later additions when Cellars 9, 10 and 11 were reused as part of the Eon Works include the addition of three brick pillars built against Wall 084 and brick cappings (089) placed over the truncated remains of the front and rear walls (084 and 087). The stone floor (088) was reused as the floor surface, as there was no apparent evidence of a later floor being built or cast over the sandstone flags. The exterior corner of the plot, on the Earl Street/ Eyre Lane corner, was 'rounded' off at this point to create the bevelled corner of the plot. The wall between cellars 10 and 11 was partly removed, and truncated to ground level, to allow access to Cellar 11 from Cellar 10. The 'rear' cellars, 10 and 11, were levelled off with a concrete layer (099). This concrete layer was cast immediately on to the former sand-stone floor surface (094). A new rear wall at the back of Cellar 10 was built in brick, which reduced the length of the cellar by 1m. All the walls, apart from the front wall of Cellar 9 (084), were rendered to create a smooth interior wall surface and to obscure the sandstone block faces (Fig. 7.11). A concrete ledge or plinth was cast against the north-west facing wall of Cellar 12 (104). It was 0.38m high and presumably acted as a surface or seating area within the cellar for the Eon Works.

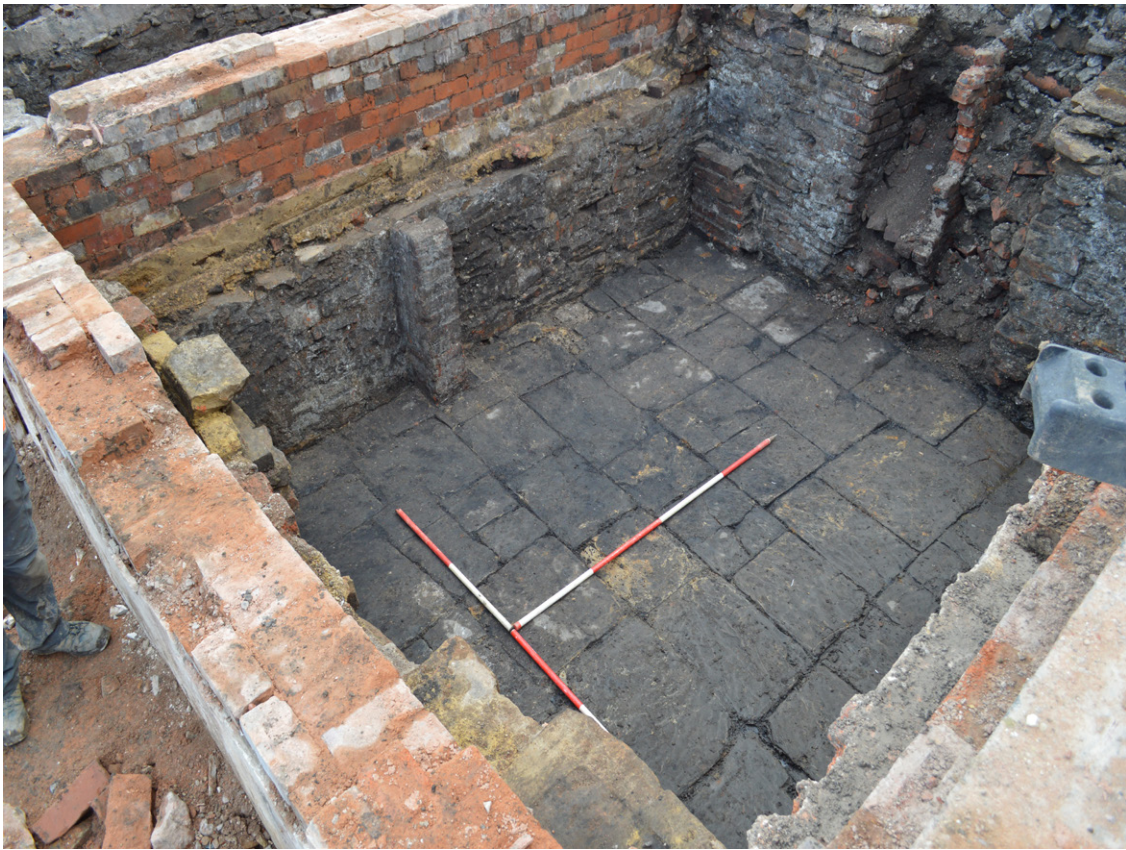
Fig. 7.12: South-facing shot of Cellar 14 (59 Earl Street)

Cellar 14 comprised the remains of the No.59 Earl Street: the corner property on Hallam Lane/ Earl Street (Fig. 7.12). The cellar was defined by the front wall of the row of cellars (113); Wall 119, the party wall between cellars 13 and 14; a north-west wall, Wall 125; and a rear wall that adjoined Cellar 15, 124. A double coal chute was present within the front face of the cellar, in Wall 113. The coal chute (120) was constructed of courses of brick and sandstone blocks, with a single skin brick wall down the middle of the structure to create two separate coal chutes. A drain was present, close to the north-west wall of the cellar (Wall 125), created by a row of two adjoining brick courses, with a sloped abutment to create a drainage channel, which flowed into the northern corner of the cellar. A brick buttress (123) that survived to a height of 0.96m (twelve courses) abutted Wall 119 that adjoined Cellar 13. Relict brick vaulting, that would have originally formed the ceiling of the cellar, was identified against the north-west external wall (125).

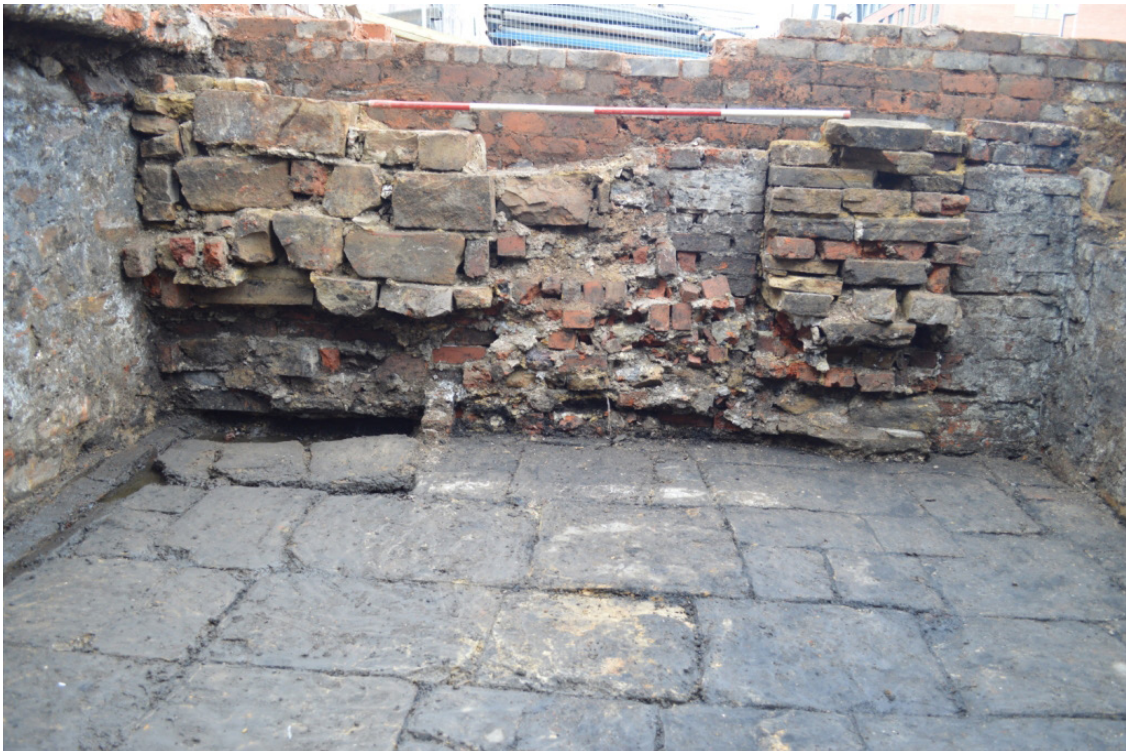
Fig. 7.13: Rear wall of Cellar 14, facing north-east

The entryway is presumed to have been blocked up at the time of the construction of the Eon Works, to add structural stability by blocking off the break in the walling to add structural strength to the brick wall (Fig.7.13).

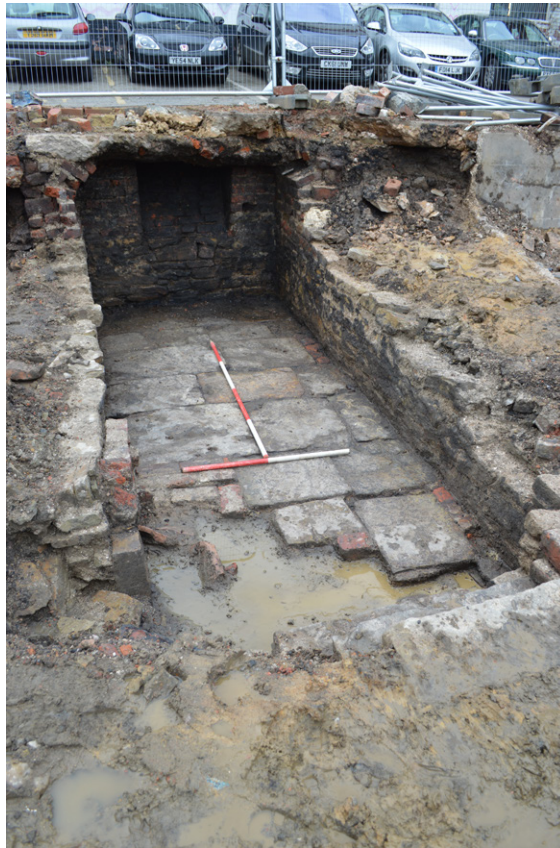
Fig. 7.14: Cellar 16 facing north

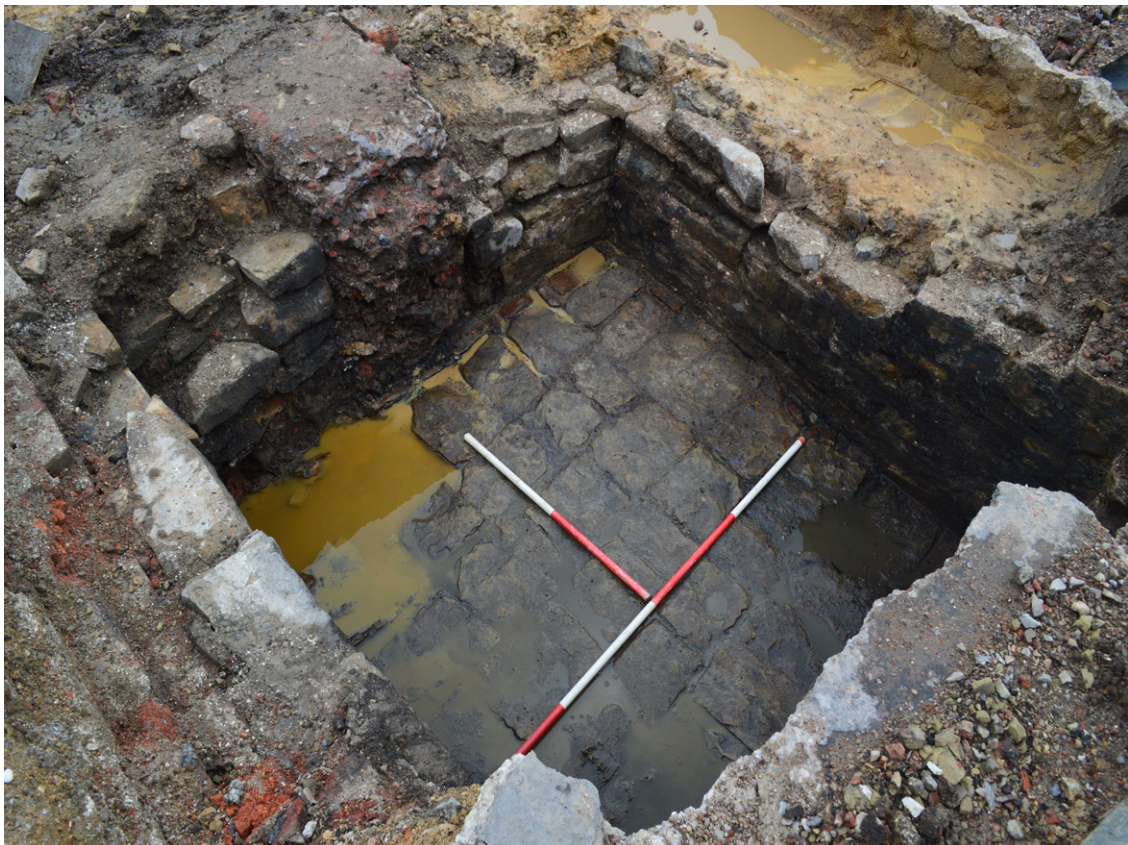
Fig. 7.15: Cellar 17 facing south

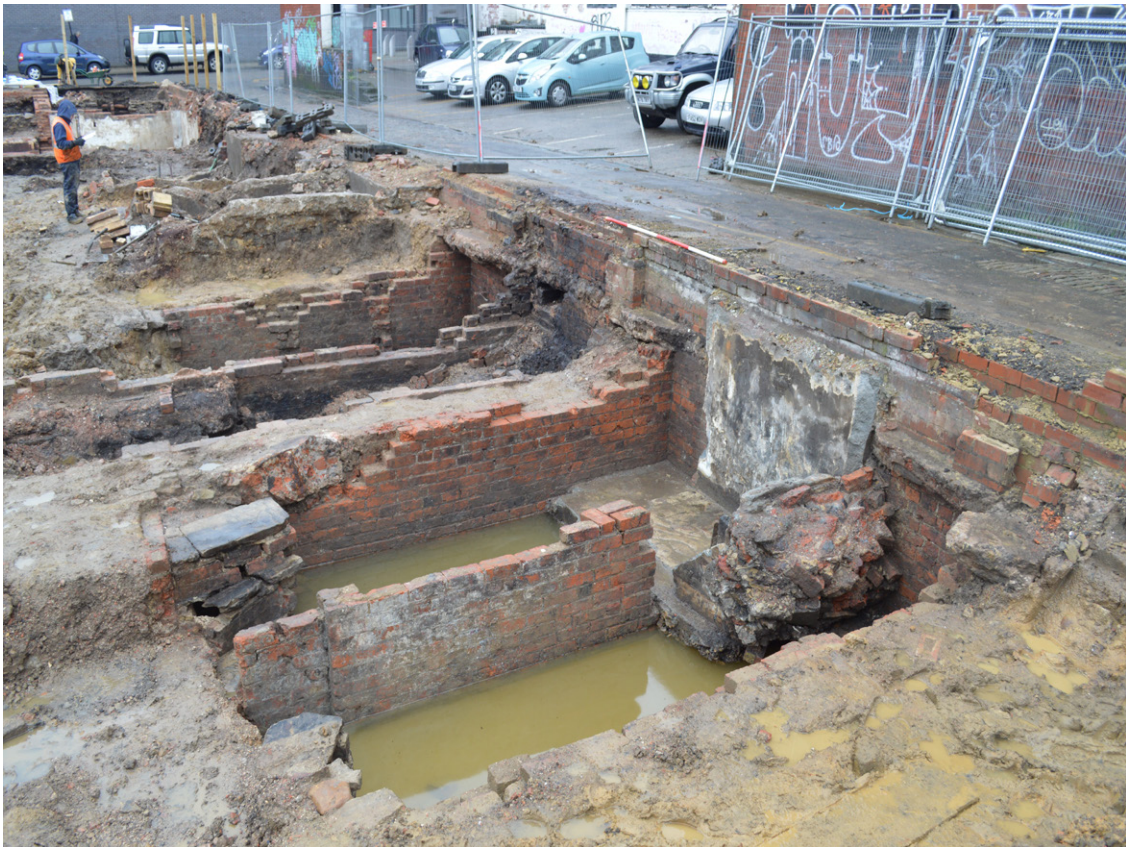
Fig. 7.16: Cellars 18 and 19, facing west

The east wall of the cellar (156) had been reused as a foundation for later courses of brick work: a portion of blue bricks on a similar alignment to the east-wall of Cellar 18. This later brickwork was inserted at some time as part of the Eon Works. The later brickwork is presumed to have been constructed to house machine or a tank associated with the steel working on the site in the mid-20th century and later (Fig. 7.16).

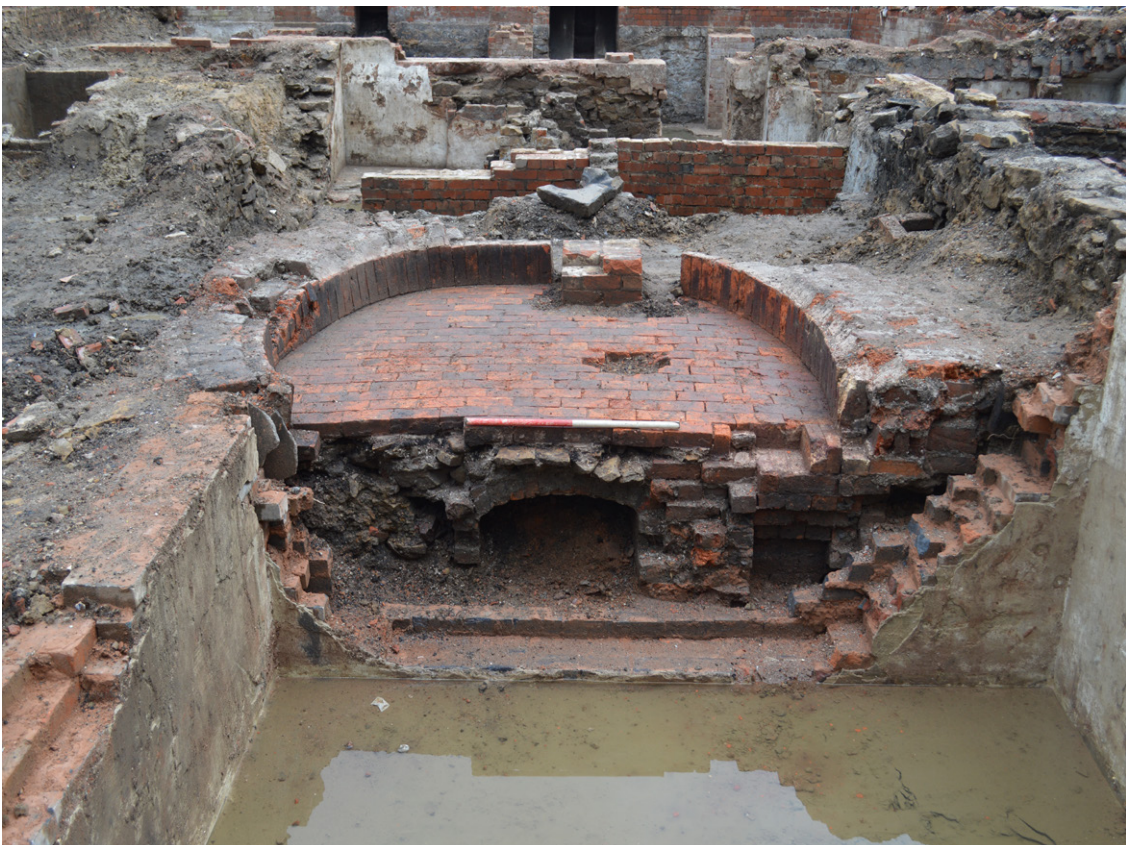
Fig. 7.17: North-west-facing section of the Oven at the rear of Cellar 15

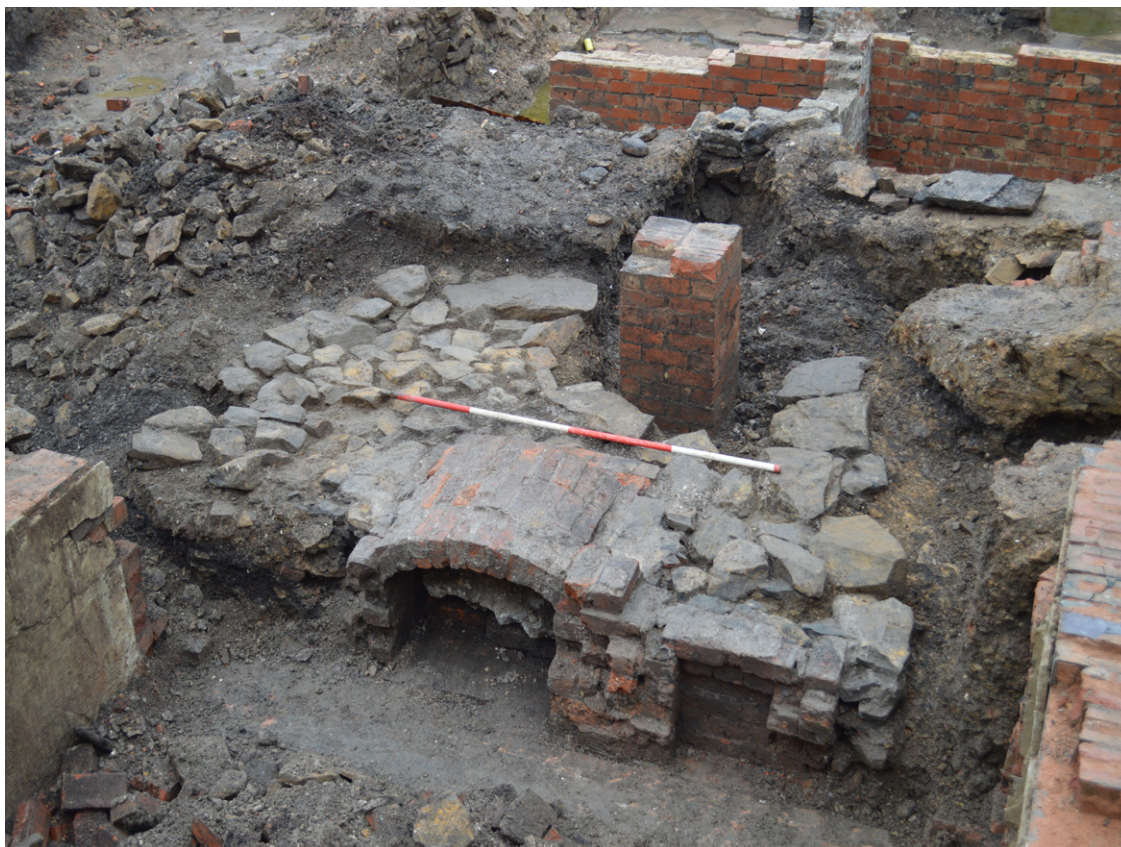
Fig. 7.18: Shot of Oven following removal of overlaying brick surface (174)

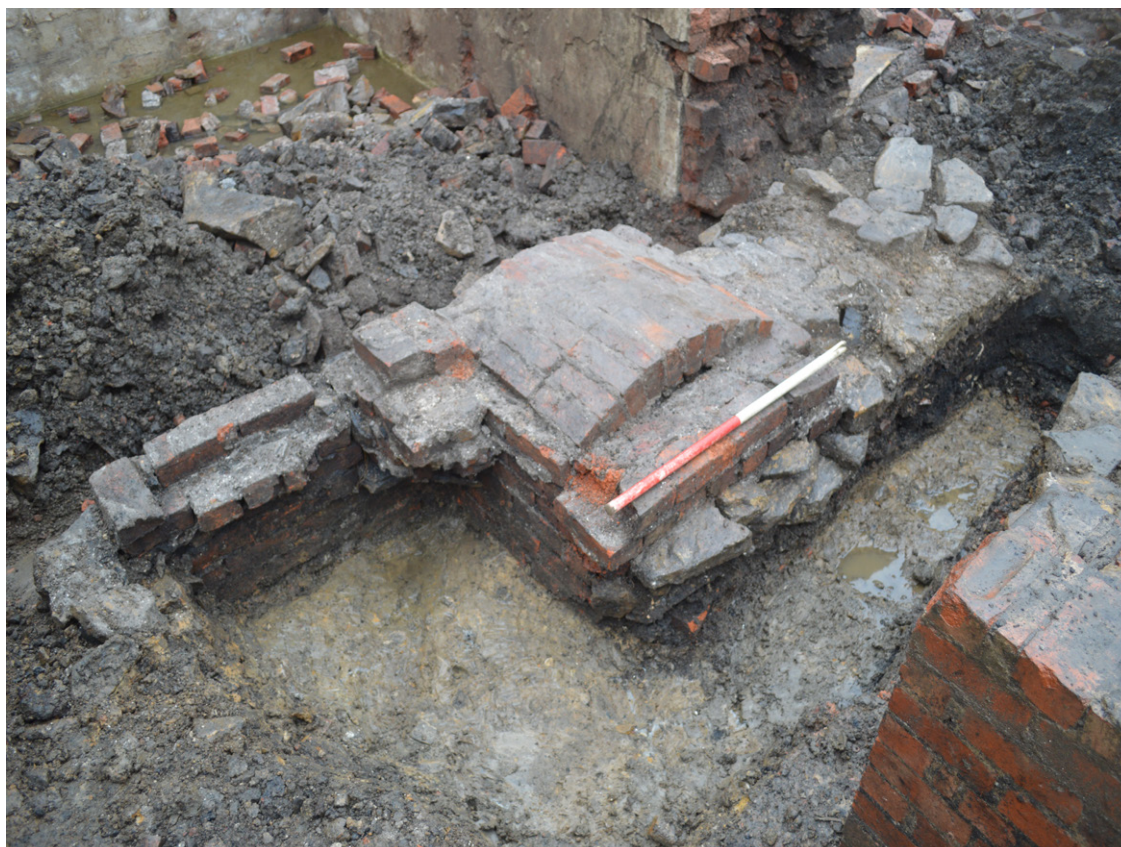
Fig. 7.19: Brick chamber beneath Oven, facing north

The brick structure at the base of the oven (179), was interpreted as storage, perhaps for fuel or tools for the oven. It did not contain a flue, or vent to any other part of the structure as had initially been speculated. Two stubs of single skin brick wall (181 and 182), abutted the brick storage structure. Upon investigation, following the dismantlement of the oven foundations, the two walls were identified as vestigial remains of the brick front of the oven, that had been lost following the insertion of the modern brick wall in the 20th century and the removal of the early 19th century walling associated with Cellar 15 and the oven frontage (Fig. 7.19).

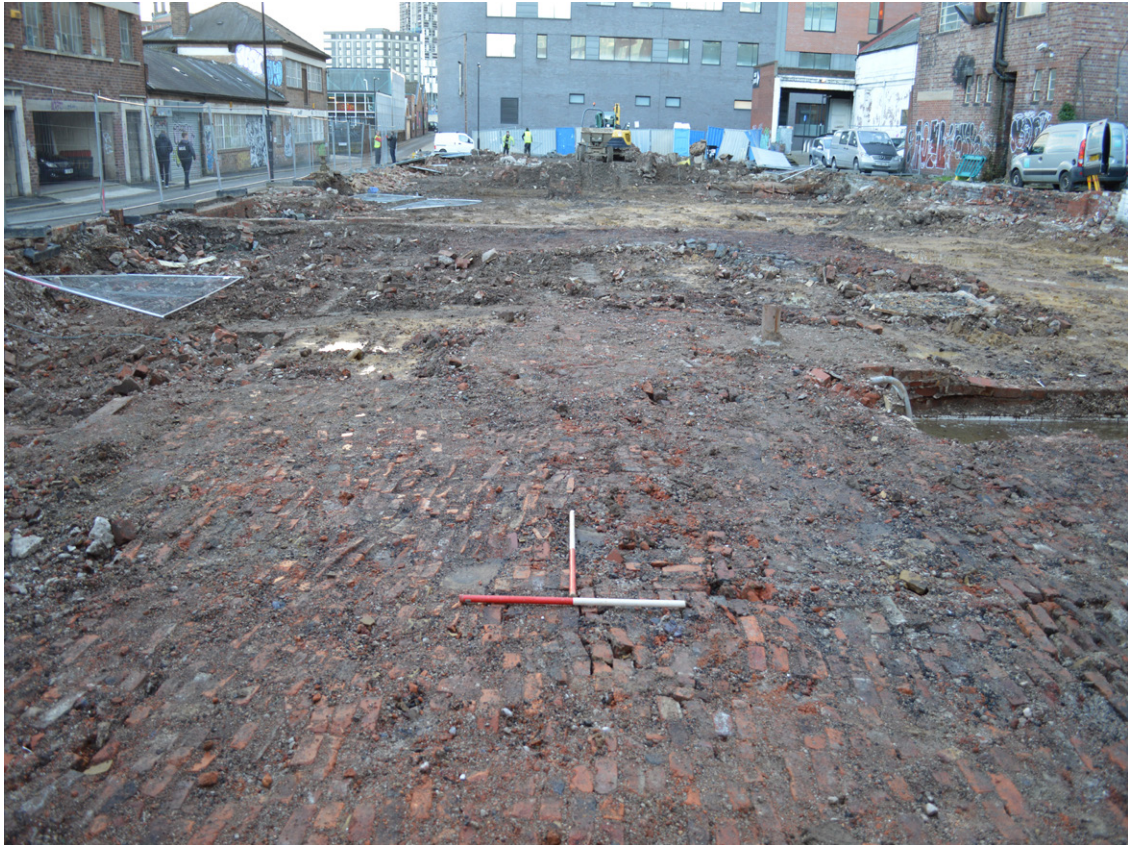
Fig. 7.20: Brick surface of the vehicle shed at the north-east of site, facing south-west
