Watching Brief and Demarcation Works during Enabling Works, Fallago Rig Windfarm, Scottish Borders

Report No. 1910

Author	Bruce Glendinning BSc PgDip MifA
Illustrator	Shelly Werner BA MPhil PhD
Editor	Melanie Johnson MA PhD FSA Scot MifA
Commissioned by	Wind Prospect Ltd <i>per</i> North British Windpower
Date issued	June 2011
Version	0
OASIS Reference	cfaarcha1 - 100676
Grid Ref	NT 6469 5037 – NT 5844 5934

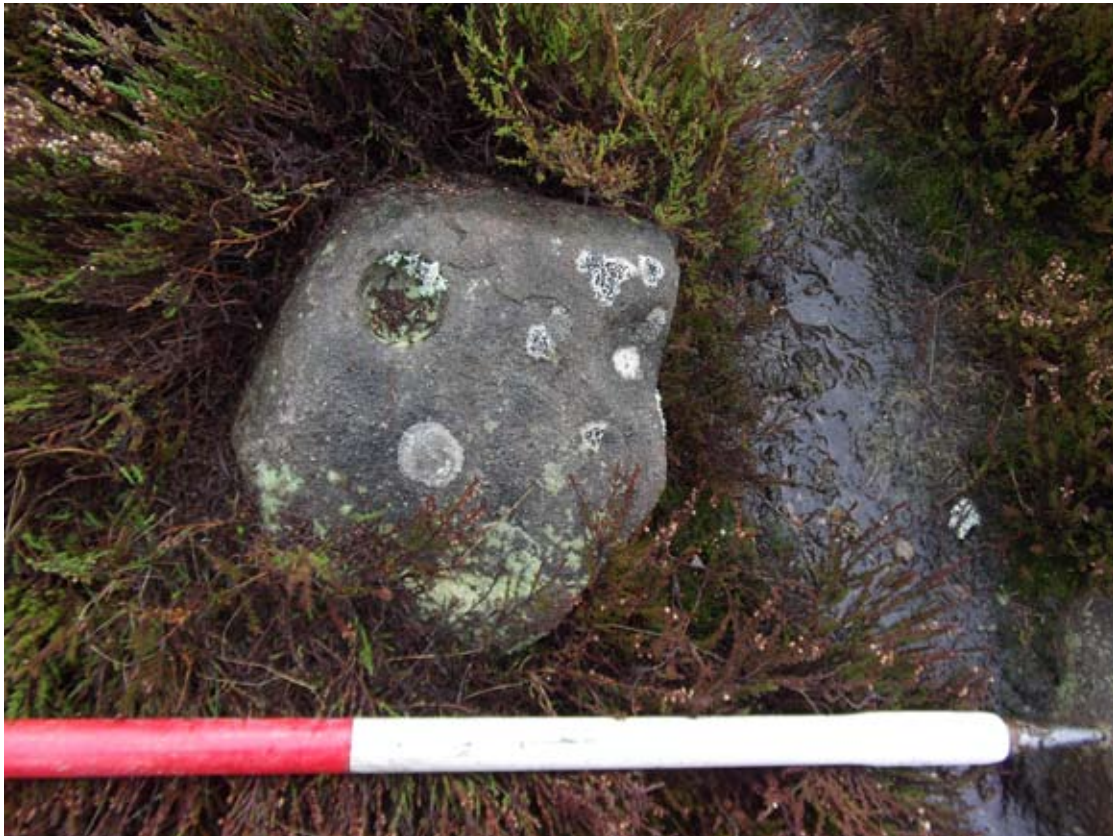
Fig 2: Site J

Site J (Fig. 2), described in the ES as a cupmarked rock, was a small portable boulder with dubious cupmarks. It was agreed with the Scottish Borders Council Archaeology Officer that the marks were more likely to be the product of erosion and that given the size and portability of the stone the identification of this as a cupmarked stone was very questionable. The stone lay in an area identified as a hard rock borrow pit (borrow pit 7) so it was agreed that the stone would be moved to a location outwith the area of quarrying. The stone's new location is NT 58753 58910.

Site J was relocated to an area outwith the development site.

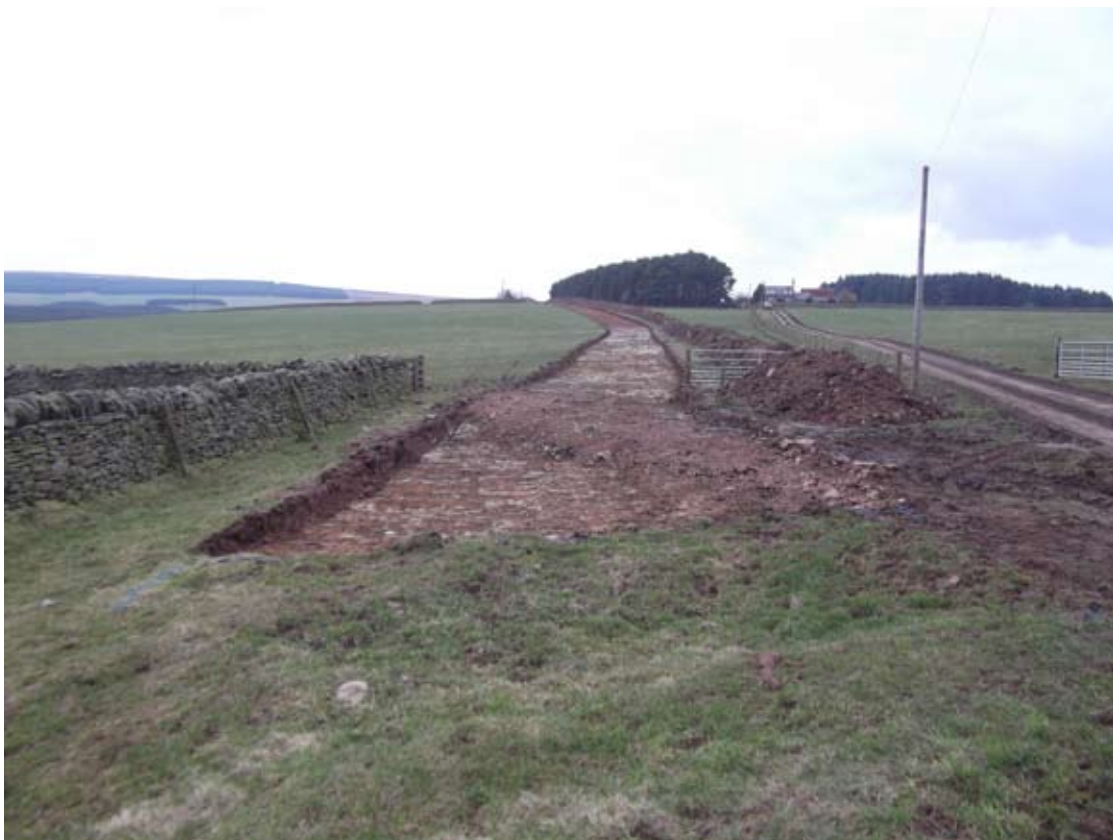
Fig 3: New road line from chainage 2600, looking north

The offline section at the Cralaw diversion (circa chainage 2600 to 3200) (Fig. 3) passed mainly through improved fields. Topsoil lay over undisturbed natural subsoil. No archaeological features or deposits were found.

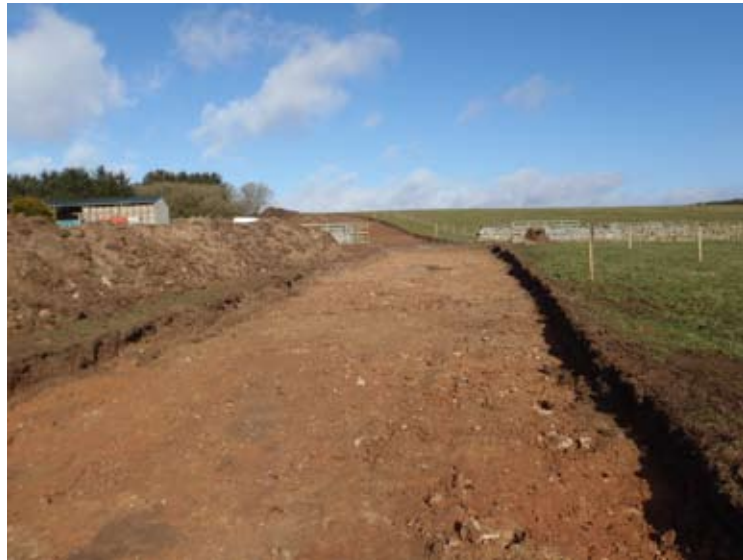
Fig 4: New road line by-passing Wedderlie Farm, chainage 1600 looking north

The access road was monitored where new off line sections were constructed. At Wedderlie Farm the road by-passed round to the east of the current farm buildings (Fig. 4). Thin topsoil lay over undisturbed natural subsoil. No archaeological features or deposits were found.

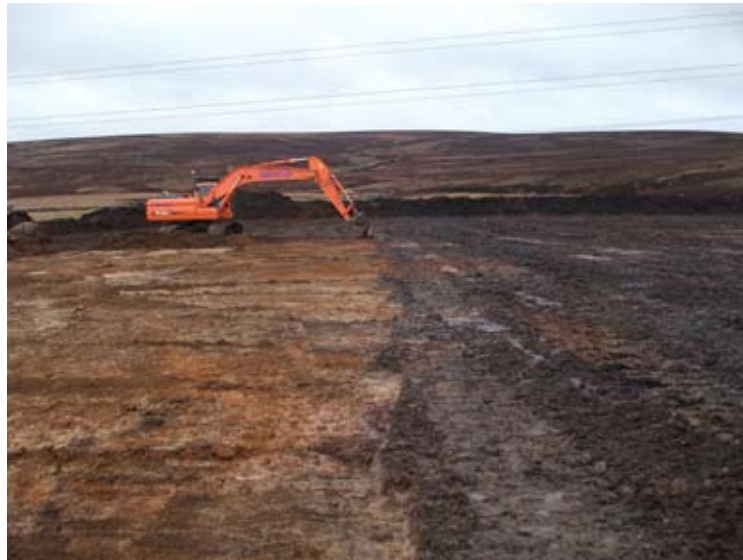
Fig 5: Topsoil stripping at substation

The stripping of this large area was monitored. A thin heather turf overlay peat which lay over undisturbed natural subsoil. No archaeological features or deposits were found.

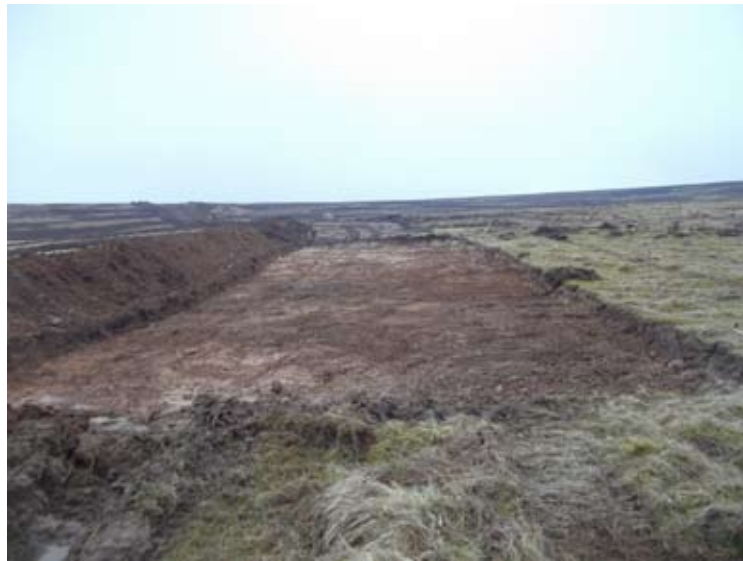
Fig 6: New road line between Dye Water crossing and chainage 7600

The new section of road running alongside the Dye Water (between chainage 7600 to 9000) (Fig. 6) passed across unimproved heath. A thin heather turf lay over peat. No archaeological features or deposits were found.
