Author	Michael Cressey BA MSc Phd MIFA FSA Scot
Illustrator	Leeanne Whitelaw BSc MAAIS
Editor	Bruce Glendinning BSc Pg Dip MIFA
Commissioned by	Surveying Solutions Ltd
Date issued	MAY 2011
Version	0
OASIS Reference	Cfaarcha1-101498
Planning Application No	10/01557/FUL
Grid Ref	NT 92002 67230.

**Proposed Marine Station, The Vennel,
St Abbs Harbour, Scottish Borders**

Report No. 1902

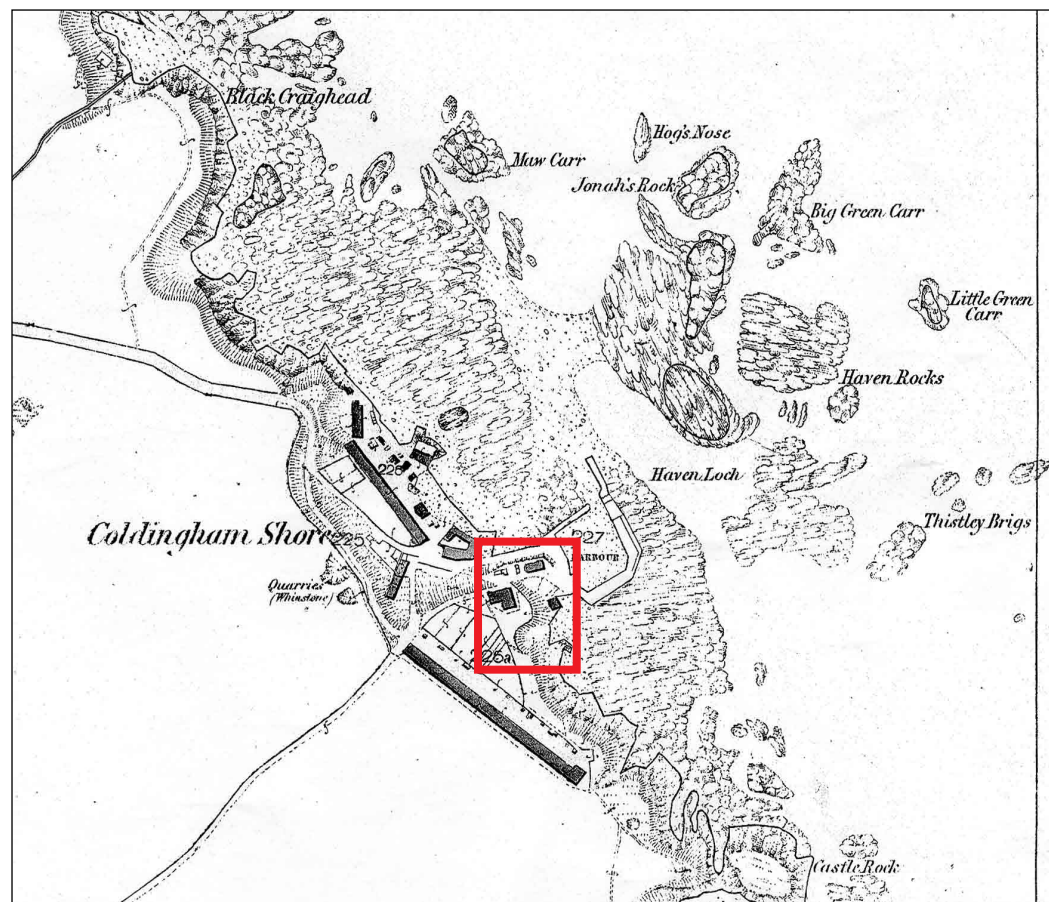
Fig. 2a - Ordnance Survey 1st Edition

The 1856 First Edition Ordnance Survey map (Fig 2a) depicts the coastal settlement of *Coldingham Shore* (St Abbs). The map shows the harbour which was constructed in 1833 (see below) and the Vennel area which was then undeveloped. A single square building occupies the site of what would later become Building 2.

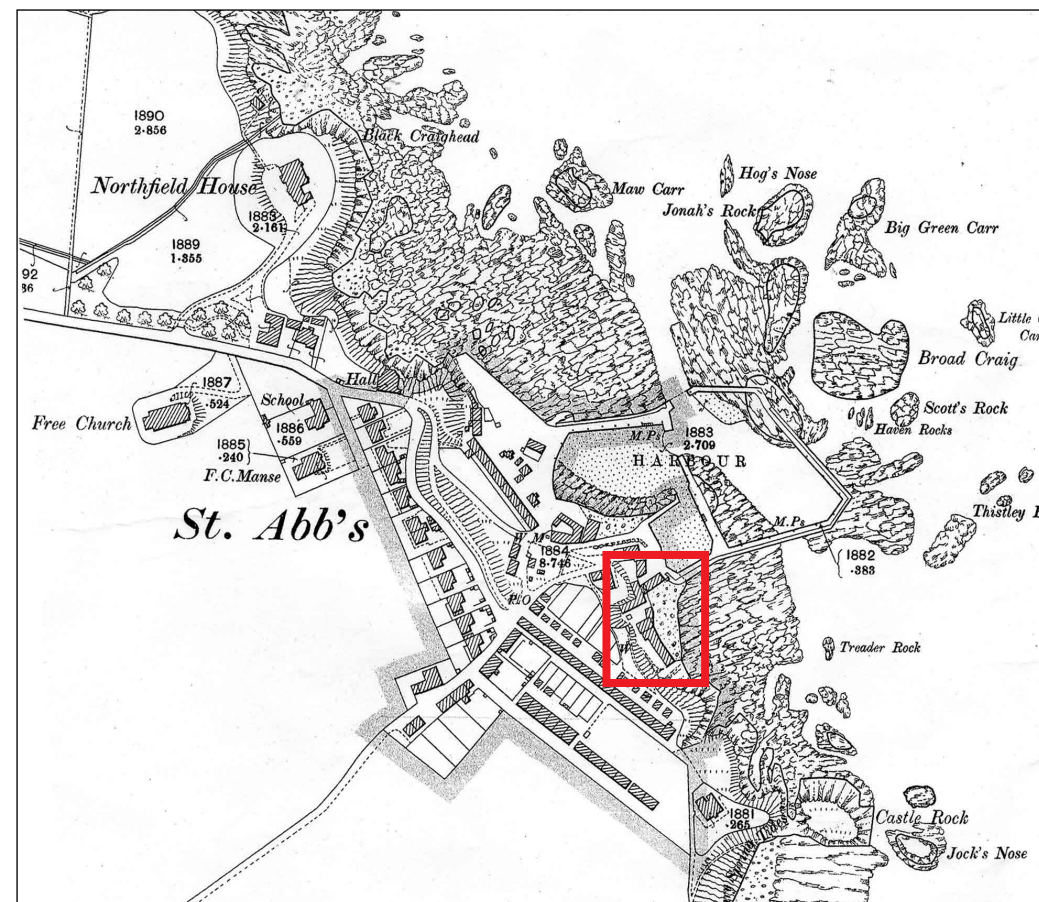
Fig. 2b - Ordnance Survey 2nd Edition, 1899

The 1899 Second Edition Ordnance Survey map (Fig 2b) the placename of Coldingham Shore had been replaced with St Abbs. The map shows that the harbour had been enlarged (D&T Stevenson c.1890) and the Vennel area was developed behind a high sea-wall. The Vennel is depicted as being accessible through a passage between two buildings. On the west side of the vennel is an adjoining L-shaped building and on the east side there is now a rectilinear building which shares the same footprint as Building 2, the former fish house. Between the east-end of the aforementioned building and the harbour wall there is a small square building which is probably Building 1 a fisherman's toilet block.

To the south of the L-shaped building is a small square structure and Rosecroft Cottage (Building 4) with an outshot building on the north-east corner which slightly envelops the gable. Adjoining the south side of the cottage is a rectilinear building which occupied the footprint of the present fisherman's sheds (Nos 1-8).

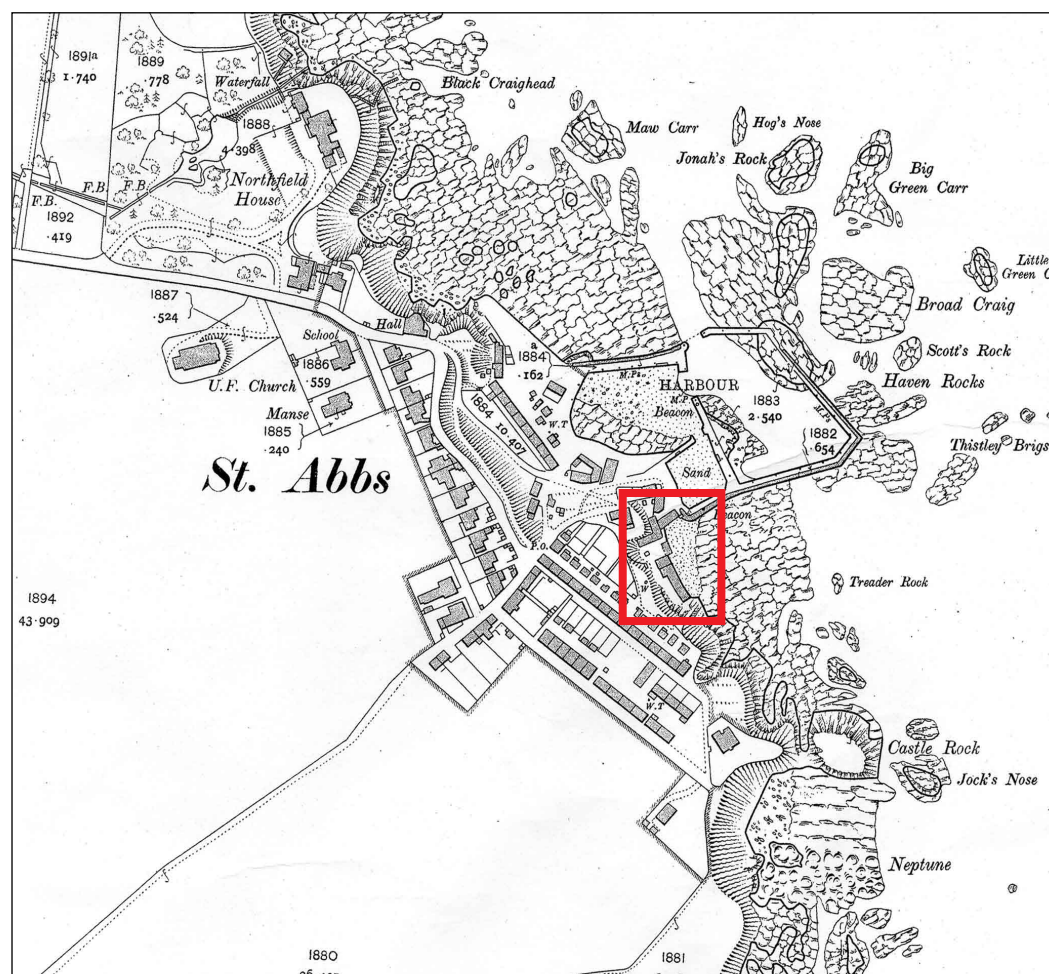
Fig. 2c - Ordnance Survey, 1908

The 1908 Third Edition Ordnance Survey map (Fig 2c) shows the harbour at its height of activity. The Vennel entrance has been removed to either make way for the enlargement of the rectangular building on the east side or it was not included in the 1906 map revision. The outshot building adjoining Rosecroft Cottage is depicted now as being at right-angles and the section adjoining its gable has been removed.

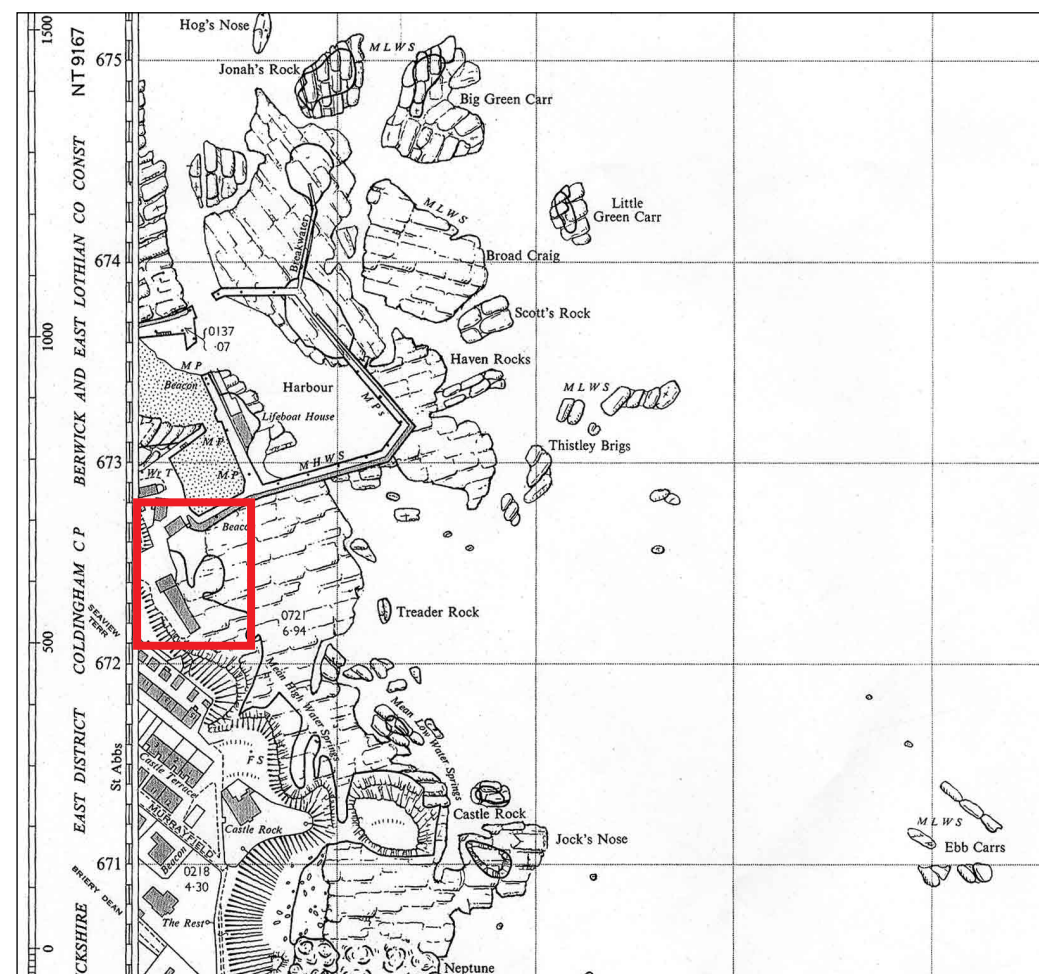
Fig. 2d - Ordnance Survey, 1968

The 1968 Ordnance Survey map (Fig 2d) shows Building 1, the former fisherman's toilet, Building 2 the former fish house, Rosecroft Cottage, Building 3 and the fisherman's sheds Nos 1-8. The map also shows that the L-shaped building has been removed. The modern garage and other fisherman's sheds were built sometime after this year.

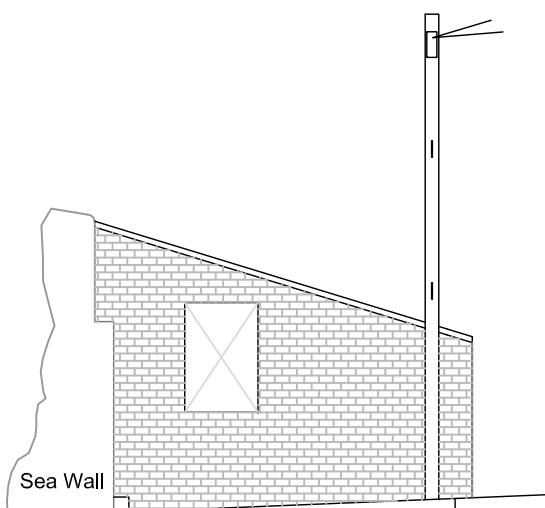
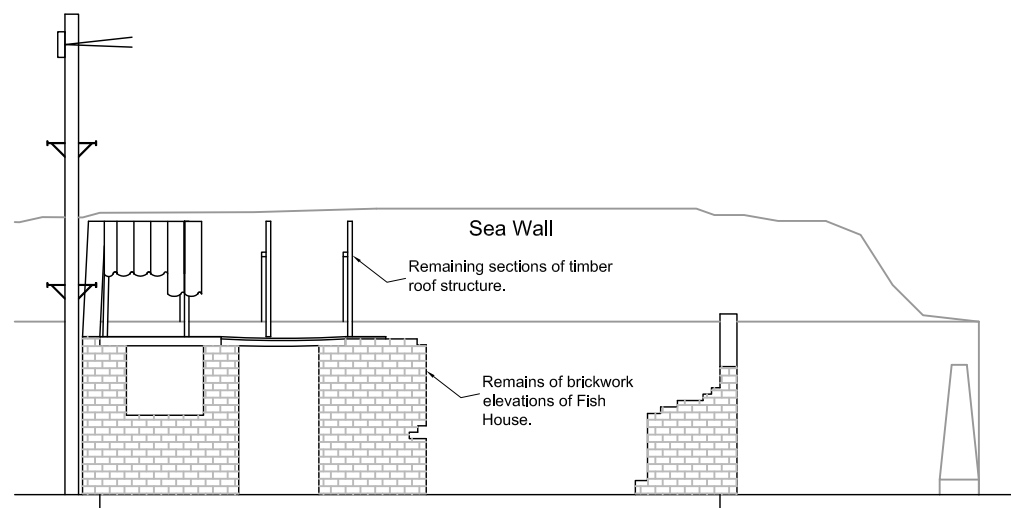
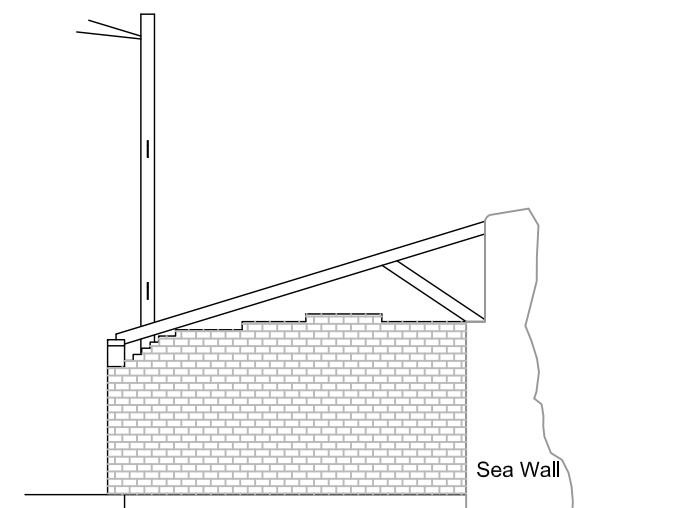
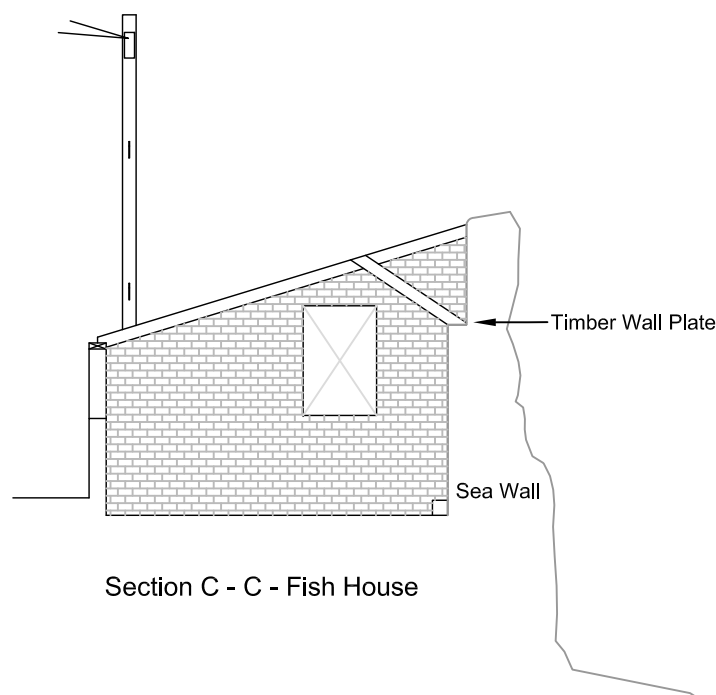
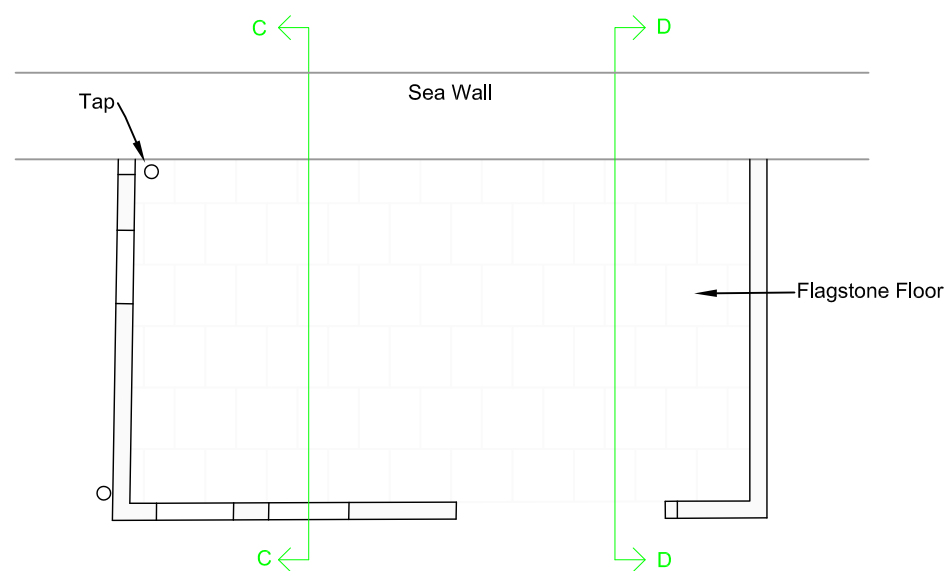
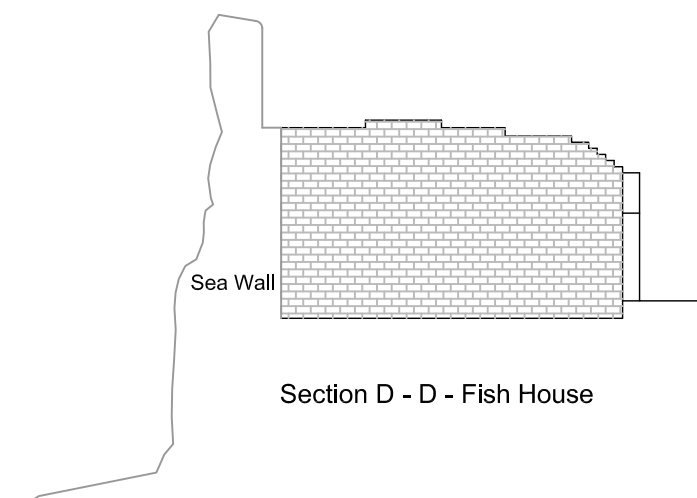
Building 2 is a roofless dilapidated brick-built lean-to measuring 8.6m long and 4.8m wide built against the 19th century harbour wall which has been modified to support a wall-plate which carried the roof joists. The east-facing gable is extant and contains a blind timber-framed window opening. The gable is built of red-brick and cream-coloured engineering brick. The north-facing (front) elevation is largely intact with a single doorway measuring 2m high and 1m wide. The doorway is flanked by a windowless opening measuring 1m by 1m. On the west-side of the doorway there was probably a larger bay opening but its walls have been removed and sides demolished. The west-facing gable wall is 2.1m high and comprises 24 courses of red-brick (9 x 3^{1/4} inch) laid in English Garden wall bond (7 stretchers and 1 header).

The interior of the building is largely featureless. The floor comprises large sandstone flags arranged in regular courses. Three roof trusses survive intact and these are softwood machine cut timber measuring c. 20cm by 10cm and scarfe-jointed. The roof trusses are supported by timber braces that rest on a wall plate that has been built into the harbour wall. The roof was originally covered with corrugated iron of which only less than a third survives. A series of truss sockets are visible at the wall head along with a cement raggle demarcating the position of the corrugated iron roof that is missing. A fresh-water tap is situated on the south-east corner of the building.

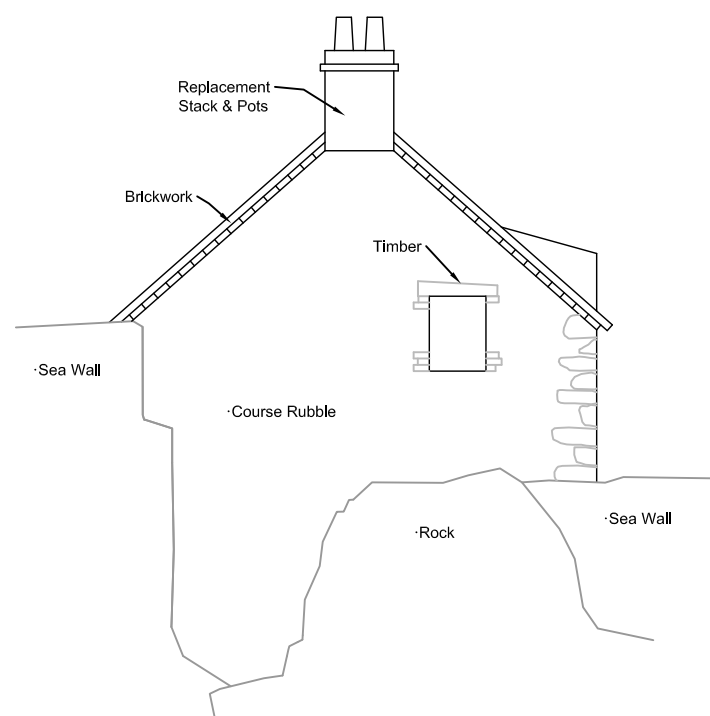
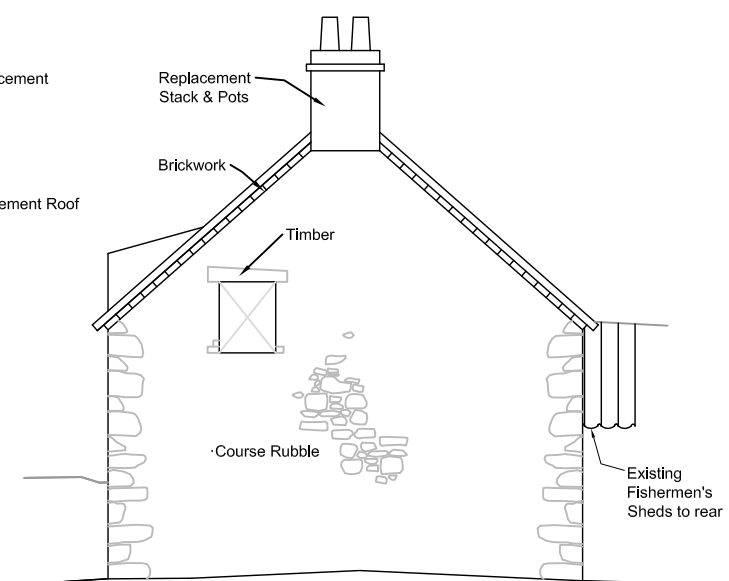
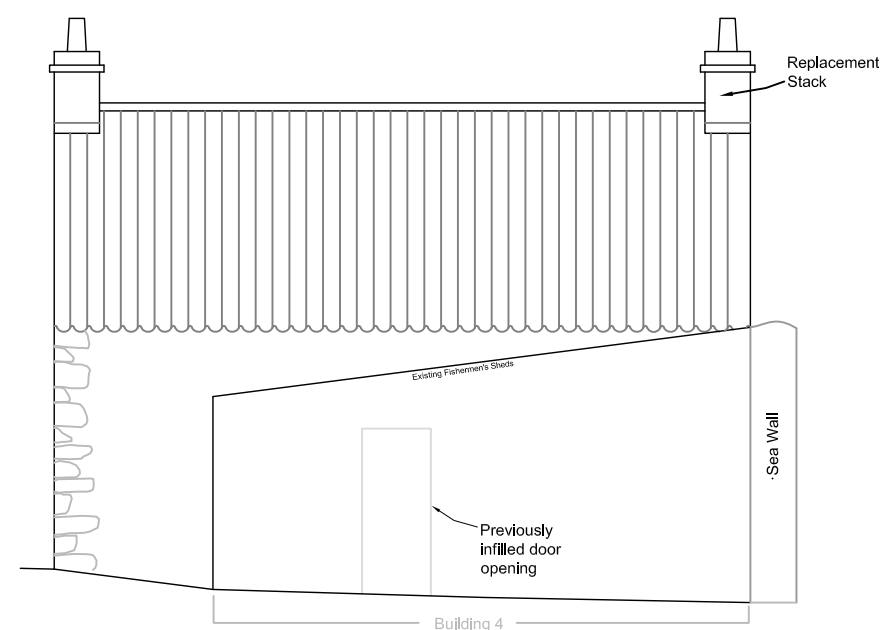
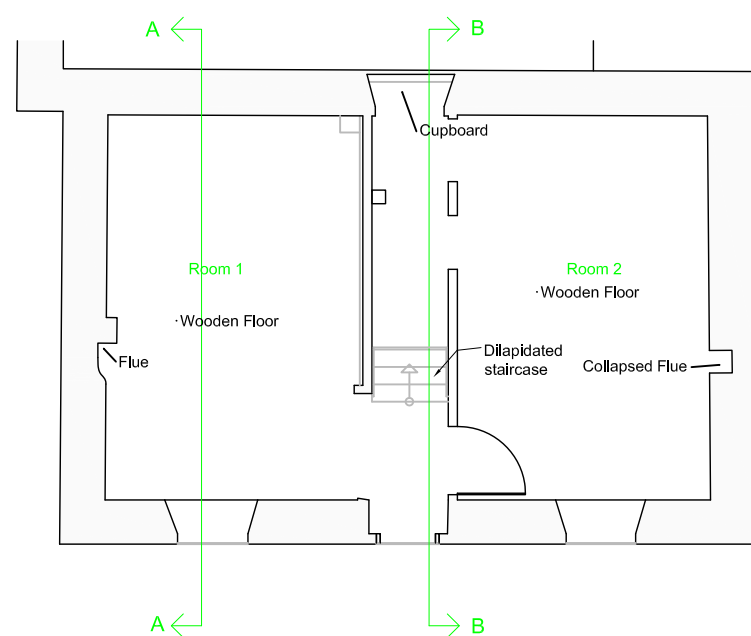
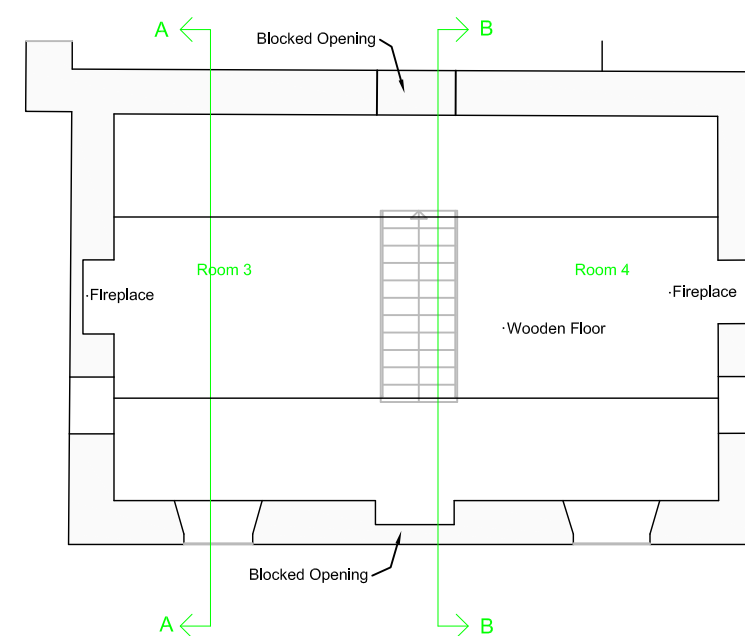
Rosecroft Cottage comprises a one and a half storey structure built of Old Red Sandstone rubble laid randomly. The building measures 9.1m long and 5.6m wide.

The north-facing gable has two bays with two square-headed windows on the ground floor and two cat-slide dormer windows on the attic floor. The ground floor windows

have inserted brick surrounds and measure 1.2m by 0.9m. A central door between the windows measures 1.8m by 0.85m. The ground floor windows and doorway have irregular timber lintels that are clearly re-used. The green-painted timbers have peg and dowel holes present indicative of having originated probably from another timber-framed building.

The west-facing gable measures 5.5m high and 5.6m wide. The quoins are rough hewn blocks. A blind window is present on the north side of the wall and measures c. 1.1m by 0.9m which has a timber lintel. The gable ridge is capped with modern brick and is contemporary with the pantile roof. The chimney stack is brick built and is also contemporary with the new roof.

The east-facing gable mirrors the west-facing gable and has a window opening in the same position. The window opening is surmounted with a timber lintel. The main build is random rubble that was earlier harled with cement but now this only survives in patches owing to its exposed position. The base of the elevation has been built over a rock outcrop and abuts a large sea wall which forms the main support for building 4 (see below).

The south-facing elevation is largely hidden by Building 4. The elevation is featureless above the adjoining building and is constructed of the same random rubble as the rest of the building. Within the interior of Building 4 there is a suggestion that a door is present in line with a below-stairs cupboard. It is suggested that it formerly adjoined the earlier pitched-roofed building pre-dating the present fisherman's sheds (Plate 2).

Rosecroft cottage is constructed on a two room plan with Room 1 and 2 on the ground floor separated by box staircase. On the attic floor, room 3 and 4 are not separated by a partition. No access was available to this floor as the staircase has been removed and the floors was unsafe.

The main entrance doorway is opposite the stairs. The door measures 2m by 1.2m and is plank-built. The staircase walls are 1m wide and brick-built and plaster lined. Only four treads of the staircase and the strings, forming the supports for the treads, survive on each side of the staircase. Below the staircase, situated on the rear, north-facing wall, there is a cupboard with shelves (1m wide and 0.5m deep). The cupboard appears to have re-used the opening of the door that lead into the earlier building shown on Plate 2.

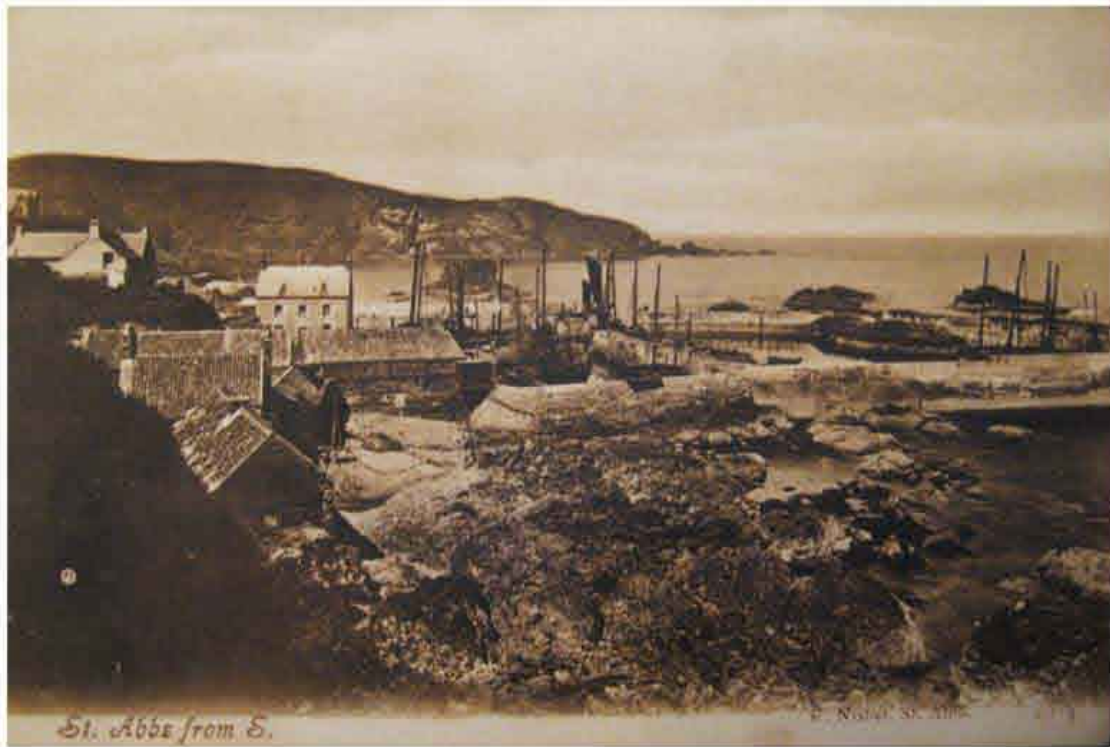
Plate 1 - Historical postcard of St Abbs showing the Vennel area

A historical postcard (Plate 1) provides evidence of 19th century layout of the Vennel buildings. Plate 2 is an enlargement of the buildings within the study area showing the south-facing elevations of the toilet (Building 1) and the building that was situated on what is Building 2. This building has a pitched pantile roof. A break between this building and the former L-shaped building adjacent is presumed to be the Vennel entrance. Rosecroft Cottage is shown with a smaller roofed building on its east side. Trending southwards at right-angles to the cottage is a linear building with a pantiled roof and central chimney stack. Fishing nets can be seen drying on the shingle beach.

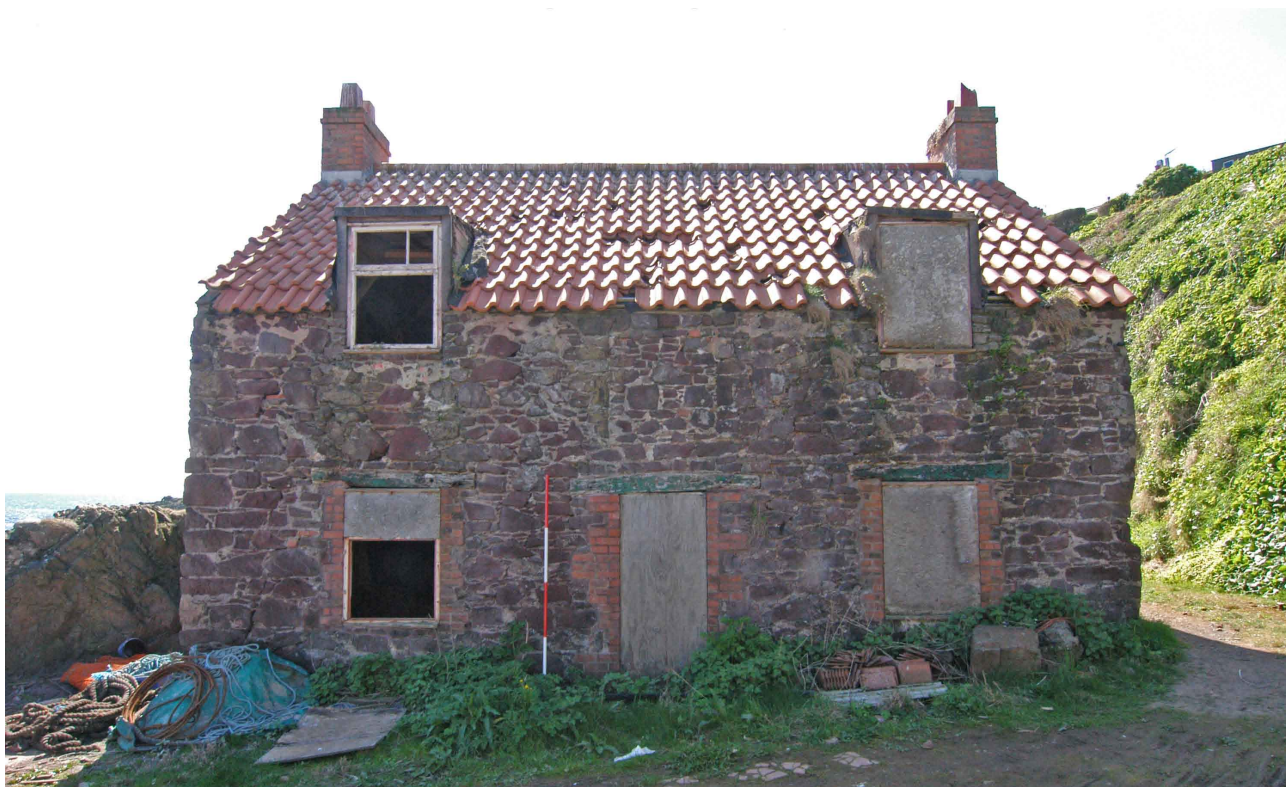
Plate 10: Building 3, Rosecroft Cottage, North-facing elevation

Above the door is a blocked window opening which has been infilled with sub-angular stonework and bonded by lime-mortar.

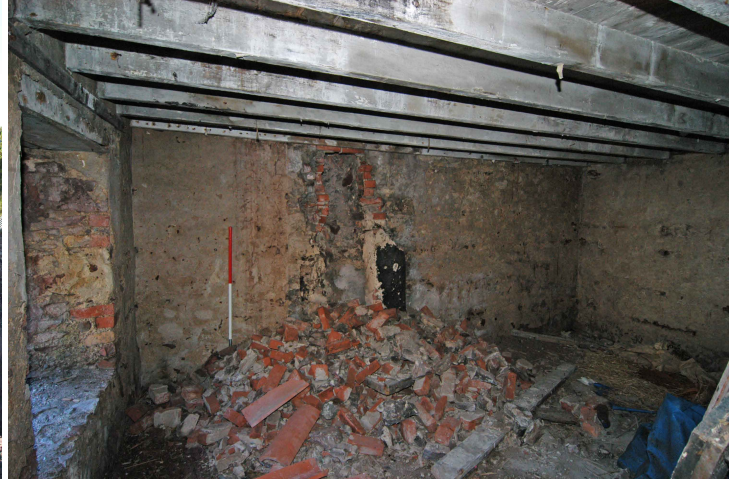
Plate 13: Building 3, Room 1 ground floor interior, west-facing elevation and floor joists

Room 1 measures 5m by 3.3m and is lit in the north-side by a single window with internal dimensions of 1.4m high and 1.2m wide. The interior walls are lined with a cream-coloured plaster. The east-facing elevation wall is tongue-and-grooved planking which enclosed the remains of the staircase. On the west-facing elevation a brick-lined flue is present and this was probably for a small stove. The floor is timber and the ceiling is bare timber joists and floor boards.

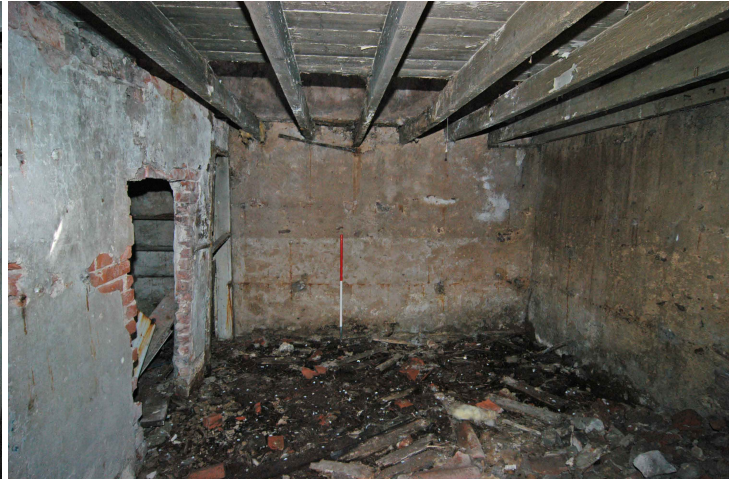
Plate 15: Building 3, Room 2 interior north-facing elevation and the stair cupboard

Room 2 measures 5m by 3.3m and is the same as Room 1 with plastered walls and the remains of the flue which has largely collapsed revealing the rubble fabric of the gable wall. The window opening shares the same dimensions as that in Room 1.

On the same elevation, partly masked by a pile of timber was the wooden lintel of a blocked opening (Fig 3, Existing south elevation). This feature corresponds with the re-used cupboard below the ruined staircase within Rosecroft Cottage (Plate 15)

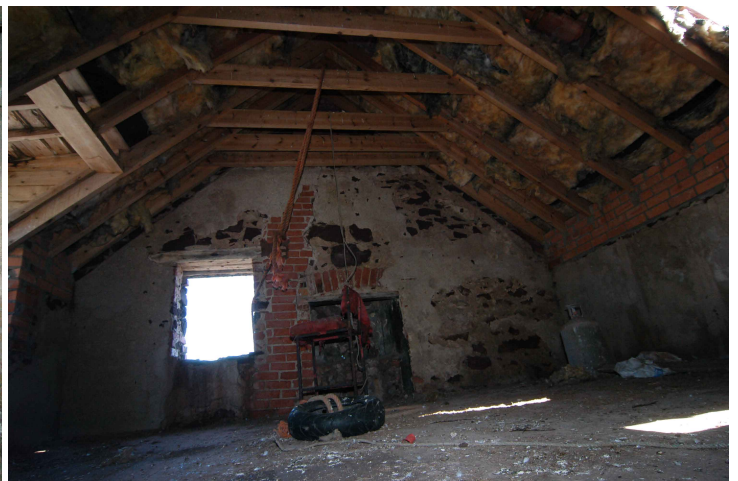
Plate 17: Building 3, Room 3 first floor interior, west-facing gable wall with fireplace

The first floor incorporating rooms three and four and combined they provide a floor plan measuring 8m by 5m. The floor is lit by the two dormer windows on the south-facing elevation and the aforementioned rectangular windows on the east and west-facing gables. A fireplace is situated at each end of the floor. Room 3 has a small fireplace with a timber lintel surmounted by a brick relieving arch. The fireplace in Room 4 has plastered stone surrounds with a mantle surmounted by a brick relieving arch which is visible in the plasterwork. Both fireplaces would have contained small cast-iron grates which have been removed. The partition wall dividing the attic rooms would have been situated between the box staircase. The partition was probably removed when the roof was replaced in c.1990. The present roof comprises A-frame rafters that rest directly on the wall heads which have been heightened with five courses of modern brick. The trusses support timber battens which have been felted. The cavity between the trusses are lined with rock-wool insulation.

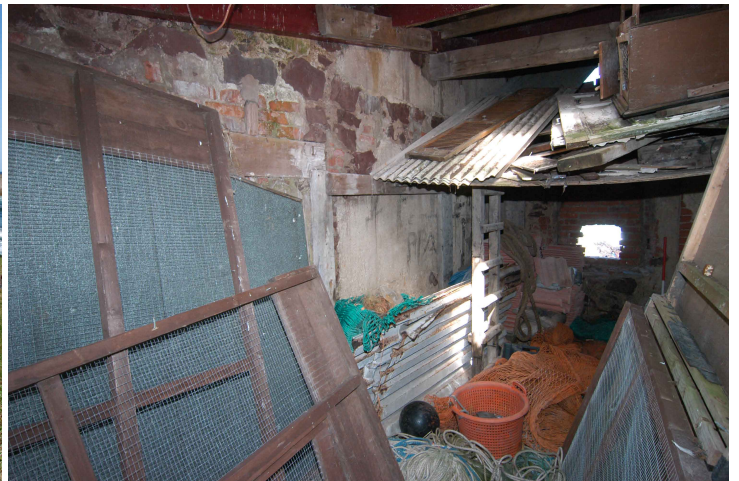
Plate 21: Building 4, Fisherman's Shed, interior of shed No 8

Shed no 8 (Fig 21) measures 6.9m long and 2.8m wide with a plank-built partition wall between it and Shed No. 7. The interior west-facing elevation contained the remains of a window that had been blocked with red-brick; a small void is present within the brickwork. Brick and plaster had been used to line the walls flanking the window opening. The south-facing elevation forms the rear of Rosecroft Cottage and this was partially lined with plaster and supported the timber frame of a rudimentary loft to support a collection of timber planks. The floor is covered with concrete.

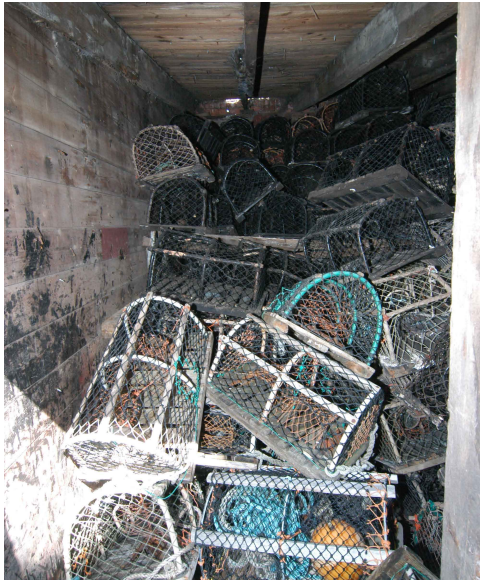
Plate 22: Building 4, Fisherman's Shed, interior of shed No 2

The building has been divided into eight individual properties using plank-built partitions fixed to a timber frame. Only shed No.2 and 8 were accessible. Shed No. 2 (Fig 22) measured 4.9m by 3m. The roof joists were 8" x 4" timbers that rested in sockets at the wall head. The room was completely filled with lobster pots masking any details on the interior walls.

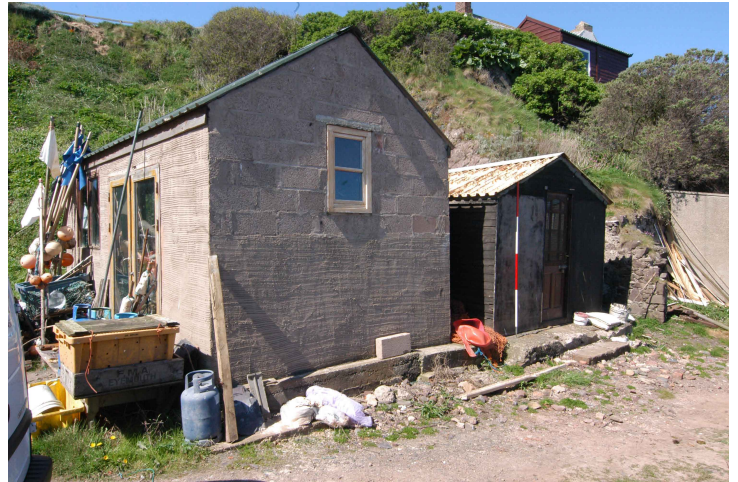
Plate 23: Fisherman's Sheds Nos. 9 & 10, east-facing elevation

This shed is a concrete mono-block construction measuring 5.4m long and 3.1m externally. The north-facing elevation is featureless. The west-facing elevation has a single-paned window in a wooden surround at its centre. The south-facing elevation has a sliding patio door which is off-centre and measures 2m wide and 1.7m high. A two paned window is present on the west side of the door. A single two-paned window occupies the east-facing elevation. The exterior elevations have been crudely rendered with cement. The shed stands on concrete foundations.

The shed measures 5.5m long and 3.1m wide and is constructed of ship-lap timber planks with a timber roof clad with steel sheeting. An 8-paned window occupies the west-facing gable. The roof is pitched and is c.3.5m high. The door is situated on the east-facing elevation and is a two panelled domestic door with windows.

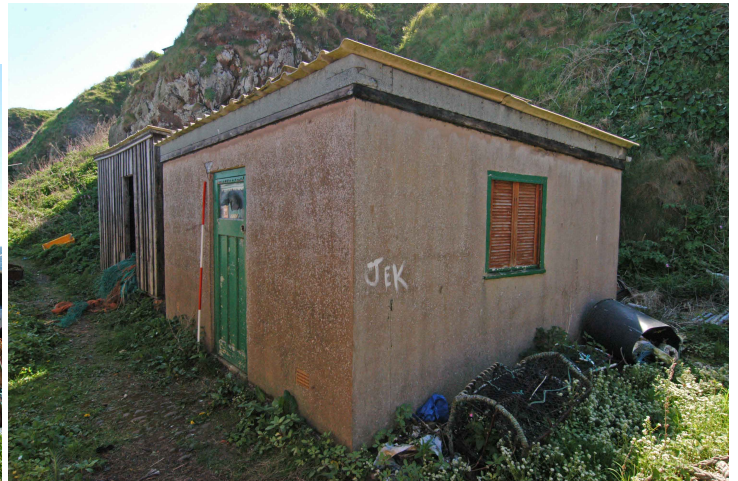
Plate 25: Fisherman's Sheds No. 11, north-east corner elevation

The shed is of concrete mono-block construction with cement render and a pent-shaped roof. The shed measures 4.8m long and 3.8m wide and is 2.7m high on the east-facing elevation. The central door on the east-facing elevation is three-panelled with a single pane above. A opening on the north-facing elevation contains a louvered timber shutter.

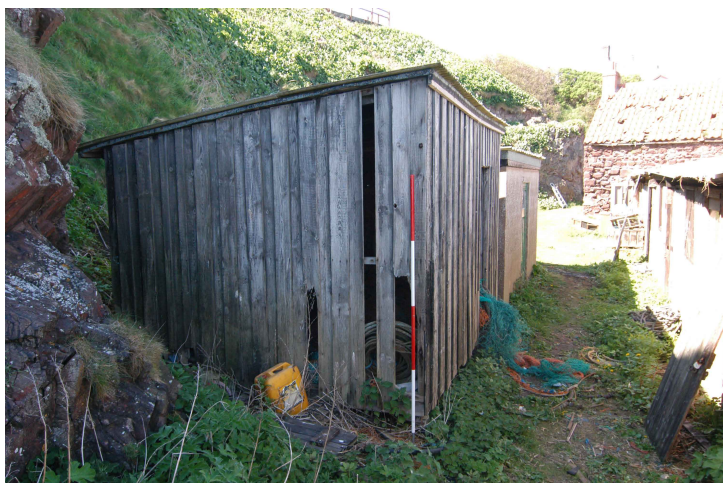
Plate 26: Fisherman's Shed No. 12, South-east corner

This dilapidated shed is a timber-framed wooden net store measuring 4.6m long and 3m wide. The walls of the shed are plank-built. The pent-shaped roof is clad with asbestos sheeting. A single door opening is present on the east-facing elevation measuring 2m by 1m. A window opening is present on the rear wall measuring 1m by 0.9m, the window frame is missing as is the door. The shed rests on brick plinths.

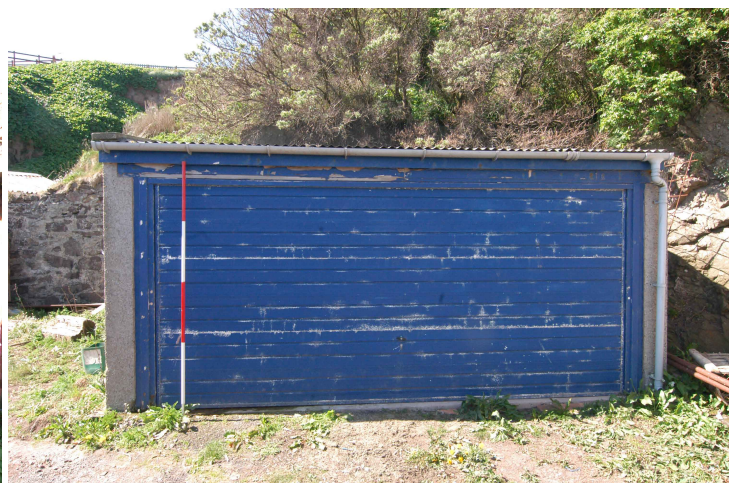
Plate 27: Modern Garage

Situated at the north end of the proposed development area, the garage measures 5.1m long and 5.8m wide and is 3m high. The garage is constructed of concrete mono block with an exterior pebble-dash render. The south-facing wall incorporates two small windows comprising thick blocks of glass. The sloping roof is higher at the rear. On the east-facing elevation there is a large blue-painted steel up-folding door. The garage was constructed after 1968 and is of no historical interest.
