**Marischal College  
Broad Street  
Aberdeen**

**Archaeological Watching Brief**

**Report No. 1911**

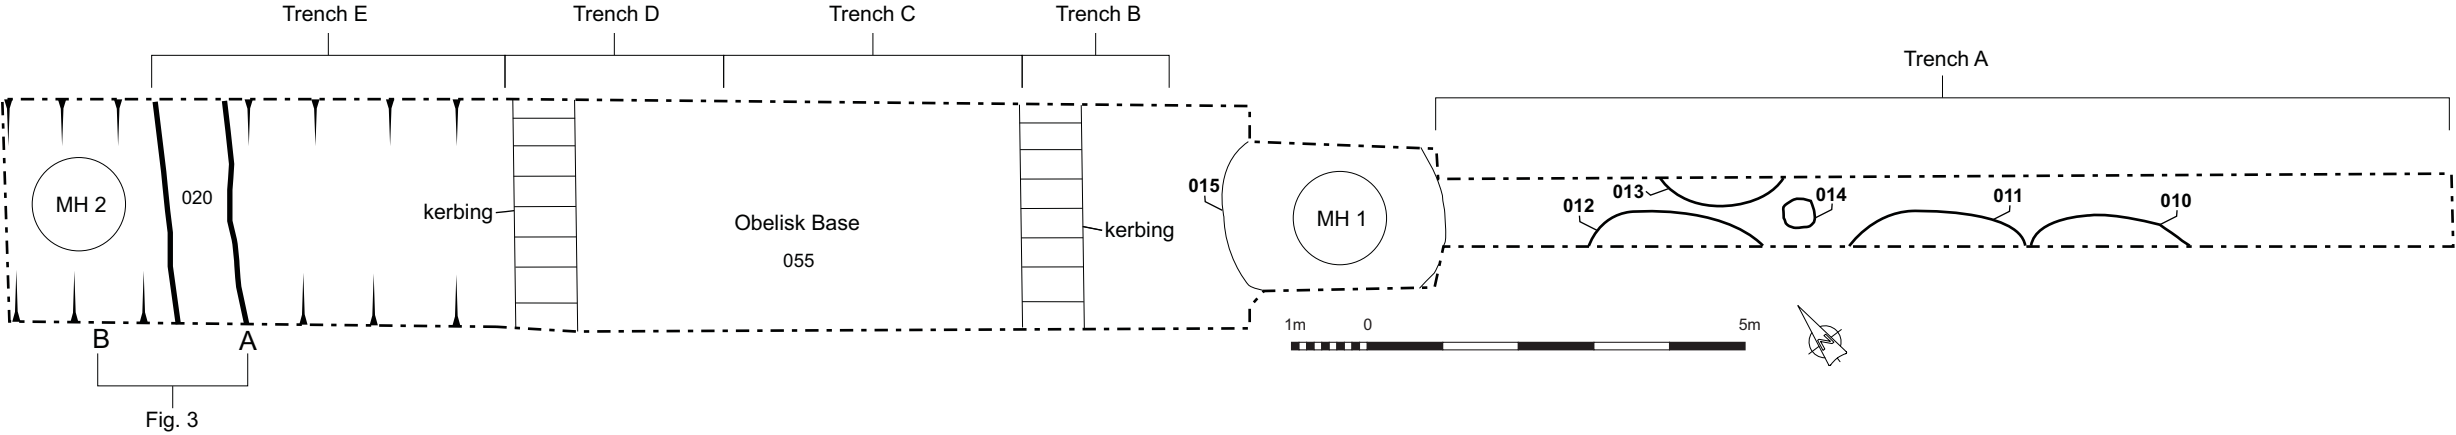
Fig. 2 Plan of Quadrangle Trenches showing location of features

The work in the Quadrangle was divided into a series of trenches, lettered A–E (CFA numbering system) in relation to individual pipe sections and two manholes, referred to as MH1 and MH2 (Fig. 2).

A number of probable pits were observed during the course of the excavation of Trench A. The pits were all seen in section with the exception of pit **014**, which was seen in plan at the base of Trench A (Fig. 2). It was not possible to obtain secure stratigraphic phasing for any of the features or deposits encountered in Trench A.

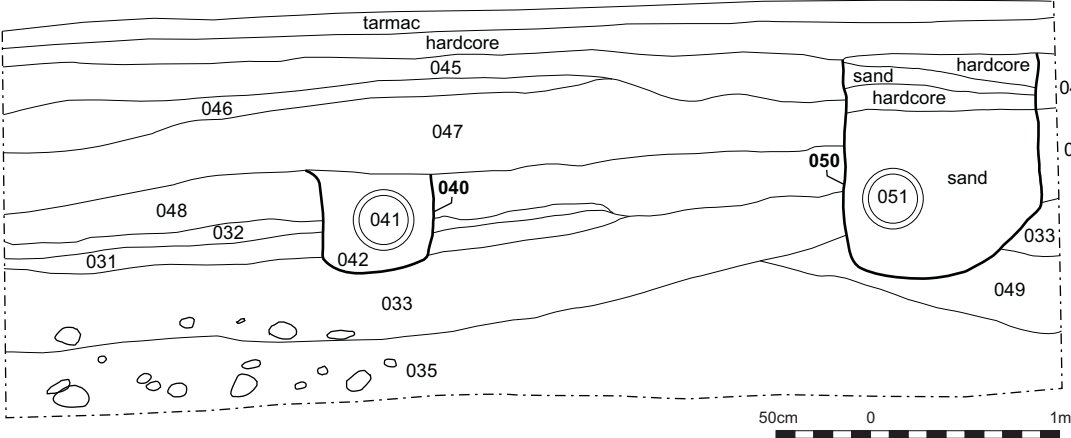
Fig. 4 South-facing section of Broad Street Trench

A series of made ground layers and a possible buried garden soil (**047**) overlay the cut for pipe **041** and can be assumed to be of modern origin (Fig. 4).

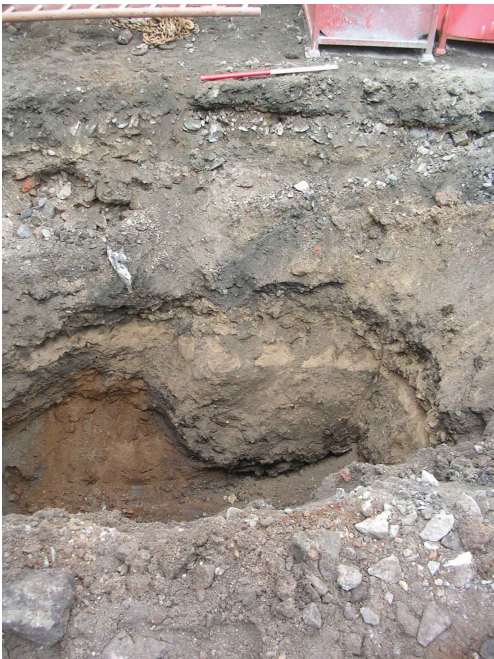
Fig. 5 North-east facing through Pit 012

Pit **012** measured *c.* 2.5m in diameter with a depth of *c.* 2m and was filled with a brown black clay silt (**007**). It appeared in the north-east-facing section of Trench A (Fig. 5).

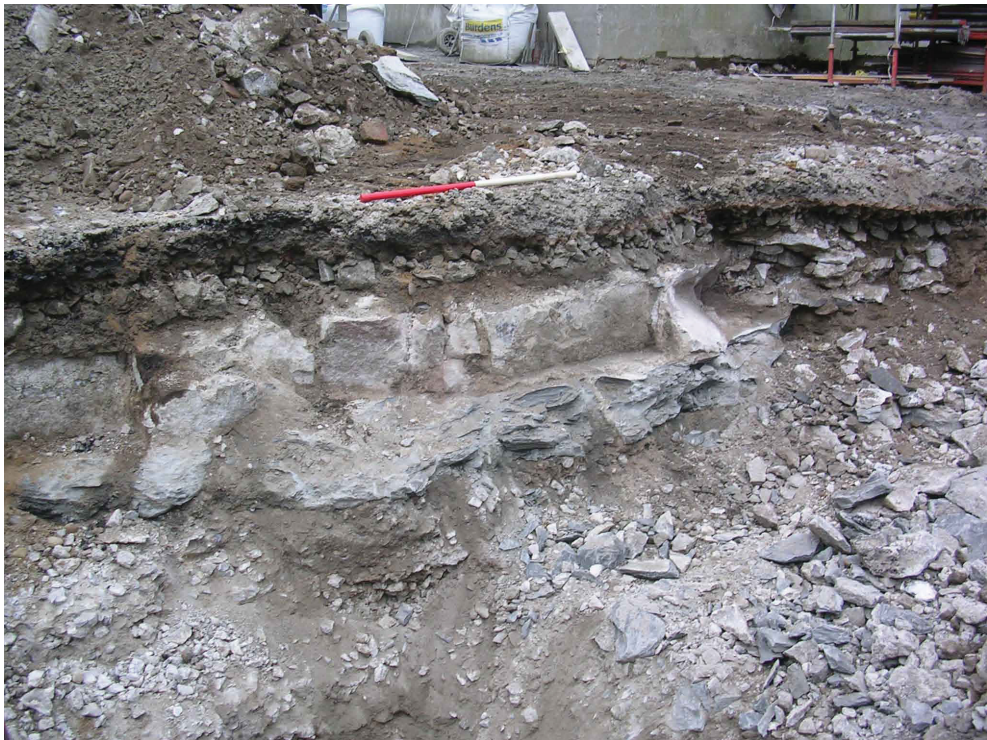
Fig. 6 North-east facing section section through Obelisk base

Trenches B, C and D were largely occupied by the foundation and base for a large structure or monument, since removed (Fig. 6). The cut for the foundation **(058)** measured 7m in length and 2.1m in depth. Cut **058** was filled by a deposit of granite and lime mortar concrete **(057)** forming the main foundation for the base. Overlying **057** was a large slate slab **(056)** measuring 6.2m in length and 0.25m in thickness. This slab **(056)** was overlain by a layer of large ashlar granite blocks **(055)** measuring 0.8m in length and 0.35m in height. The blocks extended for 8.4m and had 1.4m of kerbing visible on the north-west and south-east ends which could also be seen along the south-west trench edge. The granite blocks were directly overlain by a 0.2m thick deposit of modern hardcore **(054)** which stretched across the entire drainage trench. Cut **058** was cut through deposits **002**, **003** and **004** and into the natural, therefore completely truncating any potential archaeological remains. Finds recovered from deposits **003** and **004** comprised medieval brick, local medieval coarseware pottery, a sherd of Scottish post-medieval reduced ware, animal bone and oyster shell. These suggest a medieval date for layer **004** and a slightly later date for **003**. Finds from **002** were post-medieval roof tile and iron objects.

Trenches B, C and D contained the remains of a large foundation and base for a since removed structure. Documentary evidence has confirmed that this was the base for the McGrigor Obelisk, removed from Marischal College in 1906.

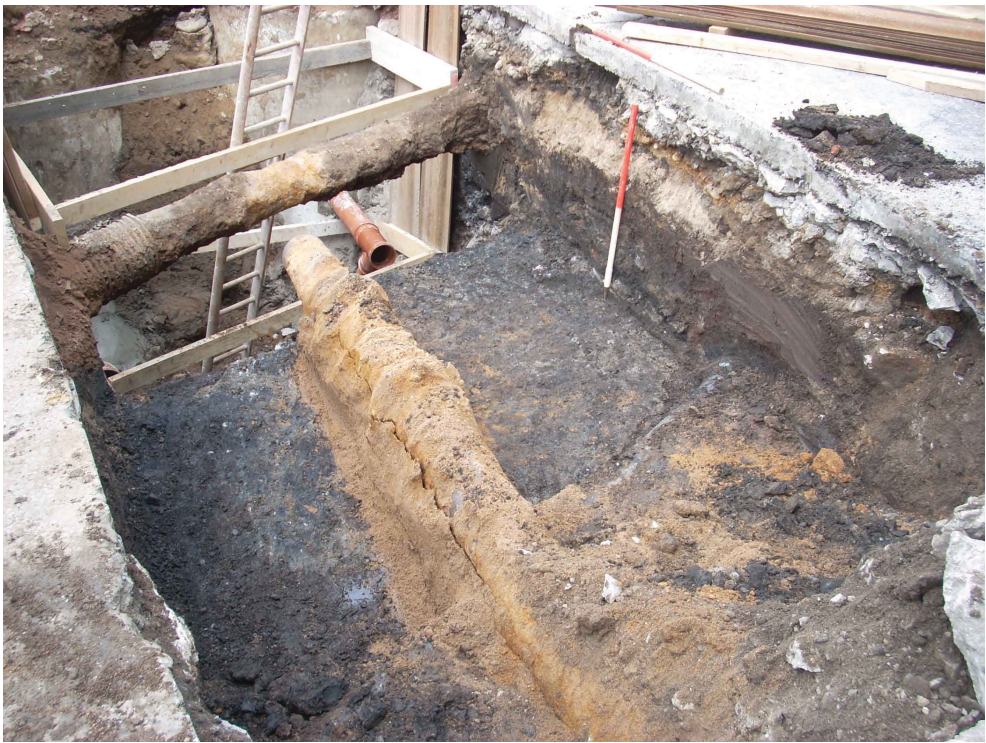
Fig. 8 Gernerall view of surface 031 in Broad Street trench

A compact clay sand and mortar surface (**031**) was encountered at a depth of 1.2m below the modern ground surface and extended for 3.2m across the width of the trench (Fig. 8). This surface (**031**) had a thickness of 0.1m and was truncated by the cut for pipe **041**, as were the two thin deposits overlying **031** (**032** and **048**). Deposit **032** contained dark brown stained animal bones and some marine mollusc shells.

The surface (**031**) was overlying a 0.45m thick deposit of brown clay silt (**033**), itself overlying a *c.* 0.45m thick deposit of possibly natural orange-red gravel sand. Deposit **033** contained leather offcuts and bone fragments, together with pottery of 13th-century date.

The excavations on Broad Street revealed a series of made ground deposits overlying a compacted surface. The surface was laid on top of a possible garden soil which contained a number of medieval artefacts.
