**Land adjacent to Armadale Station,
Armadale, West Lothian (Areas 4-7).
Archaeological Evaluation.**

**Data Structure Report
No. 1906**

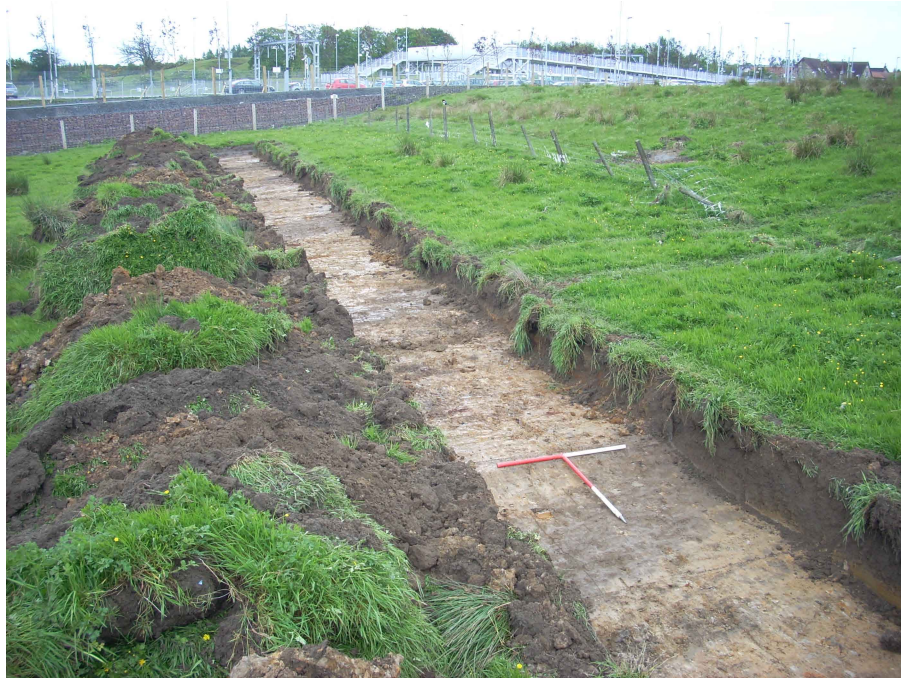
Traces of rig-and-furrow cultivation were identified in Trenches 159-164, 166-7, 173, 175, 177-9 (Fig. 4). Alignments varied widely. Widths of 1.5-2m were most common and wavelengths varied between 4-9m, with most being between 6-8m. Clay-piped field drains were recorded.

Fig. 4 Trench 161: Furrows 360, 362, 364, 366, 368 and 370 from the north

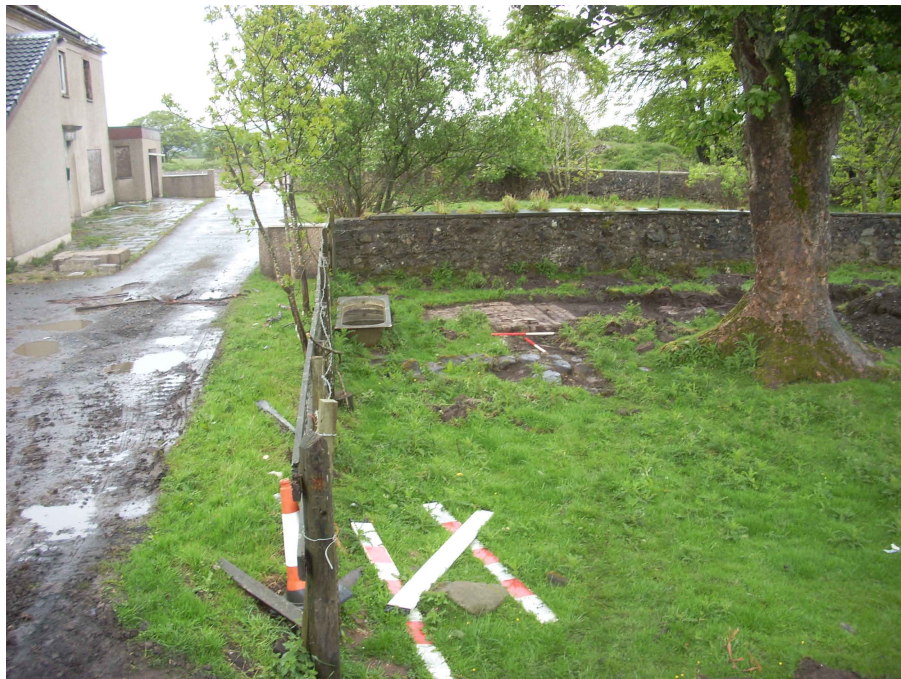
The remains of a building were recorded in Trench 126 (Figs. 5-6). This structure appeared to be sub-rectangular and had a length N-S of 7m and width E-W of 5.5m. The southern wall (**242**) was constructed from mortared volcanic cobbles whereas the western wall (**244**) appeared to be formed from similar but unmortared cobbles. A well-made split-level brick floor (**250, 251**) occupied the centre of the internal area, with traces of cobbled (**243**) and brick floors (**246**) between the external walls. Metal mounts for internal fixings/fittings protruded from the brick floors. A brick alignment (**410**) ran south from wall **242**. Large quantities of late 18th-20th century finds (Appendix 5) comprising ceramics, glass, ironwork, slates, tiles, felt (roofing material), bricks and bones are present in and around the structure. A large mature tree (Fig. 5) is growing from the SW corner of the building and very substantial roots are present throughout the area.

Fig. 5 Trench 126: the structure at Trees Farm from the west

The building in Trench 126 would appear to be one of the three buildings at Trees Farm (ES Site 21) which are shown as roofed on the Ordnance Survey First Edition map. The nature of the excavated remains, with a split-level brick internal floor suggests this structure was a workshop or toolshed associated with the farm. Although unstratified, the finds suggest a late 18th-20th-century date for the building.

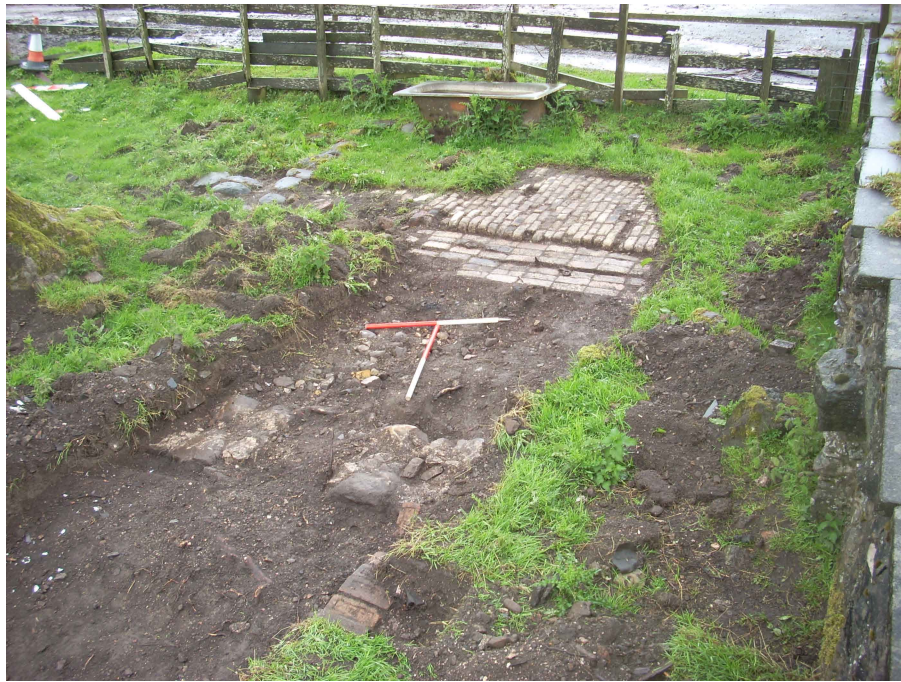
Fig. 6 Trench 126: The structure at Trees Farm from the south-east. Note the continuation of wall 242 protruding from the garden wall at the right of the photo

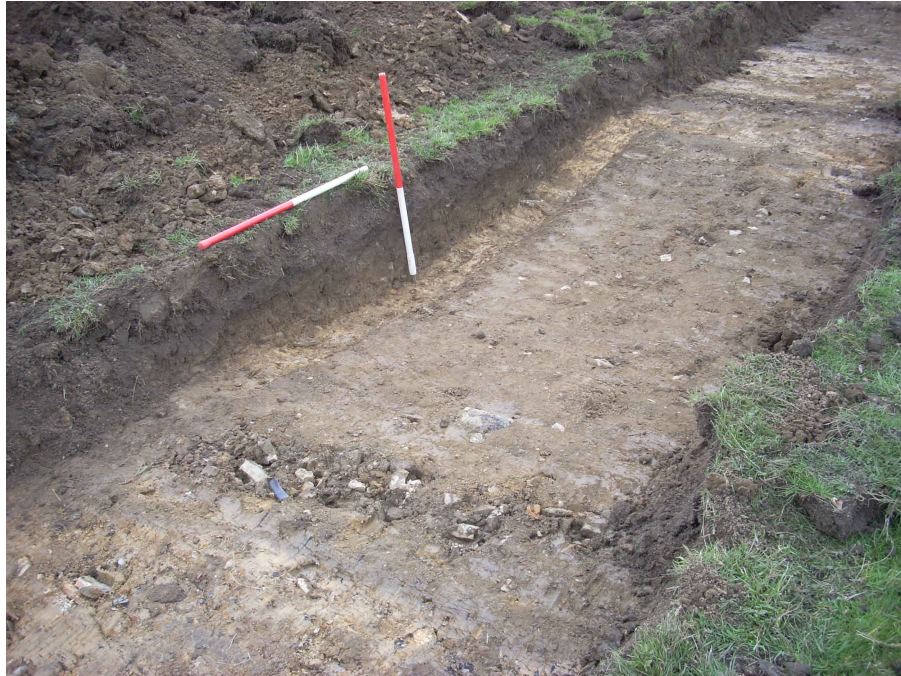
Traces of rig-and-furrow cultivation were identified in Trenches 116, 124, 127-30, 135-9 (Fig. 7). As this area covered parts of 4 different fields, alignments varied widely. Widths of 1.5-2m were most common and wavelengths varied between 4-9m, with most being between 6-8m. A sherd of green-glazed post-medieval pottery was recovered from a furrow (**150**, Fig. 7) in Trench 116. Clay-piped and stone filled field drains were recorded.

Fig. 7 Trench 116: Furrow 150. Note the slight different alignment of the field drains on either side of the furrow

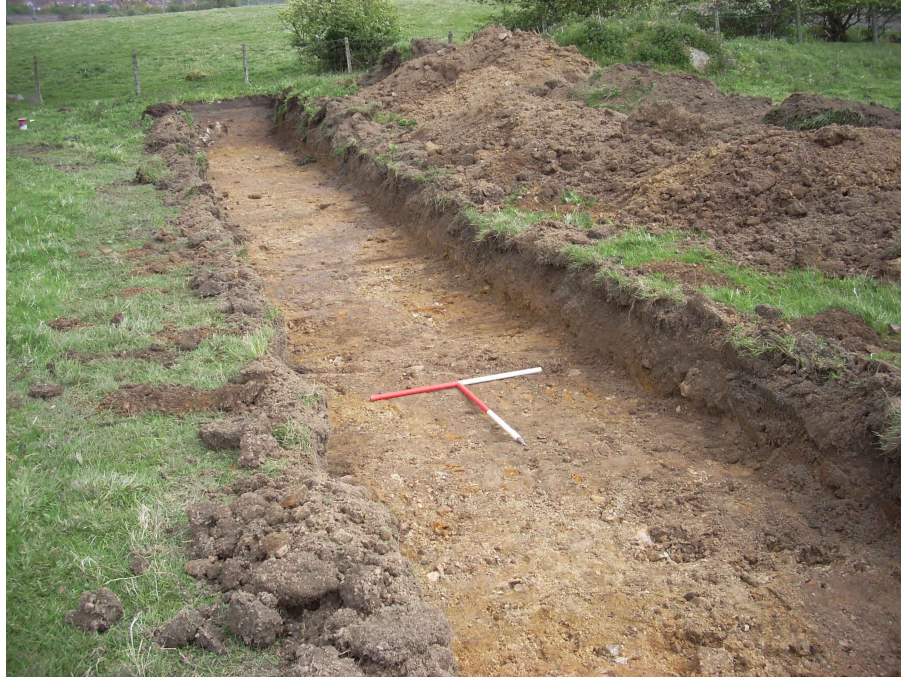
A curving ditch (**166**) was recorded in Trench 115. This had a length within the trench of 8m (Fig. 8), a width of 0.6m and a depth of 0.2m (Fig. 9). The single fill (**167**) consisted of a grey clay-silt with frequent broken stones and occasional black silty lumps. The area within the arc of the ditch appeared to contain a mound of redeposited natural subsoil (**173**) consisting of loose broken stones and a yellow creamy clay. An extension at 90° to the initial trench was excavated. No internal features were present.

Fig. 8 Trench 115: Curving ditch 166 from the south-west

The curving ditch in Trench 115 did not appear in Trench 116. There appear to be no internal features and in terms of date and function, these features are unknown.

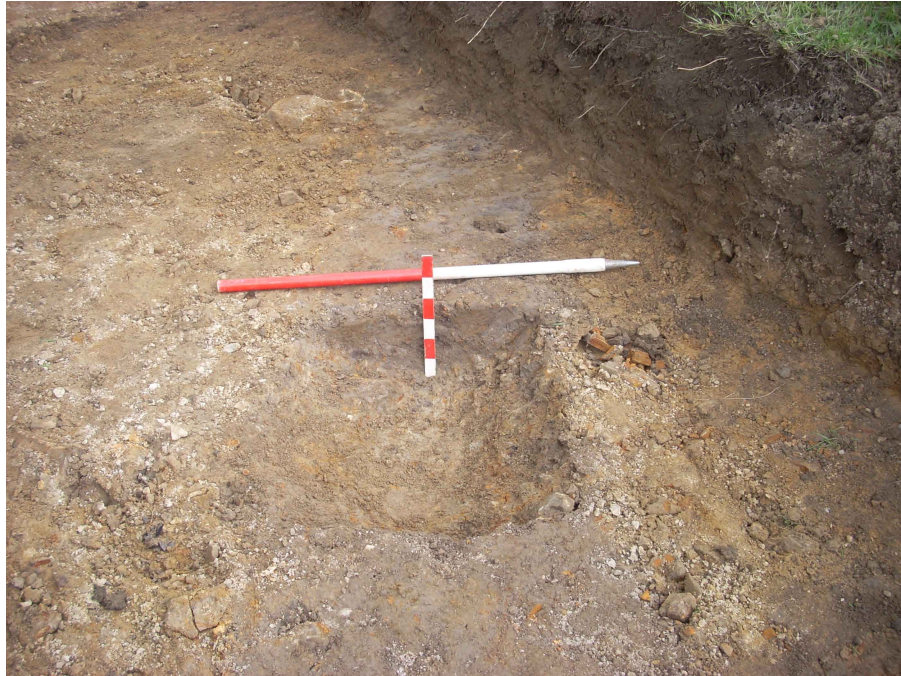
Fig. 9 Trench 115: Section through curving ditch 166

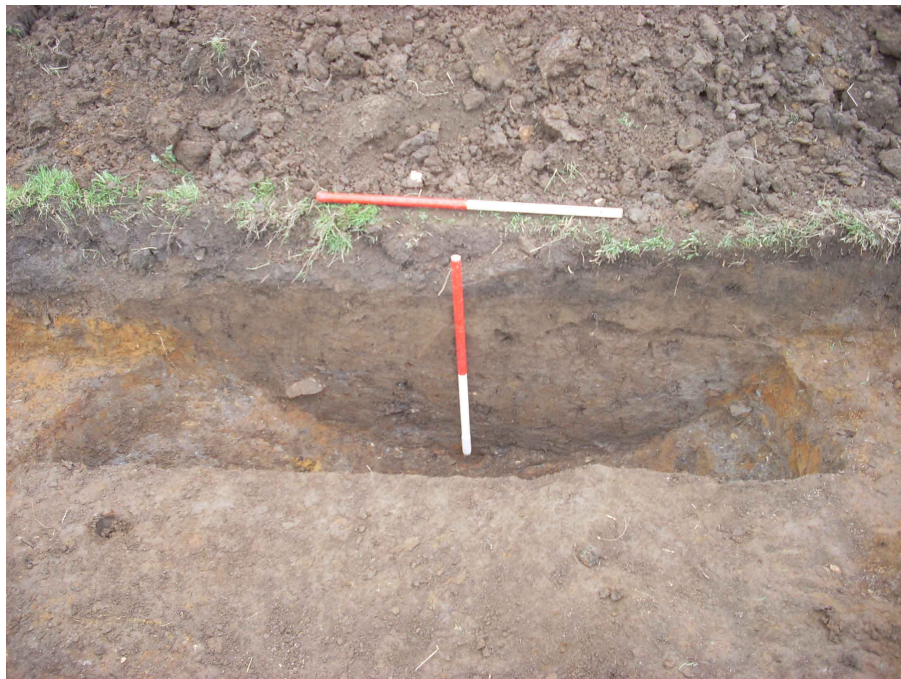
A sub-circular pit (**180**) was partially exposed in Trench 122 (Fig. 10). This had a length of 2.5m and a width of over 1.8m. The depth was 0.8m. Three clay-rich fills (**181-3**) were recorded, with the upper fill (**181**) producing 4 sherds of 15th-18th century pottery.

Fig. 10 Trench 122: Section through pit feature 180 from the north

The circular pit in Trench 122 was located at a low-point in the local topography. Both this, and the nature of the fills, suggest this pit may have been a sump or other device from which groundwater could be accessed.
