**New house to the rear of
22 Drum Street, Gilmerton, Edinburgh**

**Archaeological Watching Brief
Report No. 1912**

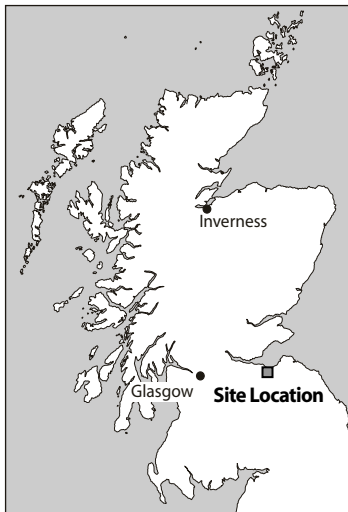
LOCATION & SITE PLAN

Existing sheds within the yard to the rear of 22 Drum Street were removed. These are shown on the aerial view of the site (Fig. 1). They had no foundations which required grubbing out. Removal of the sheds revealed the full elevations of the boundary walls.

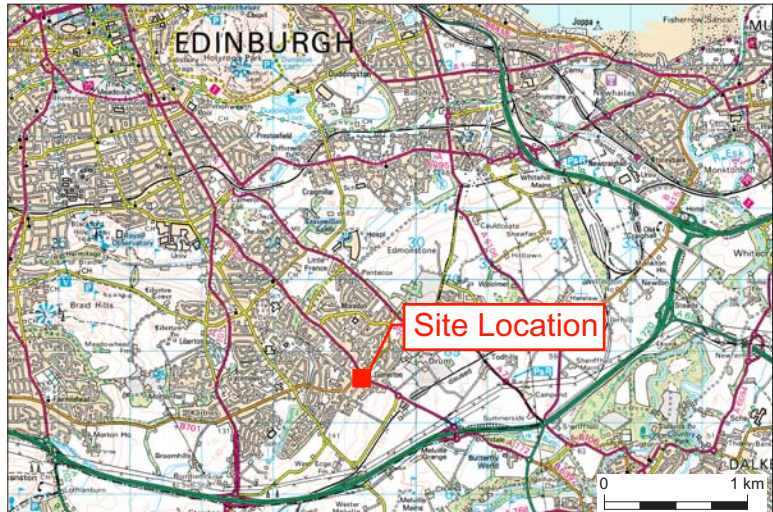
Fig. No: 1 Revision: A Client: Mumtaz Hussain

Title: Plan of the proposed building with an inset showing the location

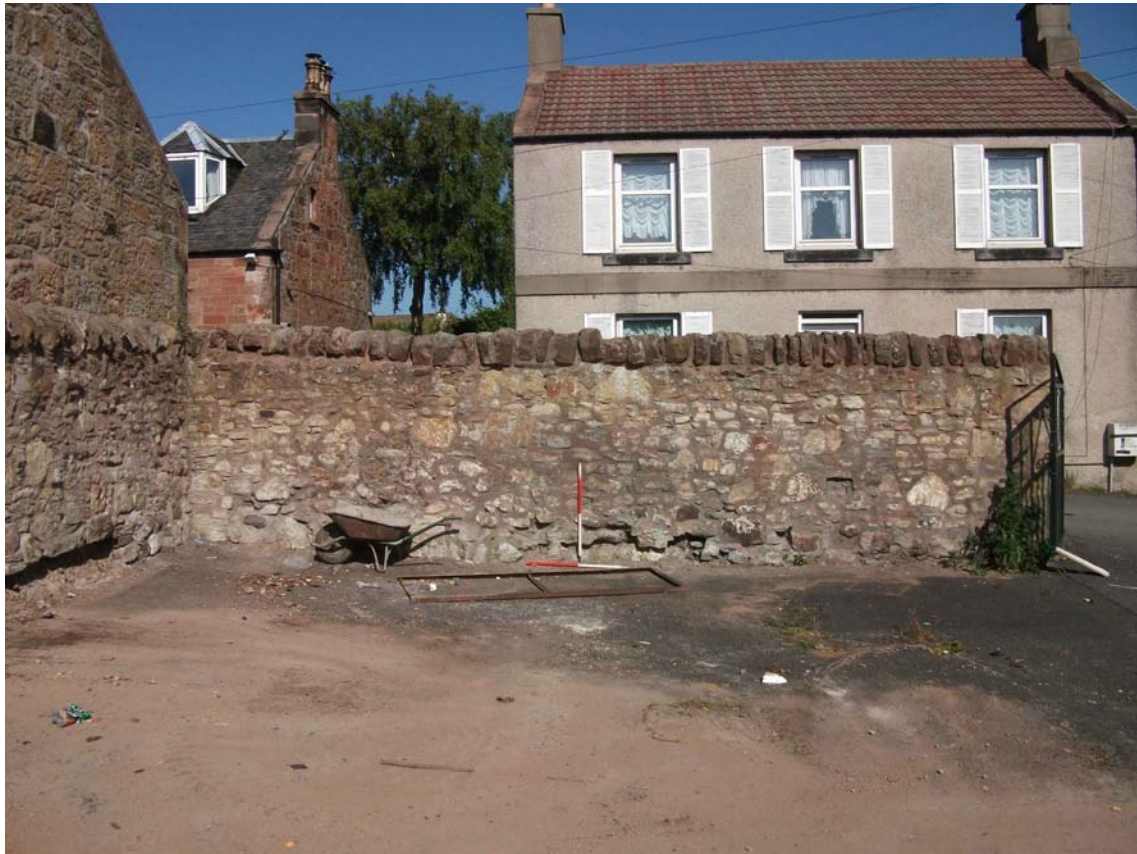
The boundary walls to the north-west (Fig. 2) and south-east (Fig. 4) are free-standing and consist of mortared red sandstone rubble with vertically-set coping stones on top. They are 2-2.5m in height and around 0.5m wide. The wall to the north-west was demolished and the north-west foundation trench for the new build was excavated along the same alignment (Fig. 5).

Figure 2: General view of the north-western boundary wall from the south-east

The north-western boundary wall preserved no evidence of the building depicted on the 1st Edition map and there was no significant difference in its construction to the south-west or the north-east of the buildings assumed location. This suggests that the wall has been rebuilt since the 1850s.

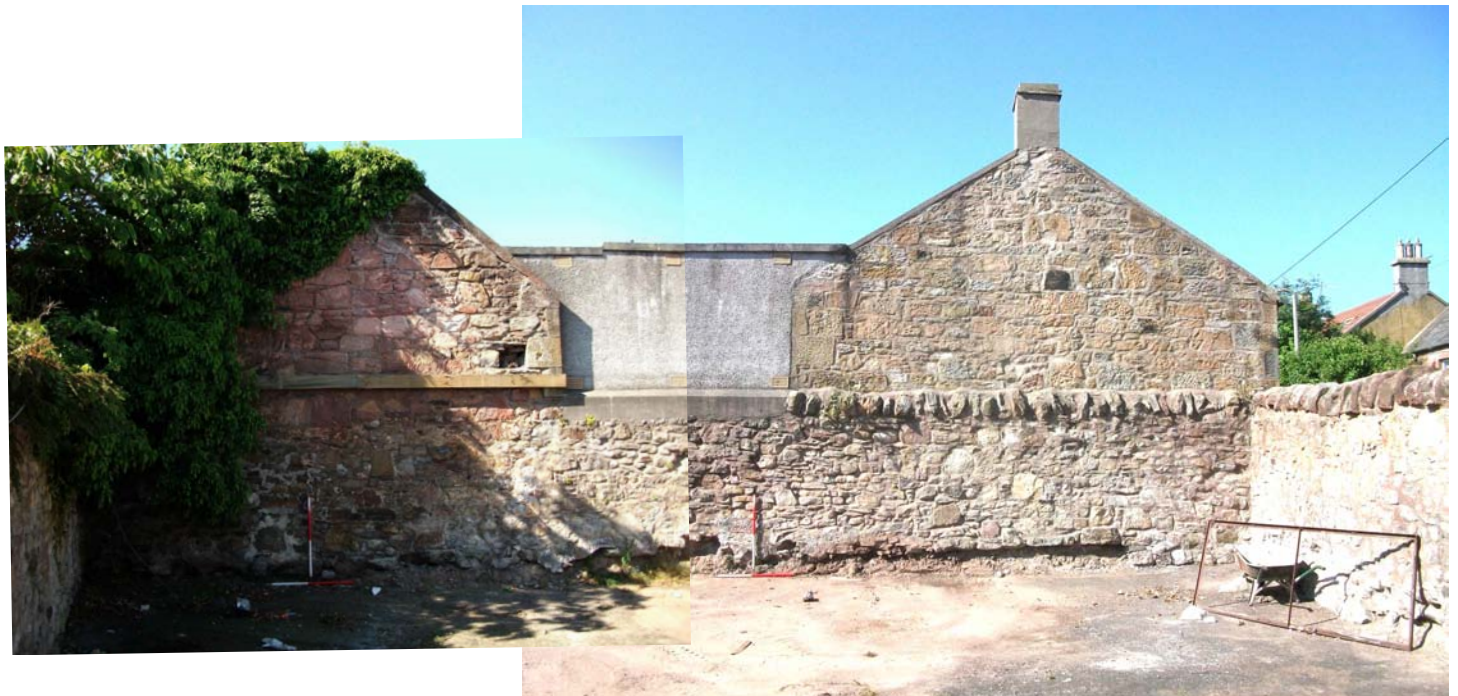
The boundary wall to the south-west is of similar construction to the above walls but has been overlain at either end by the gable walls of two adjacent cottages and in the centre by a modern harled extension to the cottage fronting the lane (Fig. 3). The cottage walls are constructed from different colours of sandstone. Construction of the one to the south (Fig. 3 left) has led to the loss of the coping stones from the boundary wall whereas the one to the north (Fig. 3 right) is built over the coping stones.

It is also notable that the boundary wall does not extend down to the present ground level over much of its length (Fig. 3) and this may indicate that the ground levels within the site have been lowered since the wall was constructed.

Figure 3: General view of the south-western boundary wall from the north-east.

The south-western wall is depicted on the 1st Edition map and is overlain by buildings which appear for the first time on the 2nd Edition 1:2500 map. Indeed, the wall is shown as running through these buildings. Viewed from inside the site, at the south-eastern end of this wall, the gable of a sandstone building overlies the wall but there is no indication that further buildings of similar nature continued north-east within the site as suggested by the cartographic evidence. These buildings may therefore have been different in construction and/or function. At the north-western end of the boundary wall the gable of a sandstone building again overlies the wall but differences in the stone and in the way it overlies the wall suggest they are not contemporary. The foundations of the south-western boundary wall are exposed. This, and differences in the levels between the development site and the adjacent lane (Drum Street), suggest that the interior of the site may have been truncated since the wall was built prior to 1853.

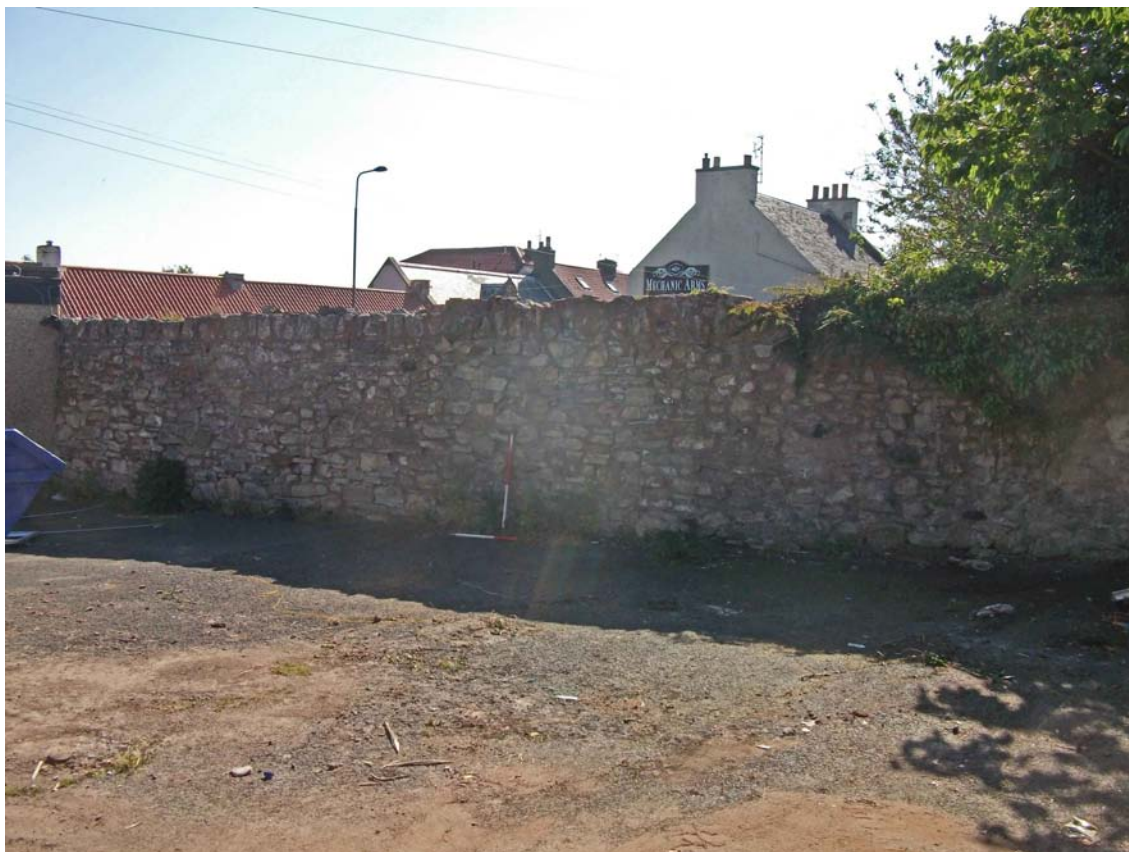
Figure 4: General view of the south-eastern boundary wall from the north-west.

The south-eastern boundary wall is also depicted on the 1853 1st Edition map and buildings appear along it within the site for the first time on the 1894 2nd Edition map. The nature of these buildings is however uncertain, and they may be open cart/storage sheds, for example, although there is no apparent access to them from what is now Drum Street. There is no evidence for these buildings preserved in the structure of the wall, but equally, there is no evidence that the wall has been rebuilt in recent years.

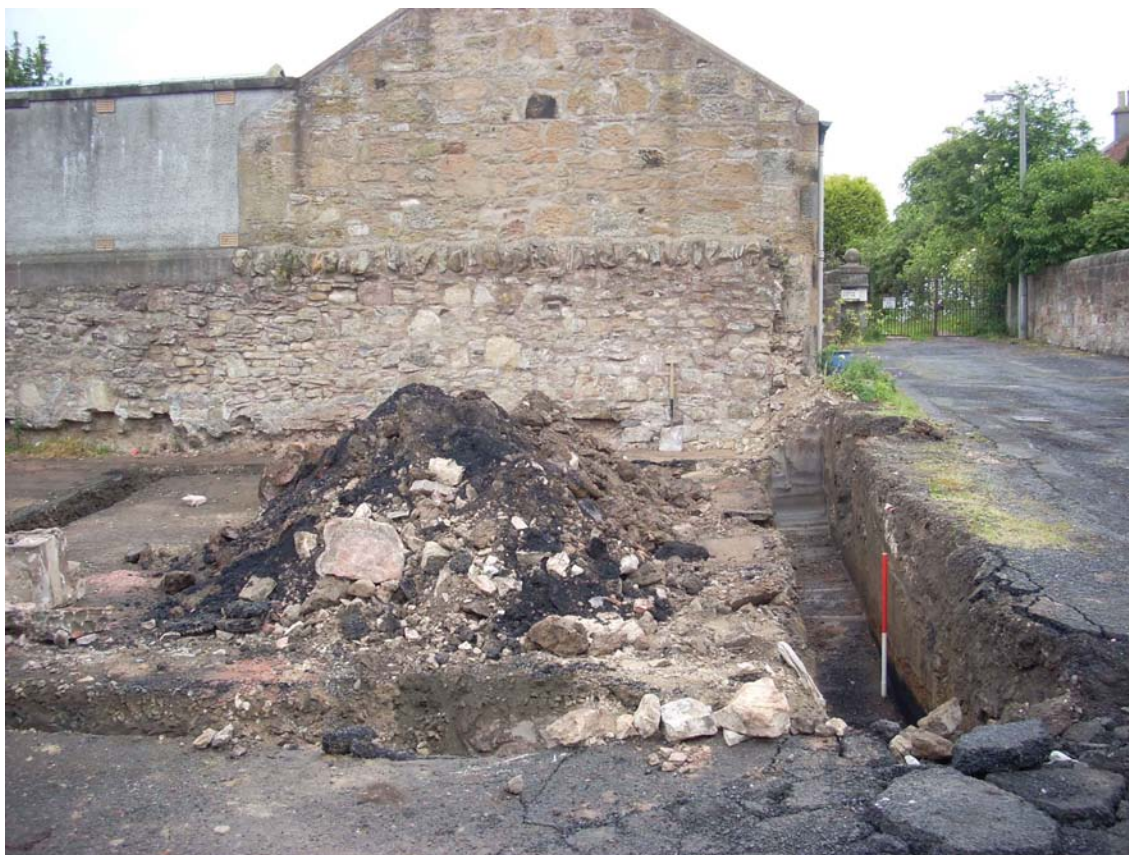
There were no features, deposits or artefacts of archaeological significance identified in any of the foundation trenches and the level of the yard within which the development took place was c.0.5m below that of the lane off Drum Street (Fig. 5).

Figure 5: General view of the excavated foundation trenches from the north-east
