## **1 Brae Park, Edinburgh Archaeological Watching Brief**

### **Data Structure Report No. 1916**

**1 Brae Park, Edinburgh  
Archaeological Watching Brief**

**Data Structure Report  
No. 1916**

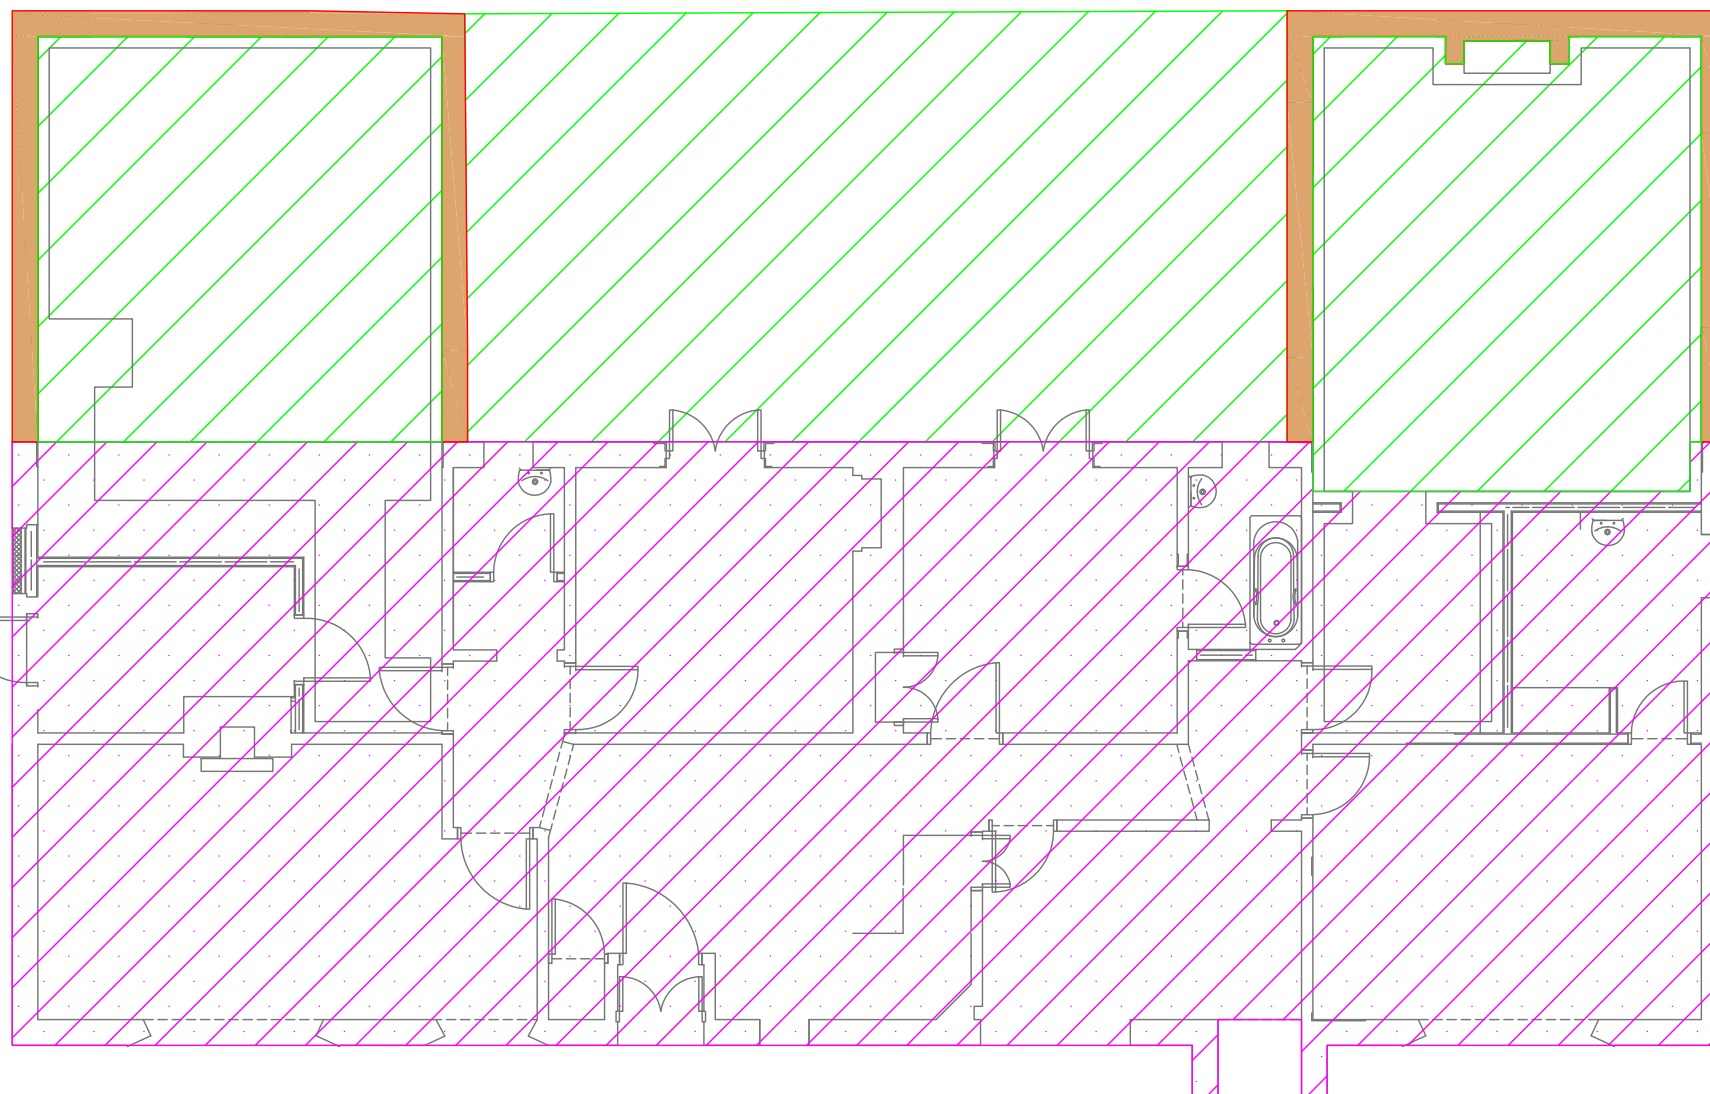
Fig. No: **2**      Revision: **A**

The watching brief monitored the excavation of foundation trenches of two extensions down to natural subsoil, and the clearance of vegetation and surface topsoil from the areas within the foundation trench boundaries (Fig. 2-4). Following discussions with John Lawson it was agreed that the patio area between the extensions would not be monitored as only c.0.3m, comprising the topsoil layer, would be stripped from this, leaving the subsoil (**002**) intact.

Title:  
**Plan of site showing monitored areas**

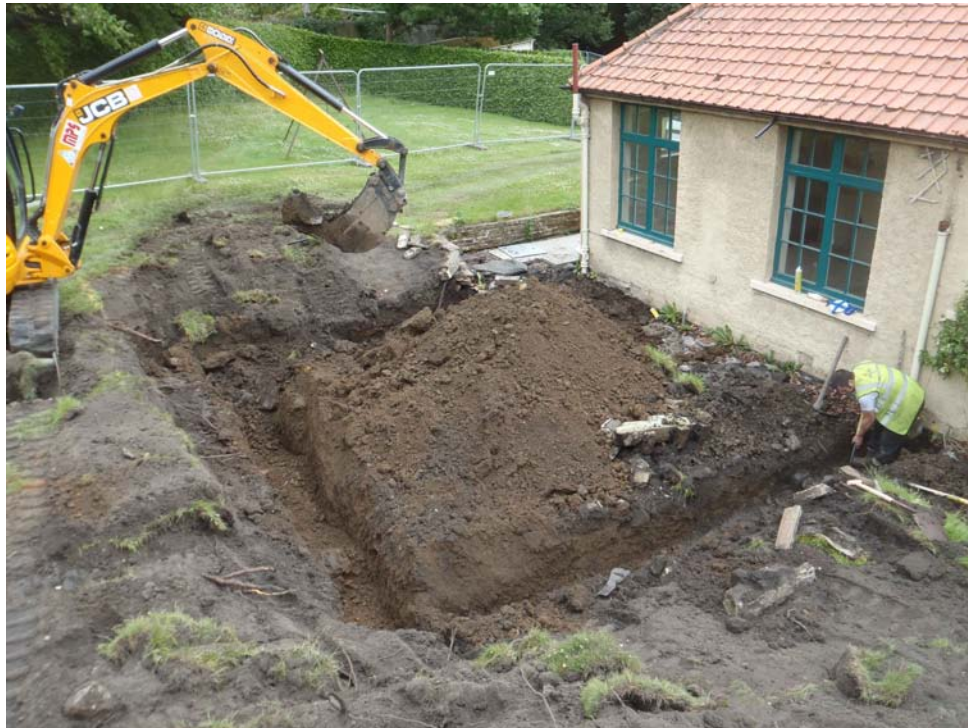
Topsoil (**001**) varied from 0.3m to 0.4m deep and comprised rich dark loam beneath the surface turf. It overlay grey clayey silt subsoil (**002**) which was 0.3m to 0.4m thick and merged slightly with natural subsoil (**000**), which comprised stiff gritty sandy clay. Some traces of bioturbation were noted including the presence of roots from a recently felled mature tree located c.2m from the edge of the site. The natural subsoil level sloped slightly downwards towards the house.

Fig. 3 General work shot of foundation trench excavation

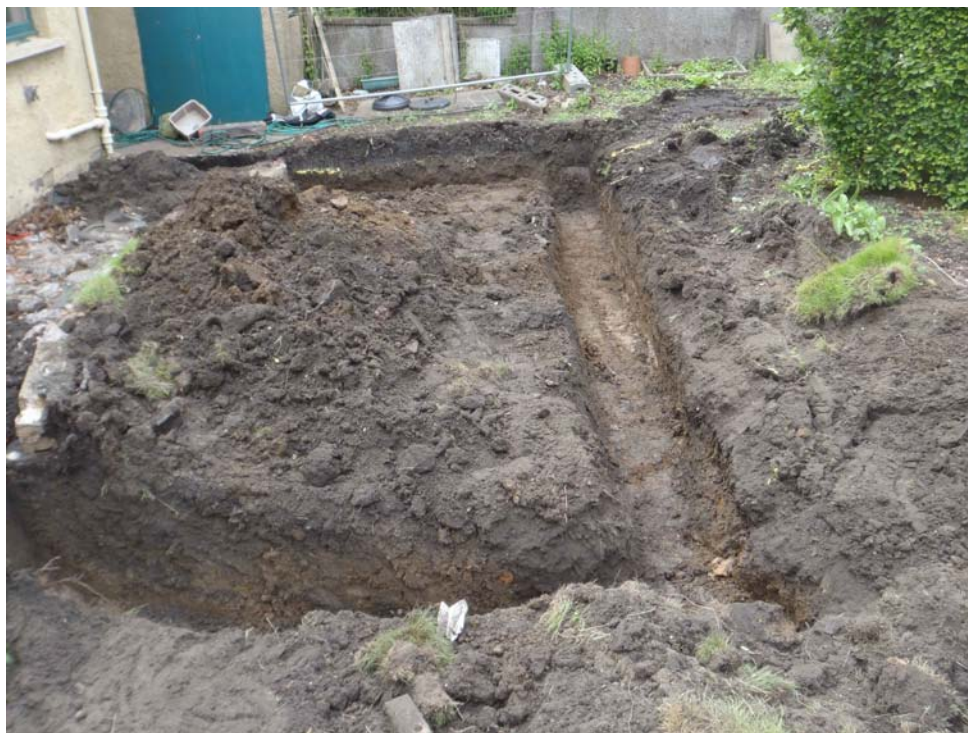
No archaeological remains or deposits were identified.

Fig. 4 View of fully excavated foundation
