**Car Park Proposal,
Bridgend Farm,
Old Dalkeith Road, Edinburgh**

**Archaeological Watching Brief
Report No. 1950**

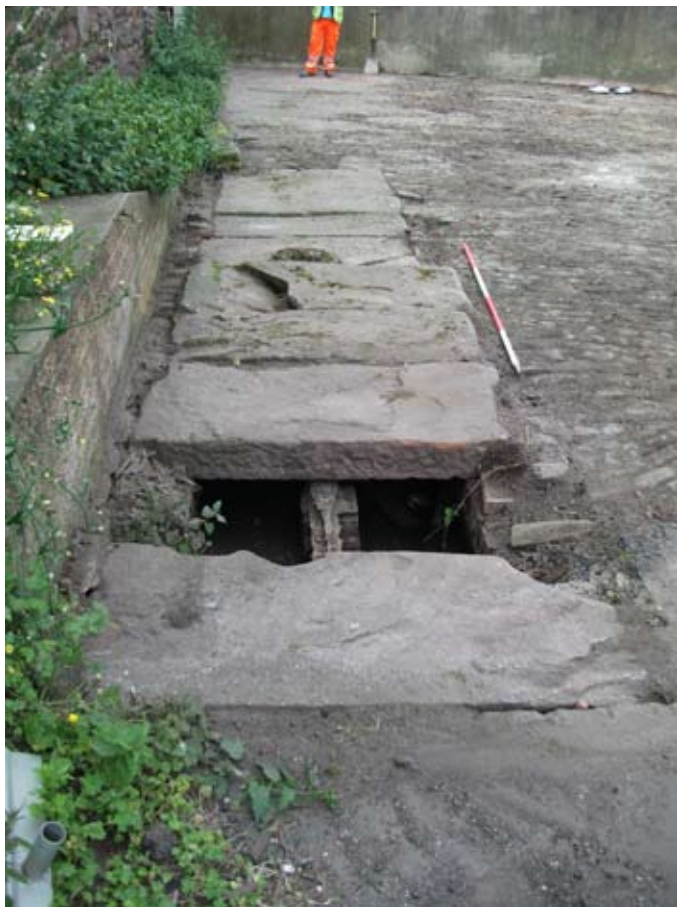
Eight sandstone slabs (**001**), each around 1.6m in length and 0.6m in width, were recorded over a length of 8.5m at the south side of the proposed car park, adjacent to the disused farm buildings to the south (Fig. 2). These were believed to be the capping stones for a drain or culvert.

Fig 2. View of the tanks with lintels in place, from the north-east

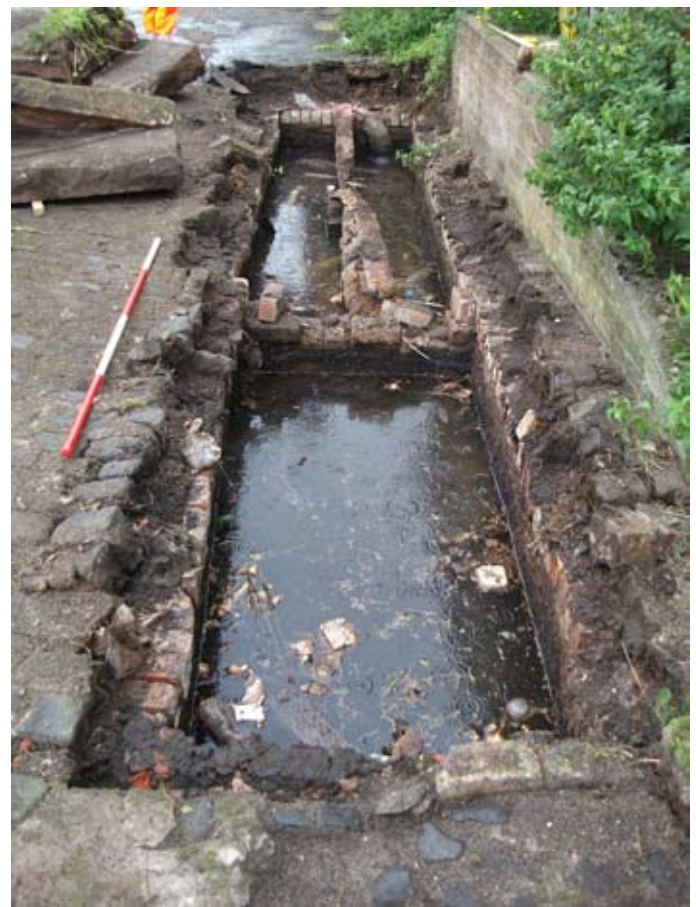
Once recorded, these stones were removed by machine to reveal two brick-lined tanks of unequal length and width (Fig. 3). These were aligned north-east to south-west. A substantial steel beam (**002**) with an 'H' profile overlay the centre of the tanks and supported the lintels. The walls and division between the two tanks were brick and the floors were concrete (Fig. 4).

The tank to the north-east (**003**) measured 3.8m by 1.2m and was 0.9m deep (Fig. 3). A brick plinth (**004**) had been constructed within it to further support the roofing beam and lintels. A ceramic pipe entered the north-east tank at ground level (Fig. 5).

Fig 3. View of the tanks following removal of the lintels, from the south-west

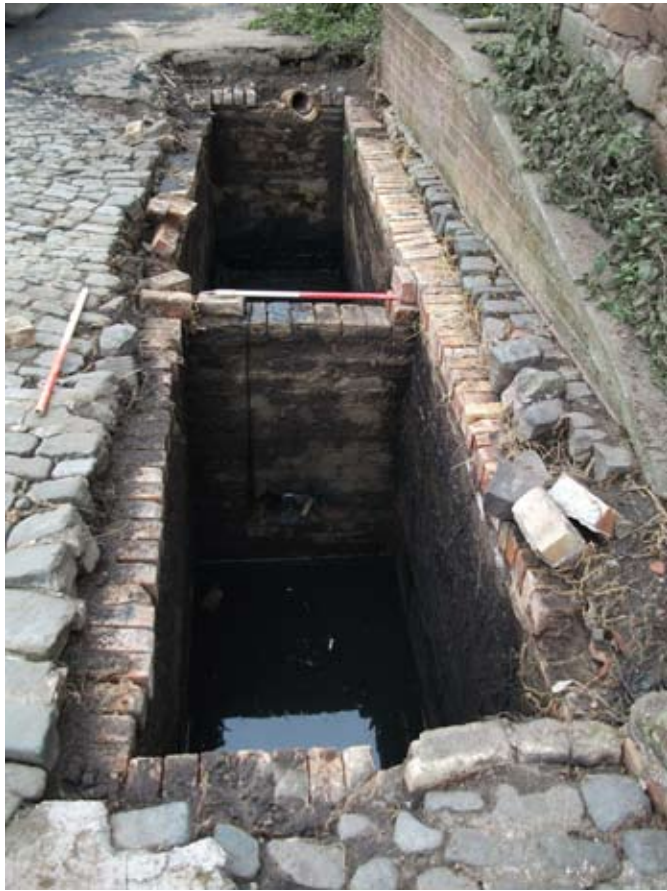
Fig 4. General view of the emptied tanks, from the south-west

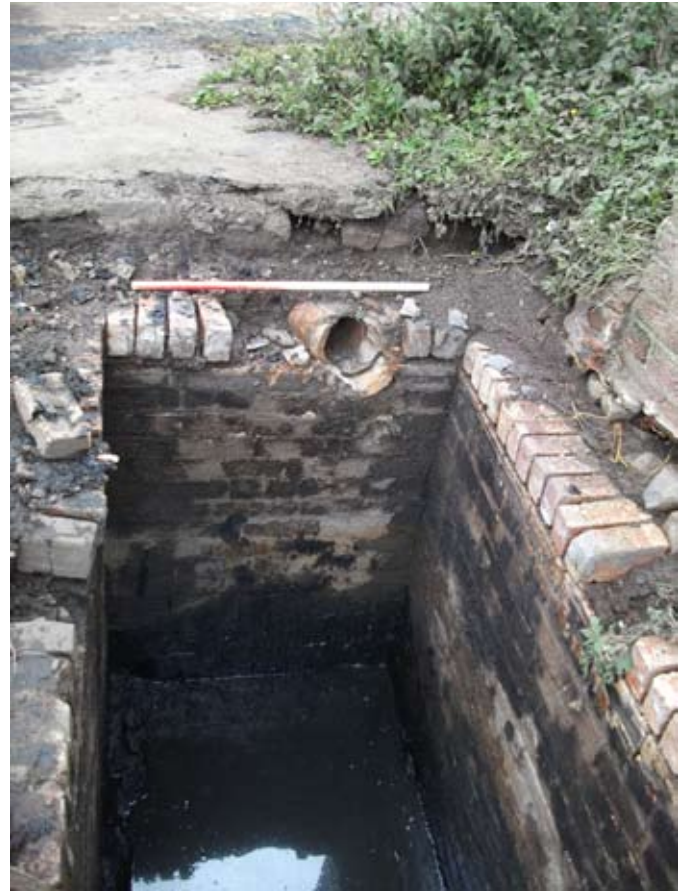
Fig 5. View of the pipe entering the tank
