**Stonehouse Cottage, Sprouston, Kelso,
Scottish Borders
Archaeological Watching Brief**

**Data Structure Report
No. 1940**

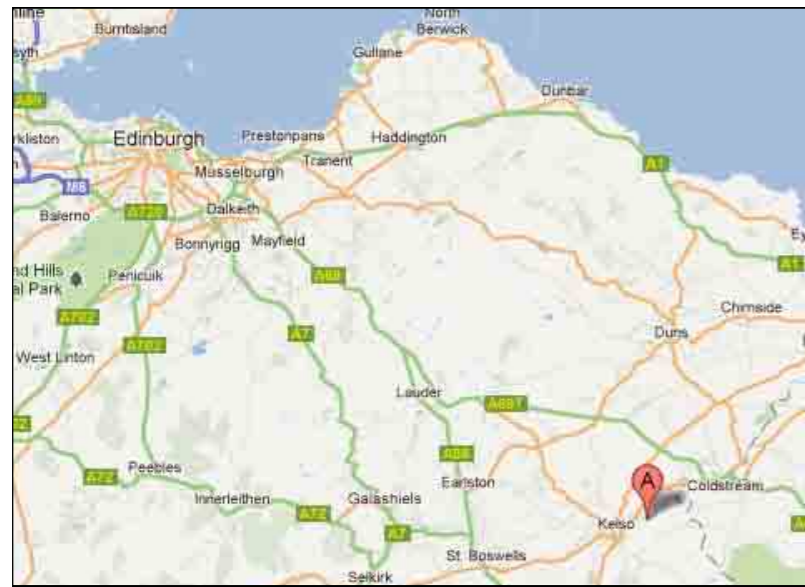
Fig. No:	1	Revision:	A
----------	---	-----------	---

Title:
Location plan and site plan showing the areas of the development covered by the watching brief and simplified plan of the wall remains located during the fieldwork

Two principal areas of ground breaking were monitored during the watching brief (Figs. 1-2): the excavation of an electricity cable trench from the main road to the north-east of Stonehouse Cottage to the Manse. An extensive area of overgrown garden between Stonehouse Cottage and Bowden Cottage to the north was stripped of topsoil prior to the construction of new garage buildings.

An area measuring 11.5m by 17.5m was stripped in the proposed area for the new garages to the north of Stonehouse Cottage (Fig. 1). A number of features were recorded in this area, including possible walls and associated surfaces, floor slabs and deposits (Figs. 2a, 4).

A trench was excavated for an electrical cable to serve both Sprouston Cottage and the Manse (Fig. 1). This ran from a connection point adjacent to the B6350, through the roadside garden wall (**025**) and south-west towards Sprouston Cottage. Outside the cottage it branched, with cables leading into the cottage and to the Manse.

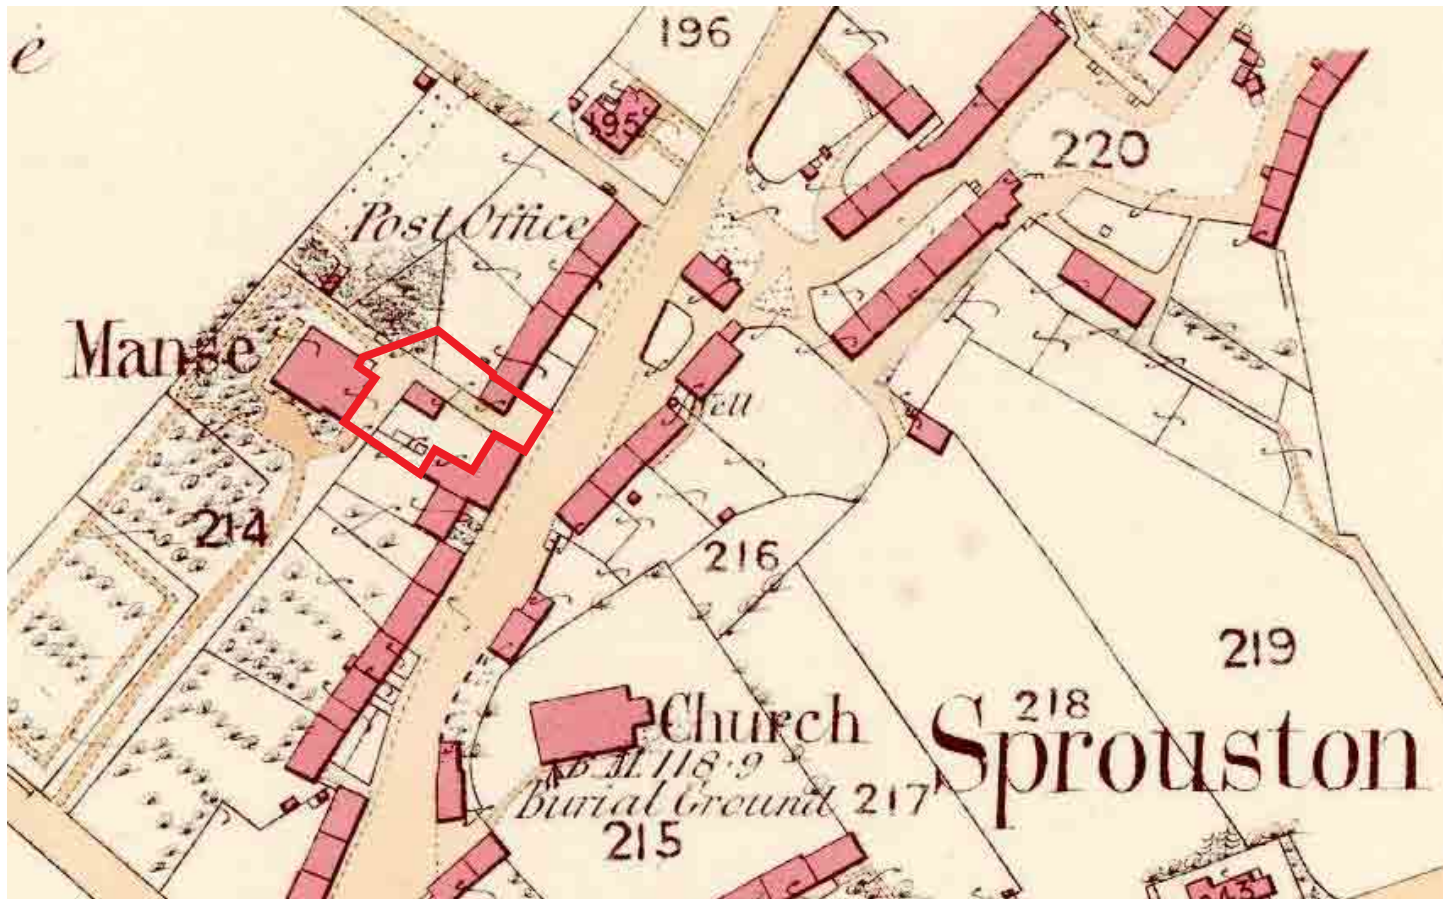
Fig.3 - Extract of the 1863 Ordnance Survey 25inch 1st Edition map

Historical maps show a number of buildings within the development area. A single roofed structure is shown as lying between Sprouston Cottage and the Manse to the north and what may be a row of roofed buildings are shown to the east, parallel to the road but set back from it. An extract from the Ordnance Survey First Edition 25inch series map (1863) is included as Fig. 2.

Three linear stony features (**026**, **028**, **031**), aligned NE-SW, were exposed in the south-east of this area (Fig. 4). These may be the bases or foundations of walls and in terms of alignment may represent the wall of the south-westernmost building of the row of roofed buildings that are recorded on the 1863 Ordnance Survey First Edition 25inch map (Fig. 3).

The unmortared linear features of small-medium rounded stones recorded in the open excavation area appear to represent the foundations of the walls of the south-westernmost building of the row of roofed buildings recorded on the 1863 Ordnance Survey First Edition 25 inch map (Fig. 3). There were no visible remains of foundation cuts for any of the possible walls. There is very little remaining of the walls and no signs of mortar. Within the interior of the building a sandy gravel was deposited, followed by a clay surface. The exterior of the building to the north-west appears to have been landscaped. It included an area of paving and adjacent upright stones which may have been steps.

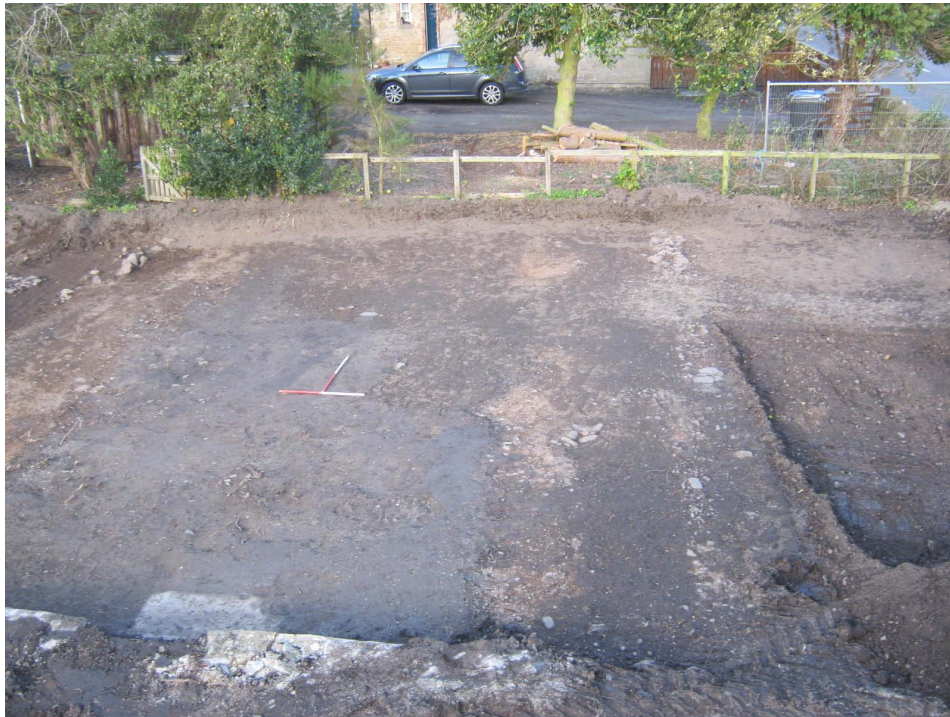
Fig.4 - General view of the building remains from the south-west

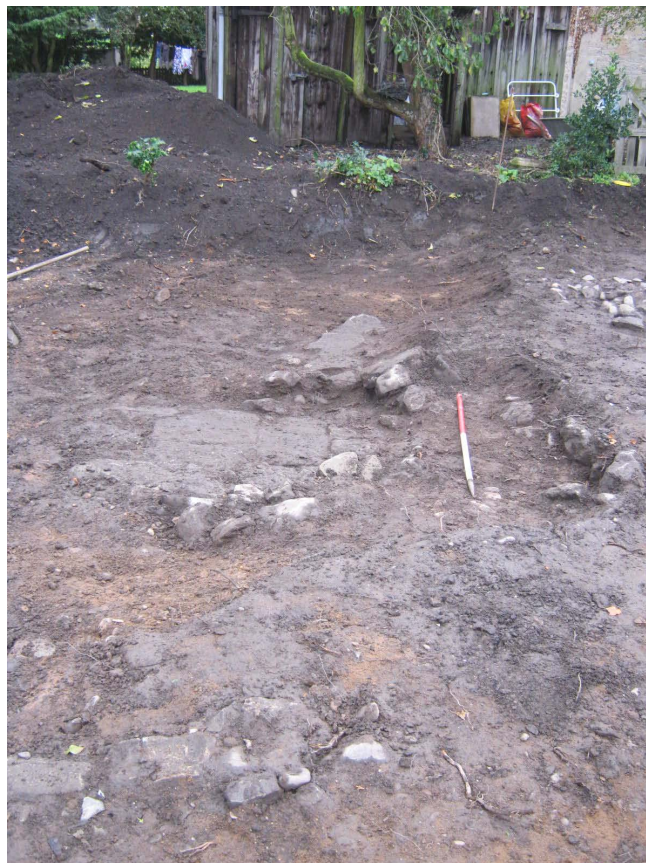
Fig.5 - View of the paving to the north-west of the building from the south-west

An area of flat, large stone slabs (**046**), measuring 5m by 1.9m, was revealed (Fig. 5). A slightly curved arrangement of upright, rectangular stone blocks (**047**) frames part of this paving on the SE, and further to the NE the area of paving is backed by a slope, which seems to form a two-tiered area with two steps. A further curving linear arrangement of upright flat stones (**048**) may form part of another step down. Features and deposits **046-049** (Fig. 2a & 5) overlay deposit **042** and may form part of a landscaped garden area to the rear of the building.

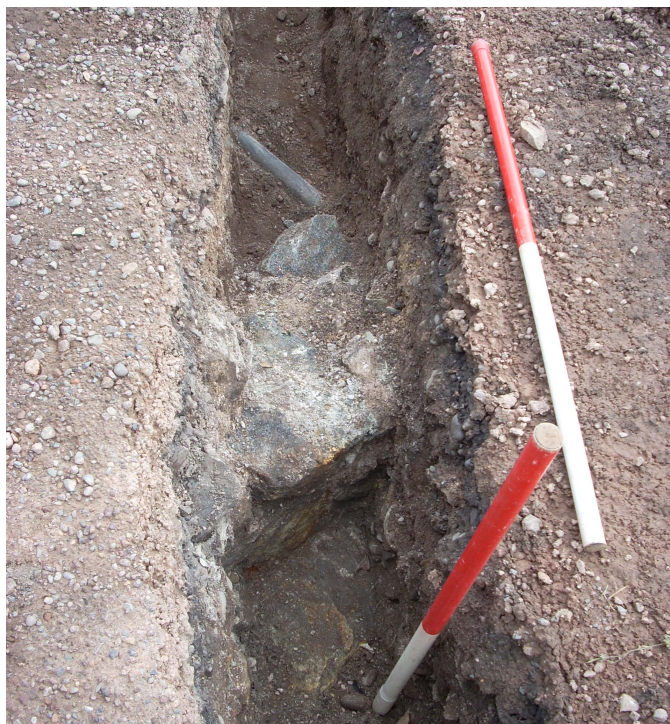
Fig.6 - Wall 008 exposed in the cable trench. The only wall made of a grey-blue schist

Towards the Manse, wall **008** was aligned NW-SE. This mortared wall was formed from a blue-grey micaceous schist-type stone (Fig. 6). It had a width of 0.6m and a depth of 0.3m with a projecting foundation course at the base. This wall had been cut by a cast-iron pipe (**009**) running parallel to wall **012**.

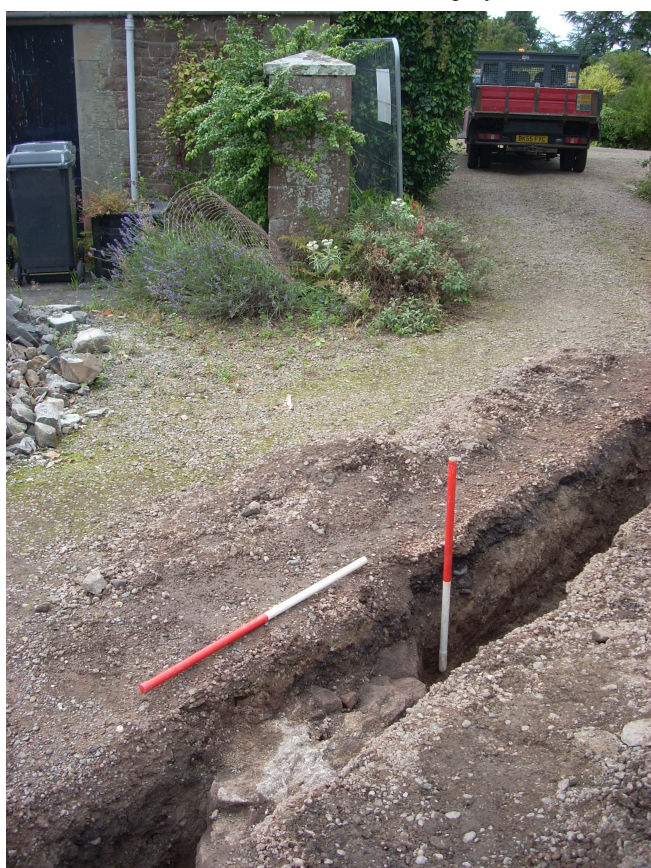
Fig.7 - Wall 012 exposed in the cable trench. Continues the alignment of the existing wall

The other walls (**012, 017**) were formed from mortared red sandstone, visually similar to that forming the Manse. Wall **012** was aligned NE-SW (Fig. 7). It was 0.7m wide and a depth of 0.25m was preserved. Wall **017** was aligned NW-SE (Fig. 8). It was 0.5m in width and a depth of 0.3m was preserved with a projecting foundation course at the base. Between these walls were deposits of mortar (**016**) and soil containing frequent rounded small cobbles (**014**).

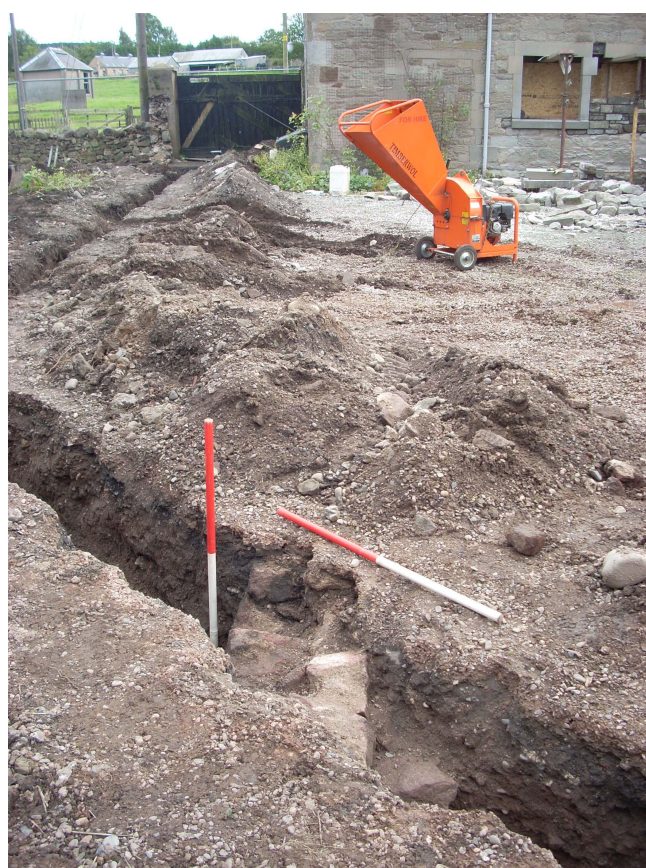
Fig.8 - Wall 017 exposed in the cable trench. This aligns with the eastern gable of Stonehouse Cottage in the background
