**Little Raith Windfarm,
Lochgelly, Fife**

Archaeological Watching Brief

Report No. 1958

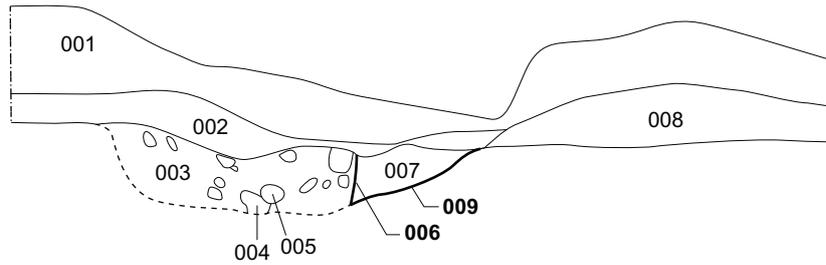
Fig. 2 - North-east-facing Section of WB Site 1 (FB1/T7)

WB Site 1 (Fig. 3) (NGR: NT 19231 91647) consisted of a 4m wide field boundary ditch and bank (**008** and **009**) forming a linear feature orientated ENE-WSW. A 1.2m length of the field boundary was excavated to reveal that the ditch measured up to 0.3m in depth and 2m in width (Fig. 2). The adjacent bank measured up to 0.35m in height and 1m in width. The ditch contained an homogenous fill (**007**) of mid-brown/grey silty clay. Subsequently, the field boundary ditch had been re-cut to a similar depth to incorporate three ceramic field drains (**004** and **005**). The cut for the drains had then been refilled with greyish-brown sandy boulder clay (**003**).

The field boundary continued along the full width of the 10m wide access track. The field boundary was still in use and the ditch and bank were visible on the surface. There were no finds from this feature.

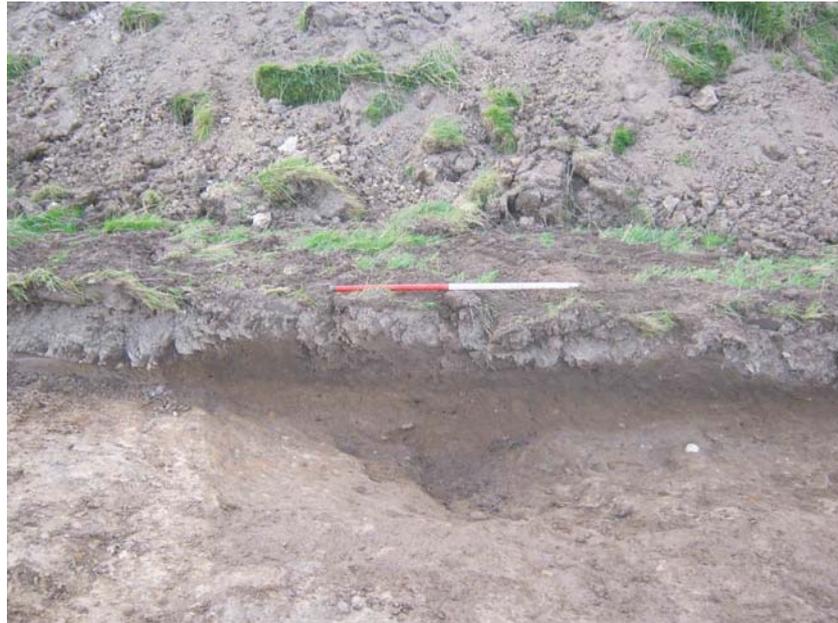
Fig. 3 - Section of Site 2 (FB2/T7)

WB Site 2 (Fig. 4) (NGR: NT 19235 91728) consisted of a very shallow ditch orientated N-S, measuring 4m in length. The ditch tapered at the eastern edge. The ditch measured 3m in width and reached a maximum depth of 0.34m (Fig. 3). The southern side of the ditch was slightly steeper than the northern side but both were gradually sloping. The primary fill of the ditch (**011**) consisted of a fairly homogenous mottled mid-brown to grey sandy clay.

The profile and depth of the feature suggests it may be an old field boundary that has been left to silt up naturally or may constitute a deep cultivation furrow. There were no finds from this feature.

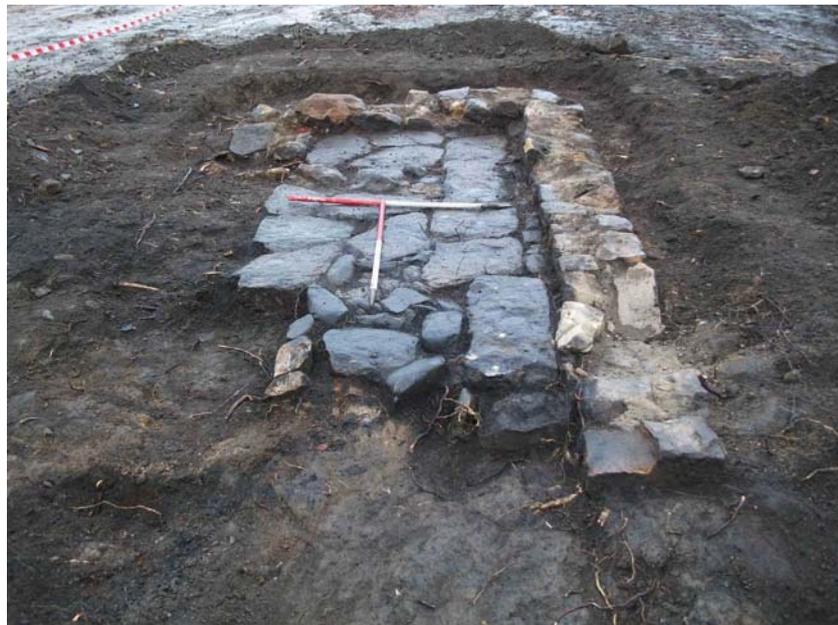
Fig. 4 - Site 3, small rectangular structure with paved floor

WB Site 3 (Fig. 5) (NGR: NT 19341 91441) consisted of the remains of a small structure with a paved floor (**015** and **016**). The rectangular structure comprised two complete walls and one partial wall reaching a maximum height of 0.2m (Fig. 4). The overall dimensions of the surviving remains were 4.15m N-S by 2.1m E-W.

Both the northern (0.46m wide) and eastern (0.4m wide) walls of the structure were complete. The western wall (0.36m wide) survived as a short stub only, measuring 0.5m long, and the southern wall was completely missing. The first course of masonry sat directly on the natural substrate (014) and had no foundation trench. An ashlar quoin was noted at the south-east corner, indicating that the entrance into the structure may have been along the southern wall.

The interior of the building was covered in grey flagstones, the floor area measuring 3.2m N-S by 1.4m E-W. The flagstones were up to 0.75m across.

The building was located to the west of Easter Lochhead farmstead and is probably the remains of a small outhouse associated with the farmstead. There were no finds from this structure.

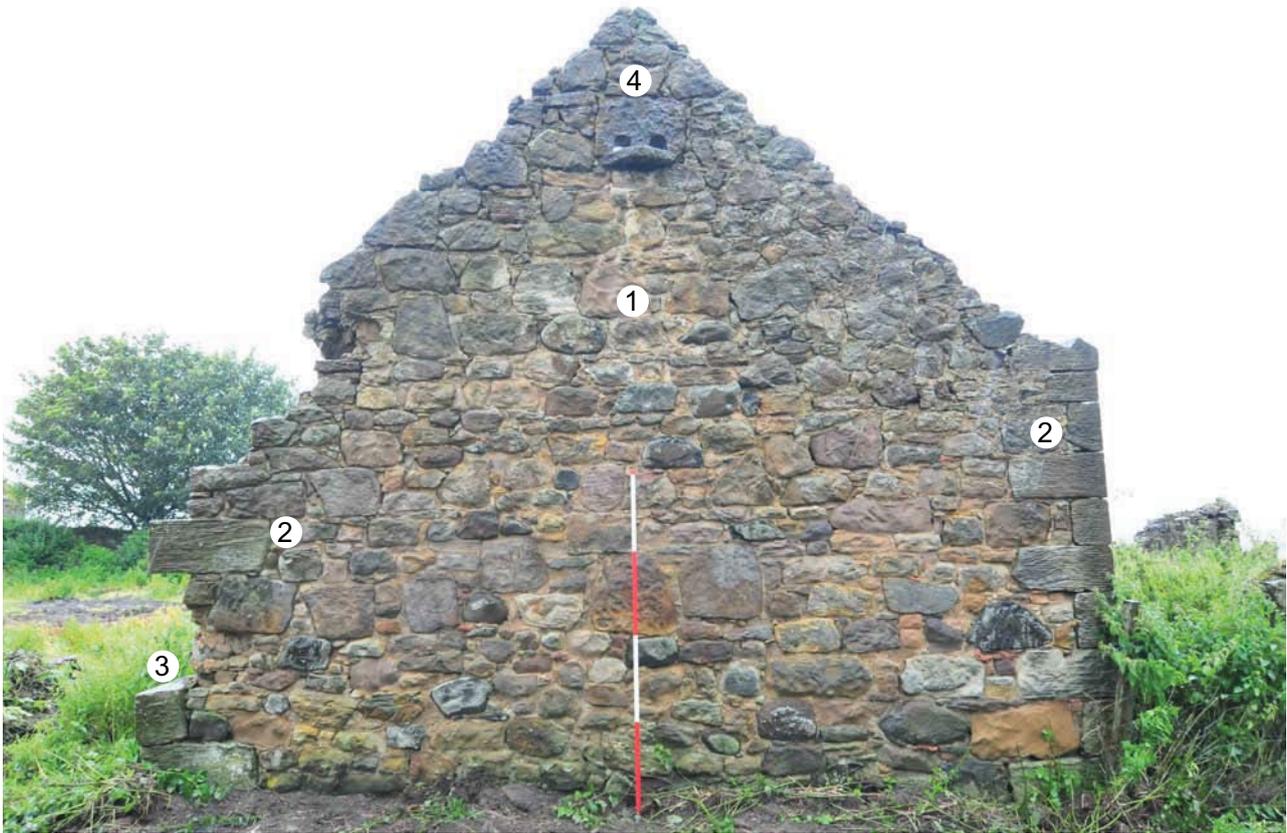
Fig. 5 - Southern gable end of East range of Easter Lochhead Farmstead

A Level 1 Building Survey (English Heritage 2006) was carried out on the southern gable end of the east range of Easter Lochhead Farmstead prior to its reduction in height due to its close proximity to the access track and its inherent instability (Fig. 5).

The gable end (feature 1, Fig. 5) of the east range of the farmstead was probably part of a barn. The entire building is in a poor state, mostly collapsed and overgrown with nettles. The side walls are only partially standing, as is the north gable. This gable forms the south end of the building.

The gable end was 5.95m wide by 4.75m high, with the wall 0.6m thick at the base and 0.45m thick at the top. The quoins on the eastern side of the gable end were 2.72m high. The wall's fabric consists of random coursed rubble and is mortar bonded. The rubble is built with occasional levelling courses and a variety of stone types, mostly beige and grey sandstone. The wall is constructed of inner and outer stone faces with a mortar bonded core.

The corners have long and short ashlar quoins (feature 2, Fig. 5) with droving and smooth margins. One top quoin survives with a socket for the bottom skew which no longer survives.

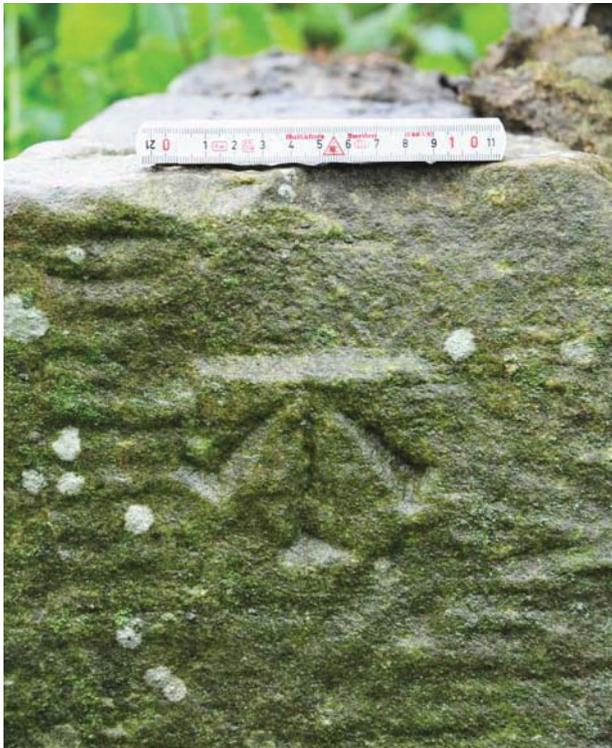
Fig. 6 - Benchmark carved into quoin (feature 3)

A benchmark is carved into one of the quoins at the bottom left of the wall (Feature 3, Fig. 6).

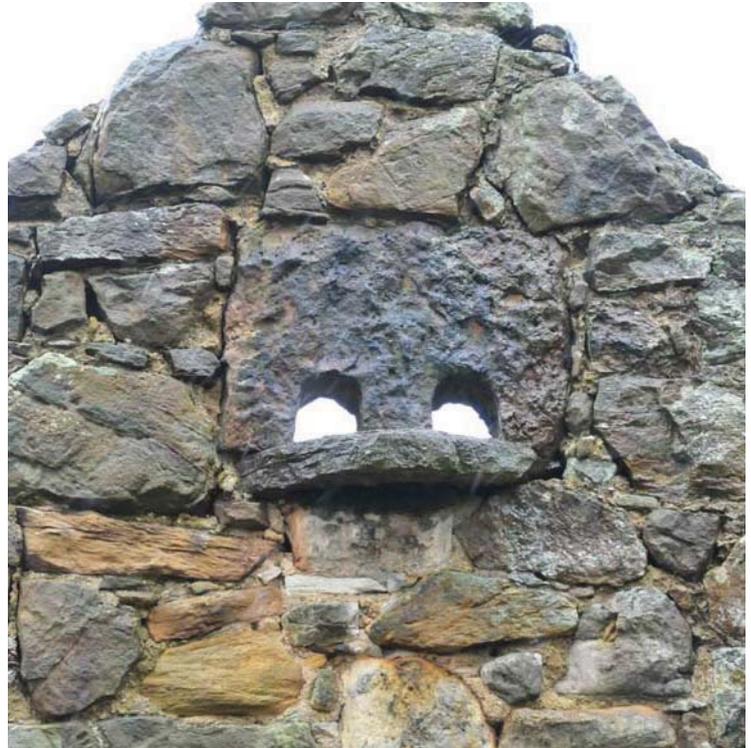
Fig. 7 - Detail of dove box (feature 4)

A square, rough dressed block with two arched pigeon holes (feature 4, Fig. 7) is set centrally just under the roof apex. The block sits on a protruding lintel.

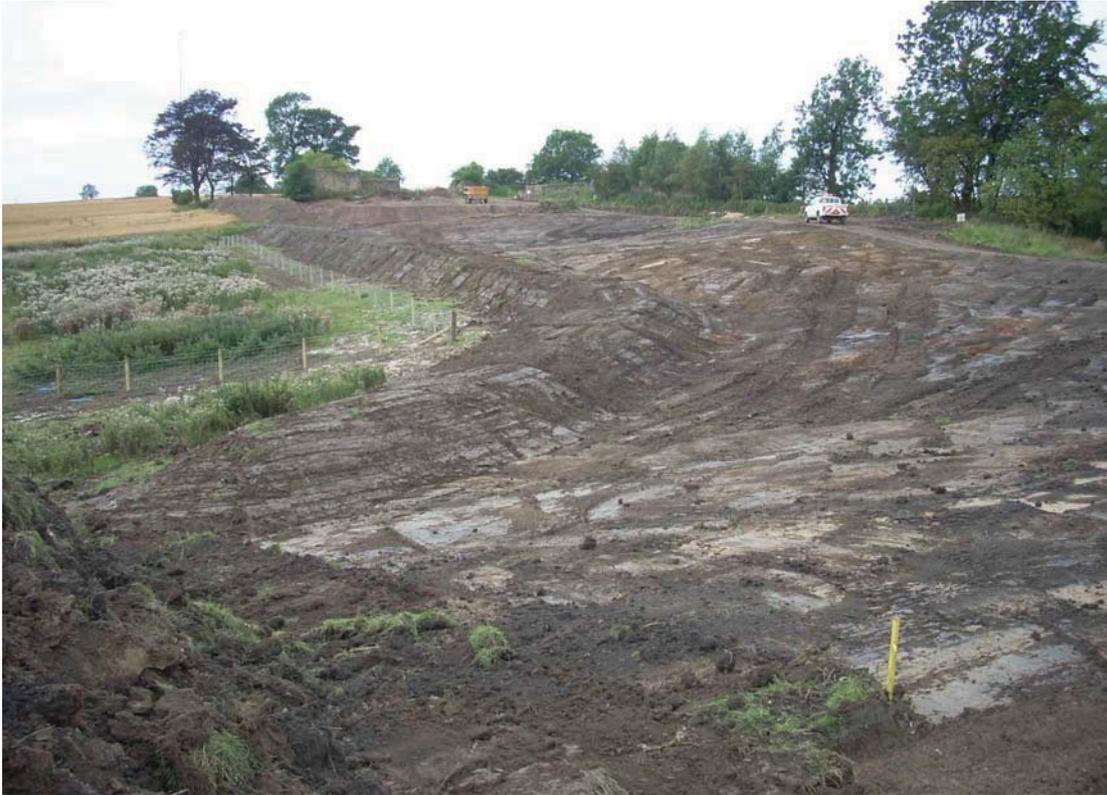
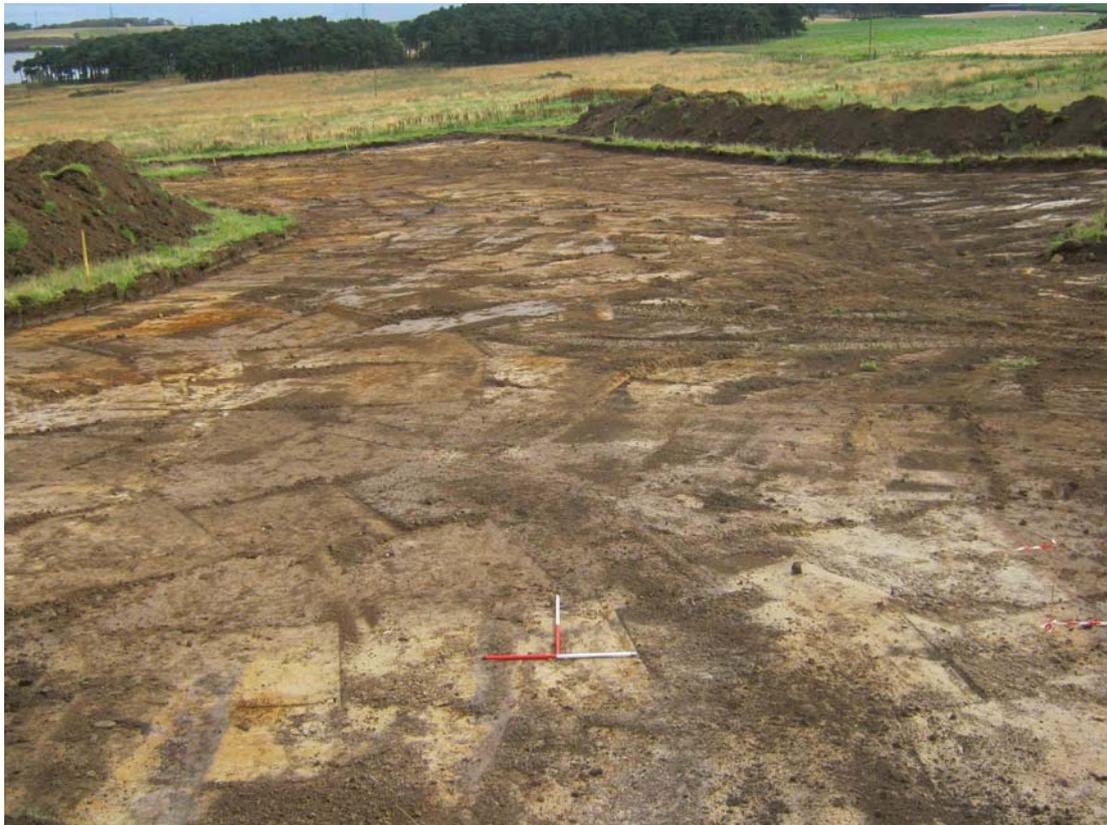
The topsoil throughout the site predominantly consisted of a mid-brown silty clay plough soil with an average depth of 0.3m (**001**) (Figs. 8-9). Underlying this was firm sandy boulder clay which varied in colour from grey to yellowy-orange (**002**). There were frequent manganese deposits in the substrate. In the eastern half of the site the boulder clay represented the natural substrate but the exposed clay in the western half of the site may have been re-deposited from previous opencast mining activities.

Fig. 8 - General view of stripped area for Turbine 8

Fig. 9 - General view of stripped area for Turbine 7
