**Low Spinney Wind Farm
Ashby Magna
Leicestershire
Archaeological Evaluation**

Report No. Y001/10

Author	Martin Lightfoot
Illustrator	Kevin Hicks BA FSA Scot., AAI&S
Editor	Martin Lightfoot BA MA MifA
Commissioned by	Broadview Energy
Date issued	04 October 2010
Version	1
OASIS Reference	-
Planning Application No	-
Grid Ref	SP559 889

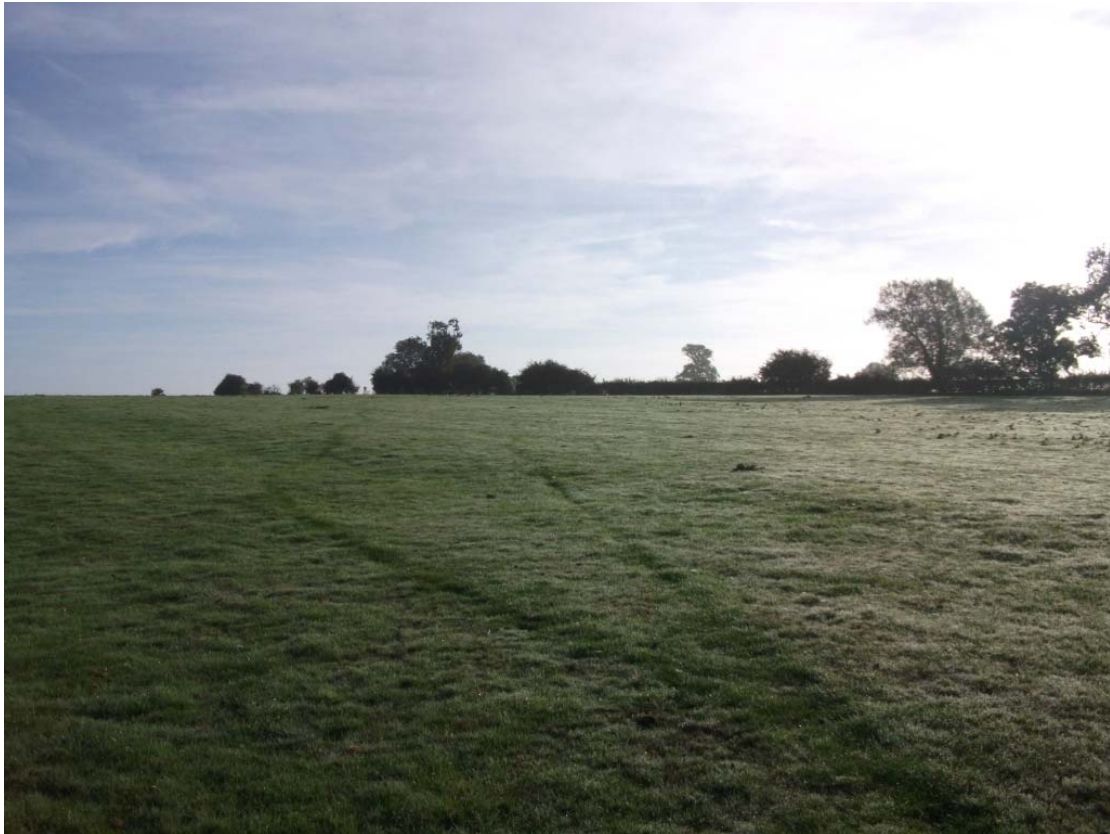
Plate 1: Proposed Compound Area (Trench 10) Looking North

Trench 10		
Orientation: South East – North West		
Dimensions: Length 26m, Depth 0.28m (max)		
Context Numbers:	Context Type:	Description:
1000	Topsoil	Mid-dark grey/brown, friable, silty loam with occasional pebbles.
1001	Subsoil	Mid-light grey/brown, friable, sandy silty clay. Moderate pebbles.
1002	Natural	Light brown, friable, sandy silty clay with frequent pebbles.
1003	Fill of Plough Furrow	Mid-light brown, friable, sandy silty clay. Moderate pebbles.
1004	Cut of Plough Furrow	Linear. Shallow Sides 15-200. Slightly rounded base. N.E. - S.W. alignment. Length 1.60m+ Width 1.90m Depth 0.08m (max).
Trench 10 contained three North-South running furrows, remnants of ridge and furrow. The central furrow was excavated but no dating evidence was recovered. The trench also contained a modern field drain towards its SE end but no other archaeological remains were encountered		
Photograph Numbers: 5-6 (post-ex)

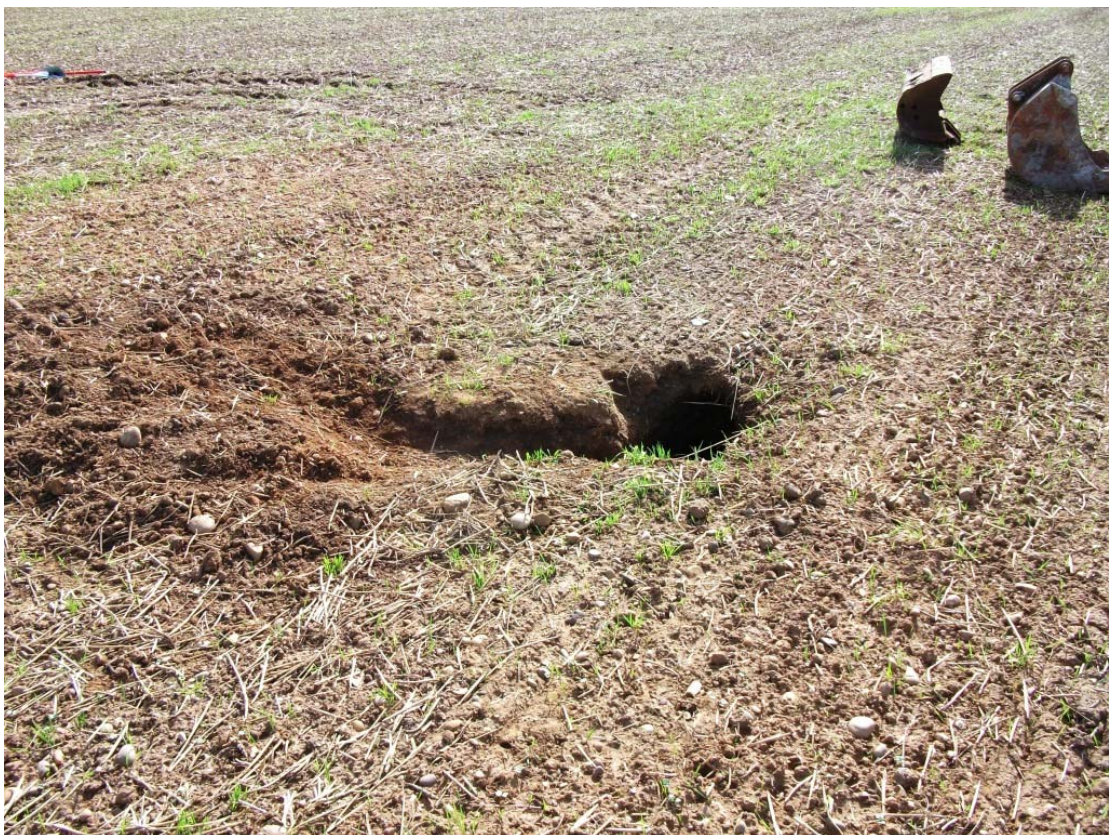
Plate 4: Badger Sett, adjacent to Proposed Turbine Location 4

2.2.5 Due to the presence of a badger sett (Plate 4), four of the trenches (4, 6, 7, 8 and 9) were relocated to respect a 30m buffer. Three of the trenches moved were targeted on geophysical anomalies; however, these anomalies were sampled by other trenches. In addition the opportunity was taken to sample anomalies not originally within the scope of the trenching (Fig. 3).

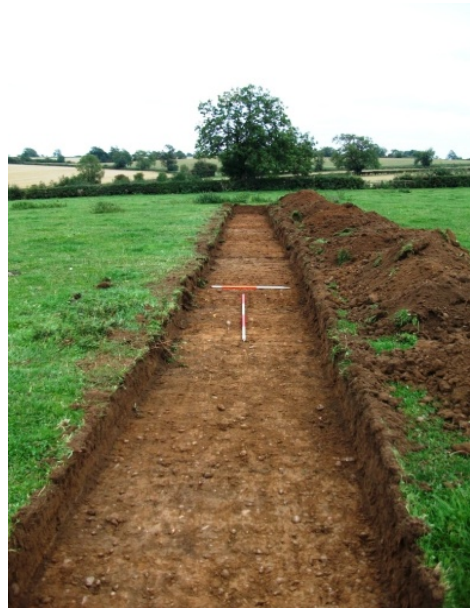
Trench 1		
Orientation: East – West		
Dimensions: Length 25m, Depth 0.28m (max)		
Context Numbers:	Context Type:	Description:
100	Topsoil	Mid-dark grey/ brown, friable, silty loam with occasional pebbles.
101	Natural	Light brown, friable, sandy silty clay with frequent pebbles.
Trench 1 contained four NW to SE running furrows, remnants of ridge and furrow visible in the field		
Photograph Numbers: 52-53 (pre-ex), 54 – 57 (post-ex)

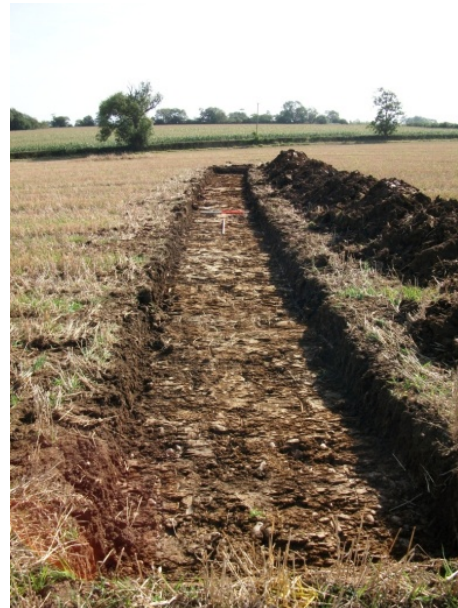
Trench 2		
Orientation: East – West		
Dimensions: Length 25m, Depth 0.24m (max)		
Context Numbers:	Context Type:	Description:
200	Topsoil	Mid-dark grey/brown, friable, silty loam with occasional pebbles.
201	Natural	Light brown, friable, sandy silty clay with frequent pebbles.
Trench 2 contained no archaeological remains		
Photograph Numbers: 7-9 (pre-ex) 12-14 (post-ex)

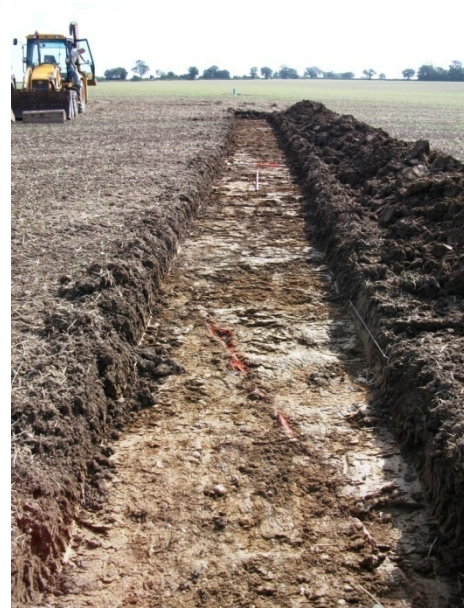
Trench 3		
Orientation: Southeast – Northwest		
Dimensions: Length 25m Depth 0.32m (max)		
Context Numbers:	Context Type:	Description:
300	Topsoil	Dark grey/brown, friable, silty loam with occasional pebbles.
301	Subsoil	Mid-light grey/brown, friable, sandy silty clay. Moderate pebbles.
302	Natural	Light brown, friable, sandy silty clay with frequent pebbles.
Trench 3 contained a modern field drain at its western end but otherwise no archaeological remains. A thin layer of subsoil was present at the western end of the trench (0.04m thick).		
Photograph Numbers: 15-16 (pre-ex) 20-21 (post-ex)		
Drawing Numbers: 3.1, 3.2

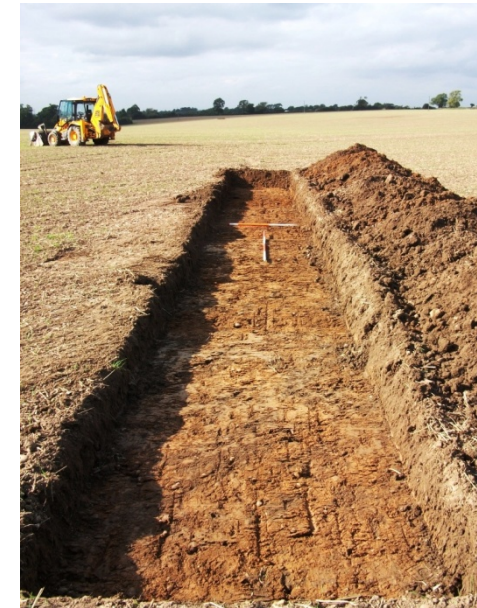
Trench 4		
Orientation: Northeast – Southeast		
Dimensions: Length 15m Depth 0.28m (max)		
Context Numbers:	Context Type:	Description:
400	Topsoil	Dark grey/brown, friable, silty loam with occasional pebbles.
401	Natural	Light brown, friable, sandy silty clay with frequent pebbles.
Trench 4 contained no archaeological remains		
Photograph Numbers: 43-44 (pre-ex), 49-51 (post-ex)

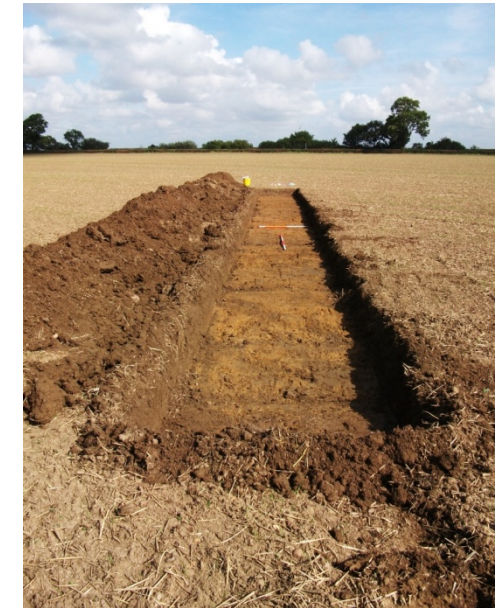
Trench 5		
Orientation: Northeast – Southwest		
Dimensions: Length 20m Depth 0.30m (max)		
Context Numbers:	Context Type:	Description:
500	Topsoil	Dark grey/brown, friable, silty loam with occasional pebbles.
501	Natural	Light brown, friable, sandy silty clay with frequent pebbles.
Trench 5 contained no archaeological remains		
Photograph Numbers: 31-33 (post-ex)

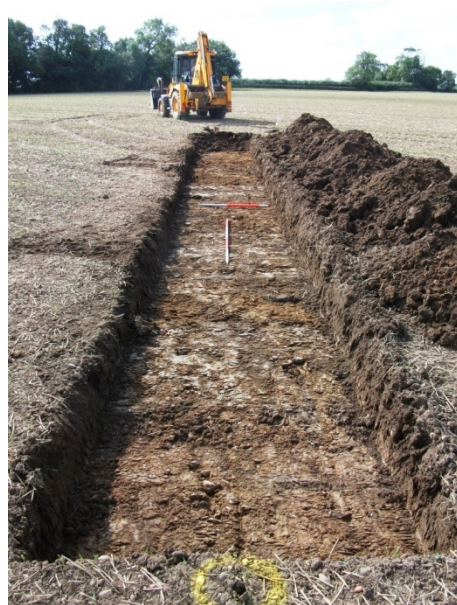
Trench 6		
Orientation: Northeast – Southwest		
Dimensions: Length 16m Depth 0.28m (max)		
Context Numbers:	Context Type:	Description:
600	Topsoil	Dark grey/brown, friable, silty loam with occasional pebbles.
601	Natural	Light brown, friable, sandy silty clay with frequent pebbles.
Trench 6 contained no archaeological remains		
Photograph Numbers: 35-37 (post-ex)

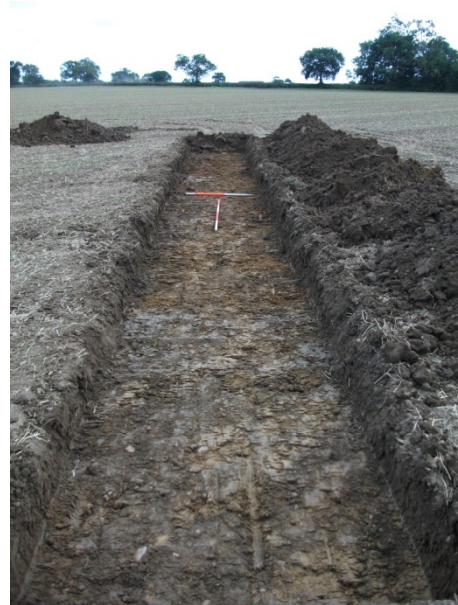
Trench 7		
Orientation: Southeast – Northwest		
Dimensions: Length 15m Depth 0.28m (max)		
Context Numbers:	Context Type:	Description:
700	Topsoil	Dark grey/brown, friable, silty loam with occasional pebbles.
701	Natural	Light brown, friable, sandy silty clay with frequent pebbles.
Trench 7 contained no archaeological remains		
Photograph Numbers: 38-40 (pre-ex), 45-46 (post-ex)

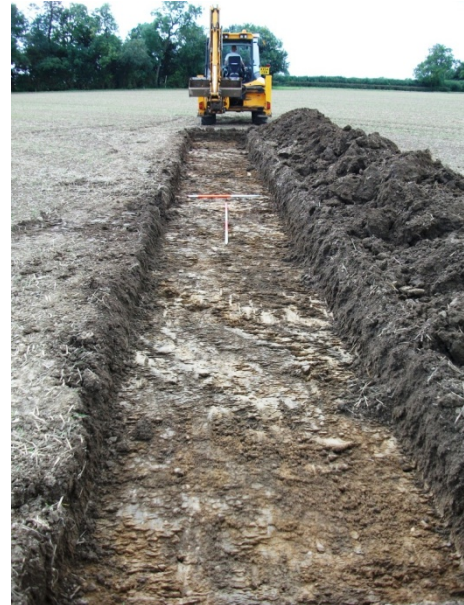
Trench 8		
Orientation: Northeast - Southwest		
Dimensions: Length 15m, Depth 0.28m (max)		
Context Numbers:	Context Type:	Description:
800	Topsoil	Dark grey/brown, friable, silty loam with occasional pebbles.
801	Natural	Light brown, friable, sandy silty clay with frequent pebbles.
Trench 8 contained no archaeological remains		
Photograph Numbers: 38-40(pre-ex) 41-42 (post-ex)

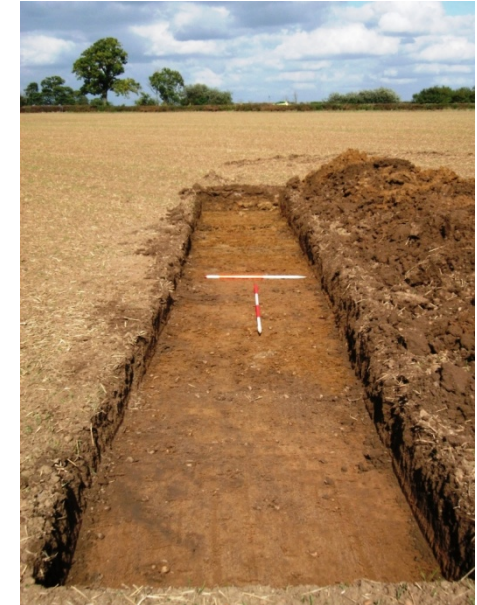
Trench 9		
Orientation: Northeast – Southwest		
Dimensions: Length 15m, Depth 0.34m (max)		
Context Numbers:	Context Type:	Description:
900	Topsoil	Dark grey/brown, friable, silty loam with occasional pebbles.
901	Natural	Light brown, friable, sandy silty clay with frequent pebbles.
Trench 9 contained no archaeological remains		
Photograph Numbers: 47-48 (post-ex)
