**Cinderhill Farm  
Denholmgate Road  
Coley  
West Yorkshire**

**Archaeological Strip and Record**

**Report No. Y009/11**

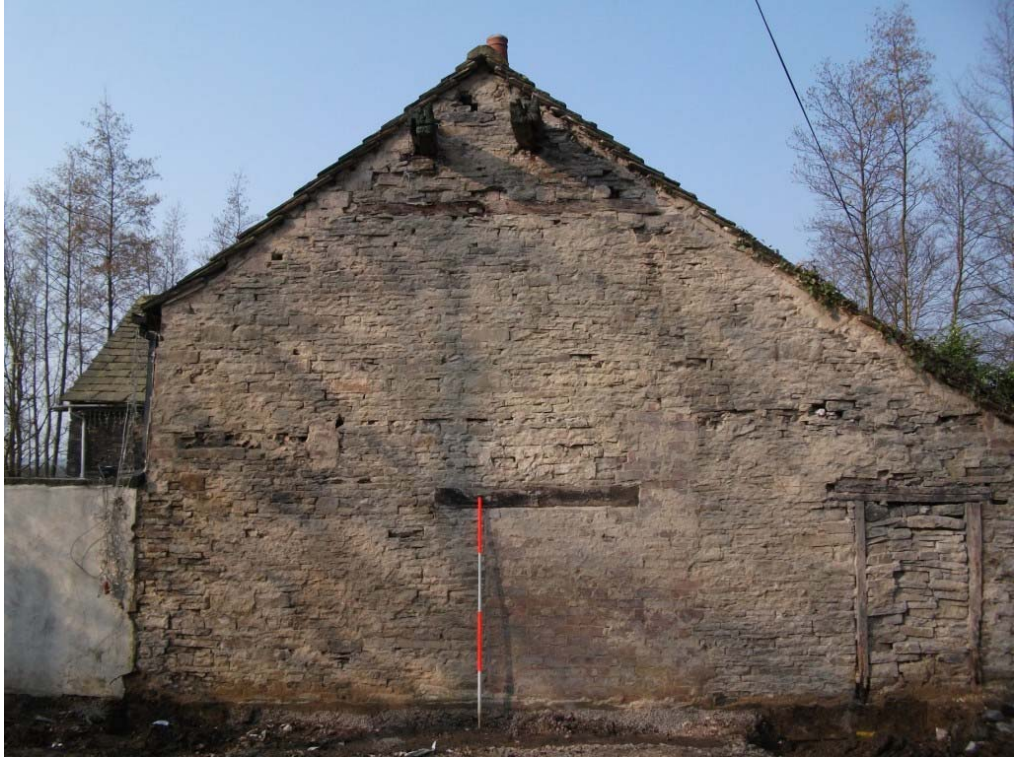
Plate 1: East-Facing Gable End of Cinder Hill Farm

Subsequent to the removal of the render on the east gable end of the building two blocked doorways were evident along with a timber beam (Fig. 2a, Plate 1). Some brick patching was also observed just below the projected floor/attic level of the building.

The blocked door towards the northern end of the elevation had a wooden enframing, in poor condition. It was blocked with closely packed but unbonded stone, very similar to the exposed stone of the building itself. The other doorway had a heavier timber lintel and was filled with modern brick work in 'Stretcher bond'. Some collapsing had occurred just above the doorway, this was similarly filled with brickwork.

The two projecting beams (evident prior to the removal of the render) are likely to have been re-used from another building and allowed to protrude. It has been suggested that they may have supported a 'smoke hood' (David Cant pers. comm.), however, there is no evidence of sooting on or around the timbers; though due to their height they were not closely inspected. A concrete drain which ran along the bottom of the gable end wall precluded inspection of the foundation.

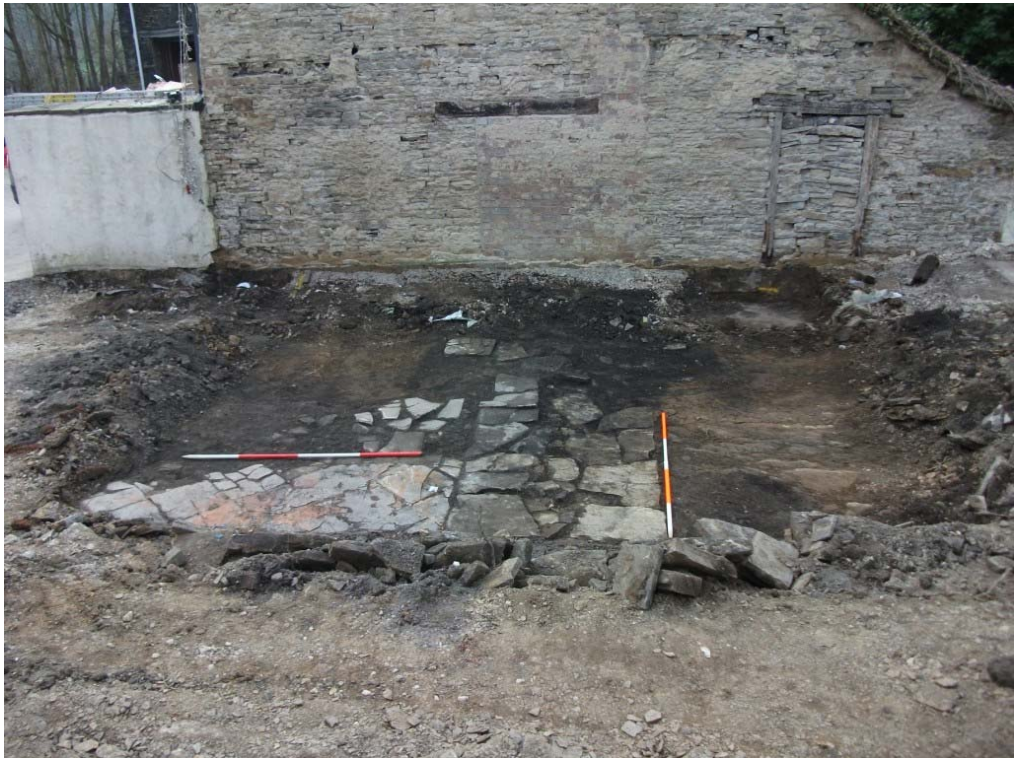
Plate 2: After Stripping, Pre-excavation, Looking North

Immediately below the surface layer which consisted of soil mixed with rubble and other building debris (100), was a flagstone surface (103) covered in degraded but easily identifiable linoleum of a reddish orange colour (102). This was confined solely to the southeast corner of the site and seemed to represent a separate room (Plate 3). A coin dating 1870 was recovered between the

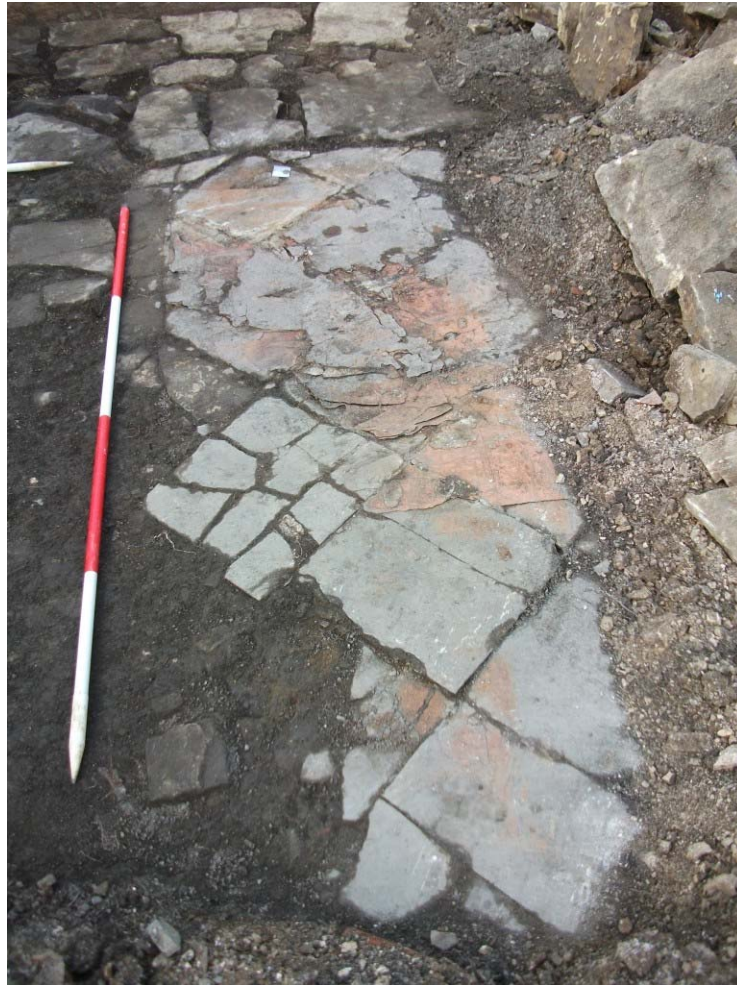
Plate 3: Linoleum (102) and Flagged Surface (103)

linoleum and the flagstones (103). This surface was abutted by a stone edging (105) which may have represented the base of a partition wall.

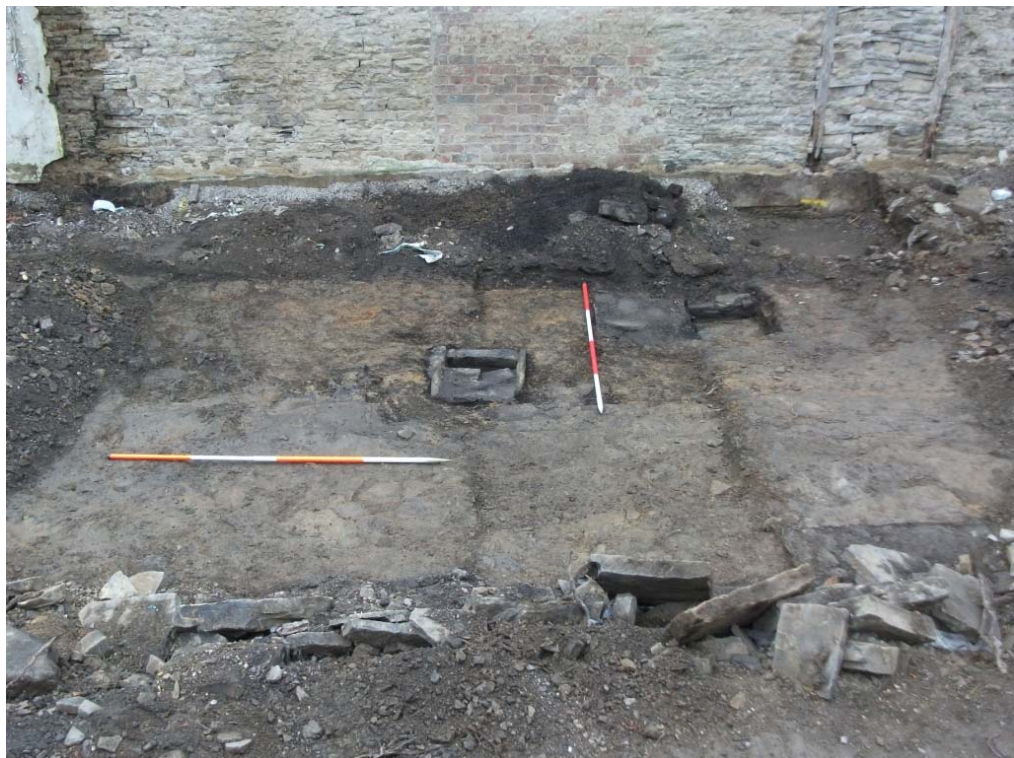
Plate 6: After the removal of the Flagged Surfaces (103 and 106) and Wall (107)

The flagstones and the wall were laid directly on a compacted natural clay layer with some charcoal and cinder inclusions (108 and 109).

Beneath the broken flagstone layer (106) and partly beneath the wall (107) was a small square stone-lined pit filled with ash and cinders (115). It is likely that this was an ash pit for a hearth, possibly associated with the wall (107) or an earlier building. A second pit (117) may also have been an ash pit, though this was highly disturbed and contained modern bricks.

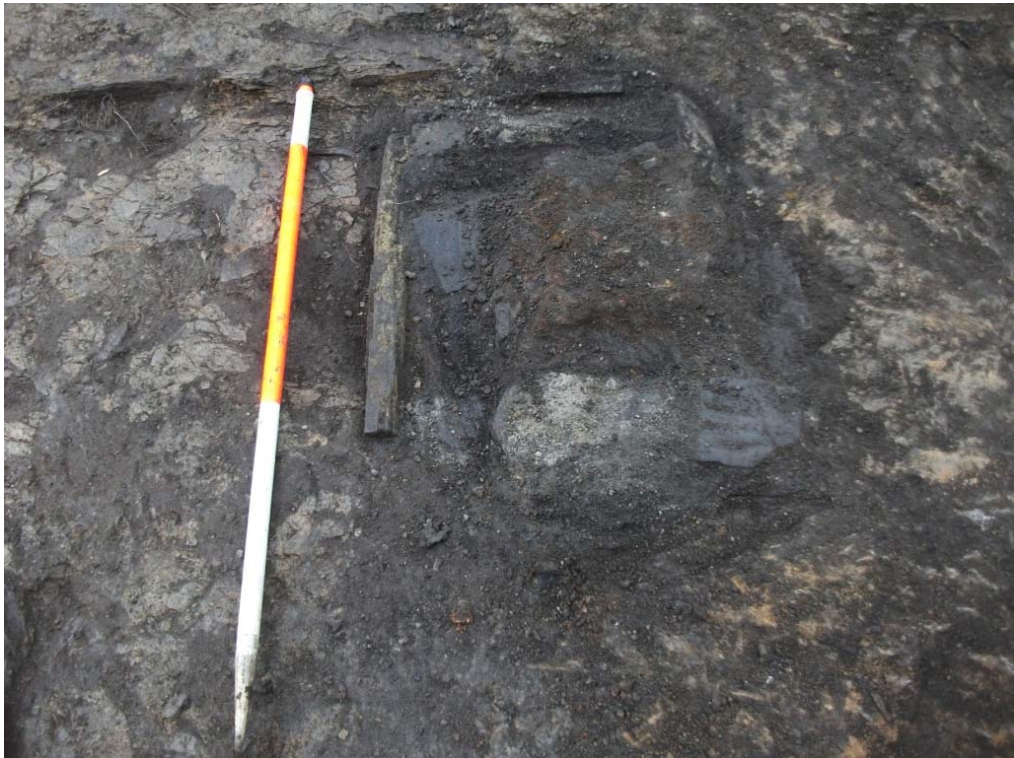
Plate 8: Pit (115) Pre-excitation

One sample was retained from the fill of a stone-lined pit (113). A friable and poorly sorted in-organic soil (Munsell colour 10YR 2/1 Black) rich in unfired sub-angular coal fragments, fragments of coal cinder and soot. Occasional brown (10YR 5/8 yellow/brown) fragments of wood-ash. The sample appears to be derived from the coal burning and the high volume of wood ash suggests that the deposit is probably domestic in nature and most probably an ash pit.
