E Kirriemuir WwTW, Kirriemuir, Angus – FE Transfer Sewer Upgrade

Archaeological Watching Brief & Excavation Report No. 1979

Author	Leigh A. Garst BFA MSc
Illustrator	Leeanne Whitelaw BSc MIfA
Editor	Melanie Johnson MA PhD FSA Scot MIfA
Commissioned by	Scottish Water Solutions
Date issued	December 2011
Version	0
OASIS Reference	cfaarcha1-114956
Grid Ref	NO 392 518

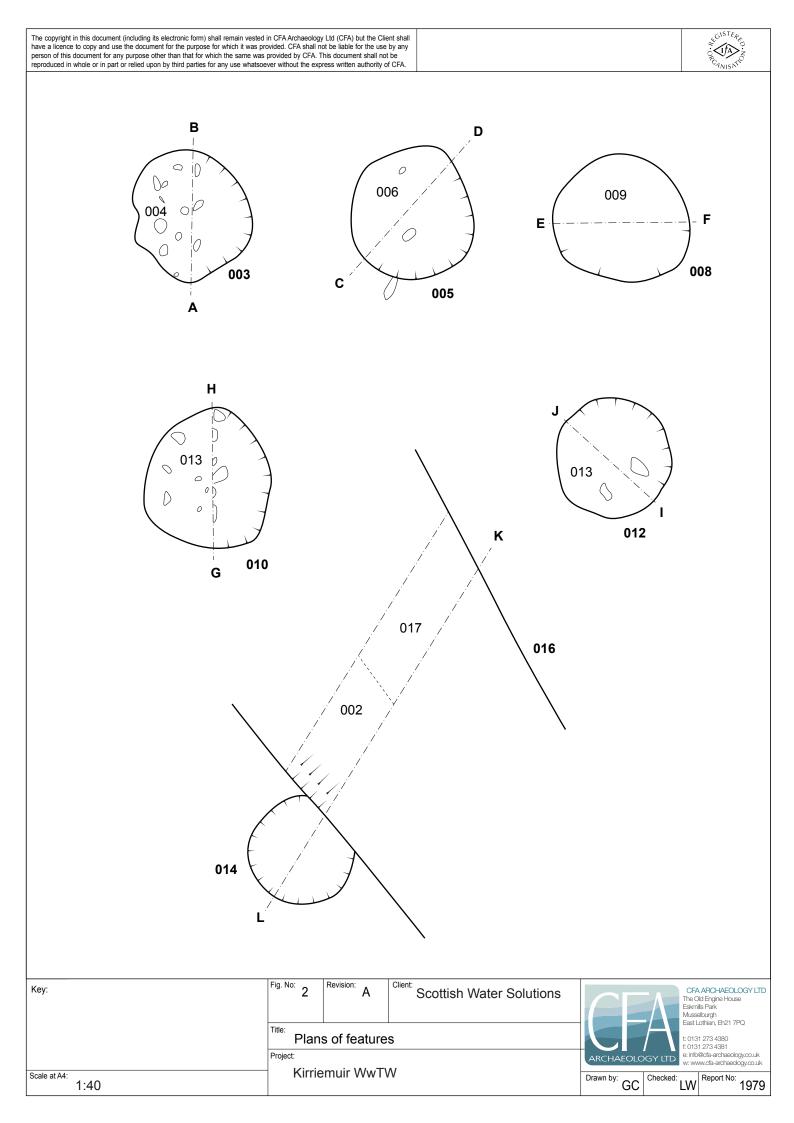
Fig. 2 Plans of features

A scatter of 6 pits, measuring between 1.1m-1.5m across, found under the topsoil (001) and cut into the natural subsoil (002) (Fig. 1-2), was identified during the watching brief. These were the subject of further excavation.

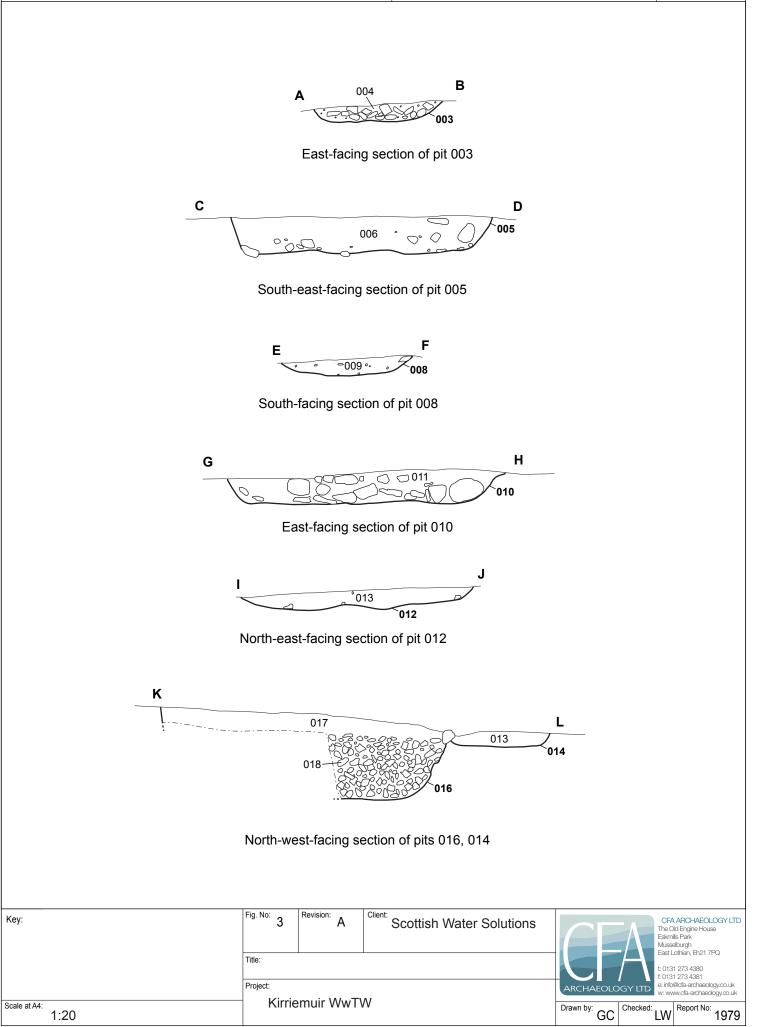
- Fig. 3 Sections of features
- Fig. 4 Pit 003, east-facing section
- Fig. 5 Pit 010, east-facing section
- Fig. 6 Oblique shot of pit 014 and field drain 016

This was a circular pit (005) 1.35m in diameter and 0.19m deep with steep sides and a flat bottom, filled with a moderately compact mid greyish-brown silt (006) with a low density of medium sub-angular stones (Fig. 2-3). The pit was cut into the (002) natural substrate overlaid with a shallow spread of dark greyish-brown peat.

This was a sub-rounded pit (008) 1.48m in length by 1.40m wide and 0.19m deep, with moderately steep sides and a flat bottom. The pit was filled with a moderately compact mid greyish-brown silt (009) with a low density of small to medium sub-angular stones (Fig. 2-3). One piece of plate window glass was found in the upper regions of (009) and a very small piece of green bottle glass was found midway through.

This was a sub-rounded pit (012) 1.35m in length by 1.29m wide and 0.13m deep, with moderately steep south and steep north sides and a flat bottom. The pit was filled with soft mid greyish-brown silt (013) with a low density of small to medium sub-angular stones (Fig. 2-3).

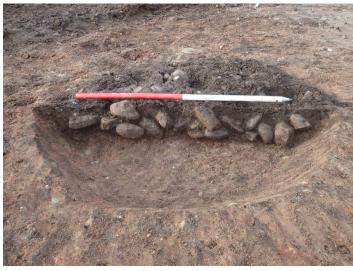
Fig 4 - Pit 003, east-facing section

This was a sub-rounded pit (003) 1.38m in length by 1.25m wide and 0.21m deep, with steep sides and a flat bottom. The pit was filled with a moderately soft mid greyish brown silt (002) with numerous medium to large sub-rounded and sub-angular stones (Fig. 2-4).

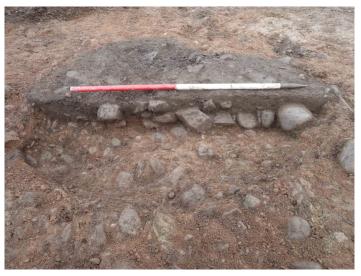
Fig 5 - Pit 010, east-facing section

This was a sub-rounded pit (010) 1.50m in length by 1.40m wide and 0.19m deep, with steep sides and a base which was flat to the south and irregular stony to the north. The pit was filled with mid greyish-brown silt (011) of moderate compaction with numerous medium to large sub-rounded and sub-angular stones (Fig. 2-3, 5).

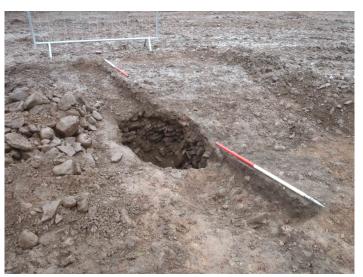
Fig 6 - Oblique shot of pit 014 and field drain 016

This was a sub-rounded pit (014) 1.28m in length by 1.10m wide and 0.16m deep with steep sides and a flat stony bottom, truncated on the north end by field drain (016) (Fig. 2-3, 6). The pit was filled with moderately soft mid greyish-brown silt (015) with occasional small to medium sub-angular stones. Small pieces of modern plate window glass and white glazed pottery were found in the upper and lower regions of (015).

A very large rubble field drain (016) running south-east to north-west through the site measured 3.0m wide and 0.84m deep; its full is length unknown. The field drain has a separate upper fill consisting of firm mid orangey-brown silty clay (017) with occasional small to large sub-angular and sub-rounded stones, overlaying the main fill of medium-large sub-angular and sub-rounded rubble (018). The field drain cuts the earlier pit (014) on the north end (Fig. 6).
