Author	Michael Cressey HND BA MSc PhD MifA FSA Scot
Illustrator	Leeanne Whitelaw BSc MifA
Editor	Melanie Johnson MA PhD FSA Scot MifA
Commissioned by	Transport Scotland
Date issued	December 2011
Version	0
Grid Ref	NT 3326 6670 (centred on)
Oasis Ref	cfaarcha1-115240

### **Eskbank Railway Station Enhanced Building Survey**

**Report No 1972**

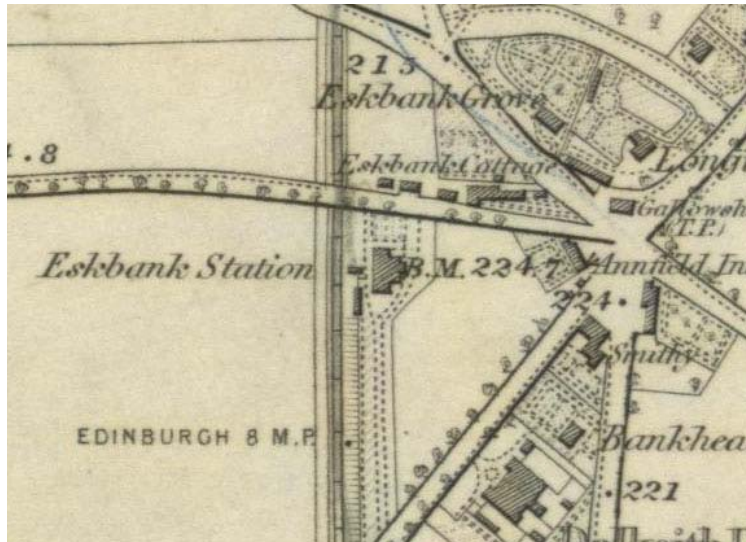
Fig. 2a - Ordnance Survey 1st Edition

The 1854 First Edition Ordnance Survey map (Fig 2a) depicts *Eskbank Station* and shows the station house and two platform buildings. The 1894 Second Edition Ordnance Survey map (Fig 2b) depicts Eskbank Station as a single line. A pedestrian footbridge and steps are shown on the west side of the Station house and ticket office. On the east platform, a roofed building is shown built against the Lasswade Road Bridge. On the same platform immediately on the south side of the footbridge there is a rectangular building with three compartments. There is also a rectangular building immediately opposite on the west platform. On the same platform, on the north side of the footbridge, there is a small roofed structure.

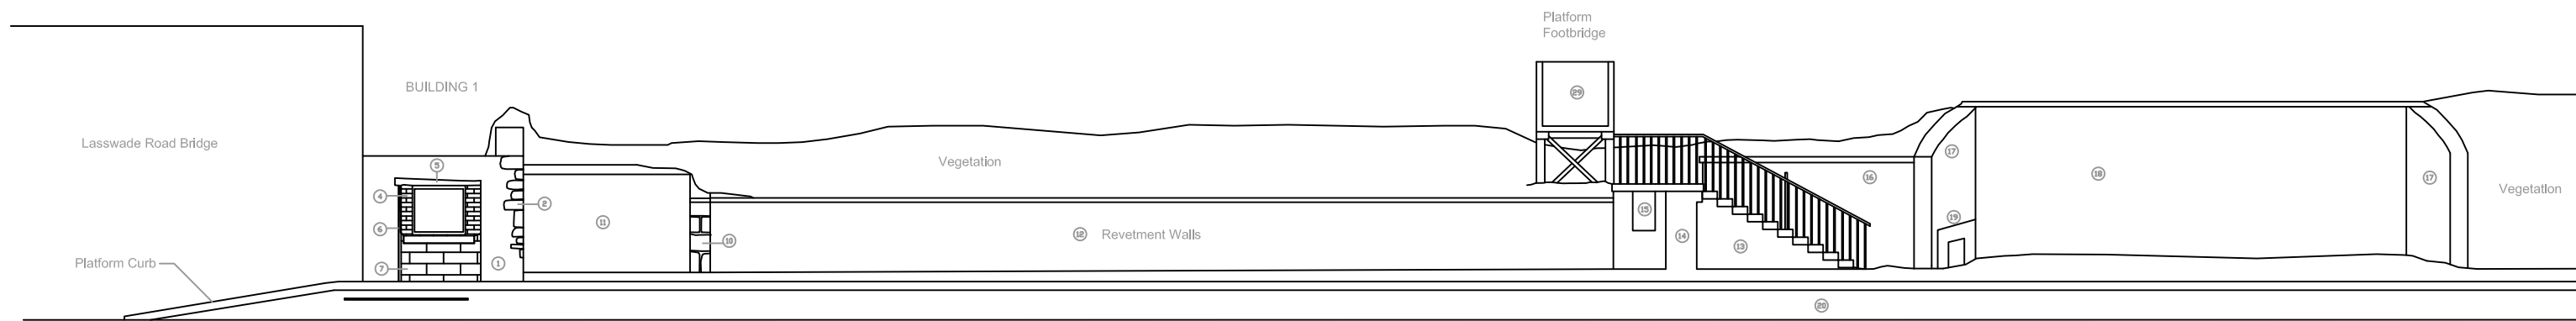
Fig. 4a - East Platform, west-facing elevation

The east platform's west-facing elevation is now described starting from the north end of the platform. Situated against the south-facing elevation of the Lasswade Road bridge is a roofless stone-built structure measuring 3.7m wide and c.3.5m high to the wall head. The main build (1) is coursed rough-dressed yellow sandstone with stugged sandstone quoins (2) measuring on average 0.4m x 0.25m and bonded by lime mortar. Occupying the centre of the building is a wooden-framed window (3) measuring 1.17m by 1.07m set within common shale brick surrounds (4). The window has a softwood lintel surviving (5). On the north-side of the brickwork there is a stone door jamb (6) in situ. Below the sandstone windowsill there are four courses of well-dressed sandstone (7) forming the blocking work of an earlier doorway.

Between the south-facing entrance (8) and a section of advanced wall (10) is the main revetment wall (11). The section of revetment wall is 3.95m wide and 2.6m high. This adjoins a wall at right angles and this wall is 3m long and 1,8m high and has lozenge-shaped coping stones. The wall is 0.37m wide.

The revetment wall (12) continues for a length of 21.4m until it reaches the steps (13) to the pedestrian foot bridge. The wall is 1.77m high and has snecked stonework with the same coping stones as the outshot section of wall.

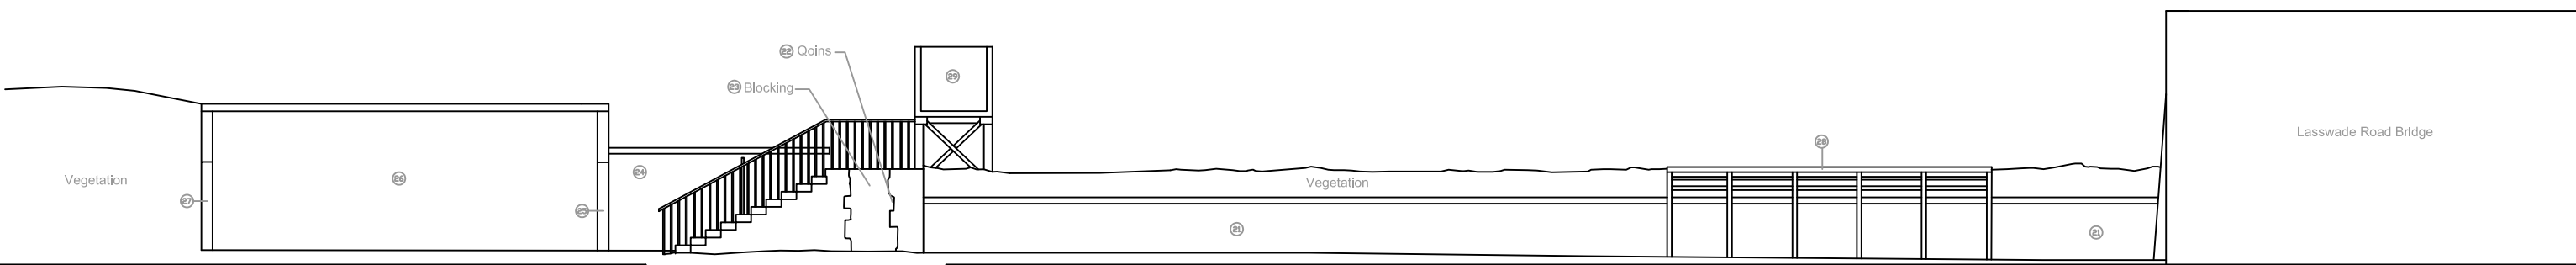
Fig. 4b - West Platform, east-facing elevation

The platform commences 8m beyond the Lasswade Road Bridge. Between the road bridge and the remains of a pedestrian platform shelter, a 3m of revetment wall is exposed (21). The same revetment wall continues for a distance of c40m where it meets the steps leading up to the iron platform bridge. The wall is constructed of snecked sandstone blocks with lozenge shaped coping stones.

The staircase on the west platform differs from that on the east as the former only had a doorway. The door surround are droved ashlar quoins (22). The interior of the door has been blocked and covered with a cement render (23). Behind the steps the revetment wall is snecked sandstone with flat coping stones (24). Approximately 2m south of the steps the revetment wall (26) has a height of 4m. Two advanced buttress walls (25 and 27) are present at each end of the wall. Beyond this the platform continues southwards for a distance of c.90m.

The historical maps show that on the west platform a rectangular building was present more or less opposite the telegraph office on the south side of the footbridge. Although there is no trace of the building today it probably occupied the ground between the two buttress walls (25 and 27 in Fig 4b).

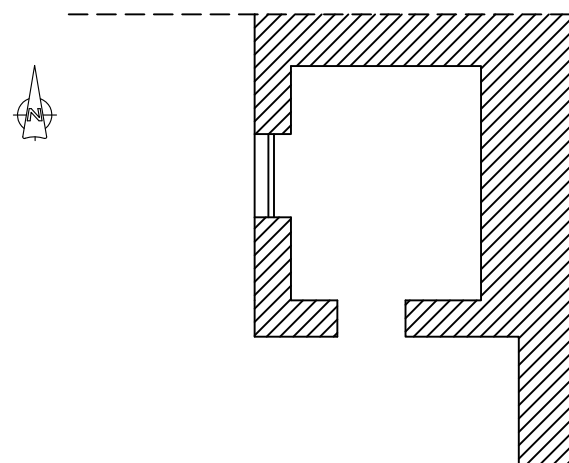
Fig. 4c - Floor plan of Building 1

The building occupies a square plan (Fig 4c) and has a rubble-strewn interior. The walls vary in thickness. The west and south-facing elevations are 0.45m thick. The thickness of the internal west-facing wall is not known as it incorporates the revetment wall behind it.

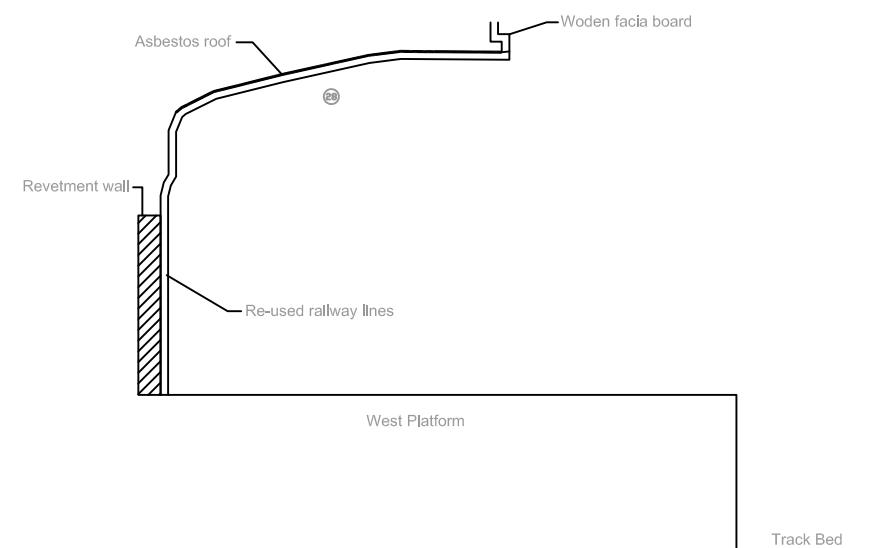
Fig. 4e - Profile of the Pedestrian Shelter (Feature 27)

The pedestrian shelter (28) is situated 3.6m from the Lasswade road bridge. It is 7.6m wide and consists of six uprights made of re-used standard gauge railway line that has been curved more or less at right-angles to support a sheet asbestos covered roof, which is 3.6m above the platform. The uprights have been bolted to the revetment wall with hexagonal bolts.

The pedestrian shelter is constructed of re-used railway line and has an asbestos roof placing its construction in the first half of the 20<sup>th</sup> century.

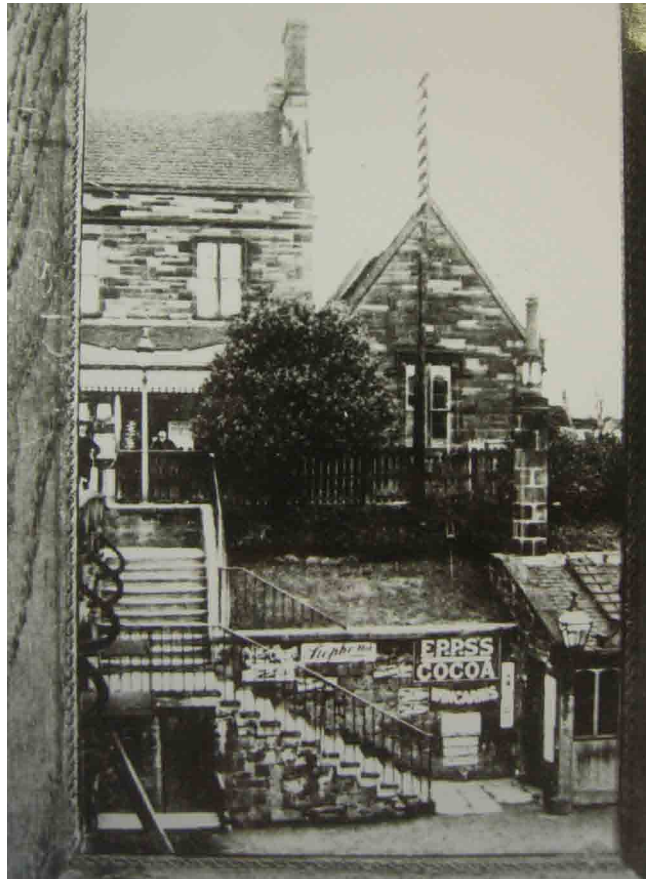
Plate 1 - A late 19th century photograph of part of the east platform and footbridge steps

An undated photograph from the late 19<sup>th</sup> century (Plate 1) shows a timber-built telegraph office situated on the eastern platform. The telegraph office has a pent-shaped slate roof, porch and pedimented clock. A tall ashlar-built chimney stack rises up at the rear. Steps lead down from a footbridge onto the platform. The footbridge is timber-built supported by timber stanchions resting directly on the platform. The below-steps room with door and window is visible. Looking further northwards along the platform, Building 1 (see below) can be seen clearly, built against the Lasswade Road bridge.

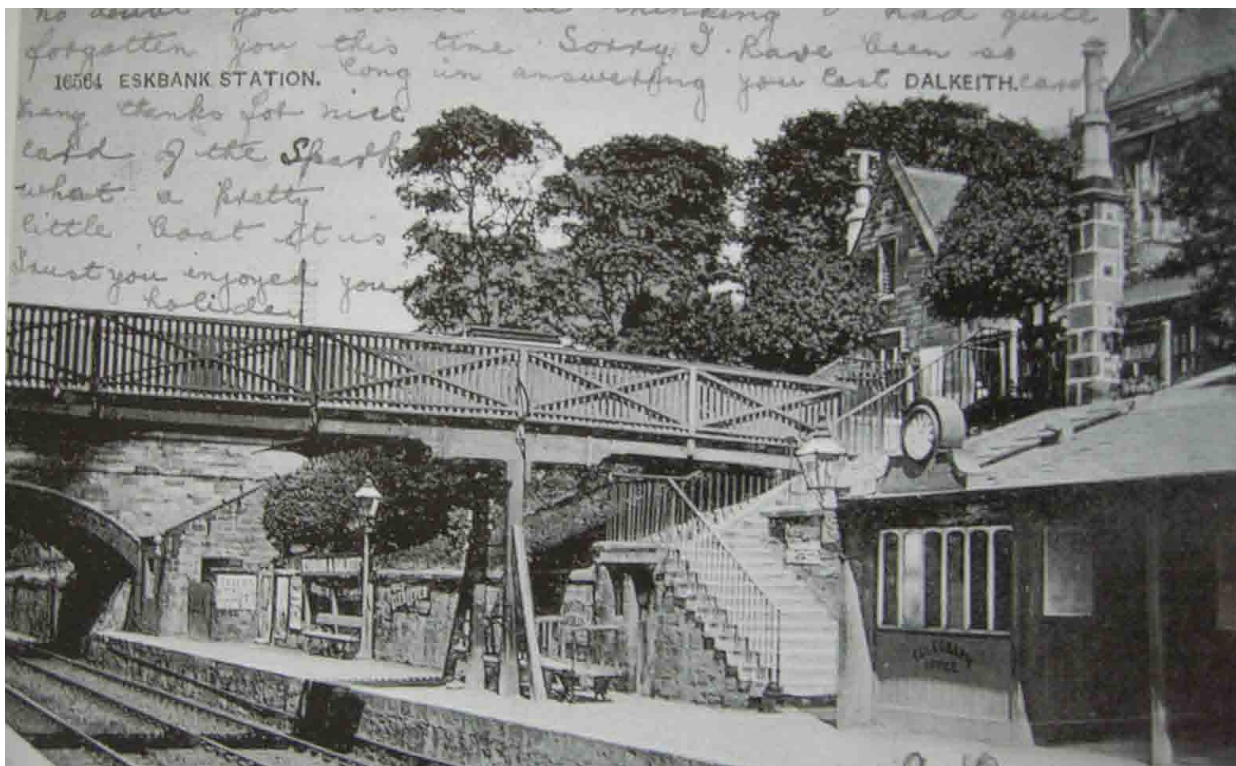
Plate 2 - A late 19th century photograph of a wooden footbridge, telegraph office and east platform

Plate 2 is dated to the late 19<sup>th</sup> century and the photograph shows the north end of the telegraph office on the east platform and the steps leading down from the pedestrian footbridge.

The footbridge (Plate 9) is a 20<sup>th</sup> century replacement for the wooden bridge shown on the historical photograph (Plate 2). It is difficult to establish when the present footbridge was installed but judging by its riveted lattice construction it is likely to be the early part of the 20<sup>th</sup> century. Although the bridge superstructure was replaced, the steps leading down to both platforms were unaltered.

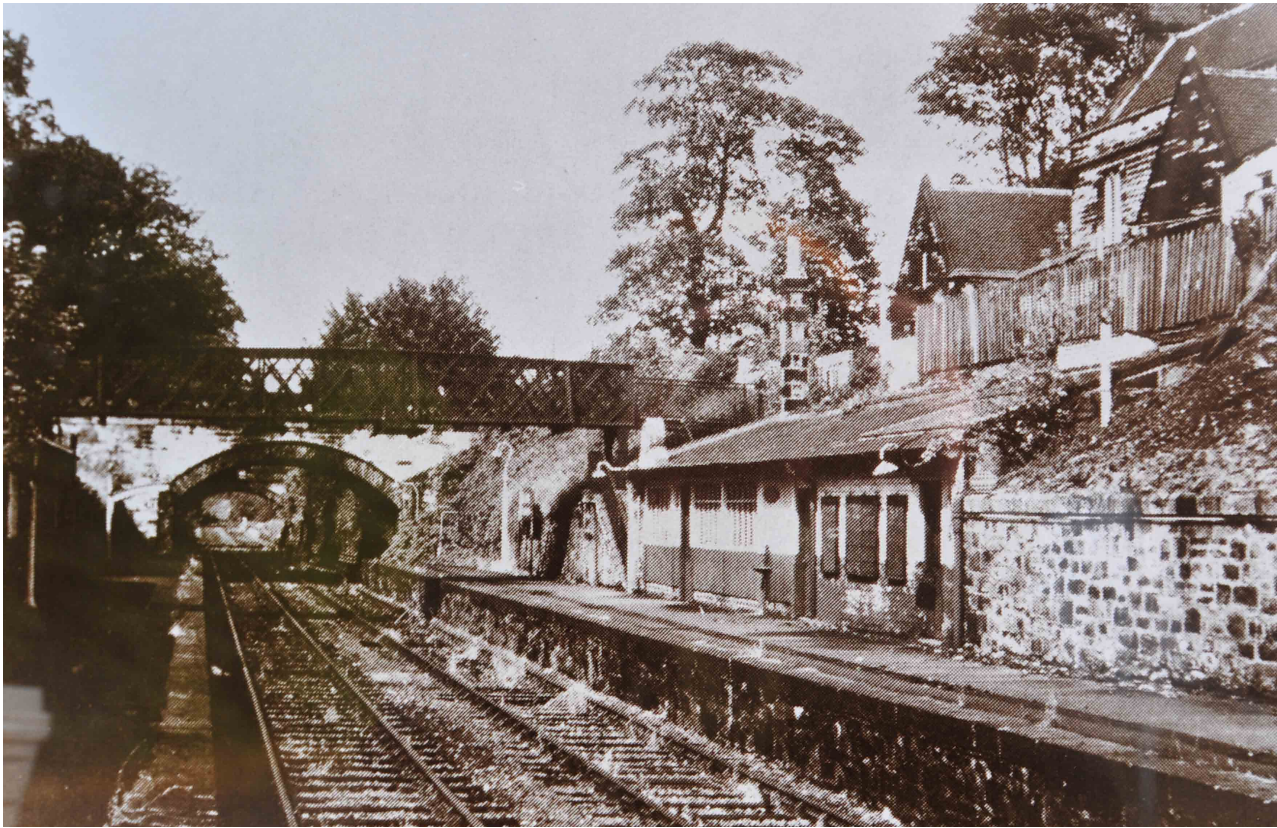
Plate 3 - An early 20th century photograph of Eskbank Station showing the existing footbridge

Plate 3 shows a panoramic view of the station with the telegraph office shown in its entirety. The photograph appears to date to the early-20<sup>th</sup> century as the gas lighting has been replaced by electric lighting. The station footbridge is the same as stands today showing that the present bridge replaced the earlier wooden bridge most probably when the railway was nationalised in 1947. Building 1 at the north end of the platform is by this time derelict. The east-facing elevation of a building on the west platform is just visible.

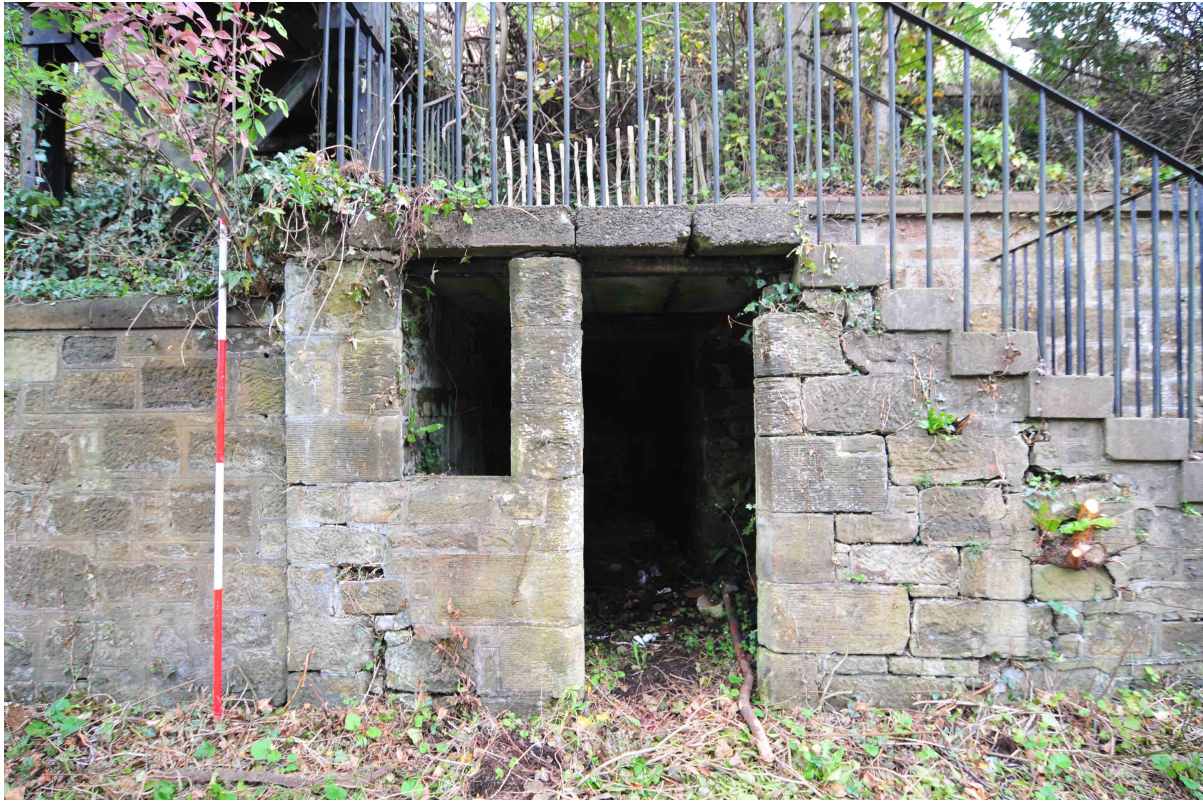
Plate 6 - Steps on the east platform leading up to the pedestrian footbridge

The staircase (13) provides access to the footbridge (section 4.5 below) and an exit from the platform to Station Road. The staircase wall is 5.4m wide with ten concrete steps rising to the lower landing. The steps measure 1.86m wide and are 0.17m high. An iron handrail with iron balusters survives to the full height of the staircase. Within the centre of the staircase elevation there is an open doorway (14) measuring 2.9m high and 0.72m wide. The sandstone door surrounds have been chamfered on their leading edge. A section of railway line has been used as relieving support above the door surround. A window (15) is present on the north side of the doorway. The window measures 0.97m high and 0.48m wide.

The interior of the below-steps room occupies an L-shaped plan. The walls have the remains of plaster adhering to them. Sockets for a timber-framed door are present on the inside of the stone door-jamb.
