**1 Kilwinning Street, Musselburgh,  
East Lothian**

**Archive Assessment  
and Evaluation**

**Report No. 1978**

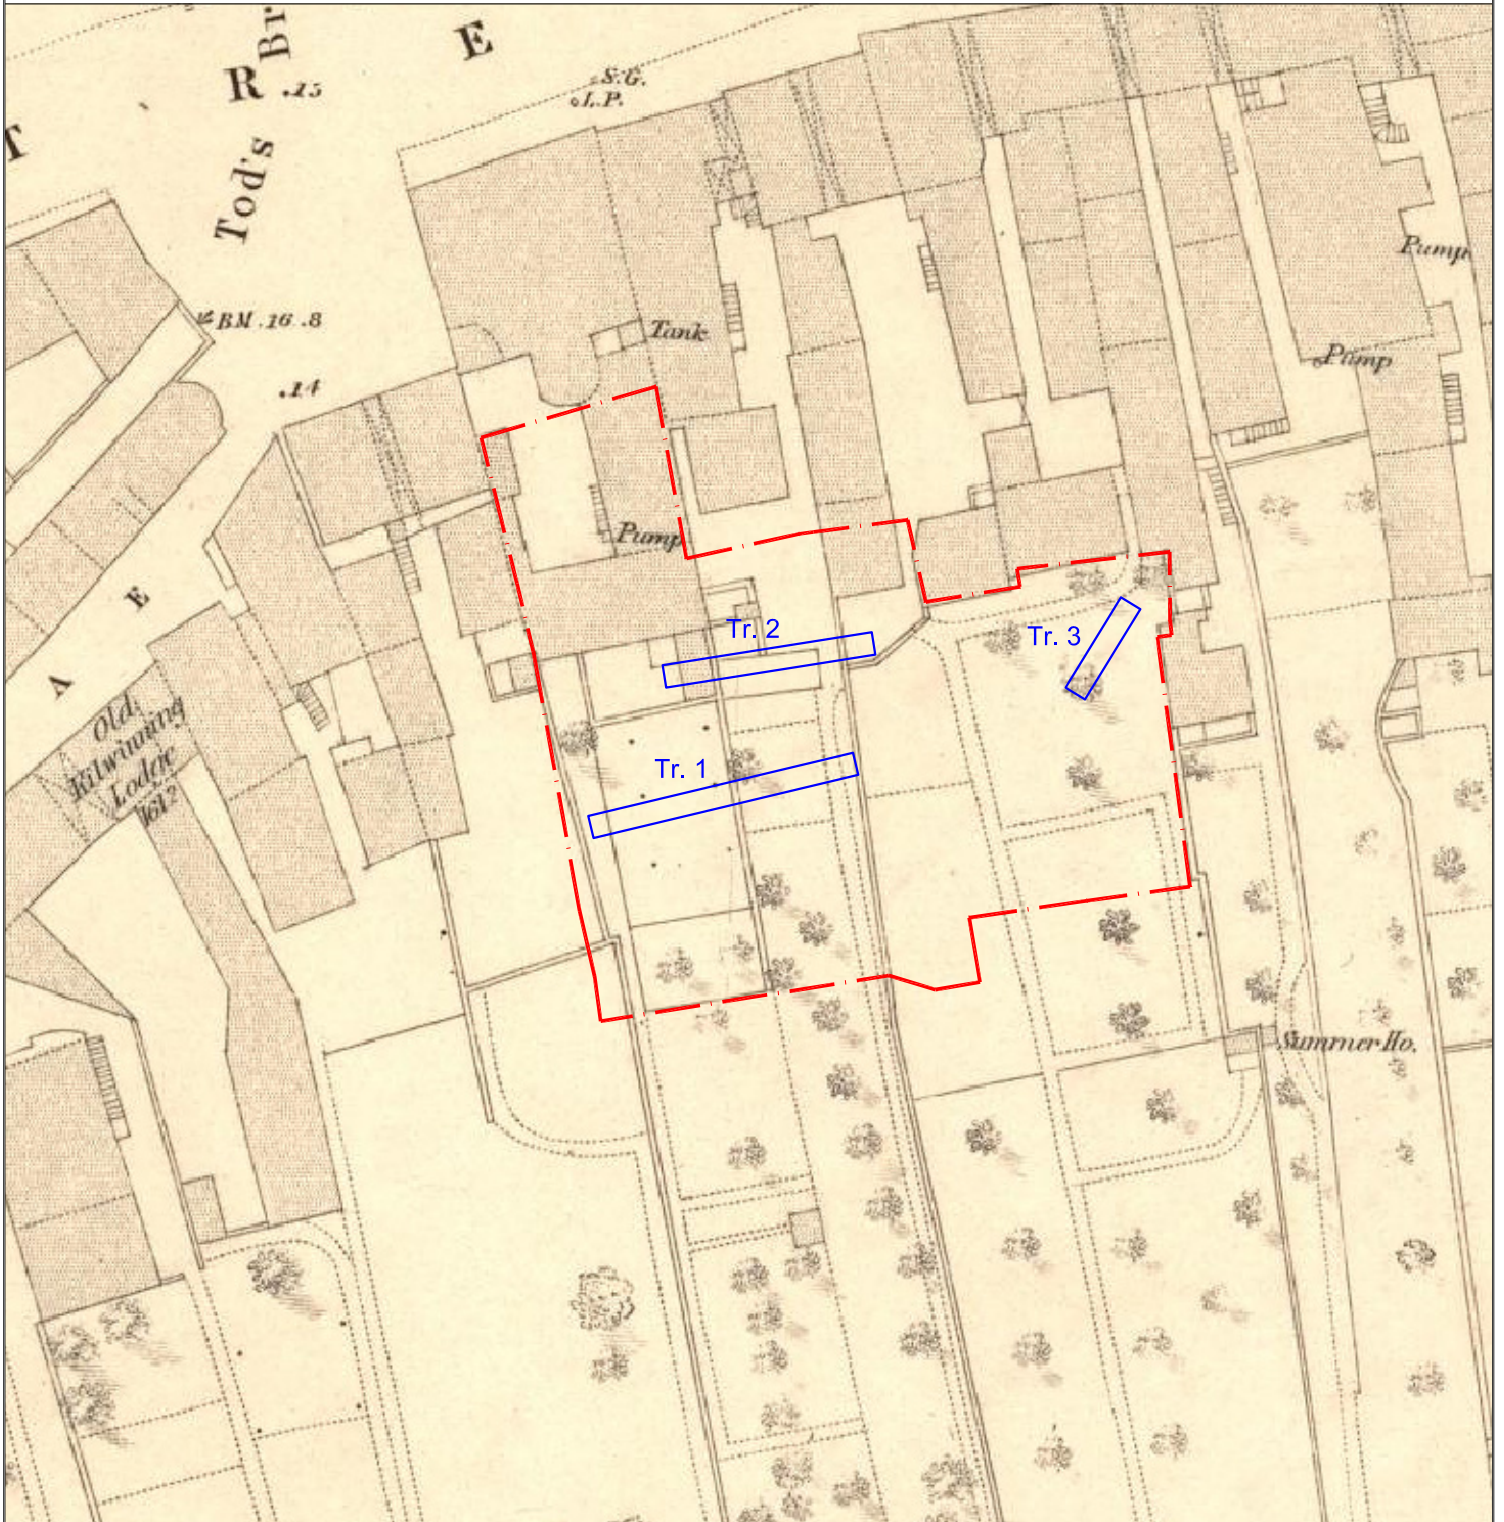
Title: Musselburgh 1853, Ordnance Survey extract

The most useful historical maps are the 1853 (Fig. 2a) and 1893 (Fig. 2b) Musselburgh Town Plans. The 1853 plan shows roofed buildings and what may be yards within the northern part of the development area. The southern part appears to contain gardens as both trees and paths are depicted. Roofed buildings are less clearly depicted on the 1893 plan but the division apparent from the earlier map is repeated. The representation of steps within the plot behind 82-84 High Street suggests the buildings to the north are well below the level of the gardens to the south.

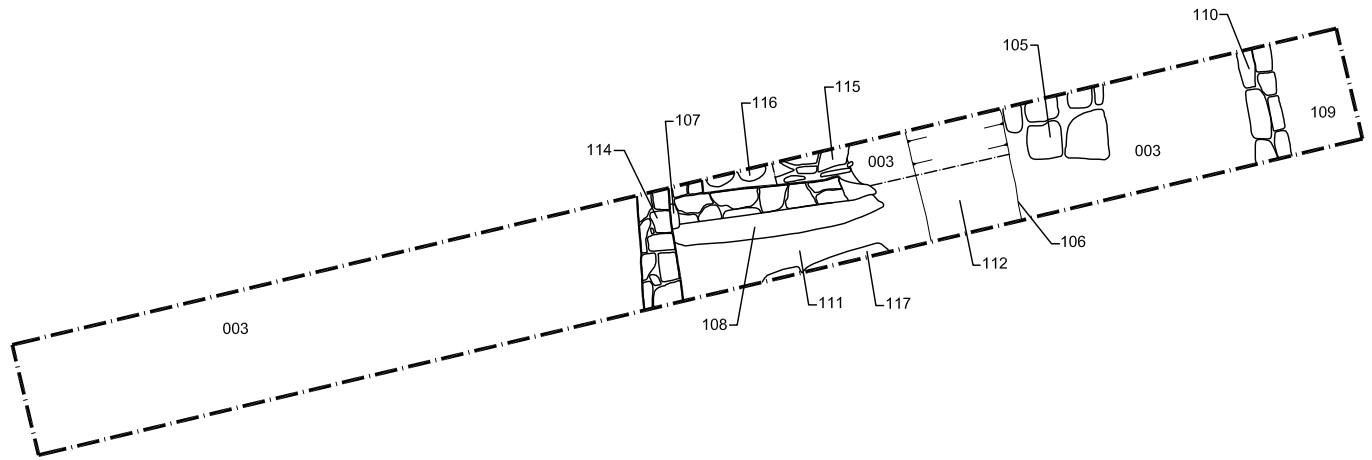
Fig 3 - Trench 1 plan

Structural remains were found in the eastern end of the trench (Figs. 3-4). The remains of two parallel sandstone walls (**110**) and (**114**) of similar construction and size were found running north-south and disappeared into the baulk beyond the trench

limits. Running at an angle from underneath (114) was a second sandstone rubble wall (107) with a clay damp-proofing layer (108) running along its south side. Between wall (107) and the northern trench edge were demolished sandstone blocks (116) overlying paving stones (115). No occupation deposits were present.

Another sandstone wall (118) with clay damp-proofing on the northern side (117) could just be seen in the north-facing section of the trench. To the east, a linear ditch (106) running north-south was discovered, filled with soft brown silty sand (112) with 19<sup>th</sup> century finds including brick, bone, pantile, stone and lead in the fill. The ditch continued beyond the trench limits. Immediately east of the ditch (106) the stub of a sandstone wall (105) without obvious mortar-bonding was found.

In Trench 1, the north-south aligned boundary walls are shown on both the 1853 and 1893 Town Plans. The structural remains in the east of the trench underlie the western boundary wall and are not shown on these maps but appear to be the remains of a building or buildings. No finds were recovered and the date of these structure(s) is unknown. They are however bisected and possibly cut by a ditch containing 19th-century finds.

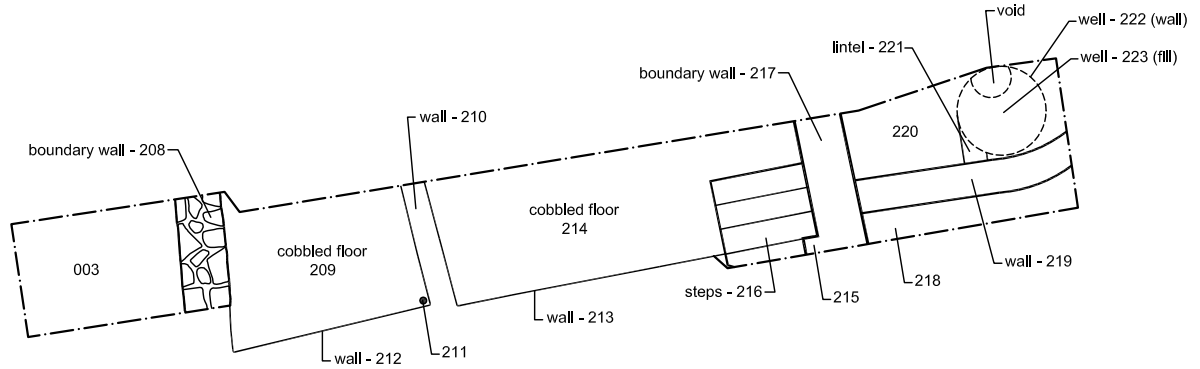
Fig 5 - Trench 2 plan

Structural remains in Trench 2 were more varied than Trench 1 (Figs. 5-6). The remains of a set of parallel sandstone walls (208 and 217) were found running north-south and these appear to connect with (114) and (110) found in Trench 1.

Wall (212) abuts wall (208) on the north-facing trench section and runs through (as 213) to the second plot boundary wall 217. An internal sandstone wall 210 was recorded, with a degraded wooden post (211) in the corner formed by walls 212 and 210. The area to the north of wall 212/213 and on either side of wall 210 was paved with rounded cobbles (209, 214). Very large quantities of finds including many complete bottles, crockery, tins, tyres and plastic rubbish were present within these structures.

To the east of wall 213, a short flight of 4 cut-stone steps (216) abutted wall (217). A door check (215) was identified on the east end of the top step.

To the east of wall 217, a mortared stone wall (219) continued east towards the edge of the trench, slightly curving to the north. Immediately to the north of wall (219) a stone-lined well (222) was found. This had sandstone lintels (221) largely obscuring the interior.

In Trench 2, the north-south aligned boundary walls are shown on both the 1853 and 1893 Town Plans. A roofed building is shown in the west of the trench in 1853 but there was no trace of this structure in the trench. To the east, an unroofed building or yard is shown on the 1853 map. All of the remains are shown on the 1893 Musselburgh Town Plan and the steps provide a very useful reference point for the whole trench. These remains do not appear to represent a roofed building, notwithstanding the presence of a door check. The well in the east of the trench is not shown on either map but the curve of the wall to the south of the well is shown in both 1853 and 1893.
