Knocknagael Farm, Inverness

Archive Assessment, Photographic Survey and Archaeological Evaluation

Data Structure Report No. 1991

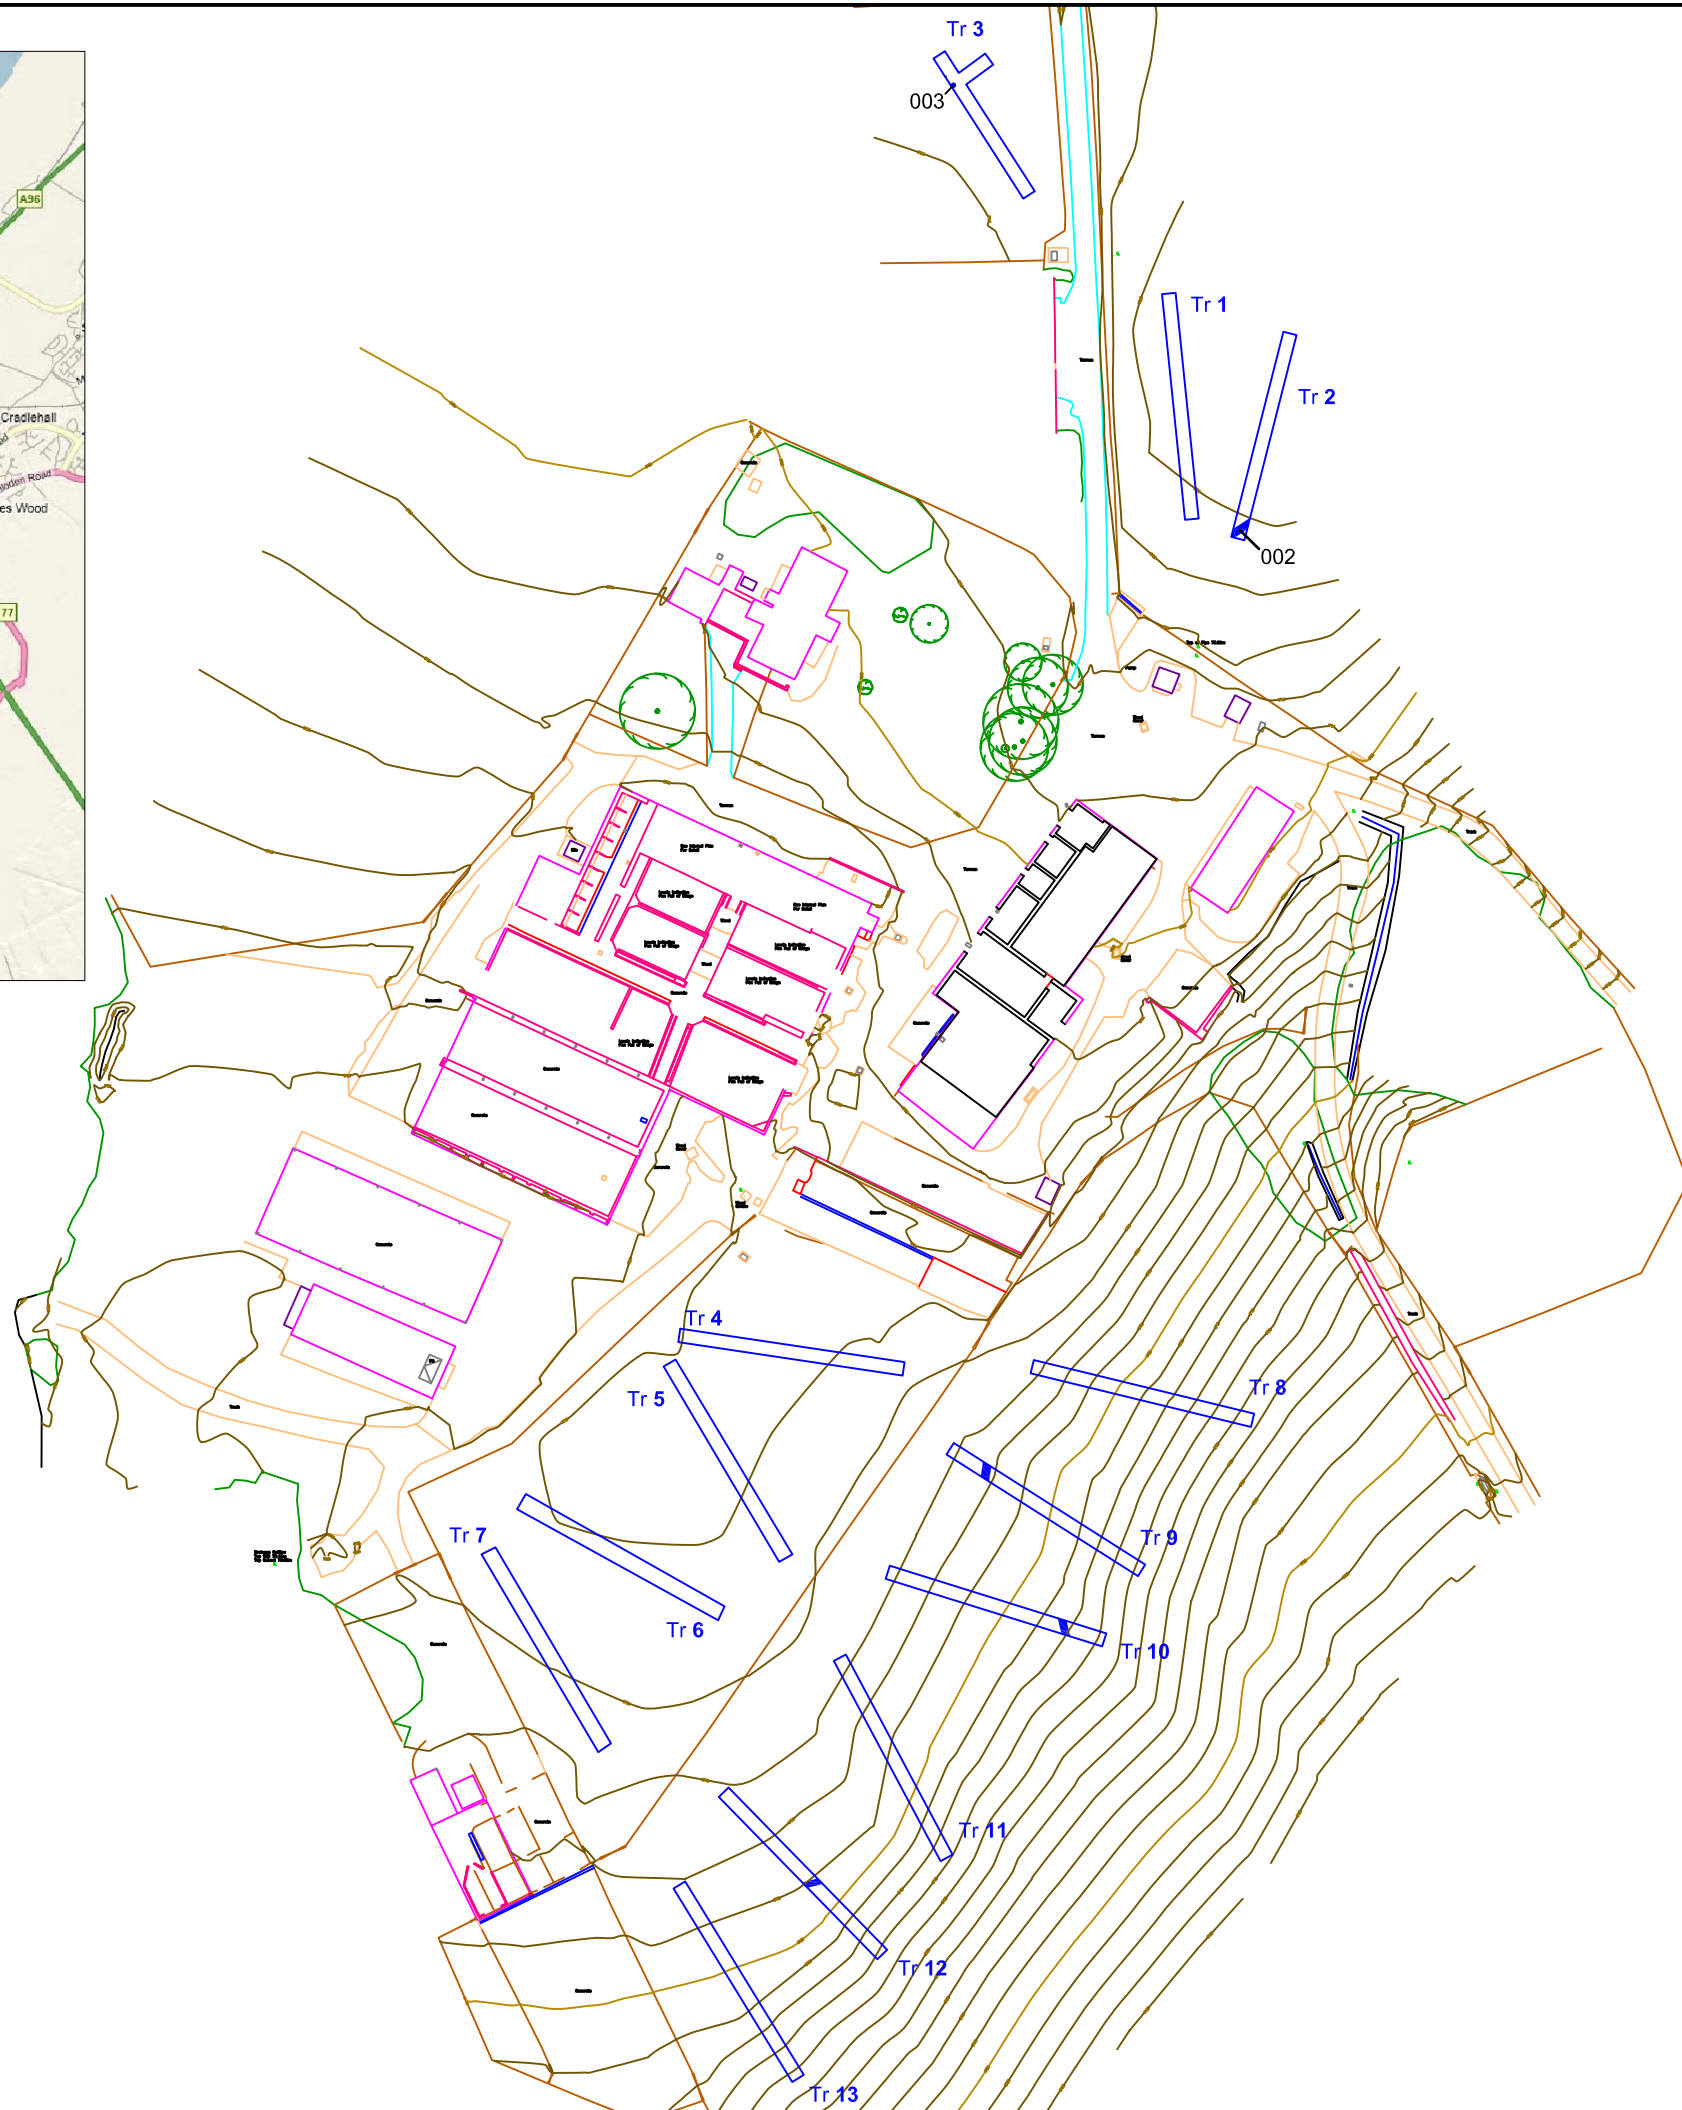
Fig. No: 1 Revision: A

Thirteen trial trenches were excavated totalling 693m² (Fig. 1). Only those trial trenches containing archaeological remains are described in the narrative below.

Title:
 Location map and plan of
 farm showing trial trenches

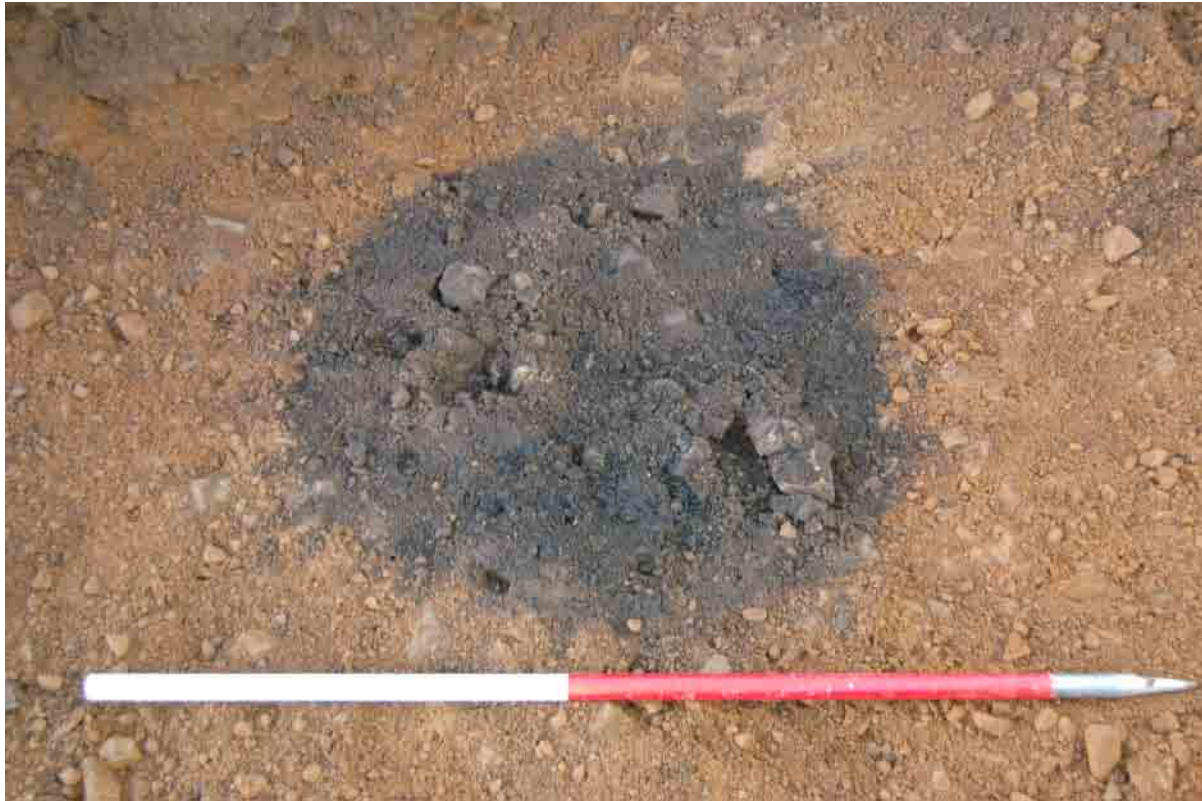
Fig 2 - Pit 003

A single pit was revealed in Trench 3. The cut (**003**) was circular and measured 0.68m in diameter and 0.16m deep (Fig. 2-3). It had shallow sloping sides which merged to a

shallow concave base. The fill (004) comprised dark grey to black silt containing infrequent charcoal flecks and occasional small stones, including fire-cracked stones. No finds were recovered. No colour change in the surrounding natural indicating burning was evident.

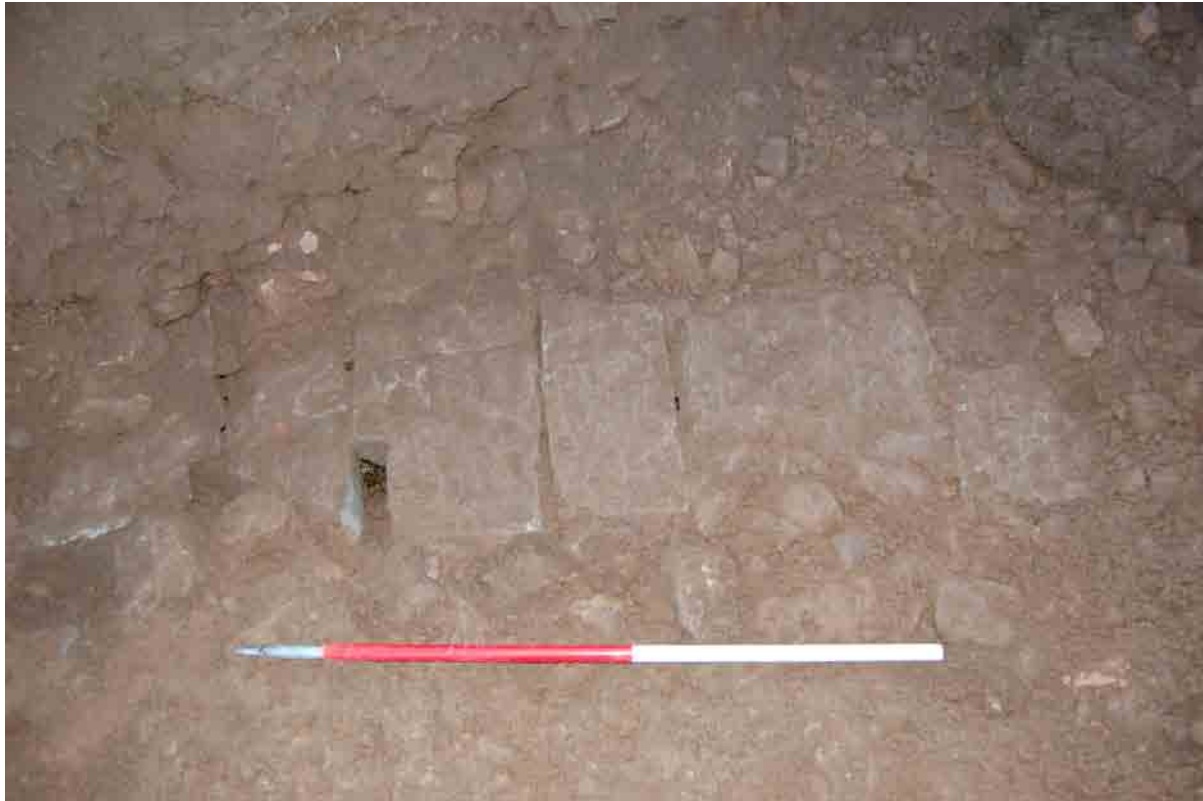
Fig 4 - Cundy in Trench 2

A stone-built cundy drain (**002**) was exposed in Trench 2, aligned roughly SW to NE. It was cleaned for inspection but was not excavated as it was still functional with a significant flow of clean water inside (Fig. 4). It measured c.0.7m wide and comprised stone sides, presumed to be orthostats, and large well-fitting capstones. The depth from the top of the orthostats to the base of the cundy was 0.2m.

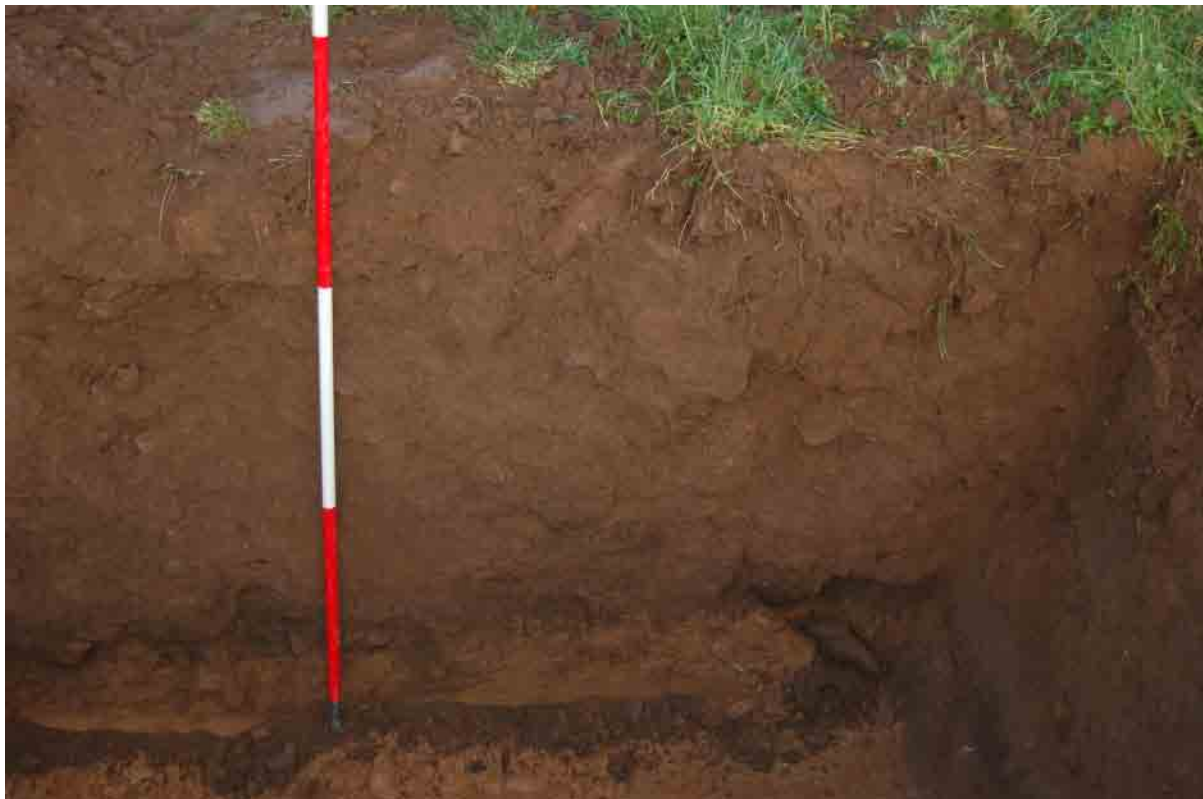
Fig 5 - Soil profile at east end of Trench 5

Trenches 4 – 7 were excavated to the south of the farmstead on level ground at the foot of a steep slope (Fig. 6). Topsoil (**001**) was 0.35m and overlay a deposit of sandy slope-washed silt (**005**) up to 1.2m deep. In Trenches 4 – 6 the slopewash sealed an almost black layer of firmly compacted silt which is most likely a buried soil (**006**) (Fig. 5). Natural subsoil was loose sandy gravel and pebbles with occasional bands of sandy clay.

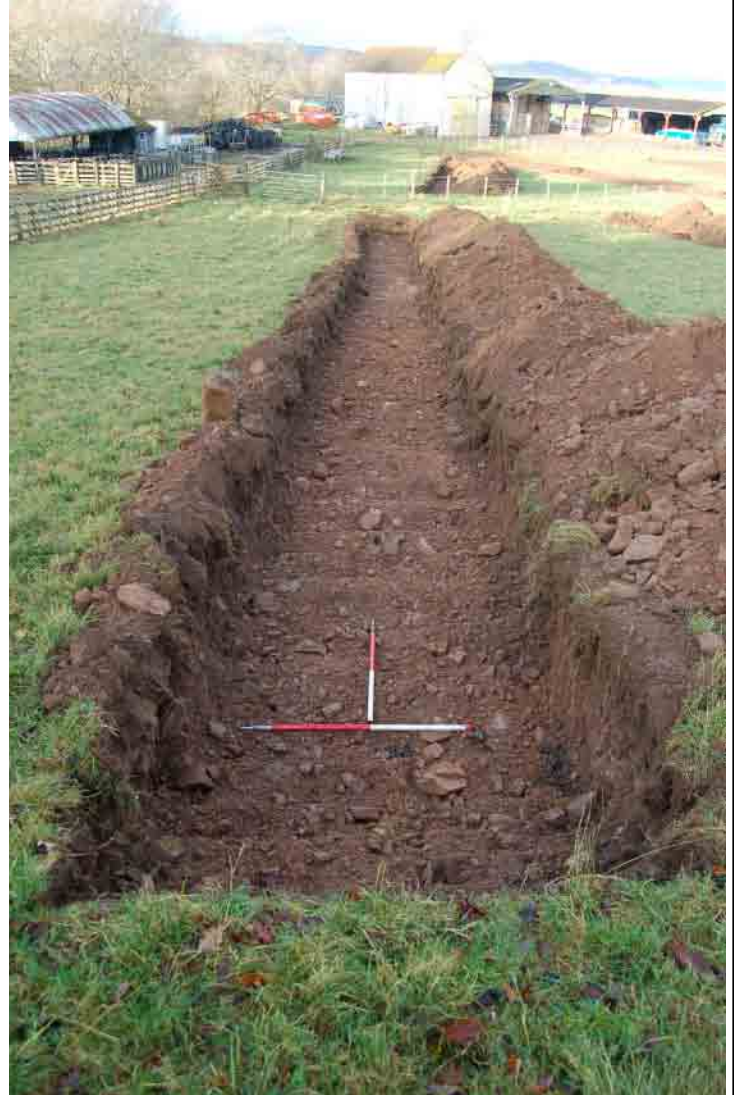
Fig 7 - Trench 13

Trenches 8 – 13 were excavated down the steep slope to the south-east of the development area (Fig. 7). Topsoil (**001**) varied from 0.35m to 0.4m deep. Slope-washed silt (**005**) was present, deeper towards the base of the slope, measuring from 0.1m to 0.8m deep. Natural (**000**) was loose sandy gravel with occasional bands of stony sandy clay.

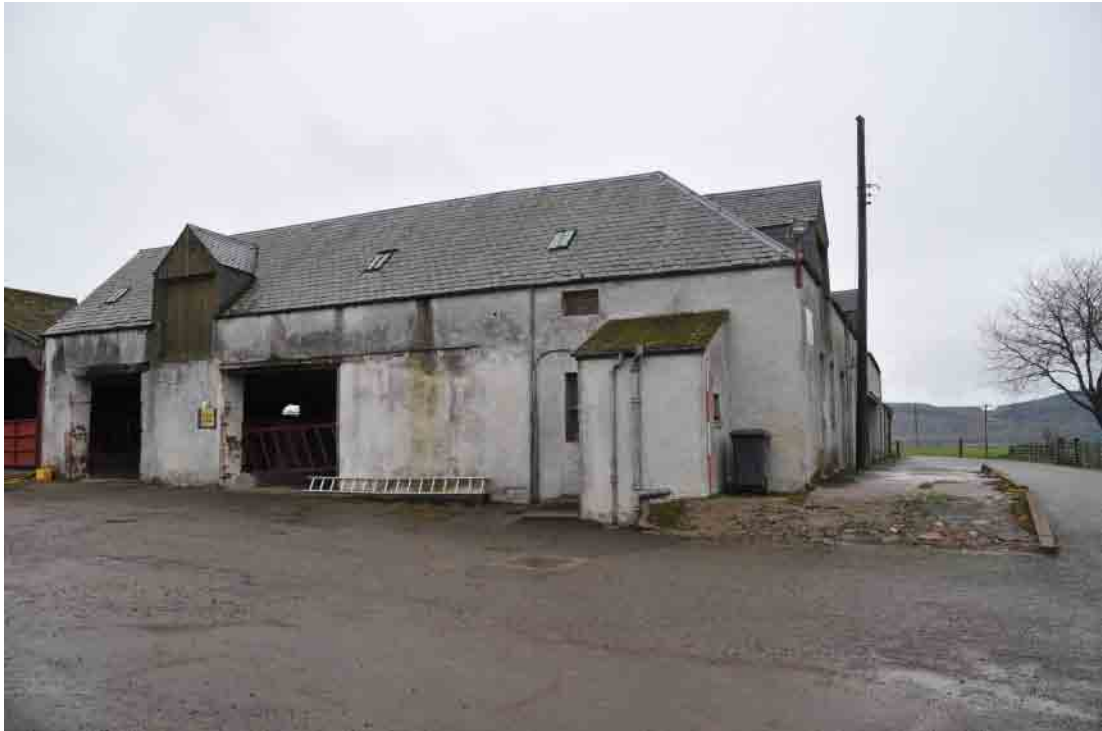
Fig 9 - West range from the east

The west range (Fig. 9-10) comprised a main north-west to south-east aligned stone built range with two outshot extensions to the south-west, one at each end. An additional extension has been built to the rear on the north-west-facing side and the entire south-west-facing side has been enclosed by modern sheds built from girders and breezeblock. The interior of the west range is divided up into small storage units and includes a long byre. A loft is contained within the roof space. The modern sheds at the rear contain large storage areas for cattle feed and wintering pens for the bulls. The original stone-built range appears as part of a quadrangular building on the 1874 edition Ordnance Survey map, although much of this appears to have been since demolished and replaced with the modern sheds, which likely date to the late 20th century.

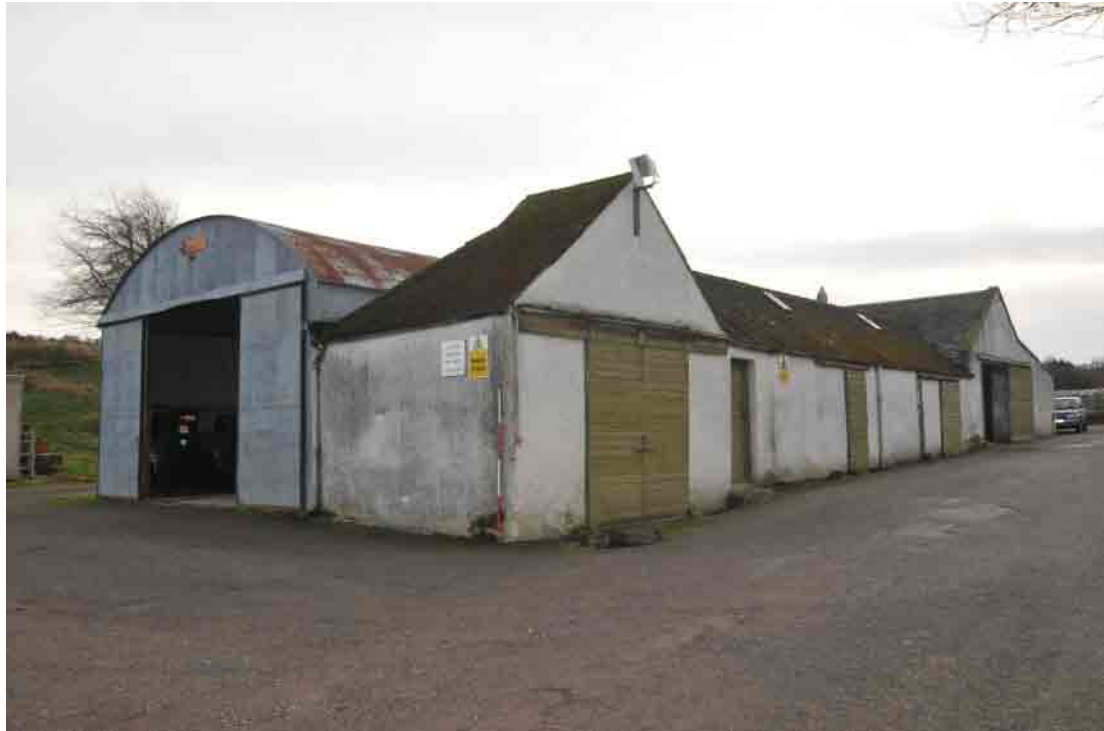
Fig 11 - East range from the north

The east range (Fig. 11-12) comprises a stone-built linear range aligned north-east to south-west. It is divided internally into small sheds and barns, and has been extended to the south-east and south-west by modern girder framed sheds. A linear building is depicted on the 1874 map which may represent this range. The build and materials suggest a similar date of construction to the west range.

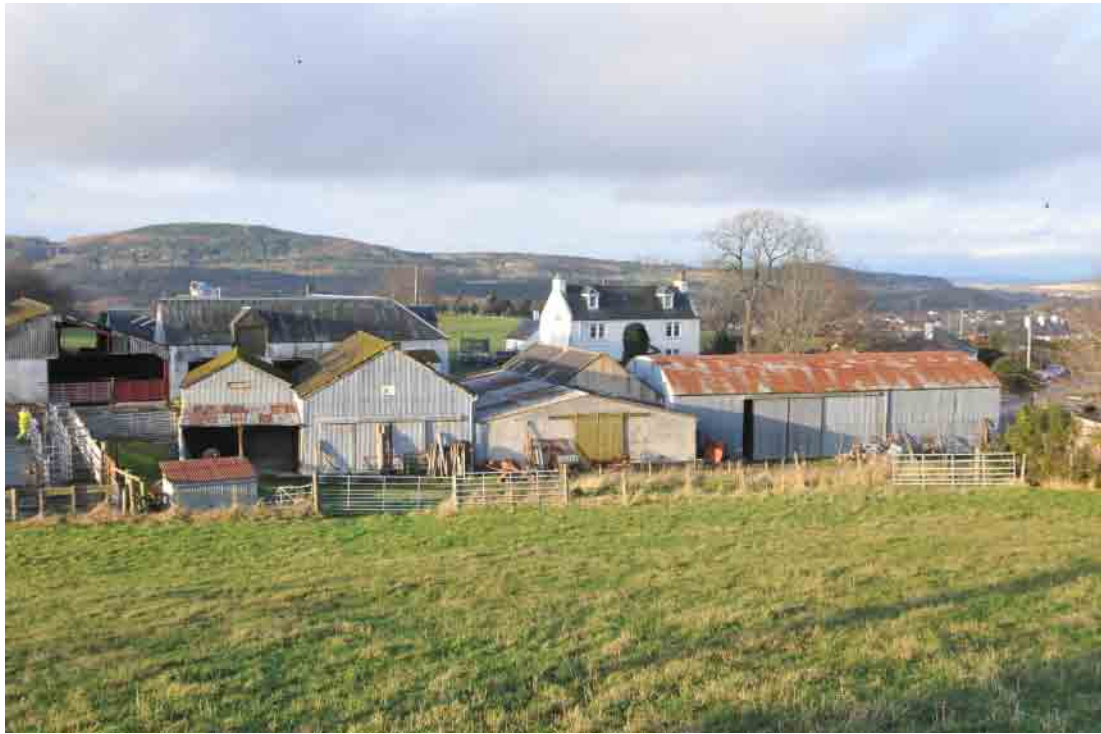
Fig 13 - General view of the farmstead from the south-east

The farmstead comprised a suite of buildings including a west and east range with modern extensions and internal modifications (Fig. 13). An asbestos and aluminium/zinc panel-built Dutch barn was present to the rear of the steading and several modern girder built sheds had been added. A stone built house and outhouse plus two rows of cottages were located to the north of the farmstead although these were not included in the survey.
