**Riggfoot Farm, Dalrieket,
New Cumnock, East Ayrshire**

**Desk-Based Assessment
and Standing Building Survey**

Report No 1993

Authors	Stuart Mitchell MA AIfA
Illustrator	Leeanne Whitelaw BSc MIfA
Editor	Bruce Glendinning BSc PgDip MIfA
Commissioned by	Kier Construction Ltd (Mining Division)
Date issued	January 2012
Version	1
Oasis Ref	cfaarcha1-116322
Grid Reference	NS 5811 1311

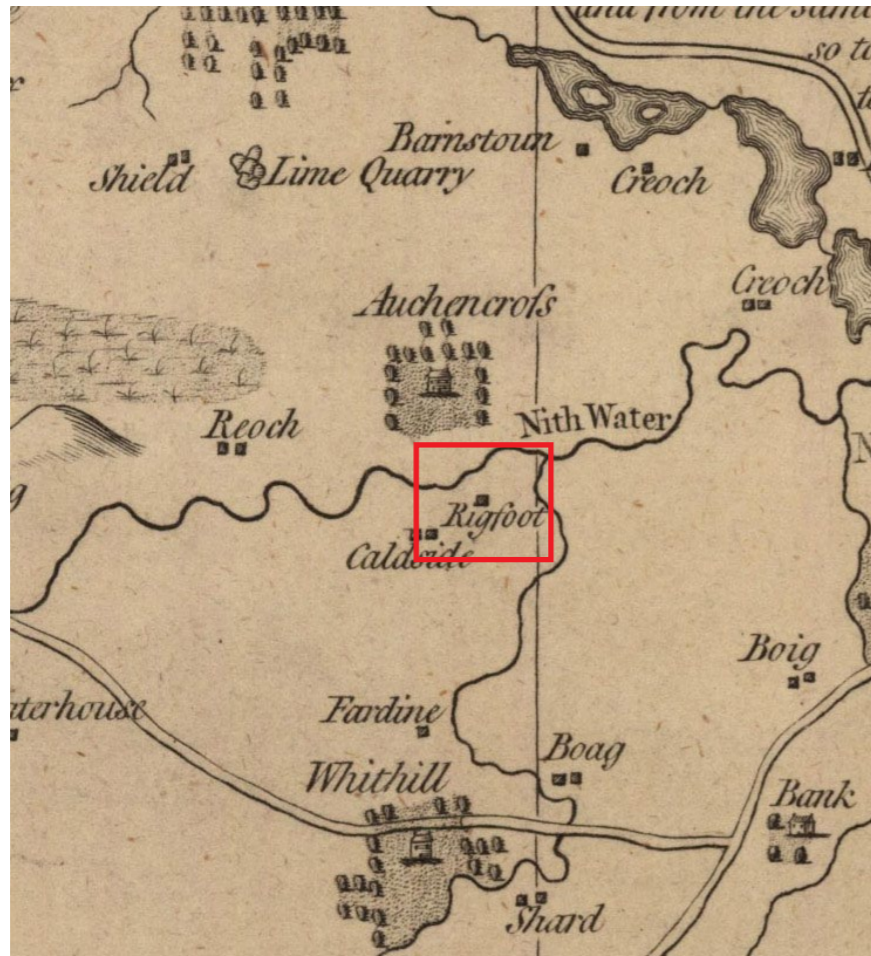
Fig. 2a - Map by Armstrong, 1775

The earliest named appearance of Riggfoot occurs on Andrew Armstrong's map of 1775 (Fig 2a). The placename 'Riggfoot' is depicted immediately north-east of Caldside and south of a fork in the Nith Water.

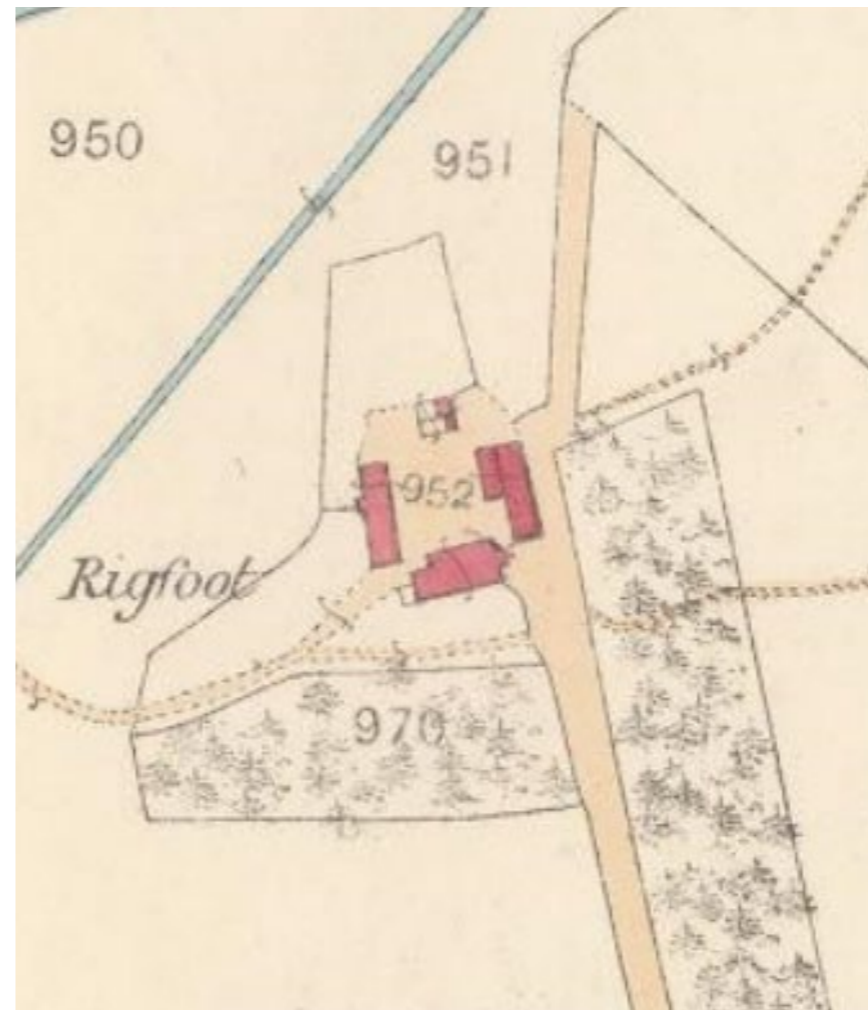
Fig. 2b - Ordnance Survey 1st Edition, 1860

The 1860 First Edition Ordnance Survey map (Fig 2b) depicts 'Riggfoot' with some differences to the current layout. There are four separate buildings shown arranged around a courtyard. A small outshot structure is depicted at the east end of the farmhouse. The north range is depicted as a small square building with animal pens. The east range has an outshot building on its east side. The west range is shown as a two compartment rectilinear building with a small outshot structure on its west side. A small square building to the south of the farmstead had yet to be built.

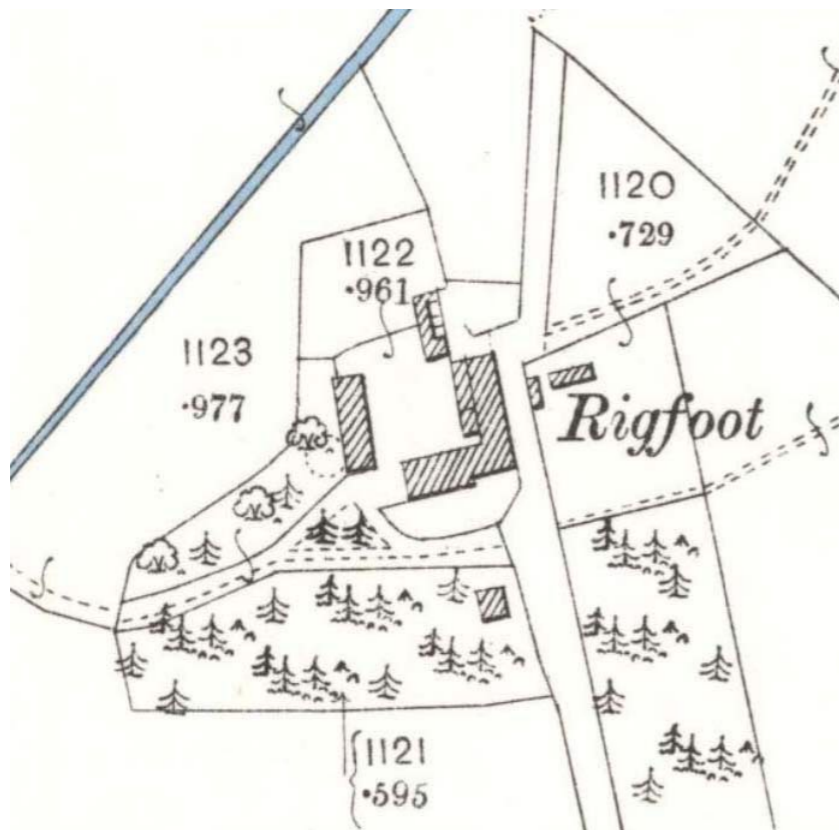
Fig. 2c - Ordnance Survey 2nd Edition, 1896

The 1896 Second Edition Ordnance Survey map (Fig 2c) shows 'Riggfoot' approximately as it exists now. The farmhouse has been enlarged on its west-facing elevation. The farmhouse and the east range have been amalgamated to form an L-shaped arrangement. The outshot building on the west side of the west range has been removed. The small detached square building appears to the south of the farmhouse for the first time. At the south-west end of the west range, there is a c.9m diameter circular area which could be interpreted as the remains of a horse gang.

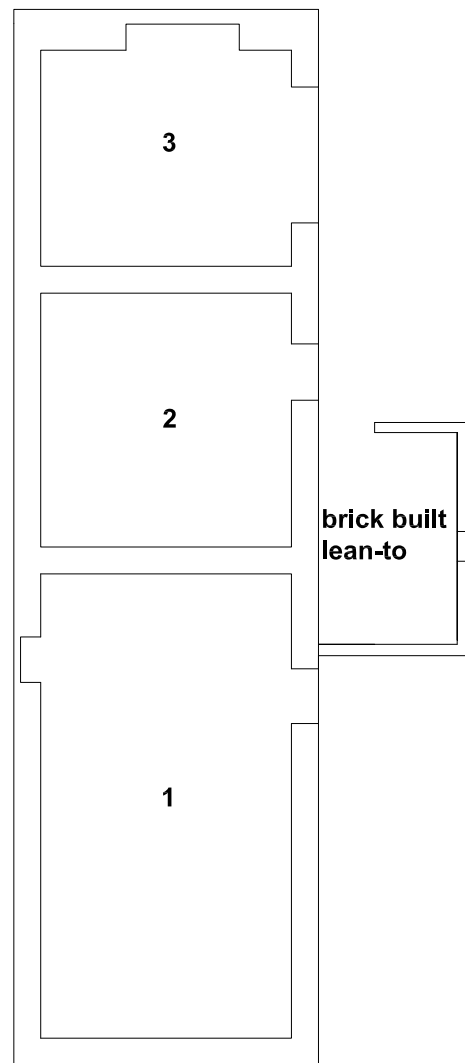
Fig.3a - West Range Floor Plan

The interior of the west range (Fig. 3a) comprises three units on the ground floor and a loft. The loft was not accessed for health and safety reasons. The three units on the ground floor level are accessed from the east side of the building.

Unit 1 forms a rectangular barn accessed from the east side of the building. The floor is surfaced in brick with areas of concrete and beaten earth. It is roofed with timber joists and floorboards, and has timber steps leading to the loft (Unit 4) (Fig. 14) through a hatch at its north end.

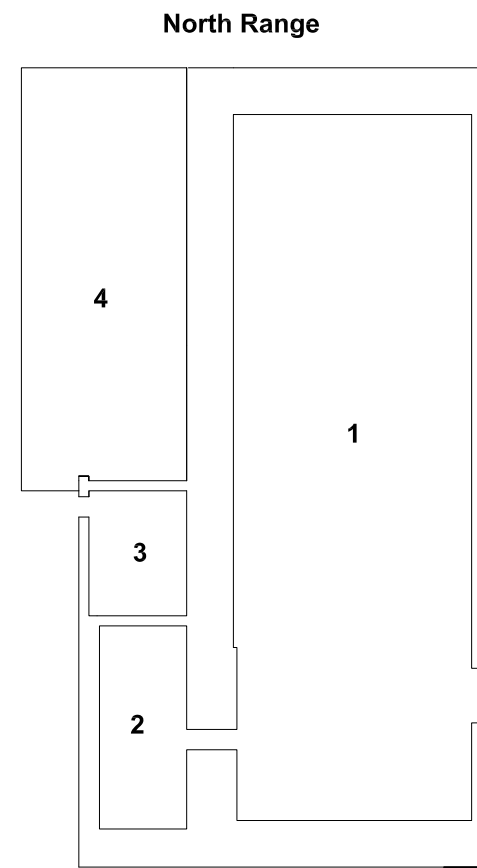
Fig.3d - North Range Ground Floor Plan

This building contains four individual interior units (Fig. 3d).

Unit 1 comprises a long barn which is defined as a pig-house on an electrical inspection sheet attached to the wall by the entrance. The interior was in a poor state with much of the roof in a state of collapse. The floor was mostly covered in refuse and debris from the collapsed roof. There are more clues to the development of this building on the interior than the exterior as the exterior has been heavily rendered and whitewashed.

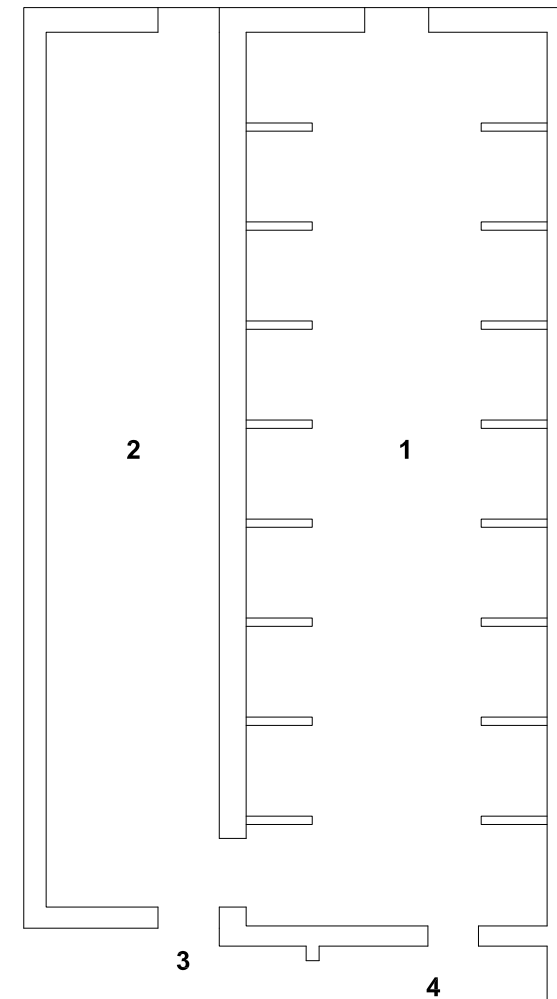
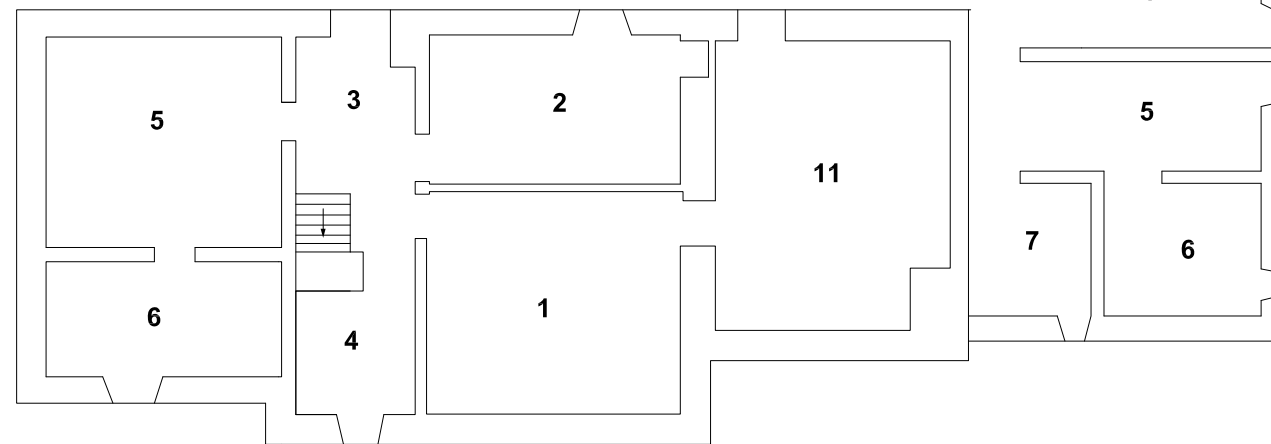
Fig.3b - East and South Range Ground Floor Plan

The interior of the farmhouse comprises 11 rooms on two floors (Figs 3b & 3c, Table 2). All interiors have modern decorations and fittings. Unit 5 has deep section timber skirting, and several ground floor rooms have tiled open fireplaces (Fig. 8). Unit 11 had plumbing fittings for a kitchen although the kitchen had already been removed. The bathroom was fitted with a modern suite. The loft is accessed via stairs with a flat central landing, and comprises two bedrooms (Units 7 & 8) with fireplaces and dormer windows looking out to the north, and a small box room (Unit 9). A small loft had been created above the kitchen (Unit 11) and was accessed by a narrow stair from the kitchen. The state of the stairs and the floor of the room prevented entry.

The interior of the East Range (Figs 3b & 18) is accessible from inside the house and from the north-facing gable into Units 1 and 2.

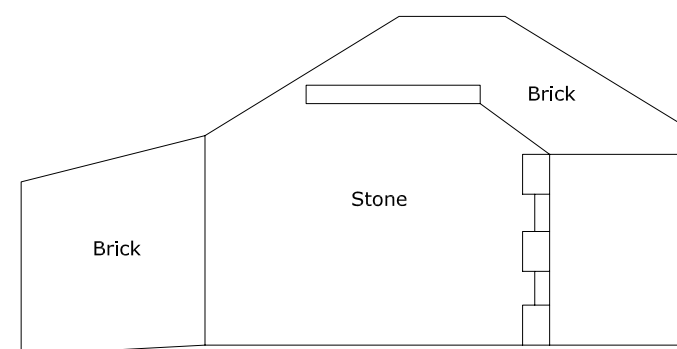
Fig. 4d - North range south facing

The south-facing elevation of the north range (Fig. 4d) forms a gable and has been substantially remodelled and repaired. The lower part of the original wall is built from stone while much of the upper part and the entire roof pitch are built of brick. Thick render and whitewash masks much of the horizon between the two so it is unclear exactly where the original build stops. The side of Unit 2 forms a lean-to at the left hand side of the elevation and is built of brick. A stone lintel is contained within the elevation although its purpose is unclear: possibly there was an earlier door or pitching window in the gable but if so no visible trace remains. The right hand side of the elevation has a cutaway recess, framed by an I-beam girder and is built from brick. Again the purpose of this is not clear.

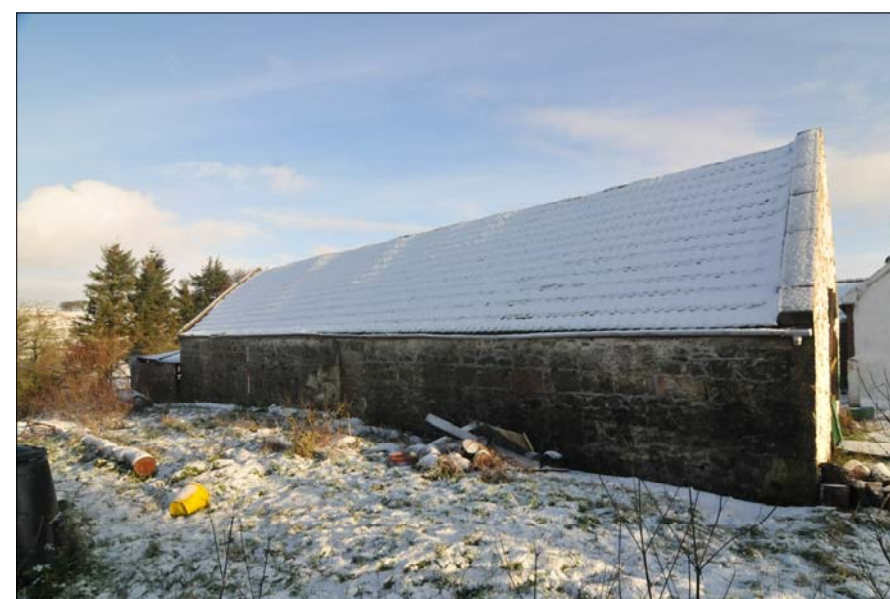
Fig. 4f - West range, west-facing elevation

The main build on the west-facing exterior (Fig. 4f) comprises a random rubble build surmounted by coursed blocks of stugged sandstone. The wall head above the sandstone comprises smaller more randomly-laid rubble construction. These alterations in wall height are evident within the interior of building (see above Section 4.5 para 3). A doorway blocked with brick is present towards the north end of Unit 1 (Fig. 3a). The doorway has dressed quoins on its north side only, the dressings on the south side have been replaced with a cruder set of stonework. The gable corners are all dressed with quoins.

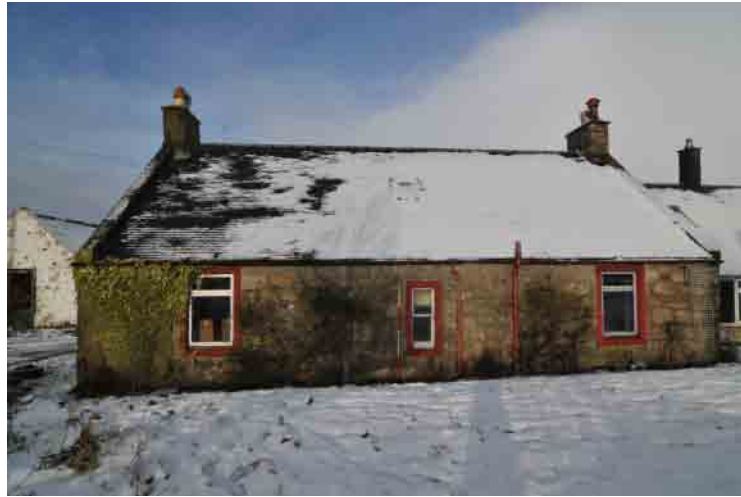
The south-facing elevation (Fig. 6) forms the rear of the house. The main build uses roughly shaped sandstone blocks in mostly regular coursing but it is much less formal than the ashlar build of the north-facing elevation. It also lacks the painted margins of the north-facing elevation, although the margins are raised on the edge of the quoins. The elevation has three vertical windows, all of which have raised and painted margins. The roof has a single small vertical skylight window.

Fig. 6 House exterior from the south

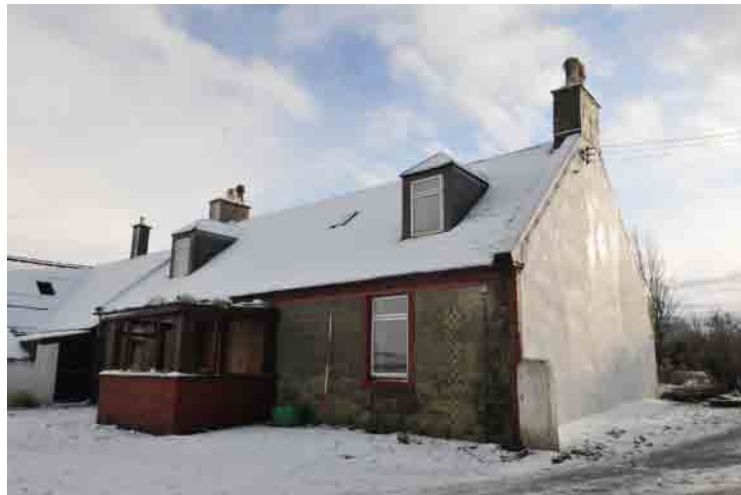
The house has a rectangular plan and is aligned east to west. It has pitched gables (Fig. 7) and has a modern extension off the east-facing gable linking it to the east range. The roof is grey slate and has sandstone skewers with an ashlar chimney stack at its west end and a brick chimney stack at its east.

Fig. 7 House exterior from the north-west

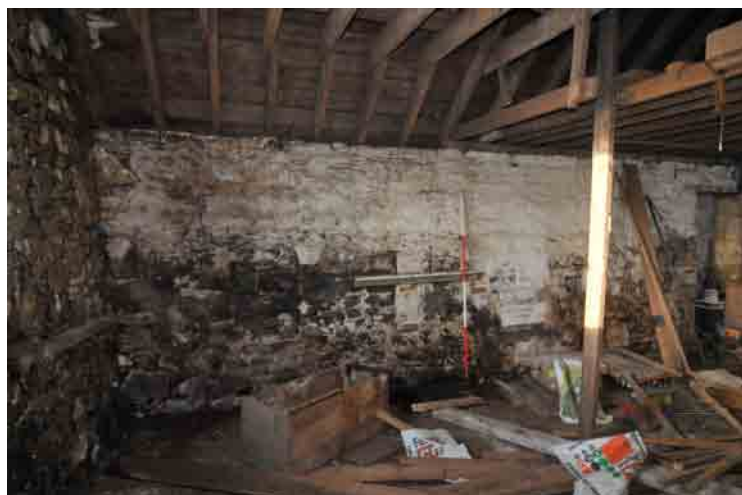
The east-facing elevation (Fig. 11) contains blocking work including a rectangular slit-vent now blocked with brick. Adjacent to the blocked slit-vent is a larger area of brick blocking work that contains a small timber-framed rectangular box set into the wall. The purpose of this blocked aperture is likely to have been associated with a belt drive that operated from an internal engine to machinery located outside the building. Further evidence for internal machinery includes the vertically set blockings on this elevation and on the west-facing elevation that are directly opposite each other, suggesting that a large structural member, possibly associated with machinery, was set across the interior. The different floor levels might also suggest the presence of machine stances. The east-facing elevation also features a sub-circular area of rough blockwork filled with rubble and mortar. The right hand side of the elevation has a bricked up doorway which now forms a recess.

Fig. 11 West range interior, Unit 1 east-facing elevation

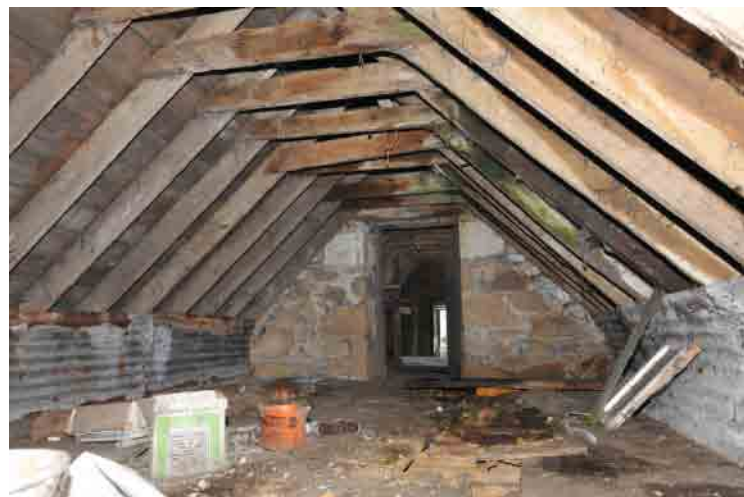
Fig. 14 West range loft from the south

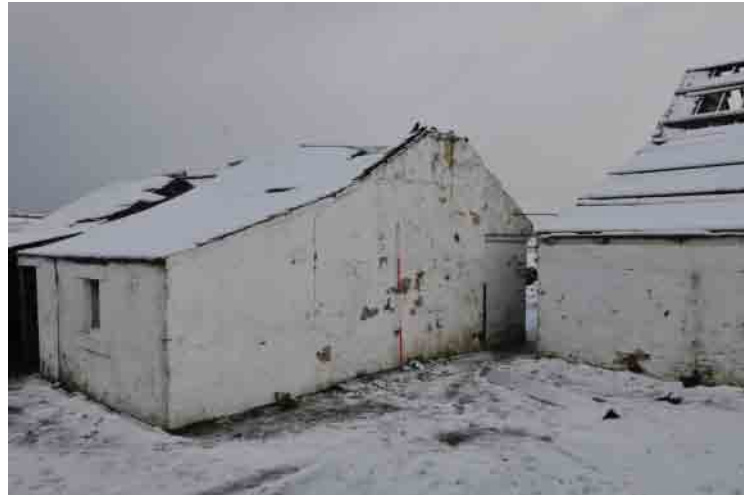
The northern range (Fig. 15) has been extensively remodelled and extended, although most of the detail is only visible on the inside, as described above.

The west-facing elevation comprises the exteriors of the corrugated iron lean-to (Unit 4) and the brick built sheds (Units 2 & 3), which have been added to the original building. A doorway gives access to Unit 3. The corrugated iron roof of the log/coal shed and the tin/zinc roofs of the sheds are in good condition. The roof of the main north range is in a state of collapse.

Fig. 15 North range, exterior from the south-west

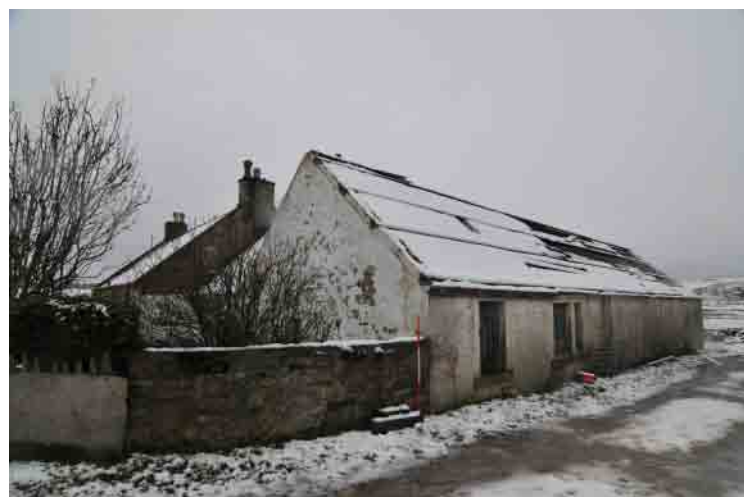
The East Range (Fig. 17) comprises a long byre aligned north to south with an added lean-to extending the width of the building to the west. It has a pitched roof which is in poor condition, with grey slates over sarking boards on a rafter and through-purlin truss. The south end of the roof has sandstone skewers while the north end has an open wall plate which would have supported a flush fitting roof.

Fig. 17 East range exterior from the south-east

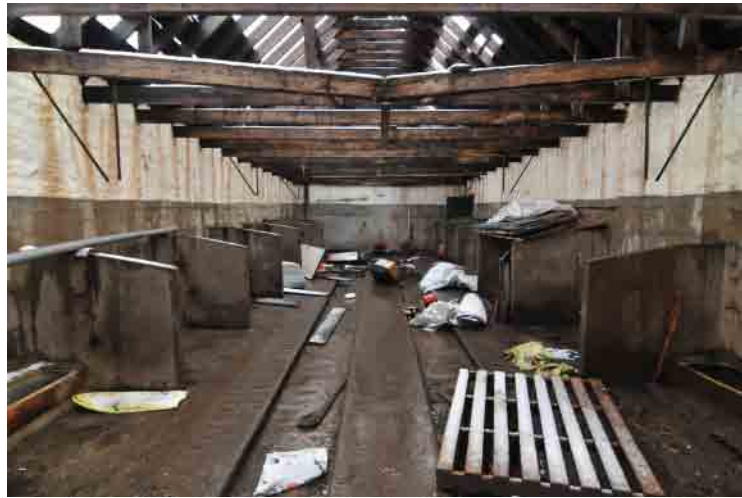
Units 1 and 2 are fitted out as byres (Fig. 18). Unit 1 has a row of concrete stalls with plumbed in drinking bowls and double feed troughs running down each side. Both have textured concrete floors and central slopping out channels. The west-facing

Fig. 18 East range (Unit 1) interior

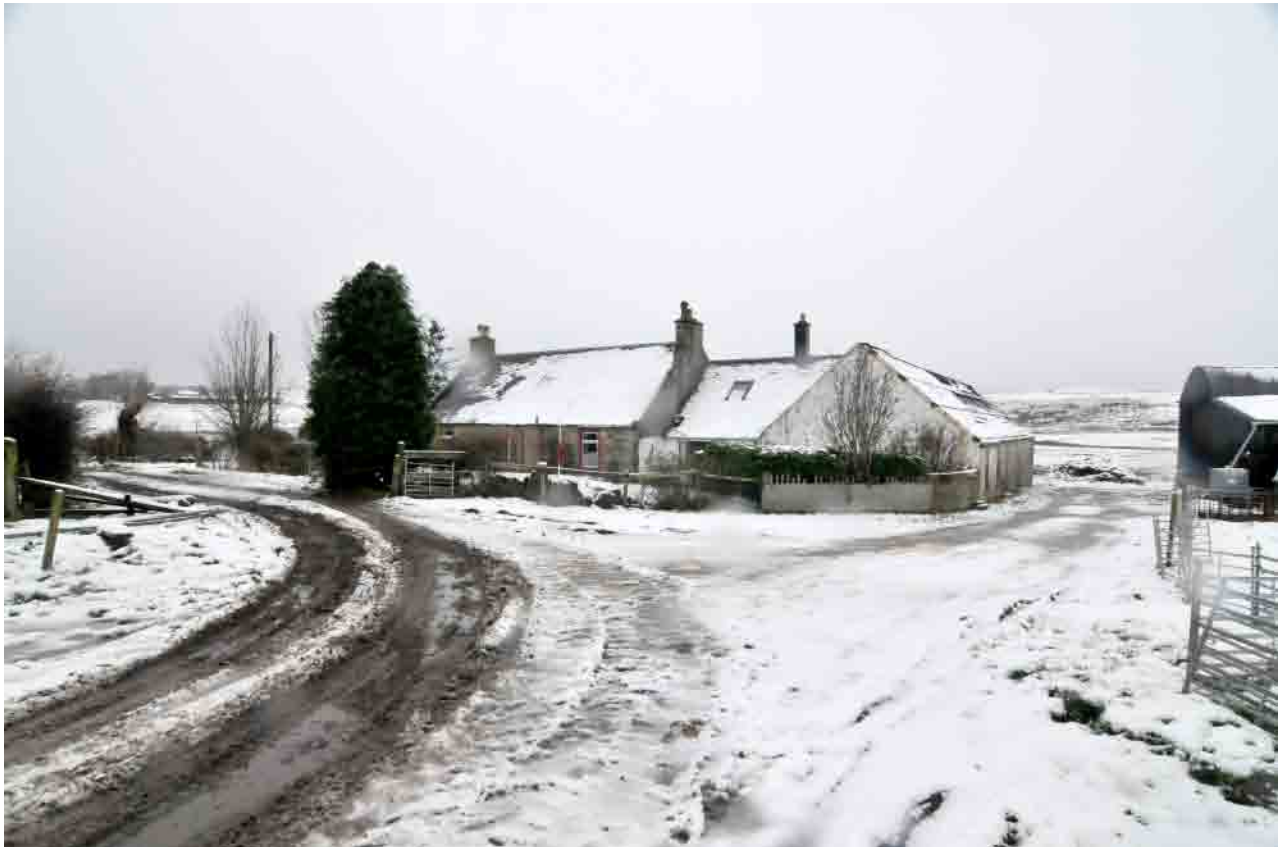
The Riggfoot Farm complex is a three-sided enclosed farmyard (Fig. 1, 21) comprising a farmhouse with an attached east range, a detached north range and west range. A small box barn c.25m to the south has been included in the survey. More recent buildings have been added to the east of the main farm complex in the form of girder and corrugated iron sheds and a large polytunnel. The farm was unoccupied at the time of the survey although parts were still in use for storage of animal feed.

Fig. 21 General view of Riggfoot from south-east
