Borders Railway Project Site 13,14 & 613 Archaeological Evaluation

Report no. 1998

**Borders Railway Project
Archaeological Evaluation of Sites 13, 14 and 613.**

**Data Structure Report
No. 1998**

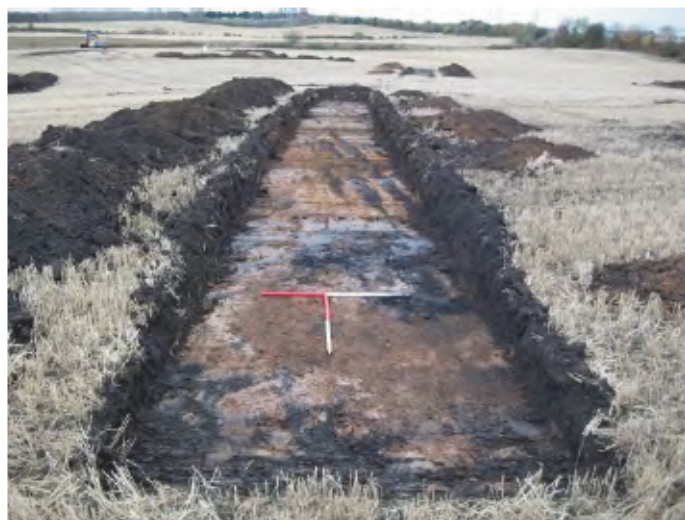
Fig. 3 Tr. 12 showing modern plough scarring from the north

Plough scarring in the natural geology due to the shallow topsoil was seen across many of the trenches, (Fig. 3), these scars followed the direction seen in contemporary ploughing and crop planting.

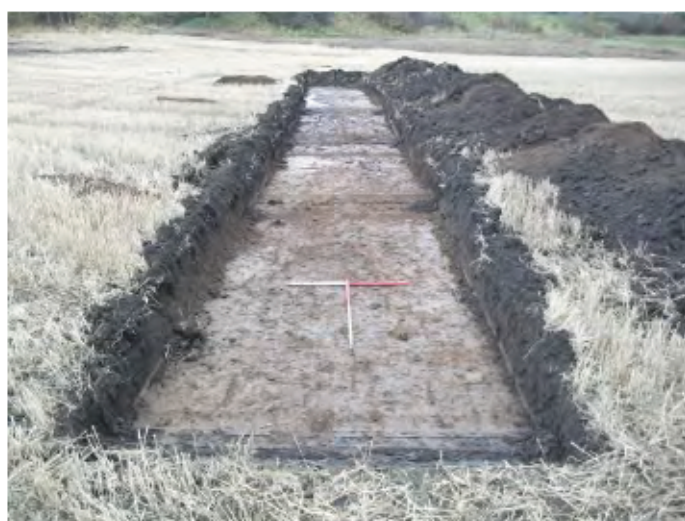
Fig. 4 Tr. 17 post-ex from the north

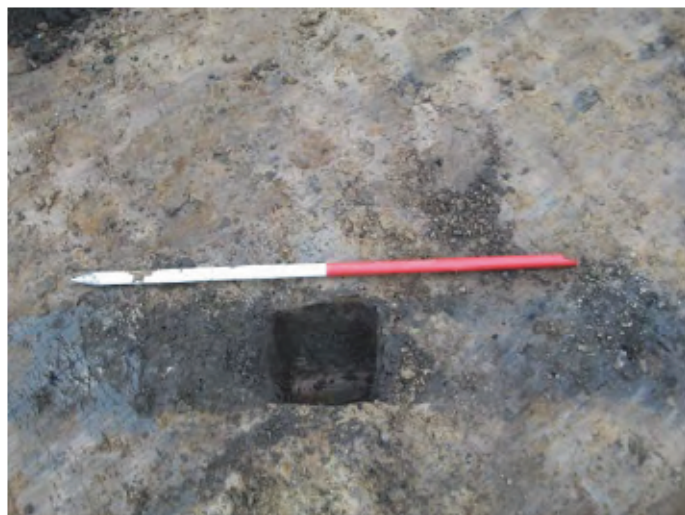
Fig. 5 Depth of ceramic field drain in the base of Tr.6

Ceramic field drains were encountered in many of the trenches. The ceramic drains were encountered in most of the trenches at a depth of approximately 0.10m below the level of the natural geology and were thus not damaged by the trench excavation process, (Fig. 5).

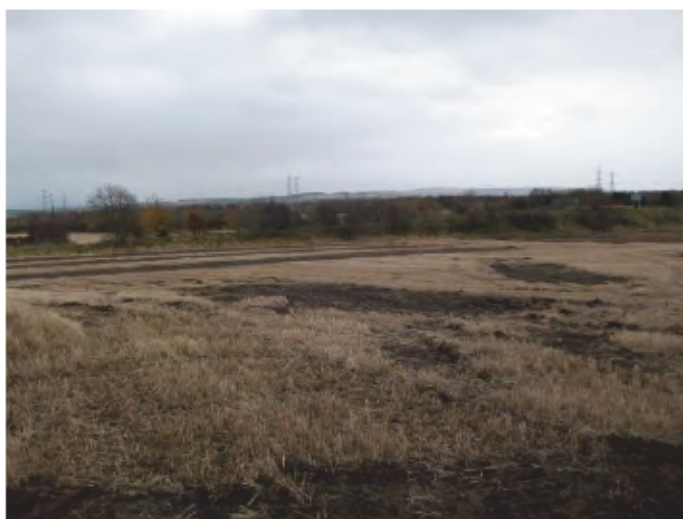
Fig. 6 General shot of South side of Millerhill Road after backfilling

Fig. 6 General shot of South side of Millerhill Road after backfilling

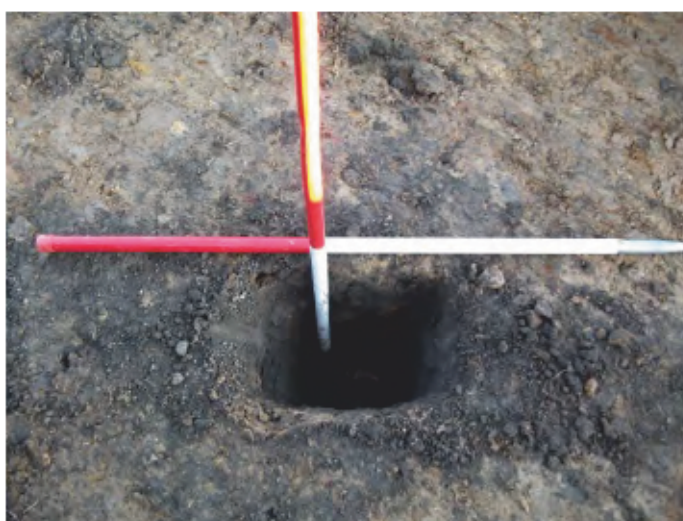
Fig. 7 Tr. 1 showing depth of ceramic field drain at base of trench

Ceramic field drains were encountered in many of the trenches. The ceramic drains were encountered in most of the trenches at a depth of approximately 0.40m below the level of the natural geology and were thus not damaged by the trench excavation process, (Fig. 7).

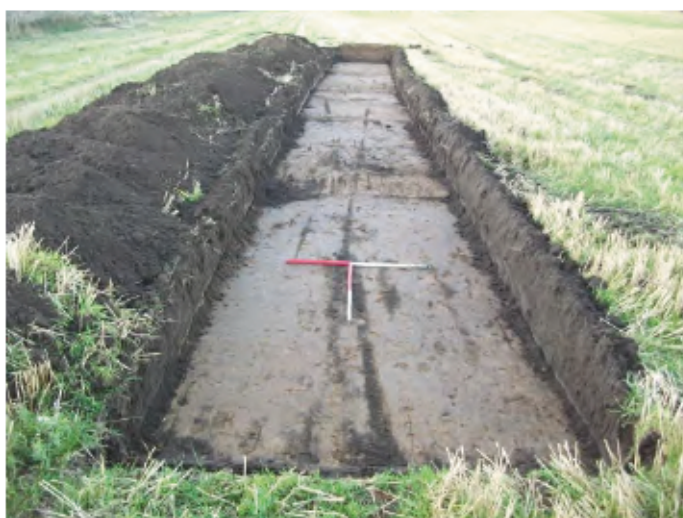
Fig. 8 Post-ex shot of Tr. 6 showing modern plough scarring

Plough scarring in the natural geology due to the shallow topsoil was seen across many of the trenches, these scars followed the direction seen in contemporary ploughing and crop planting on the topsoil surface, (Fig. 8).

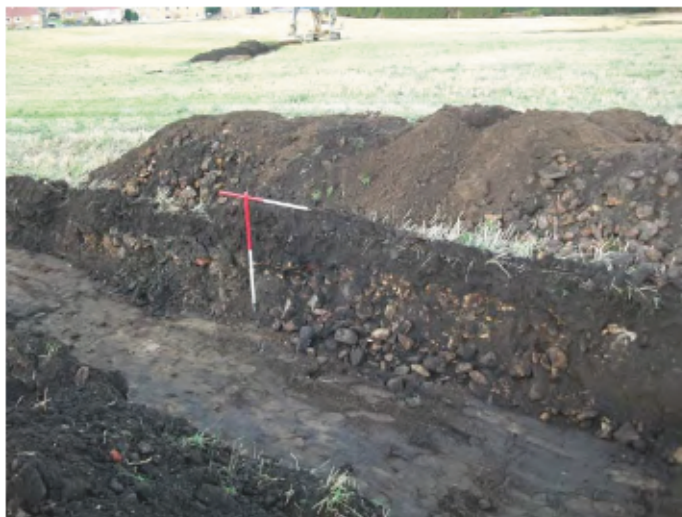
Fig. 9 South-facing section in Tr. 6 showing made ground consisting of crushed sandstone and brick

Areas of deliberate ground levelling were discovered in Trenches 2, 6, 20 and 21, These took the form of spreads of fine/small coal and crushed sandstone/brick deposits which levelled the topography where the natural dropped at a steep angle. Fragments of white ceramic and broken pieces of rusting metal were found within these deposits, (Fig. 9).

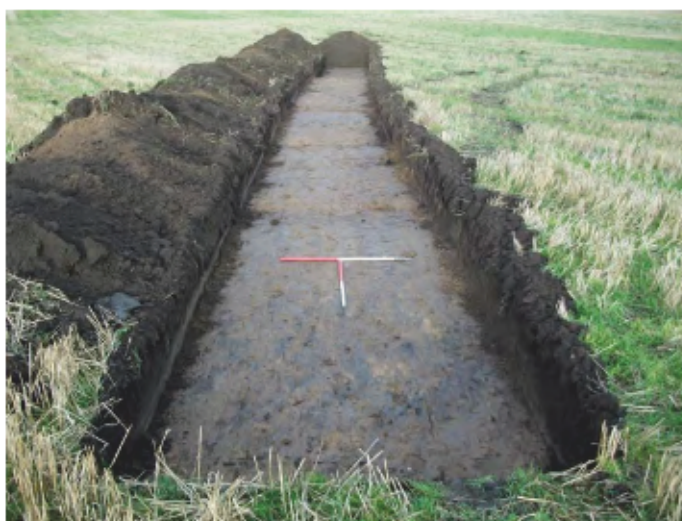
Fig. 10 Post-ex shot of Tr. 20
