**Polwarth Crofts
Near Duns,
Scottish Borders**

Standing Building Survey

Report No. 2001

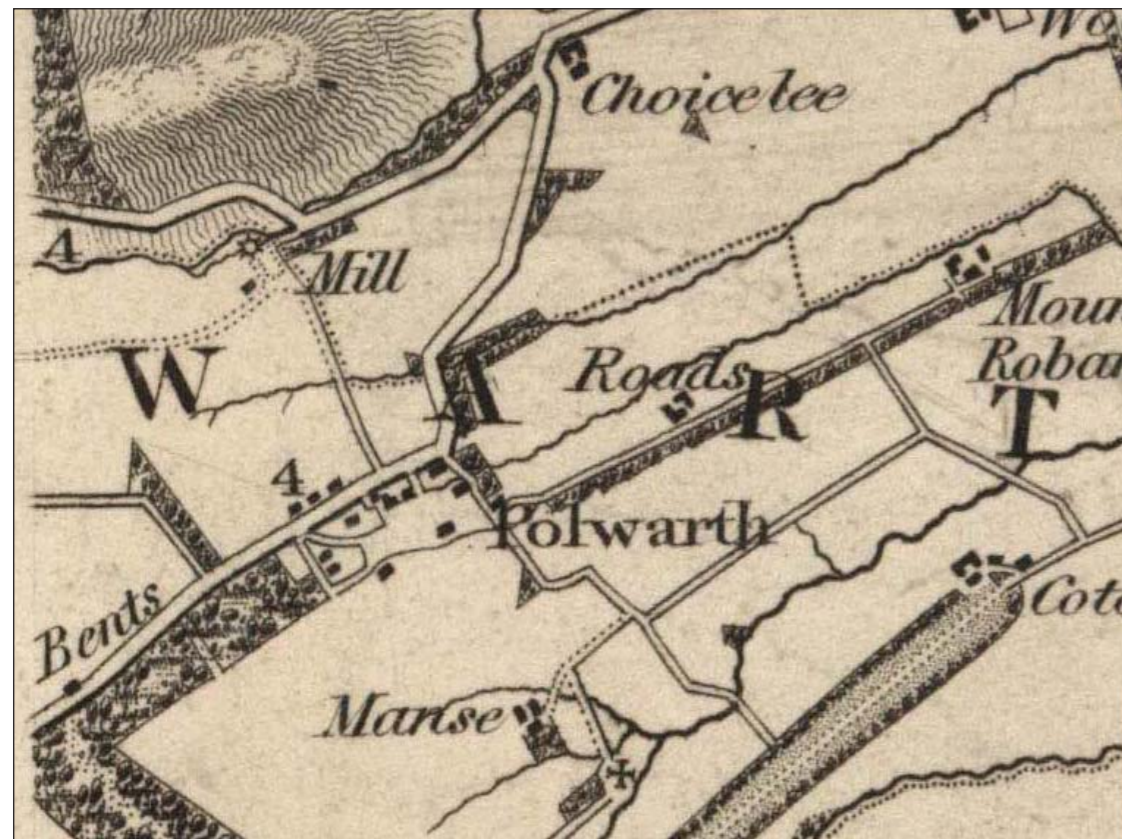
Fig. 2a - Sharp, Greenwood and Fowler, 1826 map

The 1826 map by Sharp, Greenwood and Fowler (Fig. 2a) shows Polwarth as a dispersed settlement comprising a series of rectangular buildings within four property boundaries. Polwarth Crofts does not appear on this map.

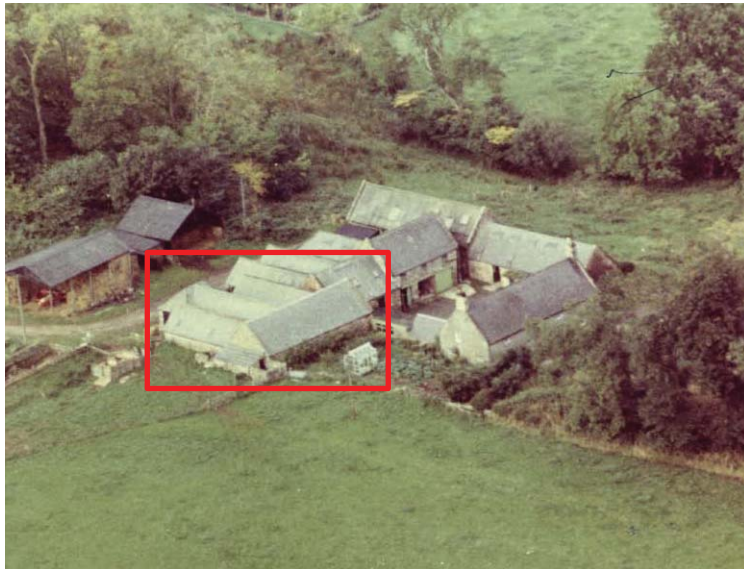
The circa 1967 oblique aerial photograph (Plate 1) shows the steading from the south-east. The east-facing elevation of the barn can be seen with three adjoining pitched roofs aligned east to west and forming a double-M arrangement on its west side. A pig sty with a slated lean-to roof is present on the south gable of the barn. Two of the cattle court roofs adjoin a rectangular building interpreted as a feed store. The stable and cartshed is shown as it was prior to conversion into a modern dwelling.

Plate 1 - A circa 1967 oblique aerial photograph of Polwarth Steading with the barn at its south end

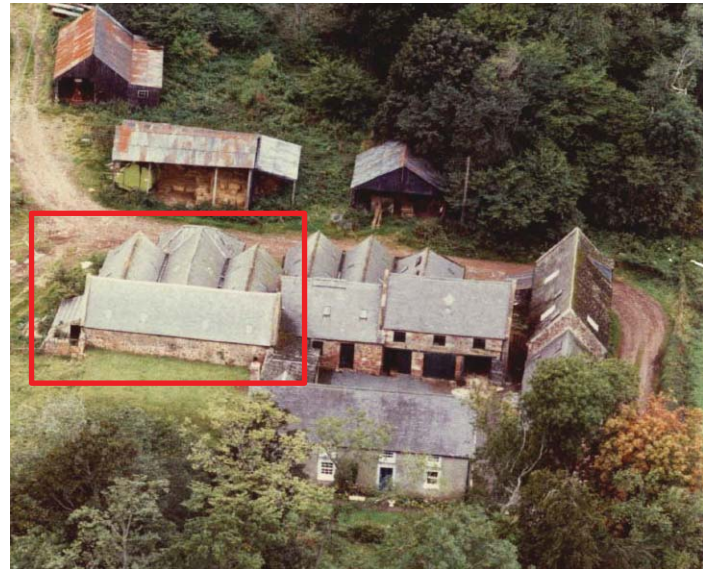
The circa 1978 oblique aerial photograph (Plate 2) is taken from the east and shows the east-facing elevation of the barn and the roofed cattle sheds on its west side. A small lean-to building can be seen built against the north gable of the barn

Plate 2 - A circa 1978 oblique aerial photograph of Polwarth Steading showing the east-facing elevation of the barn and adjoining stables and cartshed

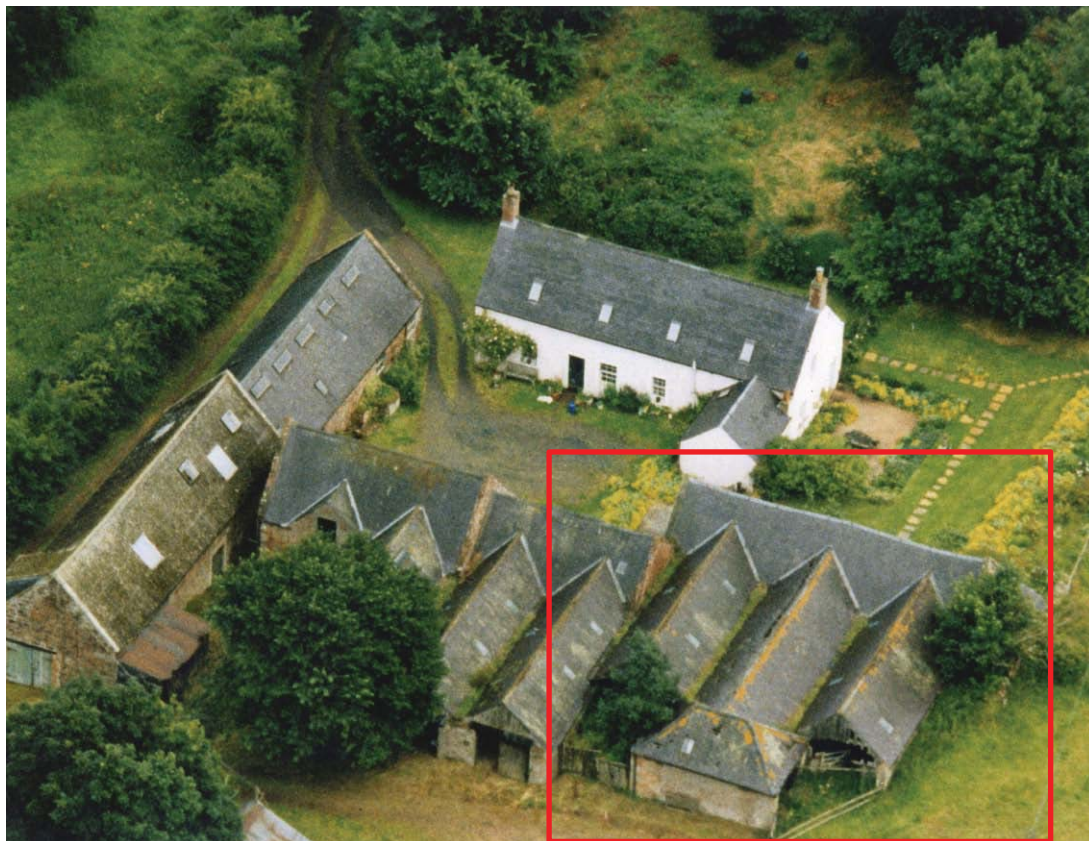
The circa 1998 oblique aerial photograph (Plate 3) shows the roof configuration of the cattle sheds on the west side of the barn. The west-elevation of the adjoining feed store is also shown. The shed on the south side of the former feed store has wooden slats on its gable to provide ventilation to the interiors. The aforementioned lean-to structure is just visible on the north end of the barn.

Plate 3 - A circa 1998 oblique aerial photograph of Polwarth Steading prior to the conversion of the outbuildings. The double M-shaped roof arrangement can be seen on the west side of the barn

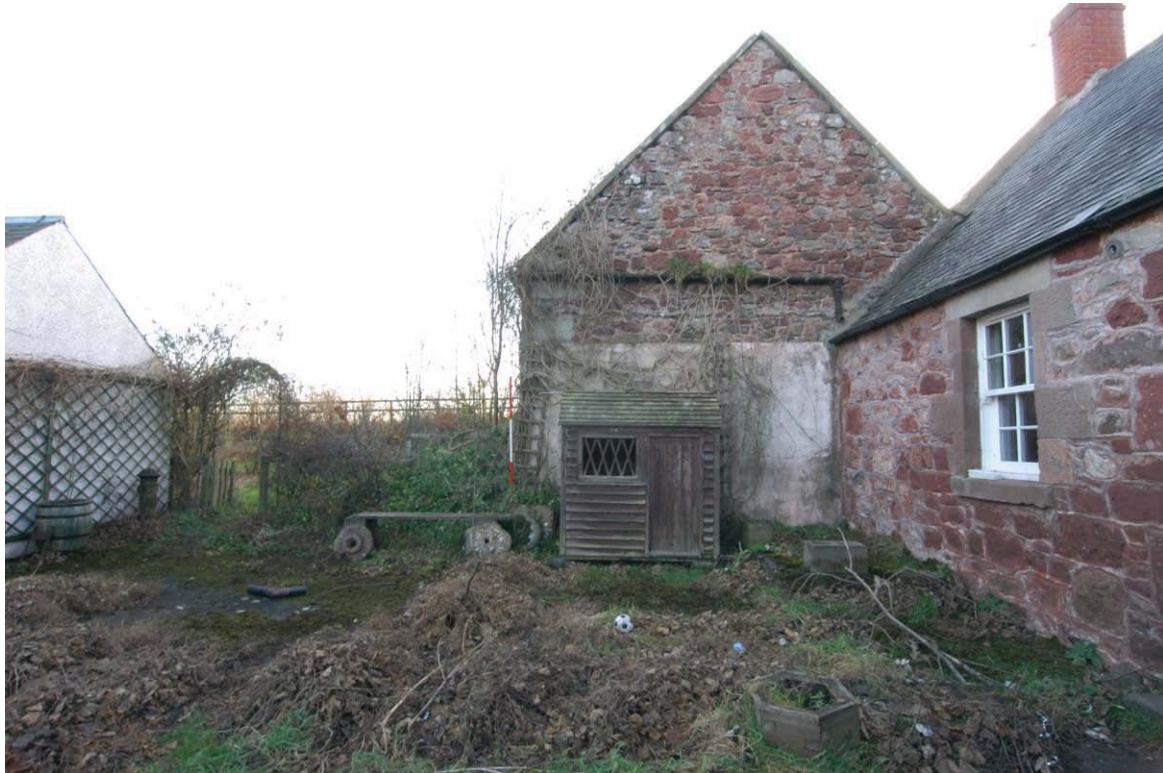
The north-facing gable measures c.4m wide and 6m high and is constructed of coursed sandstone rubble with droved ashlar quoins and ridge stones. The lower third

of the gable has been rendered with cement. Approximately 0.3m above the render is a horizontal roof line from a lean-to structure.

Plate 4 - North-facing elevation of the barn

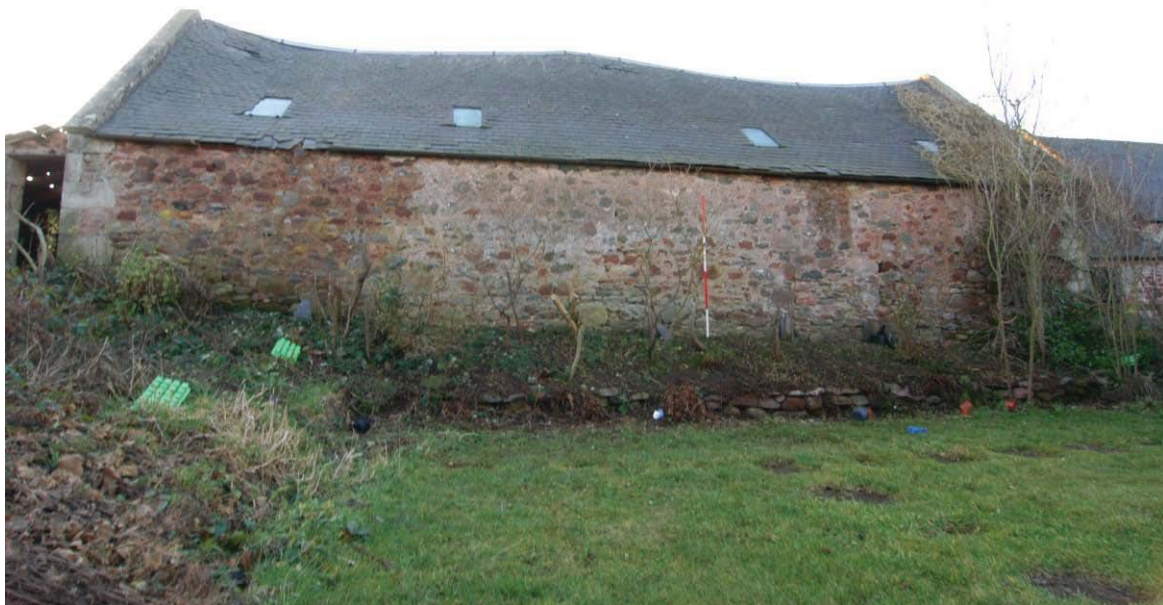
The east-facing elevation measures 14.4m long and is c.6m high. The elevation is featureless and is constructed from coursed sandstone rubble with droved ashlar quoins. The pitched slate roof is intact and has four roof lights.

Plate 5 - East-facing elevation of the barn

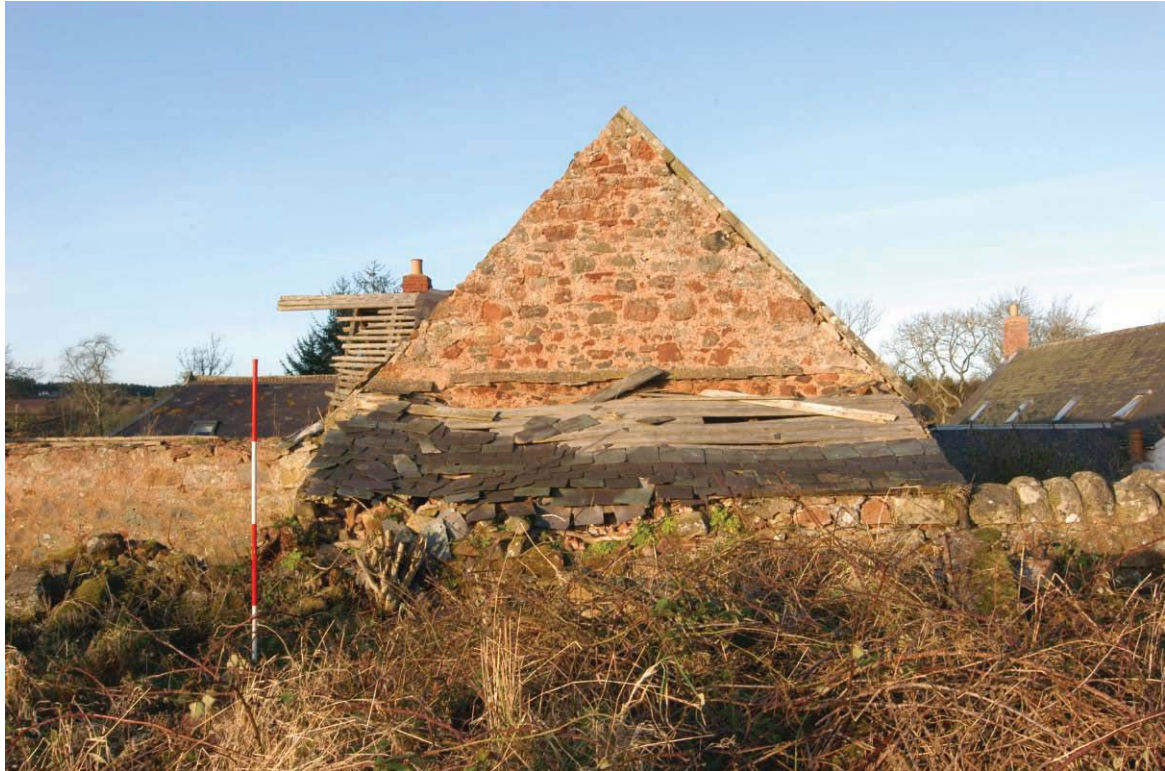
The south-facing gable is constructed of coursed sandstone rubble with ridge stones only surviving on its east side. Occupying about one third of the elevation is the slate lean-to roof of the pigsties. The timber sarking boards of the pigsty roof are exposed where the slates have been removed.

Plate 6 - South-facing gable and lean-to roof of the pigsties

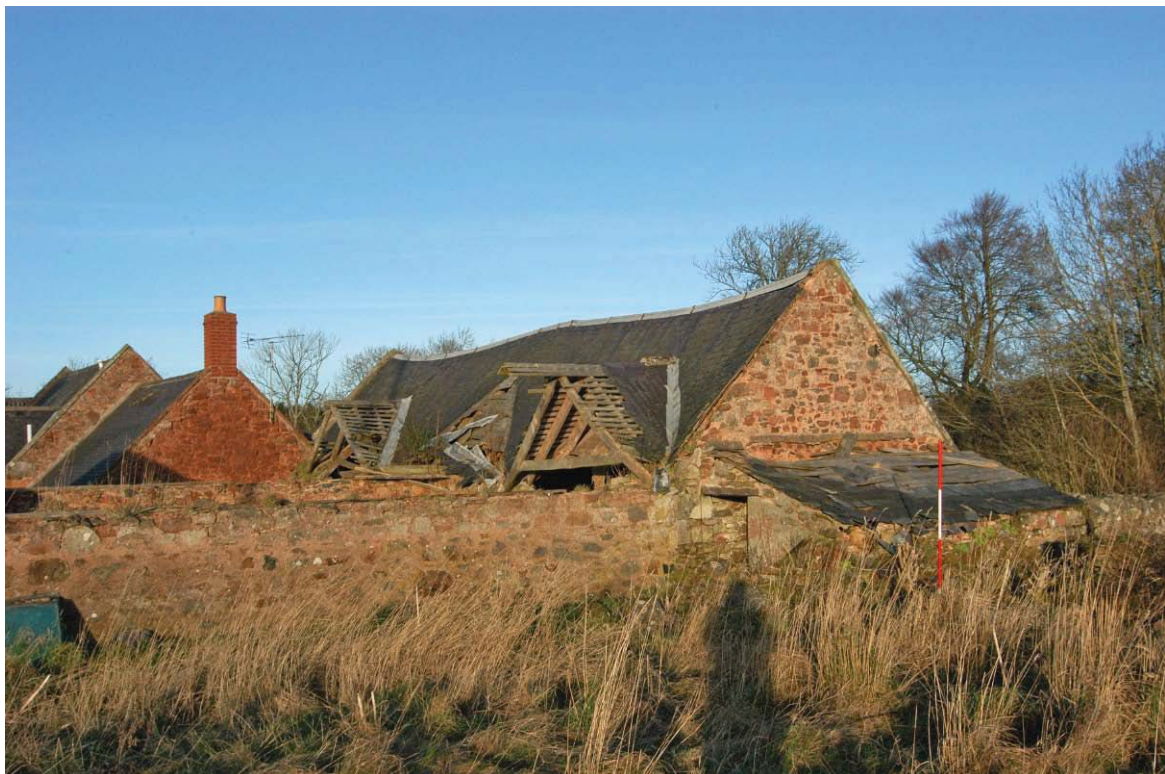
The west-facing elevation has rubble-built walls measuring 2.2m high. Two rectangular doorways are framed by rough-dressed sandstone blocks. Both doors measure 2.2m wide and are surmounted by the A-frame rafters of the former M-shaped roof. The central spine wall carried the middle hipped truss, the outline of which can be seen in the exposed sarking boards.

Plate 7 - General view of the west-facing elevation and south gable

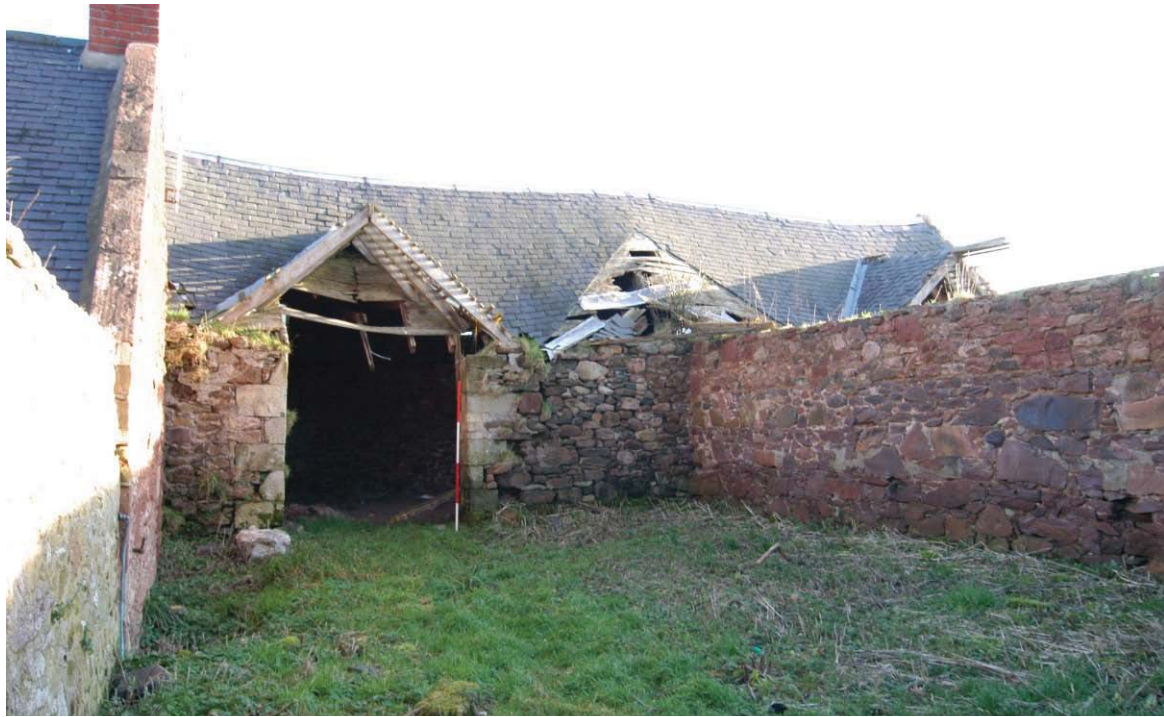
Following the same alignment as the partition wall between Units 1 and 2 is an exterior wall measuring 8.7m long that is constructed of coursed rubble and whinstone with clear evidence it has been heightened (Plate 8). This wall forms the central supporting wall that carried the roof arrangement seen on the aerial photographs (Plate 3). This former load bearing wall abuts a rectangular former feed store.

Plate 8 - Interior of the cattle court showing the entrance to Unit 1

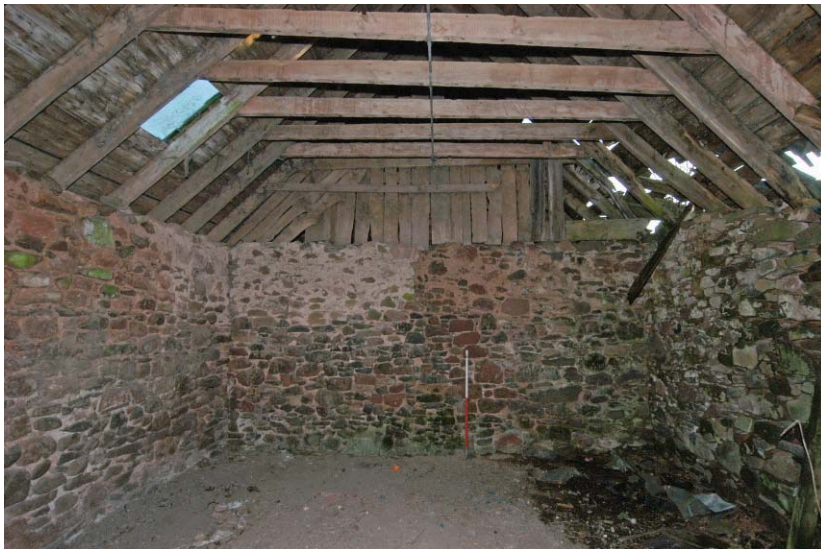
The roof comprises a series of A-framed scarfe-jointed trusses resting directly on the wall head (Plate 9). The softwood timbers are machine cut and covered with pine sarking boards.

Plate 9 - A-frame roof joists resting on the wall heads and the partition wall

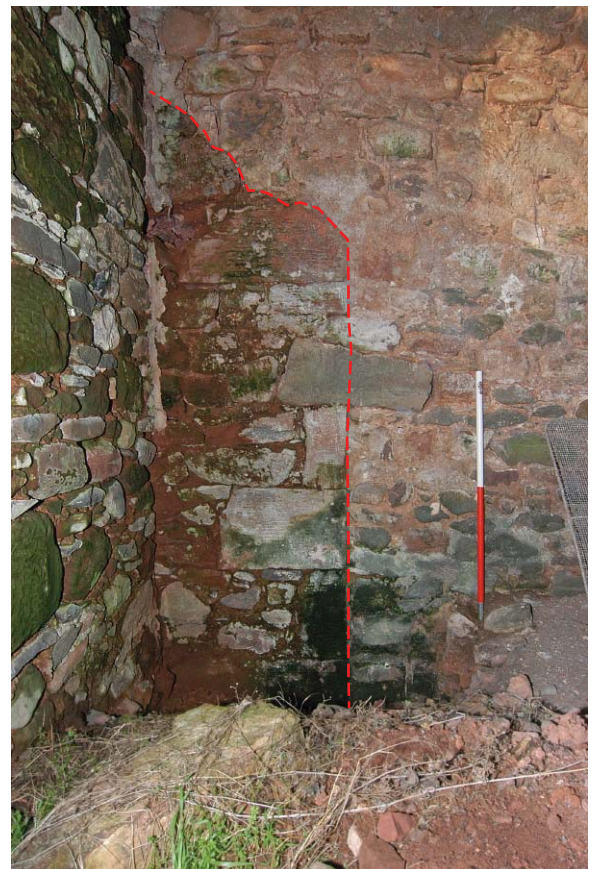
The internal walls are featureless and comprise coursed sandstone rubble with droved ashlar quoins surrounding the doorways on the interior east-facing elevation. A wooden feed stall has been built against the north-facing gable. The south-facing gable has been built onto the gable of the stable, its quoins and skew stone is visible on the interior south-facing gable. The barn's gable has been crudely keyed in with the stable gable using a large boulder (Plate 10).

Plate 10 - Quoins of the adjoining stable block keyed into the fabric of the gable of the barn
