**Former Coastguard Station, Victoria Road,
North Berwick, East Lothian**

Archaeological Watching Brief

Report No. 2029

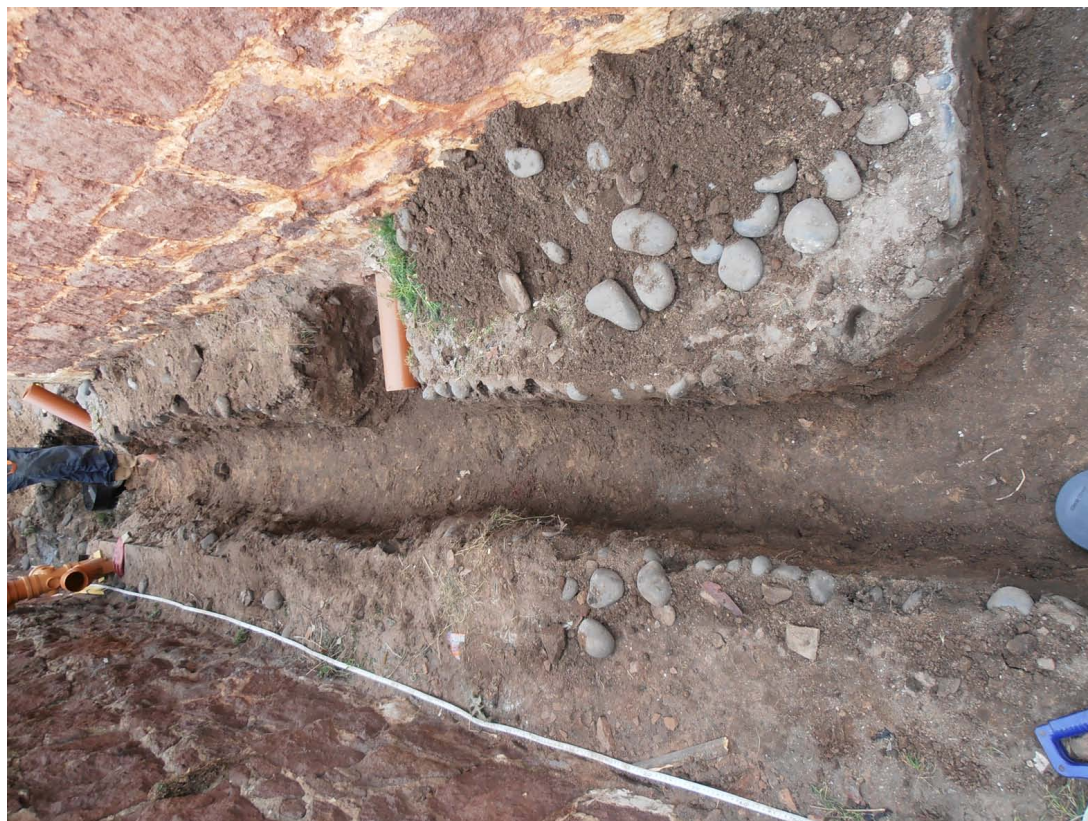
Numbers in bold in the following text refer to contexts, a full list of which is contained in Appendix 1. The watching brief monitored the excavation of a pipe trench around the western side of the building, within the enclosing wall (Fig. 2, 3). The trench was 0.5m wide, 9.5m in total length, and reached up to 0.5m deep.

The existing site surface was cobbled (**101**) which covered the whole site except for a thin strip 0.35m wide against the inner side of the western enclosing wall which was covered in concrete (**100**).

Figure 3 - General view of the service trench along the west side of the Coastguard Station

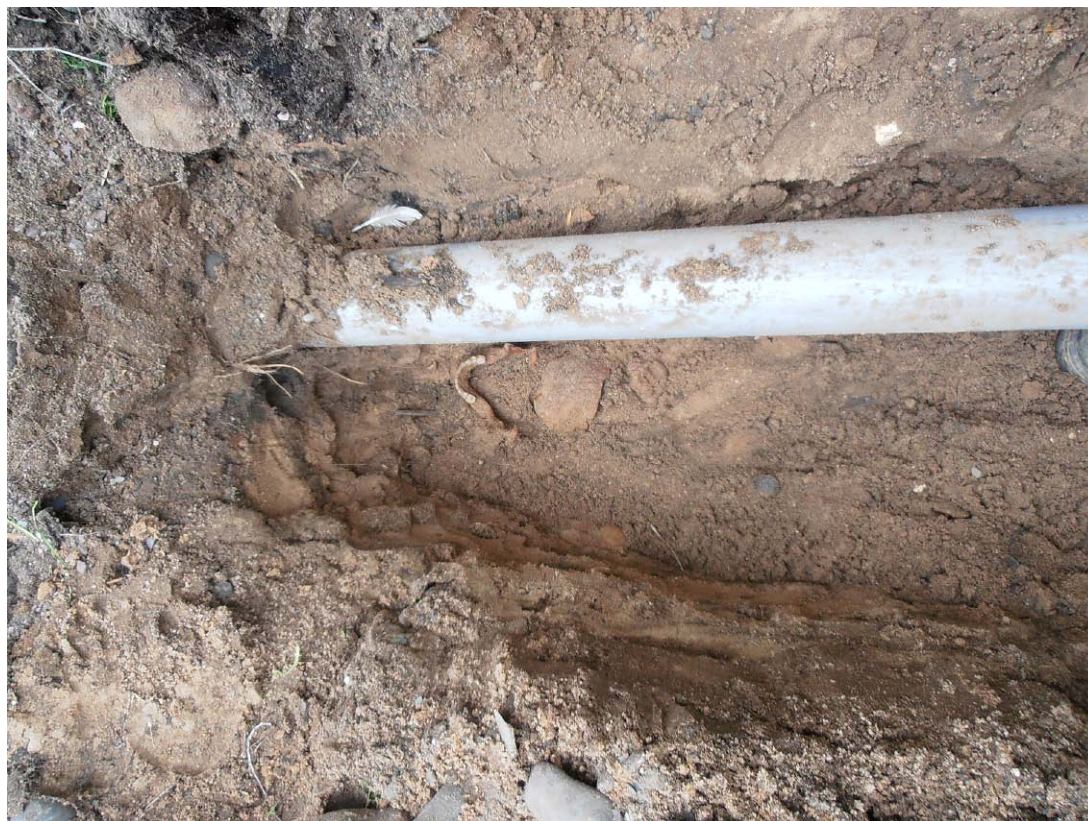
An existing pipe trench **[104]**, with a mid brown sand fill **(105)**, contained a plastic pipe and cut through deposits **102** and **103** to a depth of 0.42m. Some lengths of long bone, skull and mandible were recovered from within this fill (Fig. 4).

Figure 4 - Loose human remains in fill of pre-existing pipe

All human remains which were uncovered at the time of excavation were reported to the local police and some were removed from site by the police. These were returned to CFA and subsequently reburied in close proximity to their find spots, at the depth of maximum excavation where they will not be disturbed (Fig. 6). The trench was then backfilled.

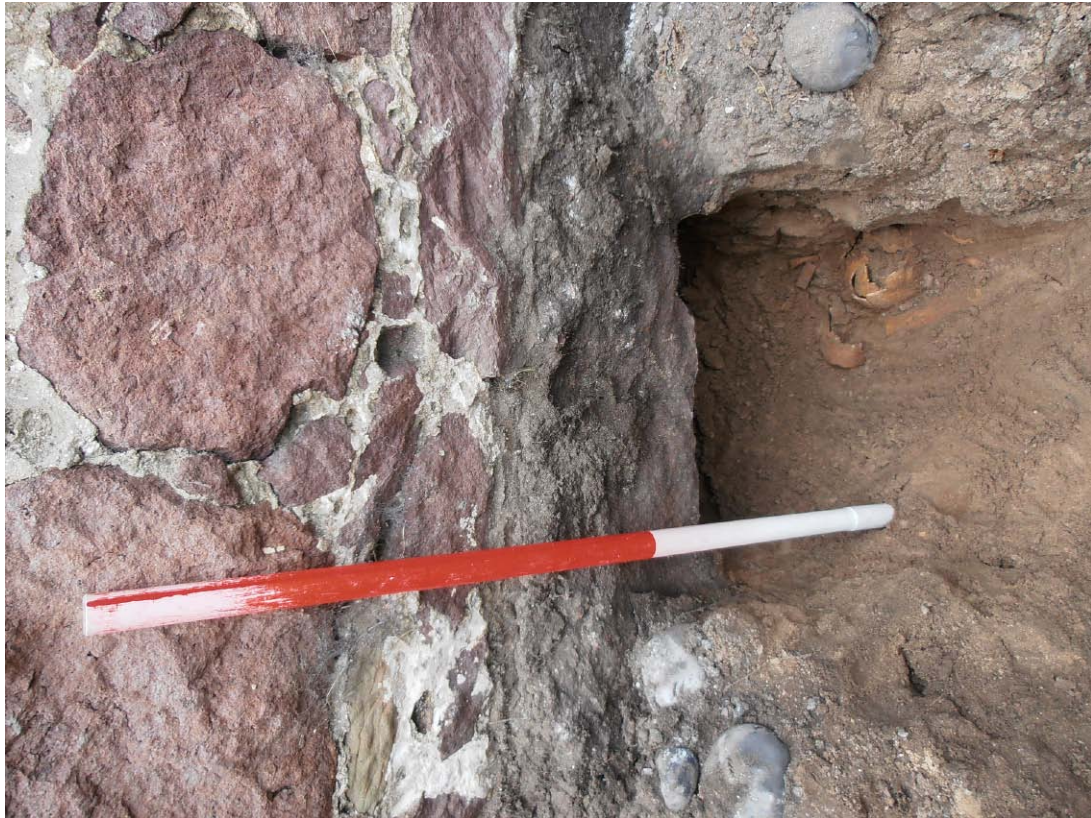
Human remains were recovered within the layers of made ground **(102, 103)** beneath the site's cobbled surface, and charnel was also recovered from within the fill **(105)** of a recent pipe trench **(104)**. Where possible these remains were left in situ. The human remains that had to be removed were reburied at an appropriate depth, close to their original find spots. Three individuals could be identified from the recovered remains, two adults and one child. These remains appear to relate to the graveyard of the 12th-century St Andrew's Chapel which lies adjacent to the development site.

Figure 5 - Human remains located below wall on west - left in situ

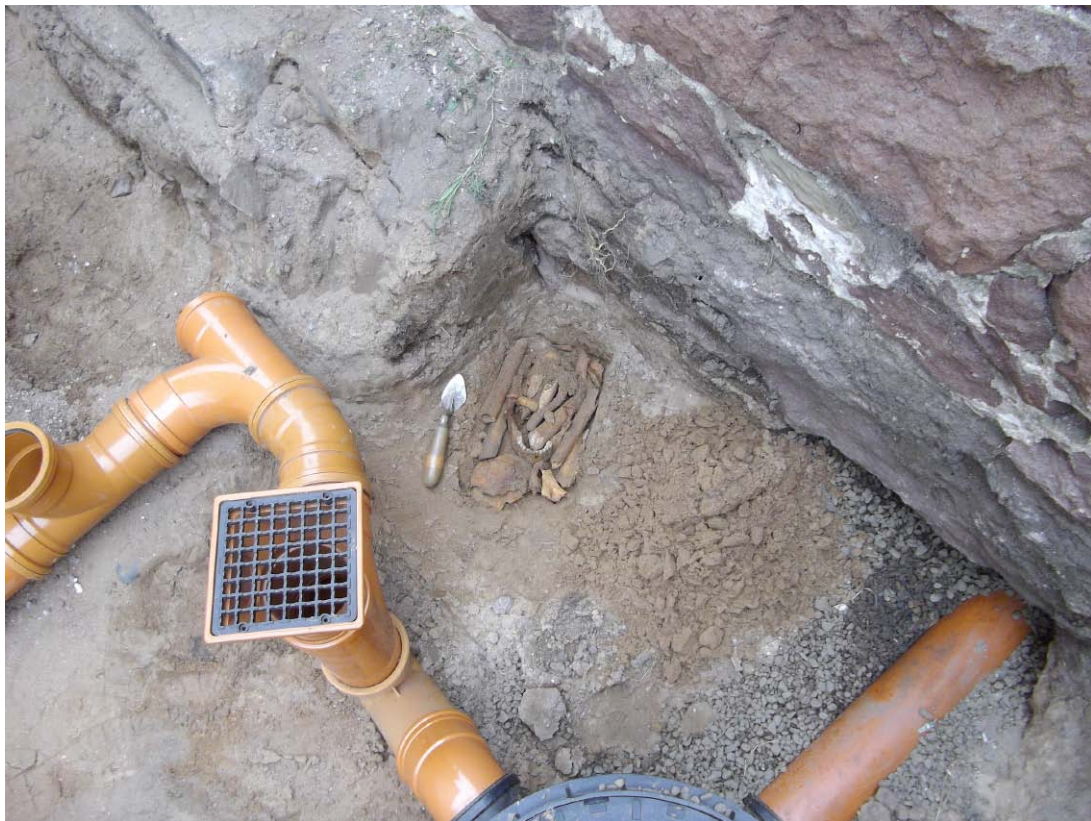
Figure 6 - Reburial cache
