**Bonnington House  
Near Wilkieston  
City of Edinburgh**

**Archaeological Watching Brief**

**Report No. 2028**

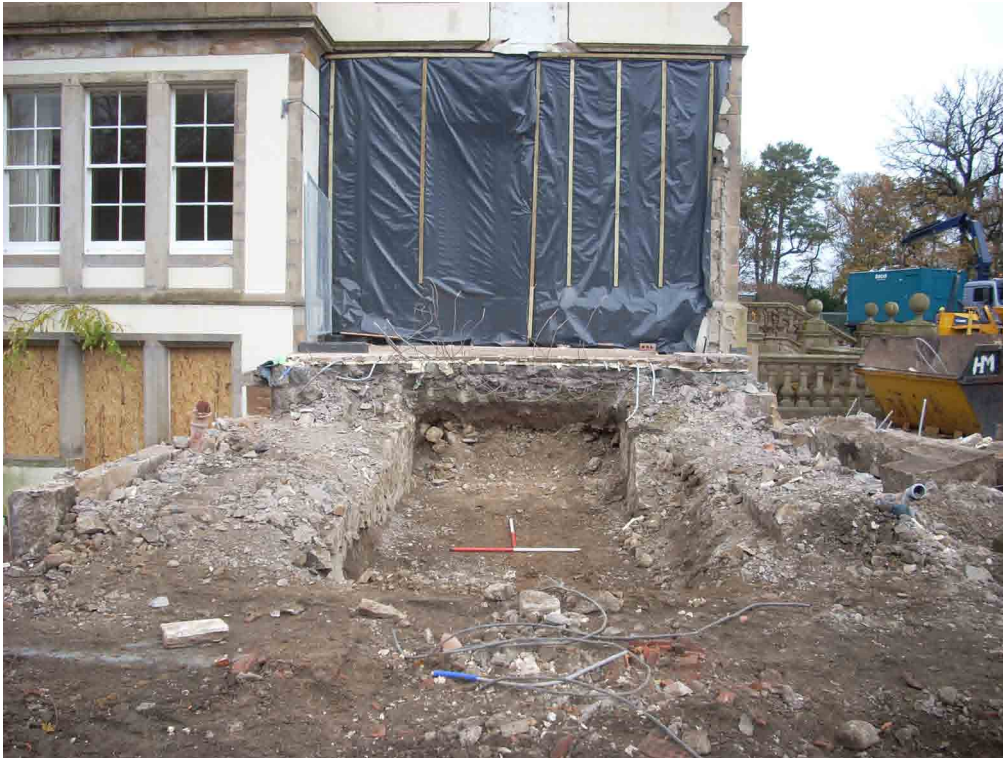
Within the area defined by walls **001/002/009** were two further walls (**003** and **004**), each measuring 5.7m long by 0.9m wide with rubble core (Fig. 3). These were aligned N-S along the axis of the structure. Rubble infill (**005**, **007**) lay between these walls and the outer walls. The walls sat on a sandy clay made ground.

Fig. 3 - The footings beneath the demolished conservatory

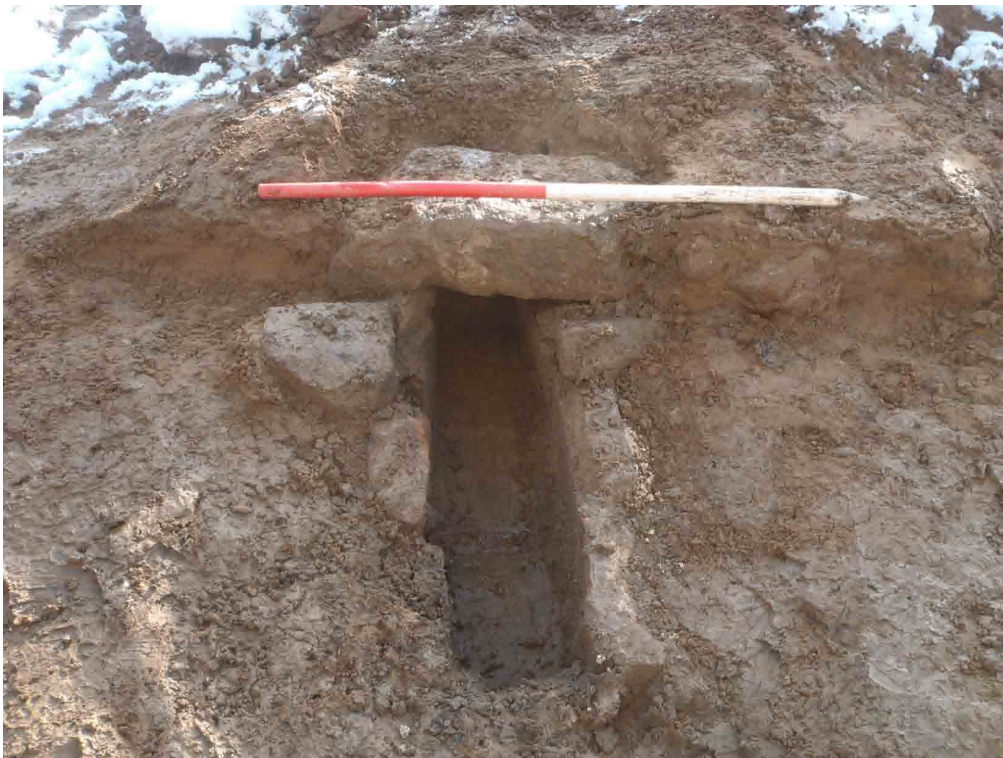
A box drain and a stone built cistern were also recorded within the southern area of the archaeological watching brief. The box drain was situated 6m SSE of the southern wall of Bonnington House. The cut of the box drain (**039**), aligned NW-SE, was 0.4m wide by 0.35m deep with vertical sides and a flat base (Fig. 2, 4). The sides of the box drain consisted of 1-2 courses of stones (**038**), set against the sides of the cut of the drain. Only one capstone of the box drain was uncovered (**037**), which measured 0.3m by 0.5m by 0.15m.

Fig. 4 - The box drain (038)

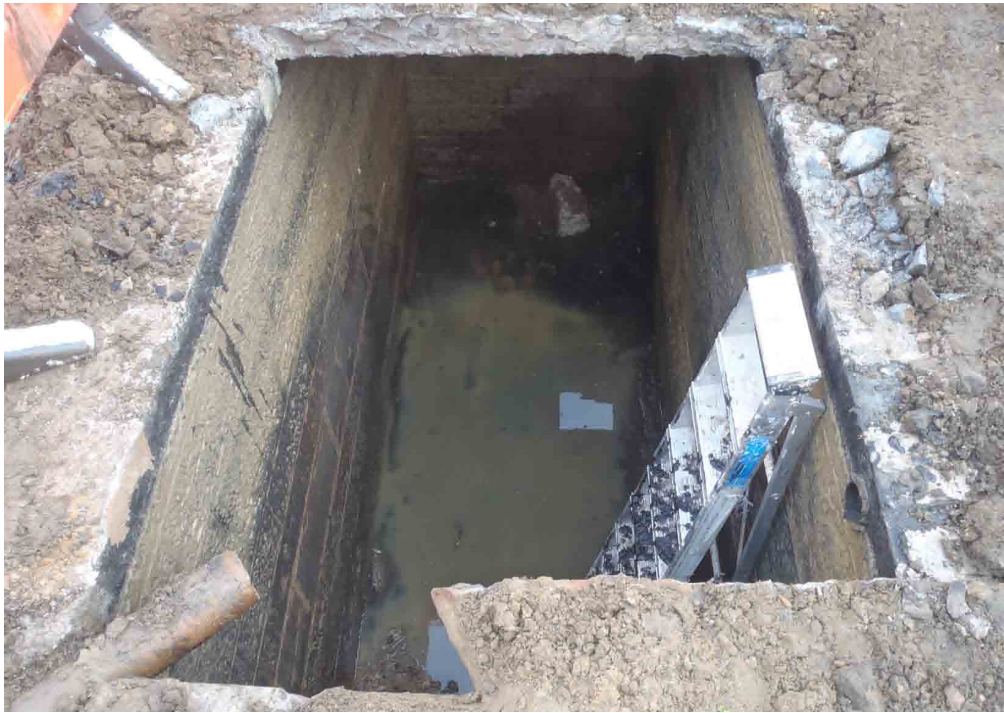
A stone built cistern (**042**) was recorded 20m south of the south wall of the main house. The cistern, measuring 3.7m by 1.4m by 2.5m deep, was stone capped with vertical sides and was full of water (Fig. 2, 5). The walls consisted of eleven courses of dressed stone. The cistern was exposed, drained of water and recorded but was then left in situ.

Fig. 5 - The cistern (042)

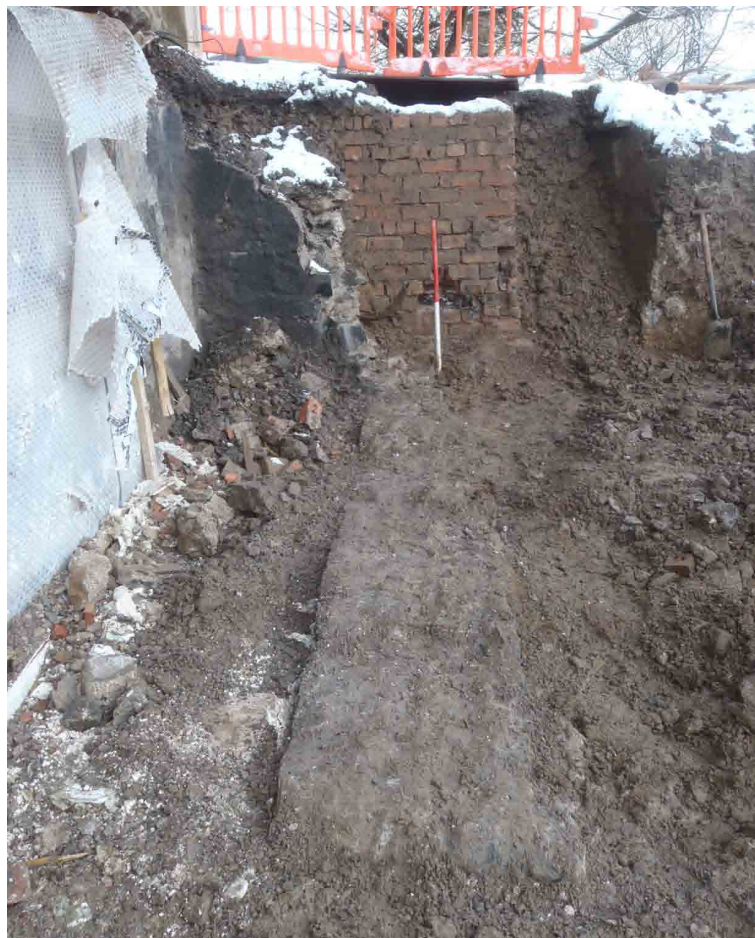
To the south of the main house, an 'L'-shaped wall (**045**) was discovered protruding from the southern wall foundations of the main house (Fig. 2, 6), in the area beneath the demolished conservatory. The N-S section protruded 1.4m from the house foundations and stood at 1.4m high. After turning to the west, the E-W part of this wall only stood to a height of 0.1m and was 3.7m long. The width of this wall was 0.5m. This may relate to the extension noted on the 1822 estate plan rather than to the pavilions depicted on Roy.

A further mortared stone wall stub (**043**) was exposed (Fig. 2). Aligned ENE-WSW, it had a width of 0.4m and a height of 1-3m. A brick built septic tank (**044**) stood beside this wall (Fig. 6).

Fig. 6 - The wall (045) beneath the conservatory with septic tank in the background

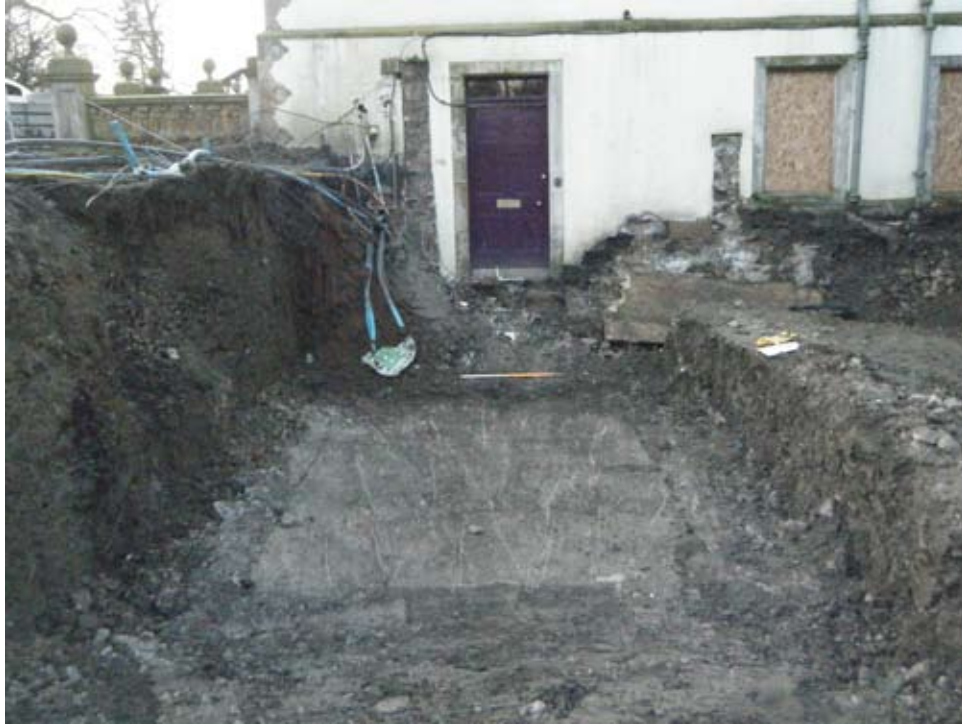
Once the walls (**048**) were removed, the modern concrete floor (**051**) and steps (**054**), which lead up into Bonnington House, were clearly visible. Type 2 hardcore (**055**) underlay these concrete steps and overlay a set of four well worn sandstone bevel-edged steps (**056**), the original steps into the boiler house which were subsequently replaced, perhaps due them being worn. The modern concrete floor overlay a modern layer of gravel chips (**052**) and a further layer of concrete (**053**), which was not removed (Fig. 7). This lowest concrete level (**053**) was abutted by stone blocks relating to the foundation wall of the boiler house (**057**) (Fig. 8).

Fig 7 - The demolished boiler house with concrete floor (053) visible

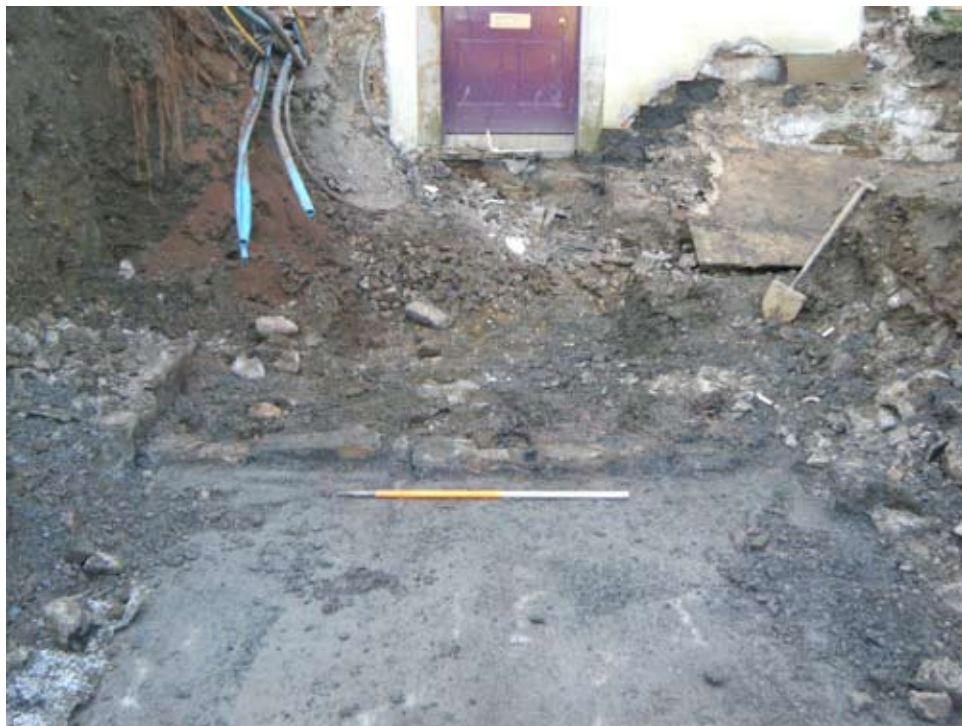
Fig 8 - Wall 057 beneath boiler house
