**Windyfield Rhynie WTW Transfer Main,  
Aberdeenshire**

**Archaeological Watching Brief**

**Report No. 2048**

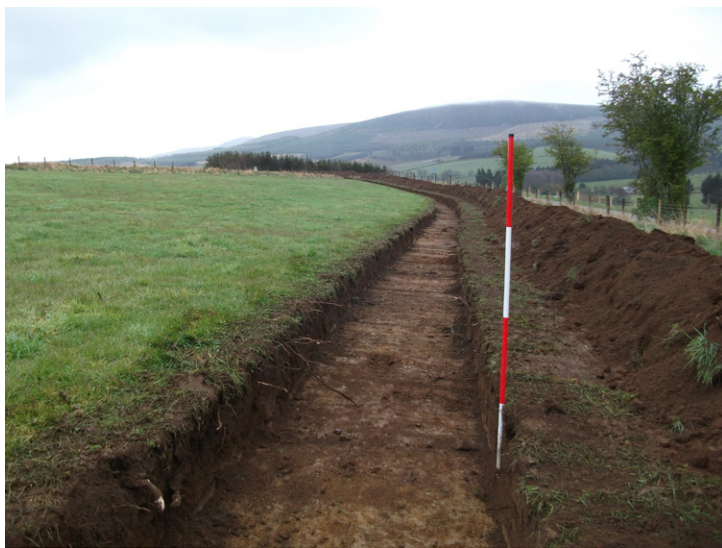
Fig. 3 - General View of the pipeline route to the west of Auchleven

At Husband Hillock, excavation was undertaken with a tracked mechanical excavator with a smooth-bladed ditching bucket (Fig. 3).

The pipeline route was monitored between Counterford at NJ 6170 2454 and the road to Harestone at NJ 6227 2454. Topsoil and subsoil were removed from a trench 1.5m wide before natural was excavated. A view of the trench is shown in Fig. 3.

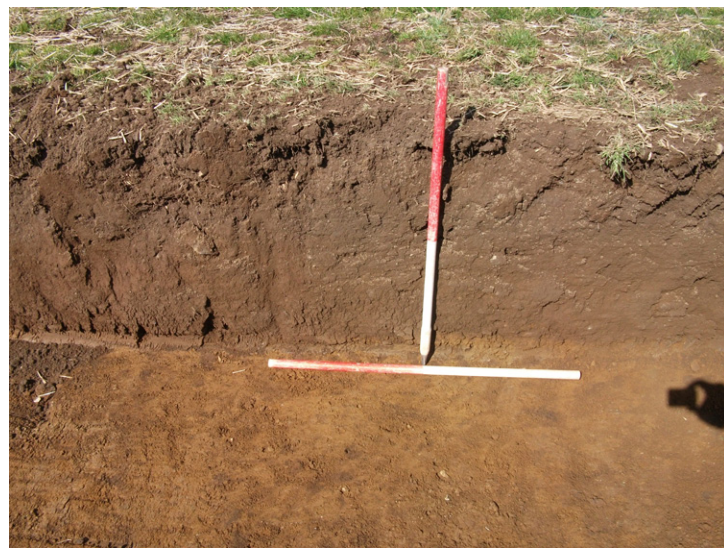
Fig. 4 - Soil profile to the west of Auchleven

The depth of the soil deposits varied (Fig. 4) but over much of the route 0.3m of dark orange-brown topsoil (**001**) overlay a similar depth of light orange-brown subsoil (**002**). The natural subsoil consisted of a light orange sandy silt with occasional small stones (**003**).

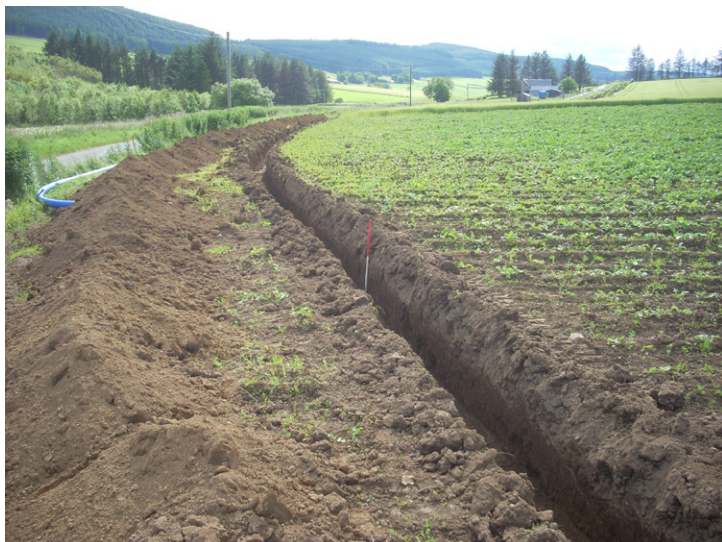
Fig. 5 - Looking west along the water main route from Mill of Leslie

The pipeline route was monitored between the track leading to Cottown at NJ 5860 2478 and Smithy Croft at NJ 5901 2490. The trench was 0.6m wide and varied between 0.3m and 0.9m deep. Views of the route from the east and west are shown in Figs. 5-6.

The depth of the soil deposits varied but over much of the route 0.3m of dark orange-brown topsoil (**001**) overlay up to 0.6m of light orange-brown subsoil (**002**). The natural subsoil was varied, consisting either of a mustard yellow stony silt or of a similar coloured clayey silt (**003**).

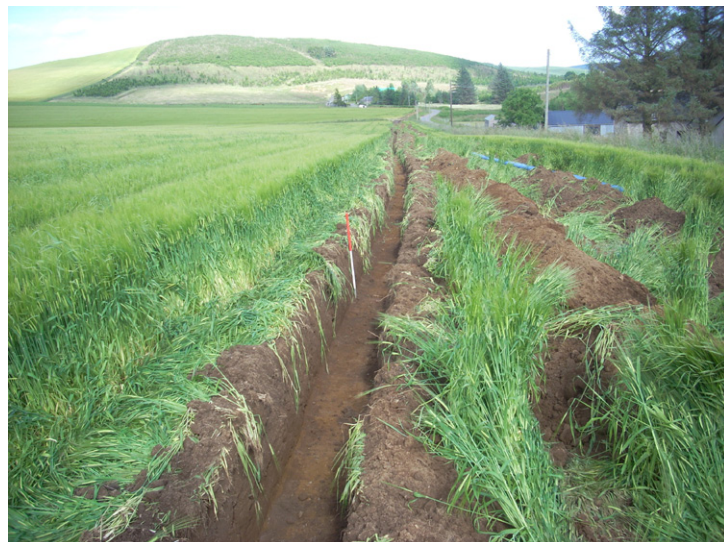
Fig. 6 - Looking east along the water main route towards Mill of Leslie
