North Berwick Law: Improvements to Summit Path, East Lothian

Archaeological Monitored Strip

Report No. 2035

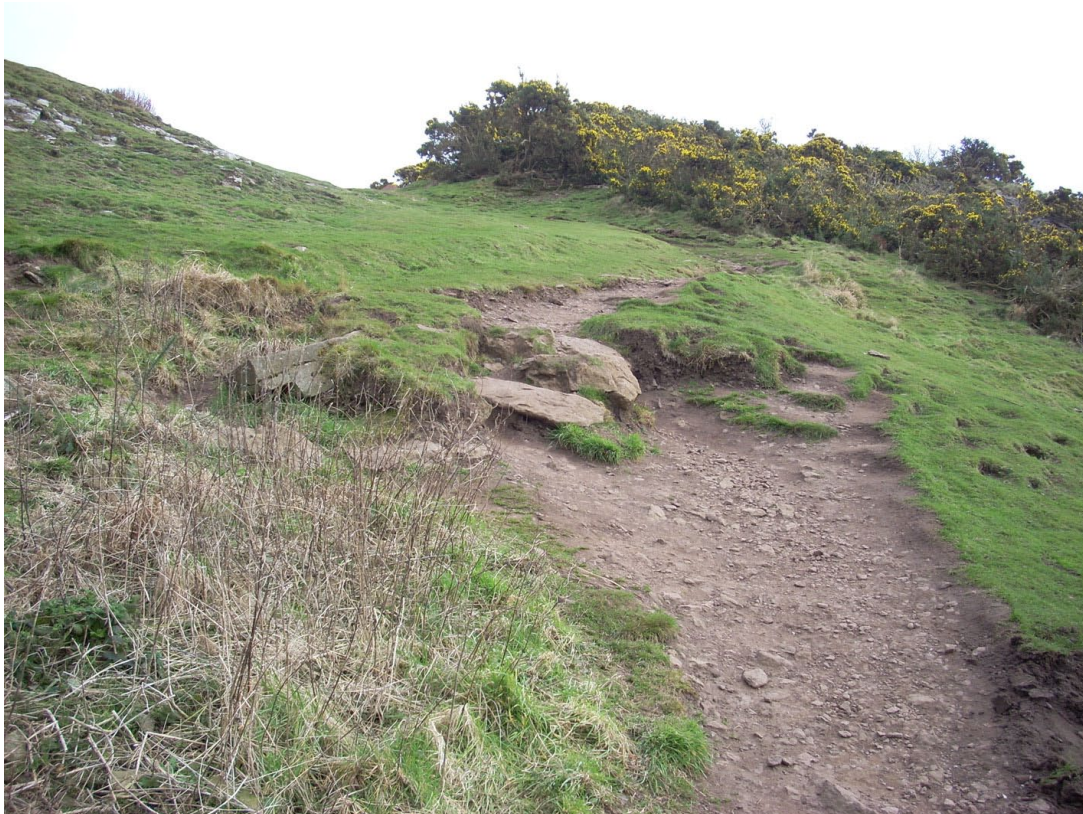
The original access path overlaid an alignment of large boulders believed to be a former rampart line (Fig. 2). At this location, the new path was constructed through a gap in the alignment of the former rampart line. Consultation between the onsite CFA archaeologist and BTCV resulted in an agreement to use spoil from the excavation of anchor bars in the vicinity to backfill areas of erosion under the rampart. This would encourage walkers to follow the formal path as opposed to using the rampart stones as steps, and prevent further degradation of the surviving rampart remains.

Fig. 2 - Original access path through rampart

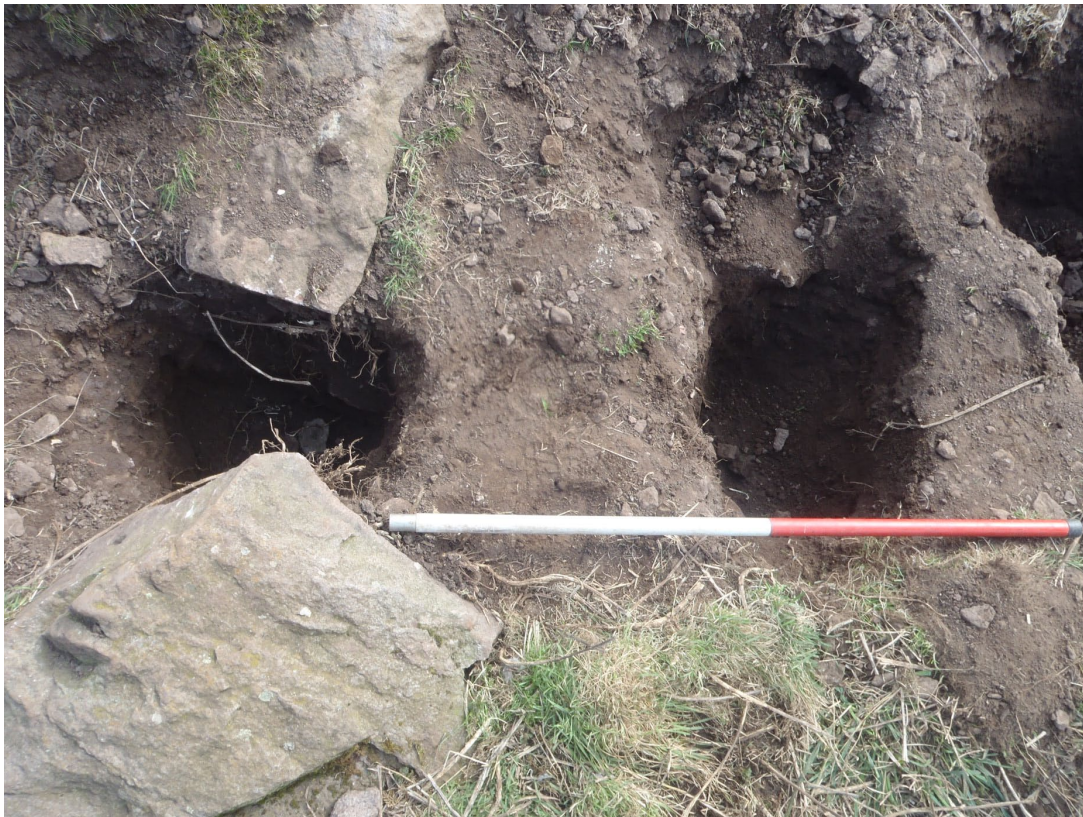
The pits for the anchor bars ranged from c. 0.3m-1m in length by c. 0.2-0.45m in width and c. 0.15m-0.3m in depth. Pits A-F removed topsoil (**001**) only, G-N removed topsoil (**001**) onto bedrock (**000**). Pits B, C and D were located between the rampart stones (Fig. 3).

Fig. 3 - Pits C and D between rampart boulders

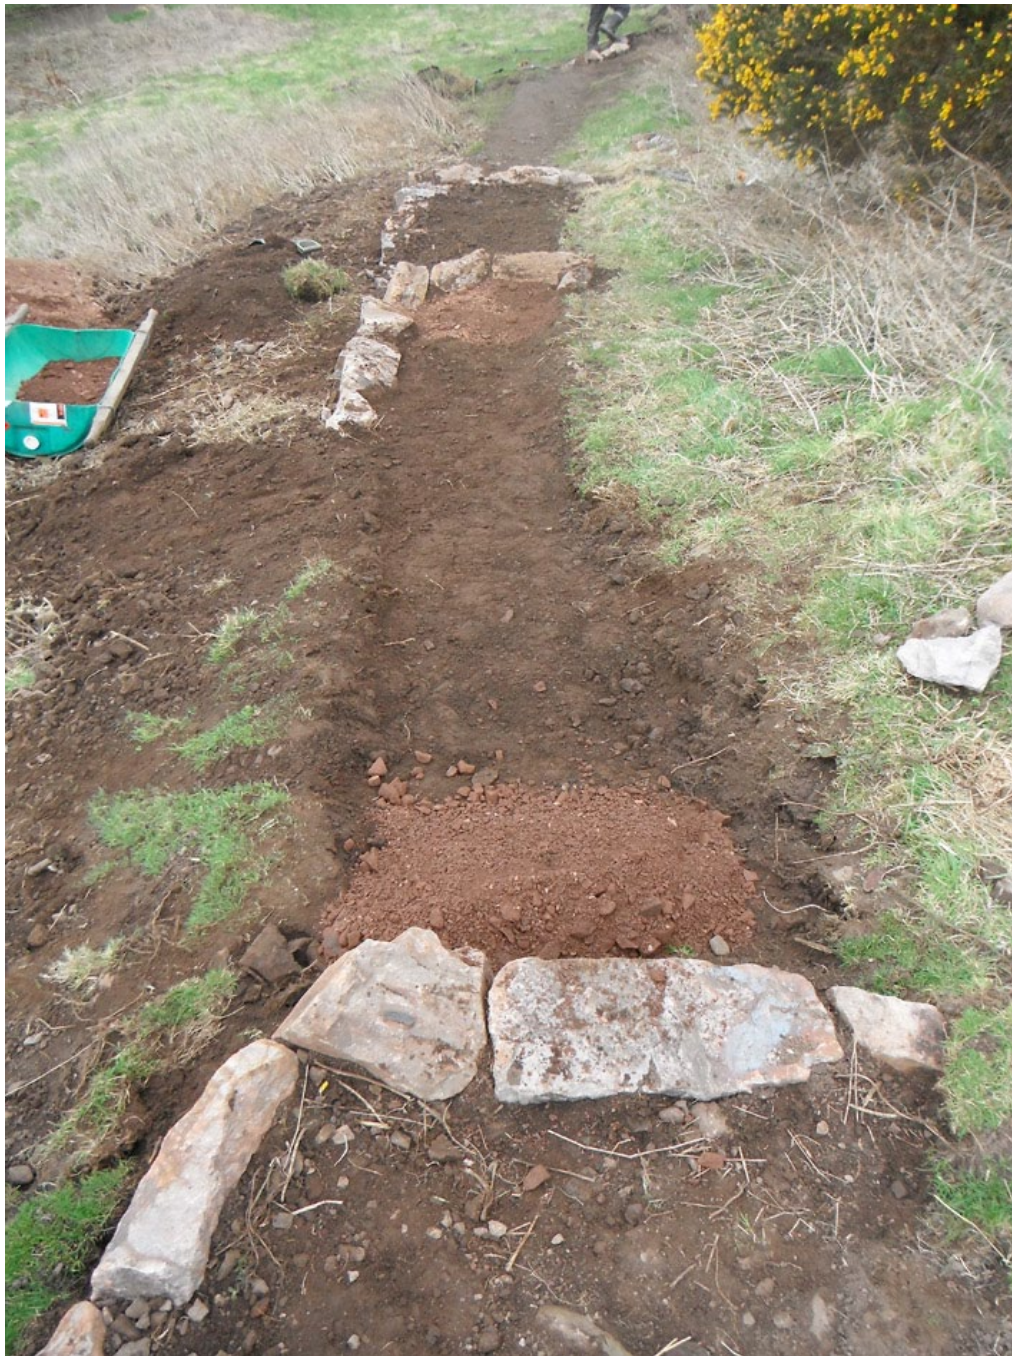
Up to 0.1m depth of gravelly topsoil was removed from the area of the path between anchor bars to create space for surfacing gravel to be laid (Fig. 4).

Fig. 4 - Re-surfacing between anchor bars
