**Howard Town Mill, Glossop,
High Peak, Derbyshire**

Archaeological Evaluation

Report No. Y036/11

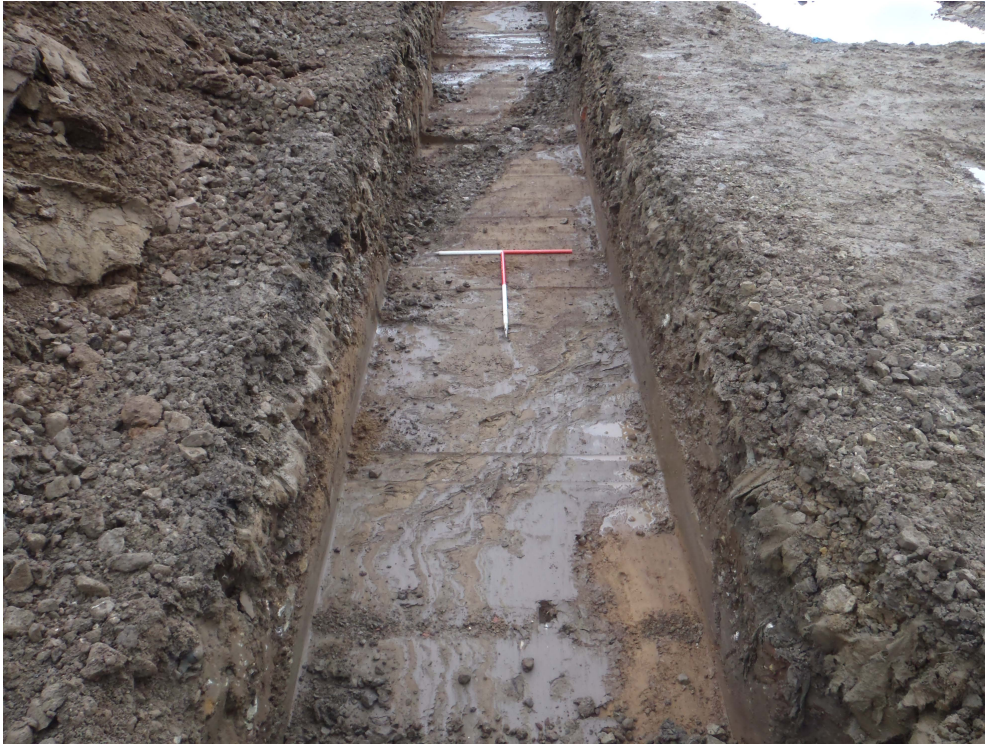
Fig. 5 - Shot of Natural Deposits (100) Within Trench Base of Trench 1

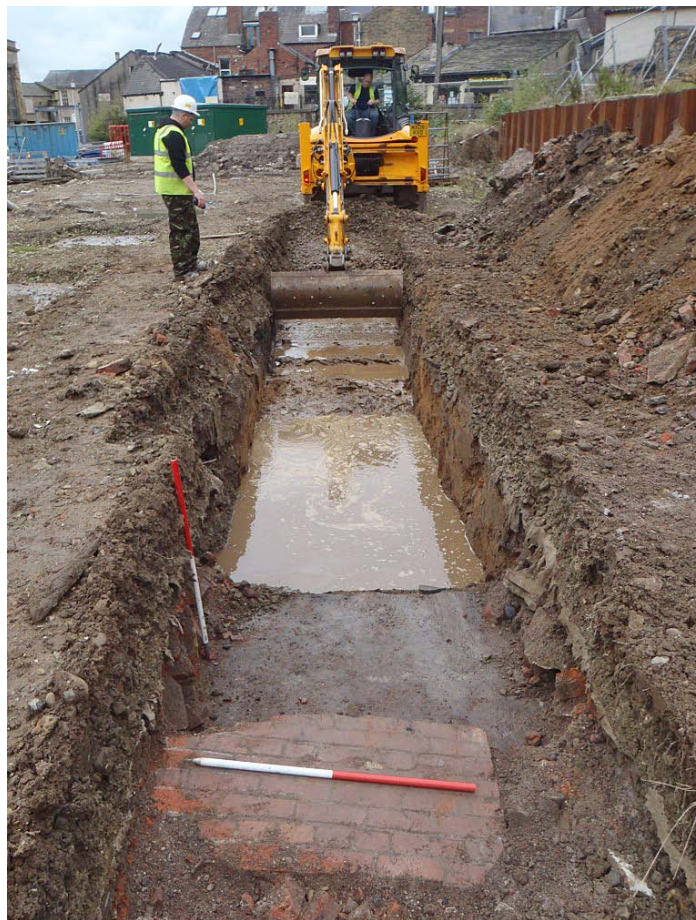
Fig. 6 - Working Shot of Trench 1 Excavation and Surface (103)

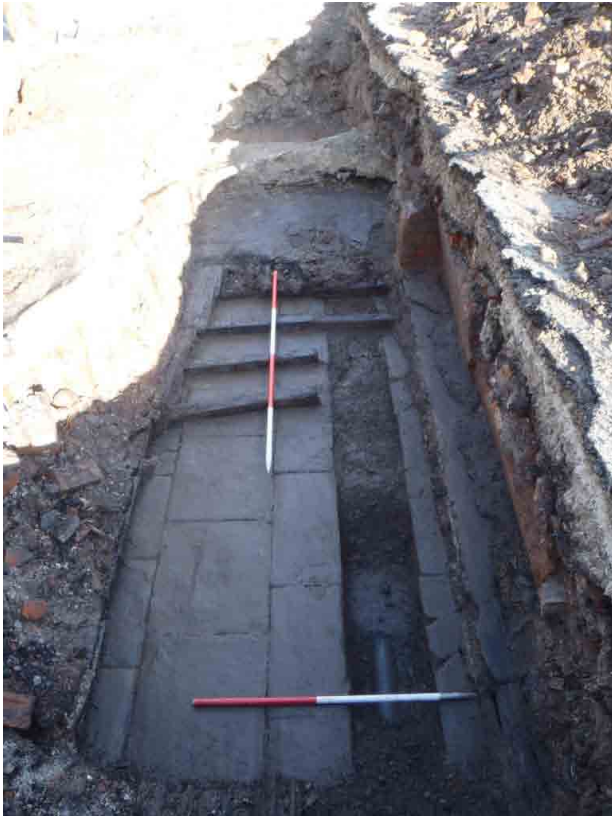
Fig. 7 - Post-excavation Shot of Trench 2

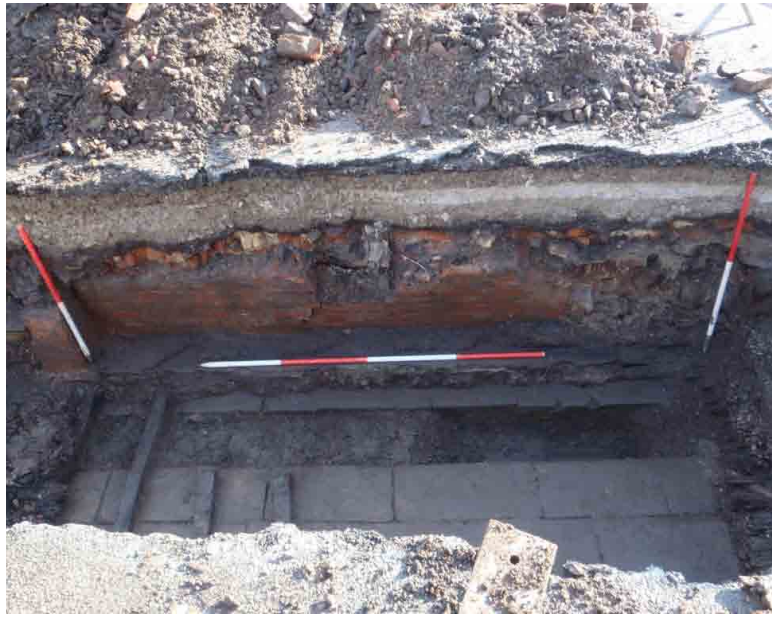
Fig. 8 - Shot of West-Facing Section of Trench 2; Walls (206 & 207); Surfaces (213 & 215)

Trench 2 (Fig. 2 and 8) contained the well-preserved remains of surfaces and sub-surface features associated with the 'Long Mill'. At the base of Trench 2 was a surface of well-laid sandstone flags with dimensions of 0.61 x 0.53m. This was edged by a north to west orientated sandstone kerb (215) which delimited a chase (212) for a metal pipe (214) (Fig. 3, 4). The pipe chase (212) was probably contemporary with the floor surface (211) and was filled in part by a deposit of greyish concrete, which tapered to the south (216).

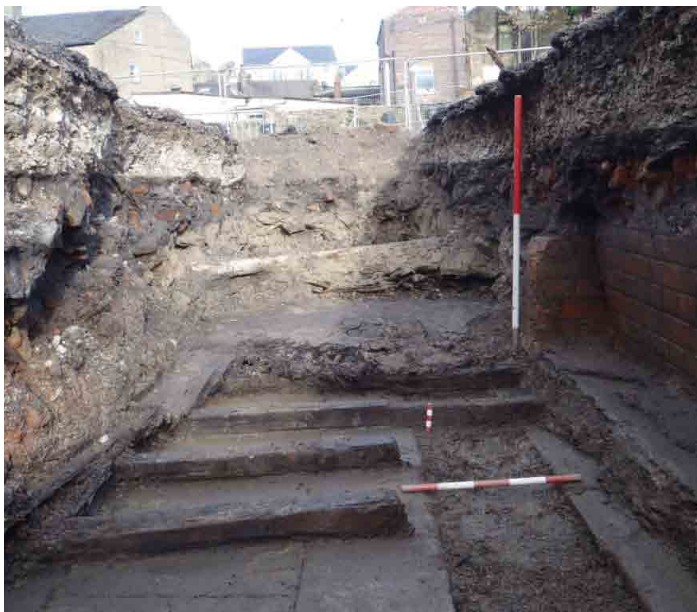
Fig. 9 - Detailed Shot of Trench 2 Surface and Features

In the east of the trench, concrete (213) overlay sandstone edging (215) and had been poured while the floor joists (210) were in place (having set around the timbers). The purpose of the concrete appears to have been to provide a foundation footing for two brick walls (206 and 207, Fig. 9).

Wall 206 was orientated north to south and survived to a truncated height of c. 0.6m. The brickwork measured 2.8m and was of English bond with a south-facing return. To the north, it abutted Wall 207, which had a west-facing return. Wall 207 was more than 0.31m long and continued beyond the limit of excavation to the east. Both walls (206 and 207) were weather-struck pointed by very hard, sandy-grey mortar. A layer of slate provided a damp proof course between both walls and the concrete foundation (213). Asphalt (208) partially covered the concrete, probably suggesting broad

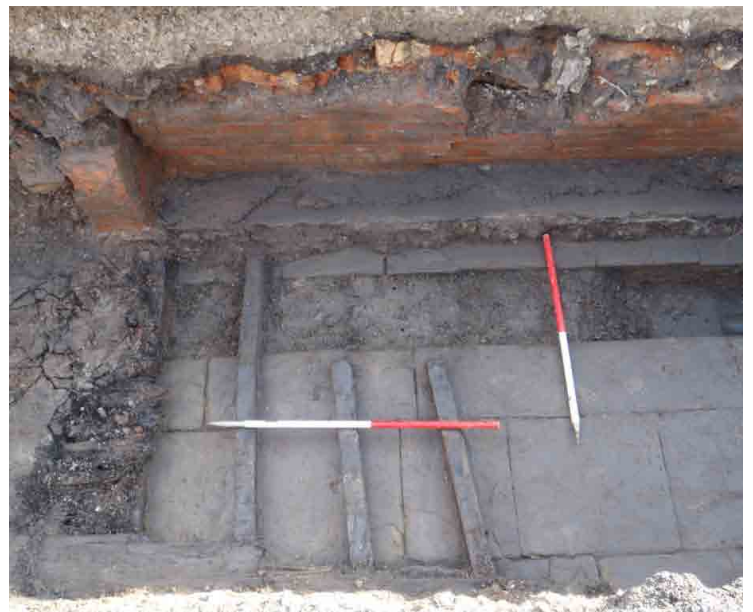
Fig. 10 - Shot of West-Facing Section of Trench 2; Walls (206 & 207); Surfaces (213 & 215)

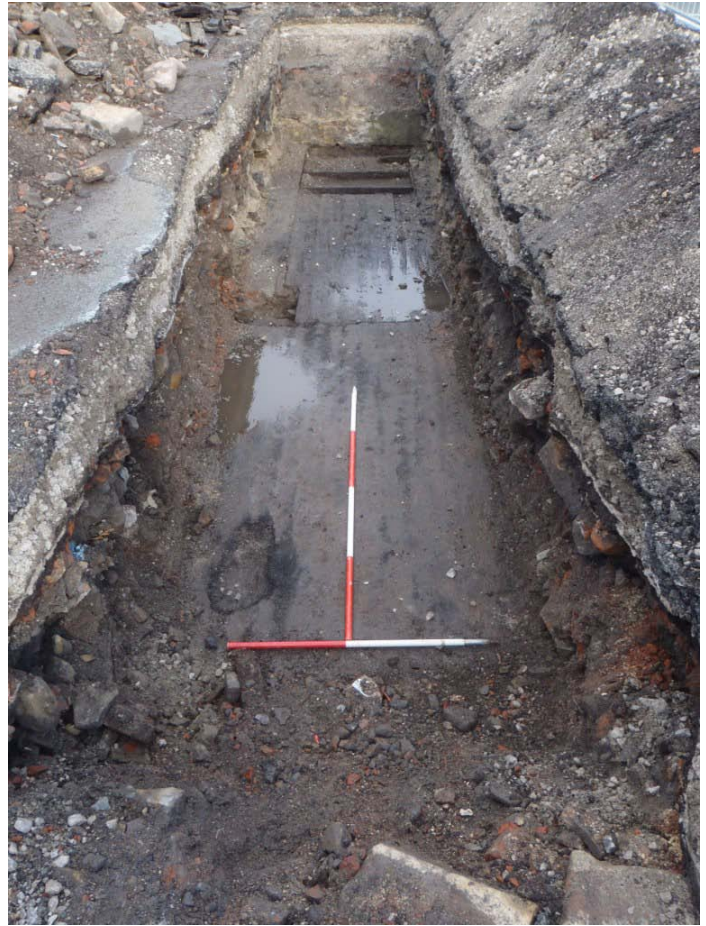
Fig. 12 - Post-excavation Shot of Trench 3

The base of Trench 3 (Fig. 3, 11, 12) contained a flagged-sandstone surface (311) above a layer of sandy gravel and mixed cobbles (312). The surface abutted the internal elevation of the south facing, former east to west orientated wall (310) of the 'Long Mill' building (UMAU 2005, Site 8). The wall was constructed of sandstone rubble fragments bonded by sandy, lime mortar (Fig. 13). Directly above the sandstone surface (311) was a series of east to west orientated floor joists (309), which supported a wooden floor (307) which was asphalt (306) covered to provide damp proofing. The internal south-facing elevation had a skim of lime render which respected the floor height created by the wooden floor (307), which confirmed that the sandstone surface (311) was the earliest constructed surface recorded (Fig. 13). Concrete (308) was recorded to the west of the trench. It slightly lipped over the wooden surface (307) and bulged around the floor joists (309) into the cavity below. The purpose of the concrete is unclear, however, it did not continue to the south, and it abutted Wall 310 to the north and is interpreted as a later modification to the interior of the 'Long Mill'.

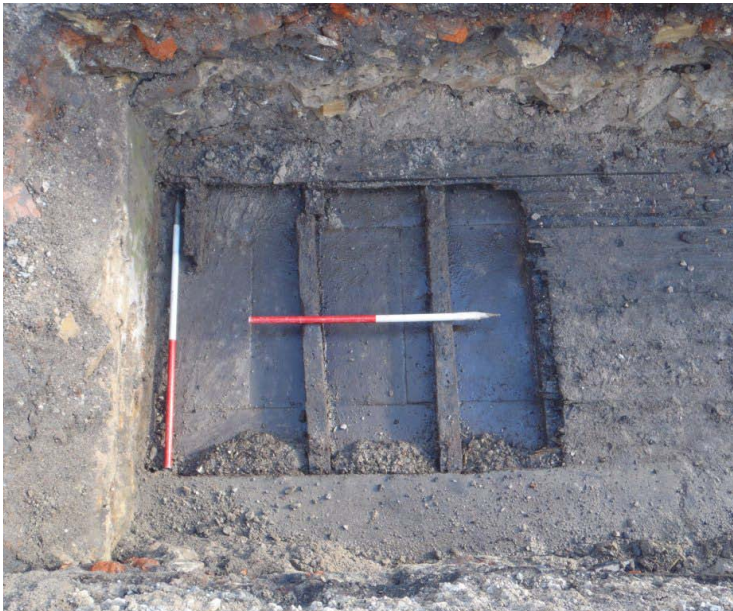
Fig. 13 - Shot of Surface (311) and (307) and Wall (310)

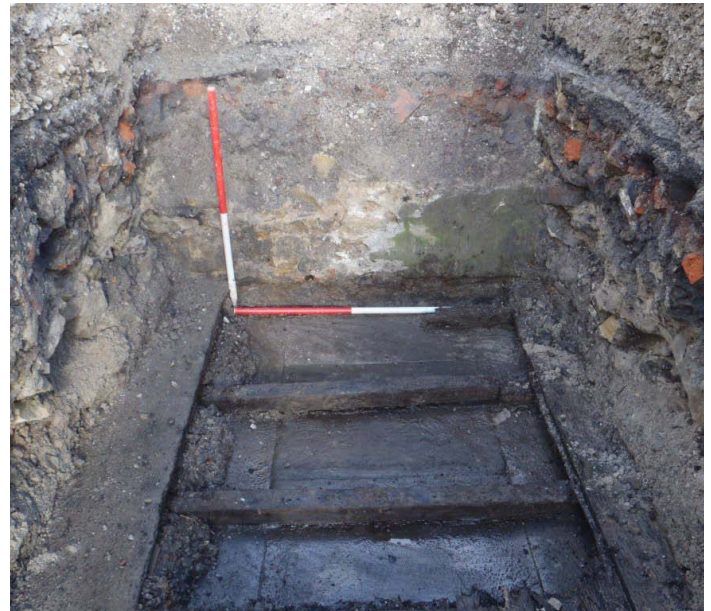
Fig. 14 - Shot of Surfaces (311) and (307) and Wall (310) Trench 3

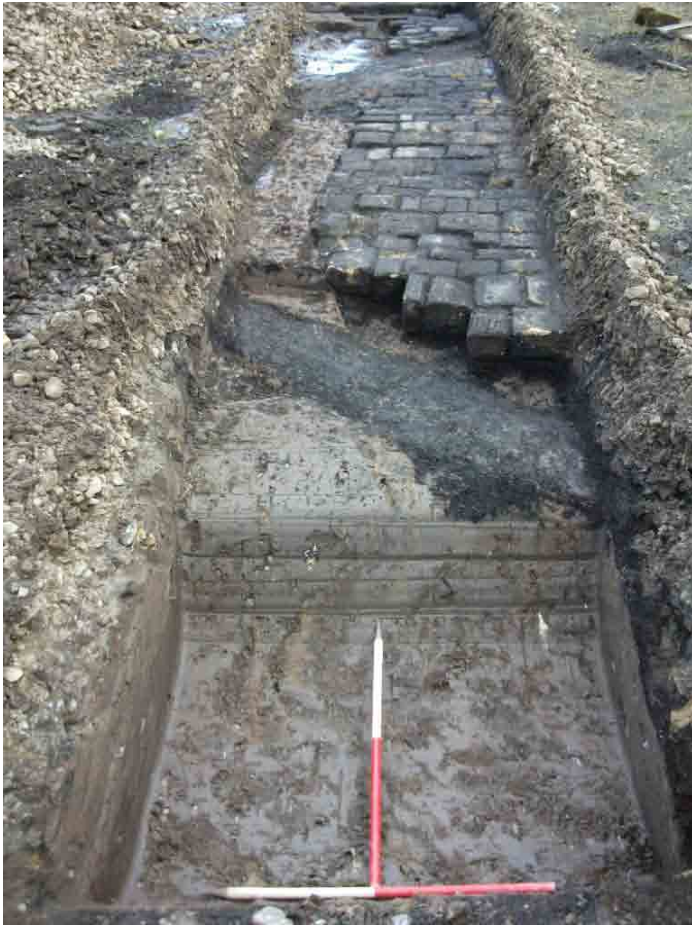
Fig. 15 - Post-excavation Shot of Trench 4

Trench 4 (Fig. 4, 15, 12) contained relatively well-preserved remains of a former out building (UMAU, Site 13). Including the north to south orientated western wall (403). To the east of this was a flagged sandstone-surface (402 and 405), which had been cut obliquely to abut Wall 403. One Flagstone (405) had four equally spaced holes (404),

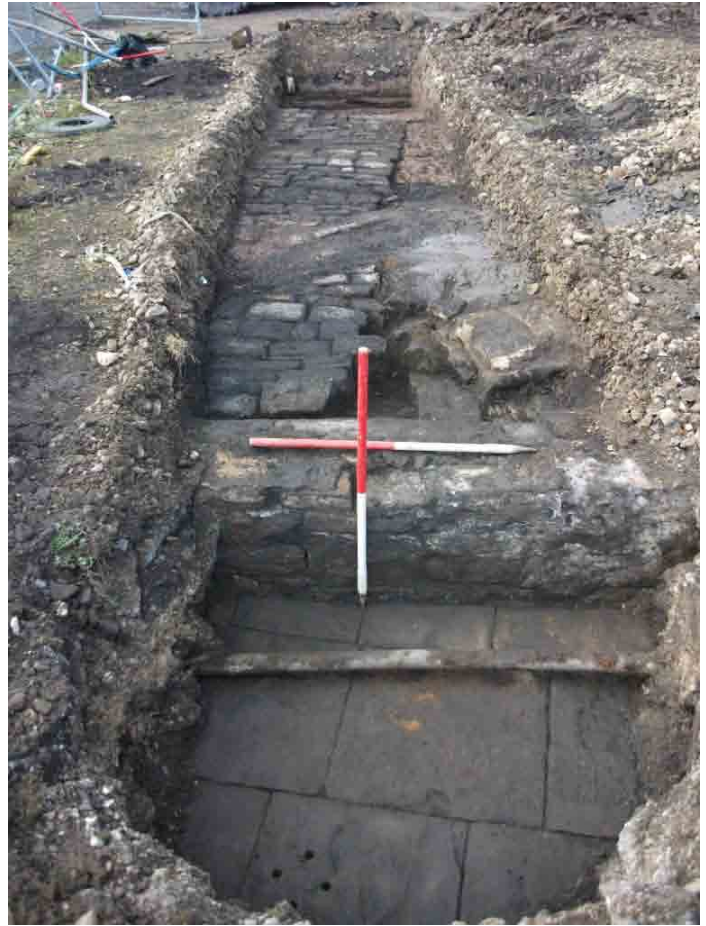
Fig. 16 - Post-excavation Shot of Trench 4

seen as a square, within the slab. The holes may have been a fixing point for a bracket or base plate (Fig. 16). There was a scarcement to the west of Wall 403, possibly indicating the presence of a former ground surface. The fractured remnants of a wall stub (406) orientated west to east abutted Wall 403 and was probably a later addition to the main building. To the west of Wall 403, a surface comprising sands stones setts was uncovered (407 and 408). The surface had been deposited in a shallow, flat-based 0.22m deep cut within firm, sterile, greyish, light-brown clay (400). The cut was filled by a deposit of cinder and ash (412) providing the bedding for the stone sett surface (408, Fig. 17). Three concrete-capped services were also recorded in Trench 4; all were interpreted as modern intrusions, and modern overburden form the material to the surface (401).

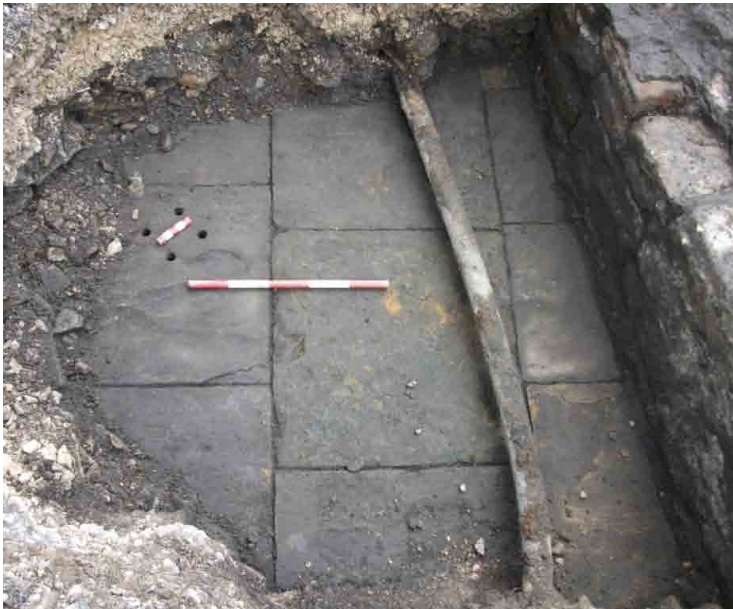
Fig. 17 - Shot of Internal (Site 12) Surface (402), Slab (405) and Holes (404)

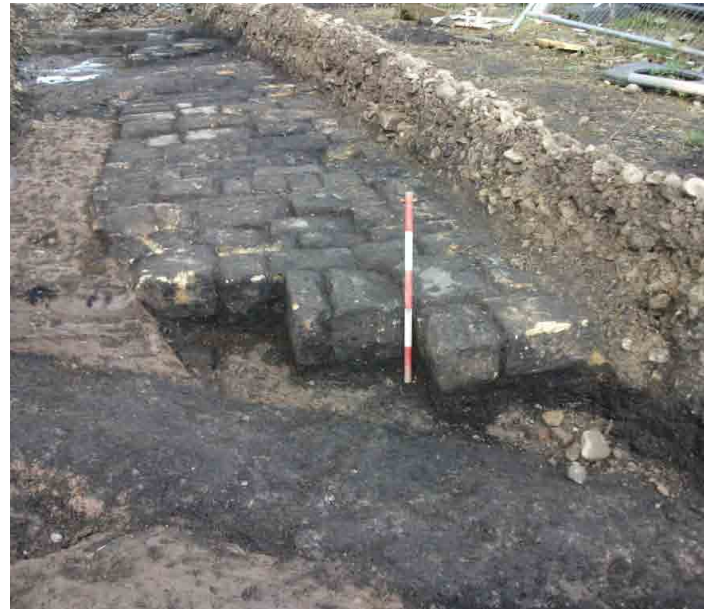
Fig. 18 - Shot of Surface (408), Bedding Layer (412) Within Cut (411)

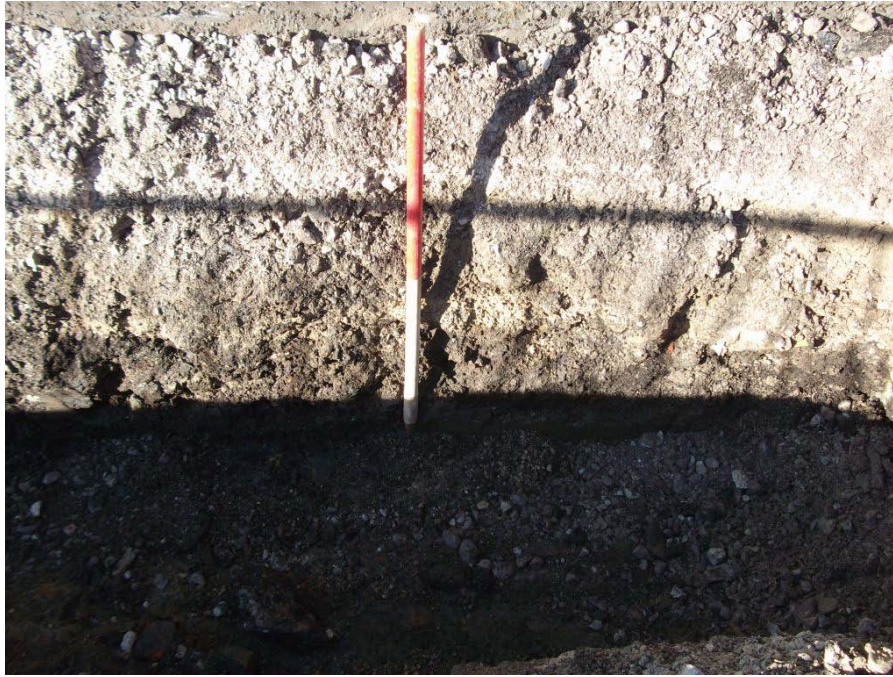
Fig. 19 - Post-excitation Shot of Trench A in Watching Brief Area

Trench A was 11m north to south by 3m east to west. The maximum excavated depth of the trench was 1m. The excavation revealed made ground used as levelling material for the modern tarmac surfaces (Fig. 19).

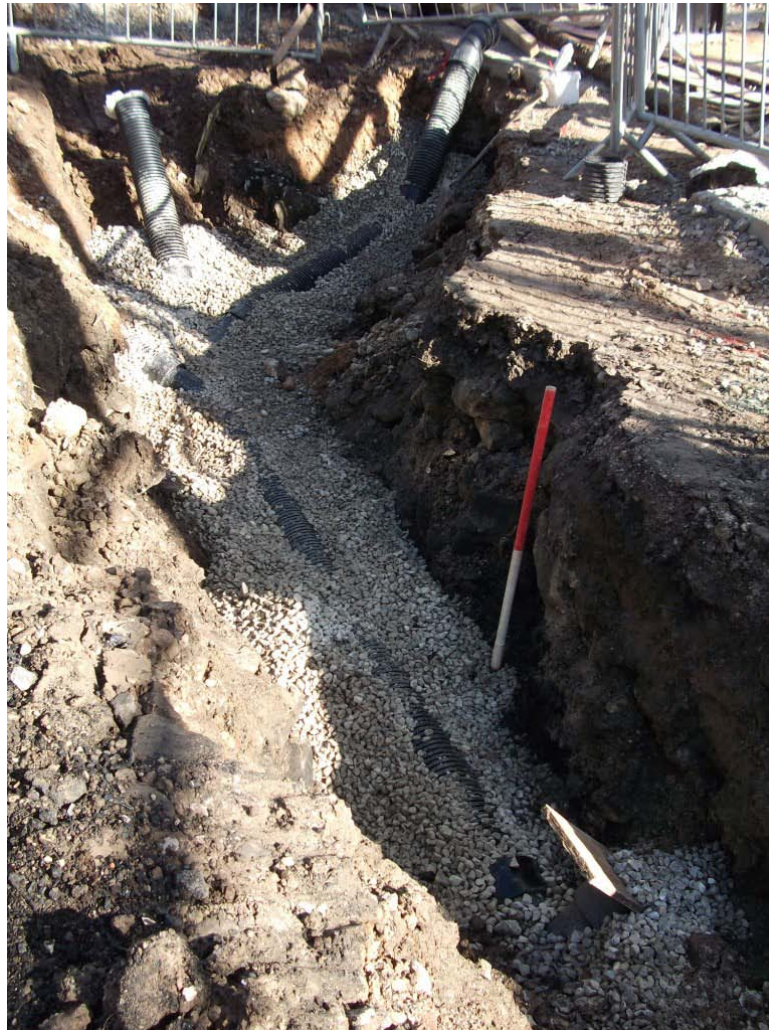
Fig. 20 - Post-excitation Shot of Trench B in Watching Brief Area

Trench B was 8m north to south by 1.5m east to west. The maximum excavated depth was 0.9m. The excavation removed 0.2m of burnt coal and ash which was covered by 0.5m of mixed silty clay with sandstone cobble inclusions. A former tarmac surface was encountered covered by 0.2m of stone chippings and gravel. All the deposits were assessed as made ground and were deposited to build up the area for modern surfaces (Fig. 20).

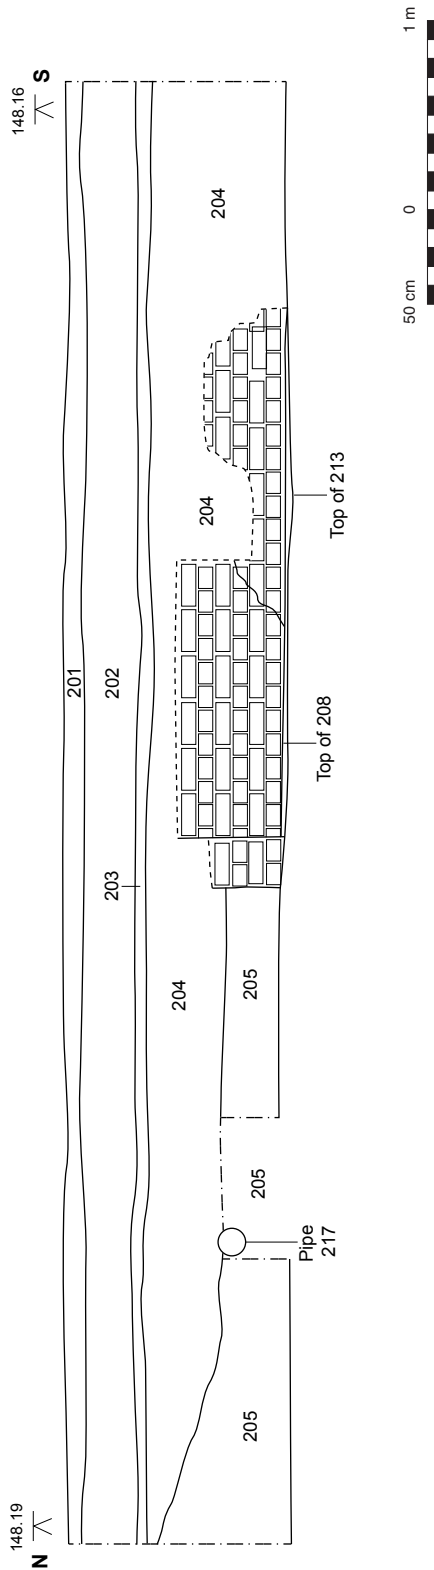
Fig. 19 - West-Facing Section of Trench 2

The stratigraphic sequence in Trench 2 (Fig. 19) was completed by demolition material and made ground. To the north of Trench 2 a tip (north to south) of demolition material comprising large sandstone fragments and crushed mortar (205) was recorded. This was probably the demolished remnants of the north wall of the 'Long Mill'. It contained an *in situ* cast-iron pipe covered by a deposit of compacted demolition material (204); mixed building debris and modern detritus such as plastics as well as slate, mortar fragments and brick fragments, attributed to the former 'Long Mill' building. The demolition debris also contained rectilinear frogged bricks, stamped 'Cheshire' and 'Greenwood Glossop' along with a number of cast-iron objects (217) (Fig. 10), including; base plates, stanchions, drain pipes and a length of steam pipe. A former ground surface comprising tarmac (203) covered the crushed sandstone (205), which was in turn covered by a series of made-ground deposits comprising sand and gravel (202) and a modern tarmac surface (201).
