## **Camster Wind Farm, nr Wick, Caithness: Archaeological Watching Brief and Demarcation**

**Report No. 2073**

Author	Gary Savory MA
Illustrator	Leeanne Whitelaw BSc MifA
Editor	Melanie Johnson MA PhD FSA Scot MifA
Commissioned by	Natural Power (on behalf of E.ON)
Date issued	June 2012
Version	0
OASIS Reference	cfaarcha1-127866
Grid Ref	ND 2589 4711 (centred)

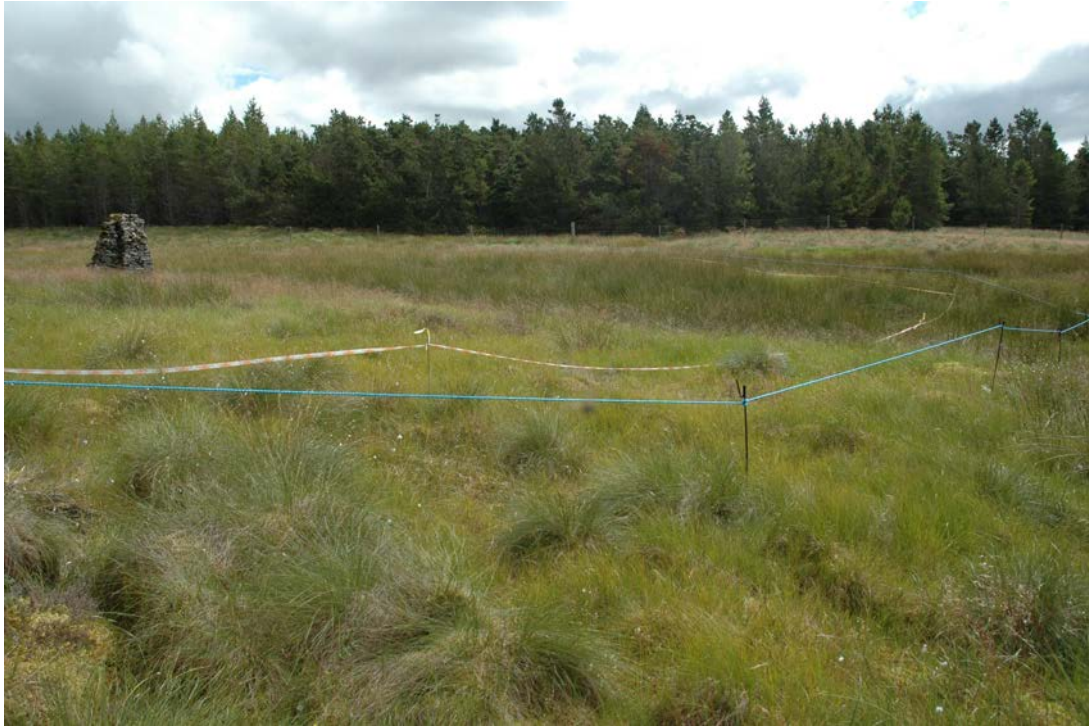
Fig. 2 - Site 5 demarcated

Site 5 was demarcated initially with red-and-white barrier tape and then with road pins and blue rope, with a buffer zone of 20m from all visible parts of the site (Fig. 2). Site 63 was demarcated with a buffer zone of 5m. The sites were unaffected by construction works.

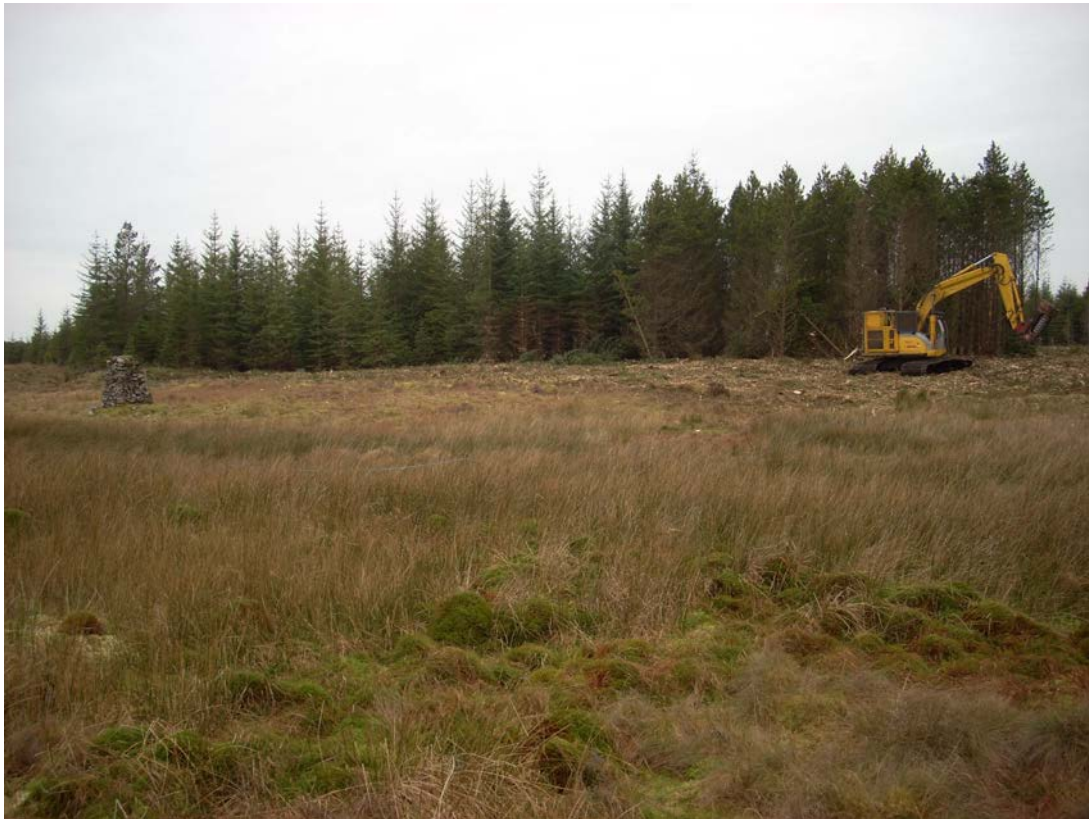
Fig. 3 - Tree felling in the vicinity of Site 5

Tree felling inside the demarcated area of Site 5 was monitored, as was felling around the margins, to prevent any accidental damage to the site (Fig. 3). The site was unaffected by the works.

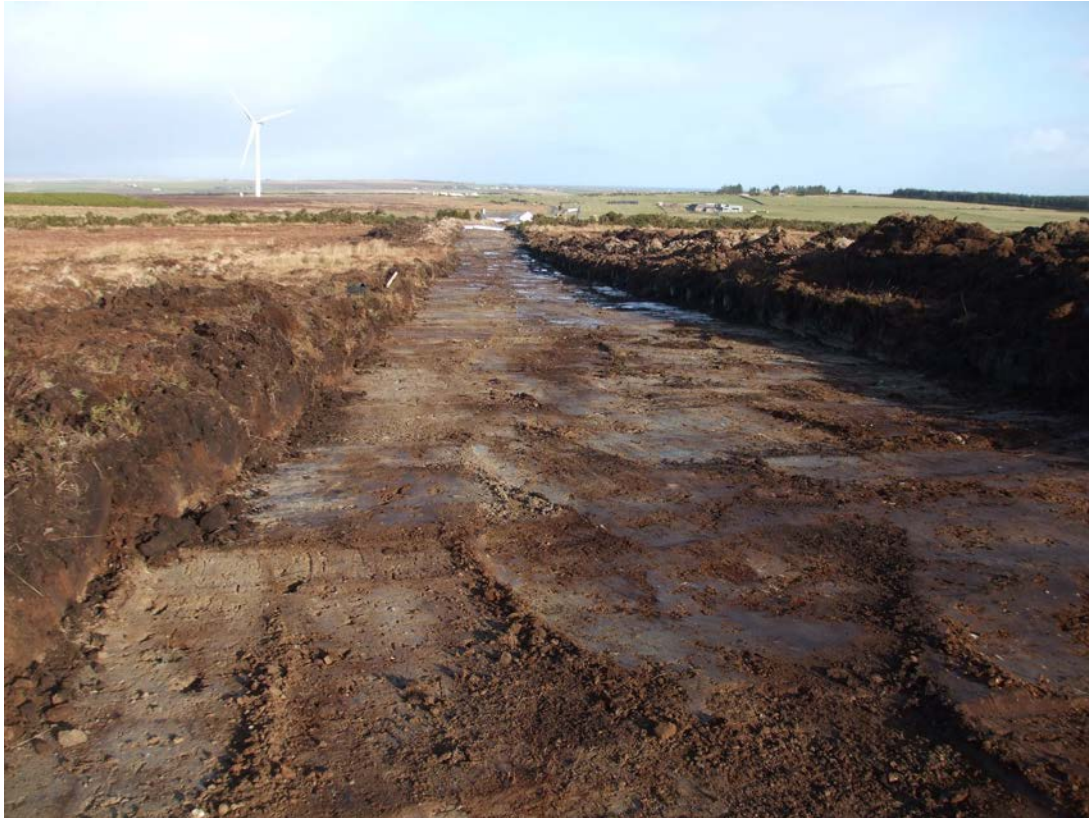
Fig. 4 - General vie of topsoil stripping along principal access track from Achairn

The topsoil throughout the site predominantly consisted of a dark brown silty peat (**001**) with varying depth, ranging between 0.1m and 2m deep; peat in areas of floating roads and piled turbine bases was known to be over 4m deep from probing. Underlying this was natural substrate consisting of mottled grey-blue sandy clay, yellow clay or orange-brown stony clayey silt (**002**) (Fig. 4-8).

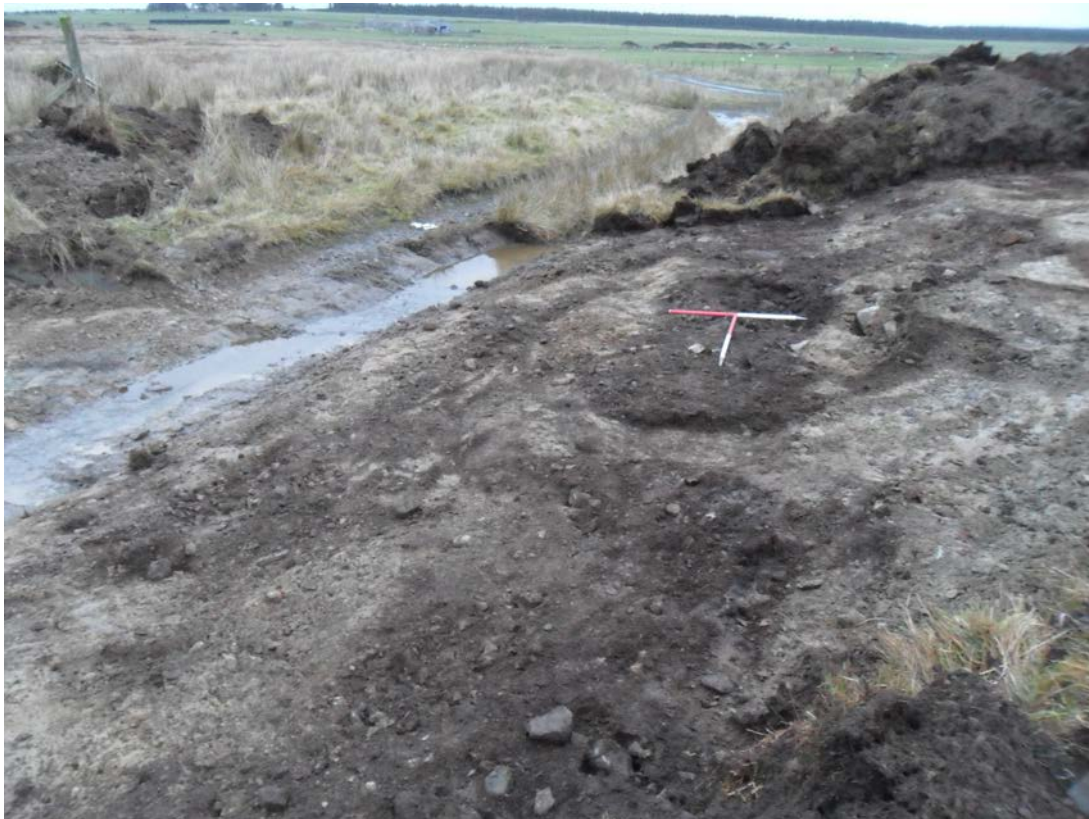
A shallow, linear feature (**003**), orientated north-west by south-east, was identified in the north-eastern area of the development whilst conducting ground works associated with the access road leading towards Achairn Cottage (NGR: ND 29892 50082 to ND 29883 50084) (Fig. 9). The feature traversed the entire 10m strip for the access road and continued to the north-east and south-west. A 0.75m slot through the feature revealed it measured 1.1m wide and 0.12m deep, with a flat base. The fill (**004**) consisted of a grey-brown sandy-silt containing rounded-angular stones. The feature ran parallel to an existing farm track and it likely represents the remains of an earlier track.

Fig. 9 - Linear feature (003) showing SE-facing section

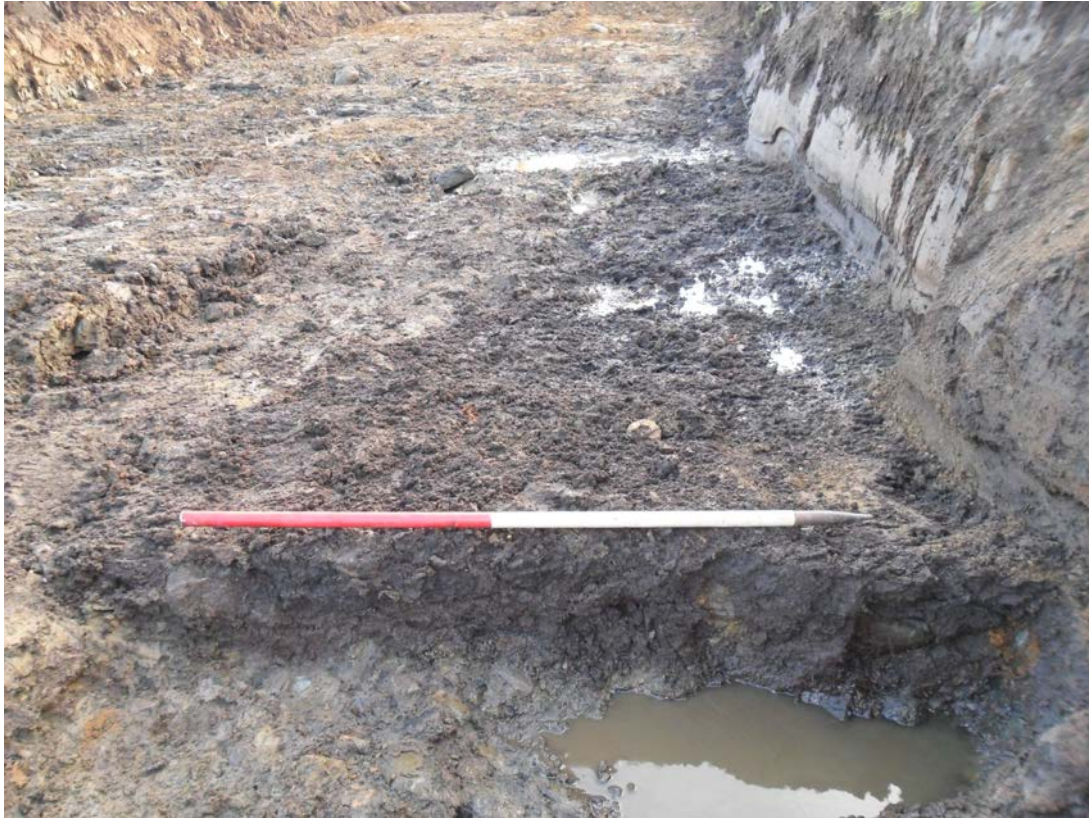
A large, curving, linear feature (**005**) which continued under the south-west stripped edge of the access track (ND 29959 49972 to ND 29947 49984) measured 15.8m long, 1.6m wide and 0.3m deep (Fig. 10). The fill (**006**) consisted of a brown-grey clay-silt with a high percentage of rounded to sub-angular stones. The feature was located within an improved pasture field and may represent some form of drain.

Fig. 10 - Linear feature (005) showing NW-facing section

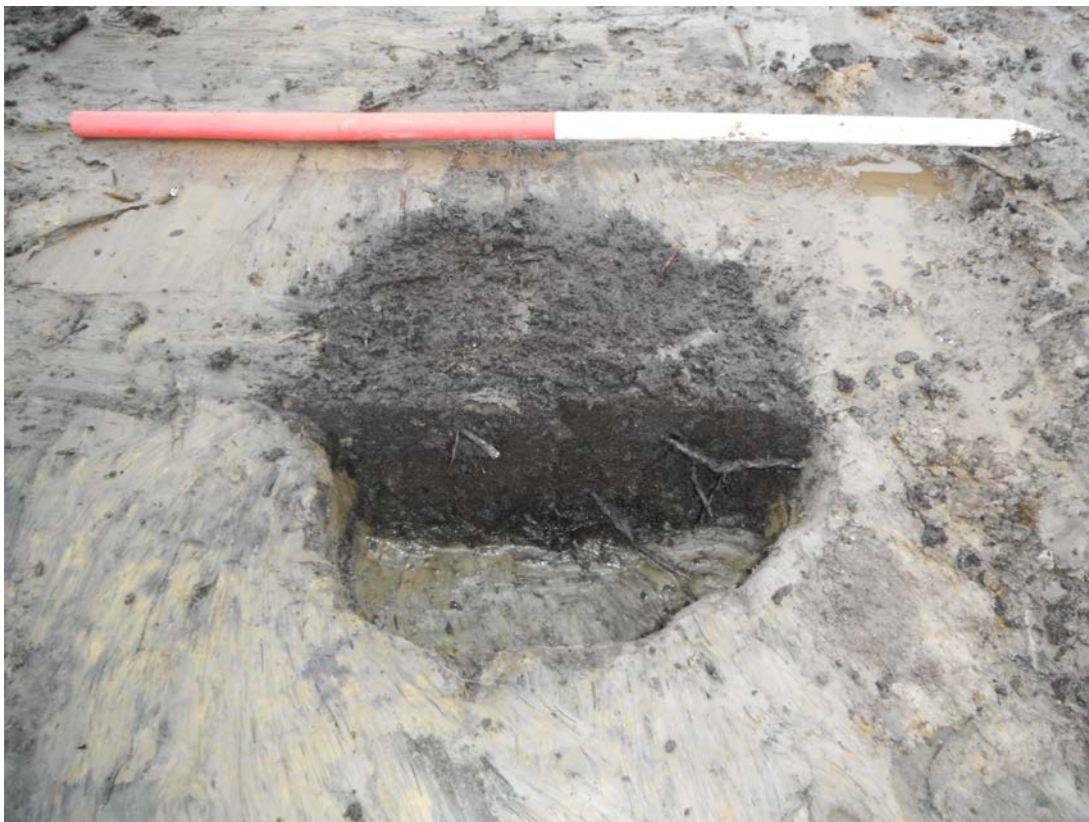
A small circular feature (**007**) measured 0.43m in diameter and 0.21m deep and was located at the southern edge of borrow pit B (Fig. 11). The fill (**008**) consisted of a dark brown silty-peat, the same as the overlying topsoil. There were no artefacts and this feature is unlikely to be archaeologically significant and may in fact be a stone hole.

Fig. 11 - Circular pit/stone hole (007) showing W-facing section
