Makerstoun Church, near Kelso, Scottish Borders

Archaeological Watching Brief

Report No 2081

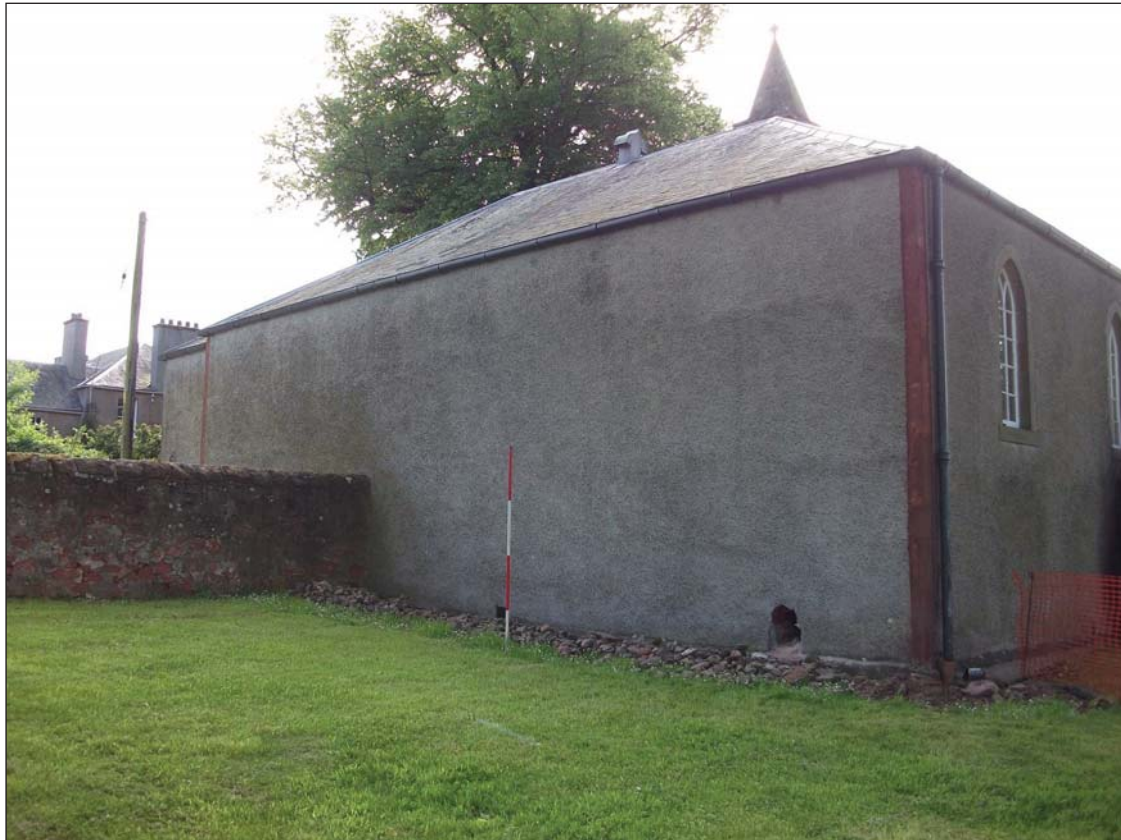
Fig. 2 - Watching brief area prior to excavation. From the west.

The watching brief area abutted the west side of the church (Fig. 1, 2). It was rectangular and measured 8.5m by 4.5m. Depth to natural (**002**) was c.0.6m (Fig. 3). Natural was orange-brown sandy clay with occasional sandstone. Topsoil (**000**) was c.0.1m to 0.2m thick and overlay a subsoil (**001**) which was 0.4m to 0.5m thick and comprised mid brown-orange silt with frequent stones and tree roots. A small rectangular extension to the development was excavated on the west side for a disabled ramp, measuring 2.6m by 1.5m. Only a 0.15m thick layer of topsoil was stripped from this.

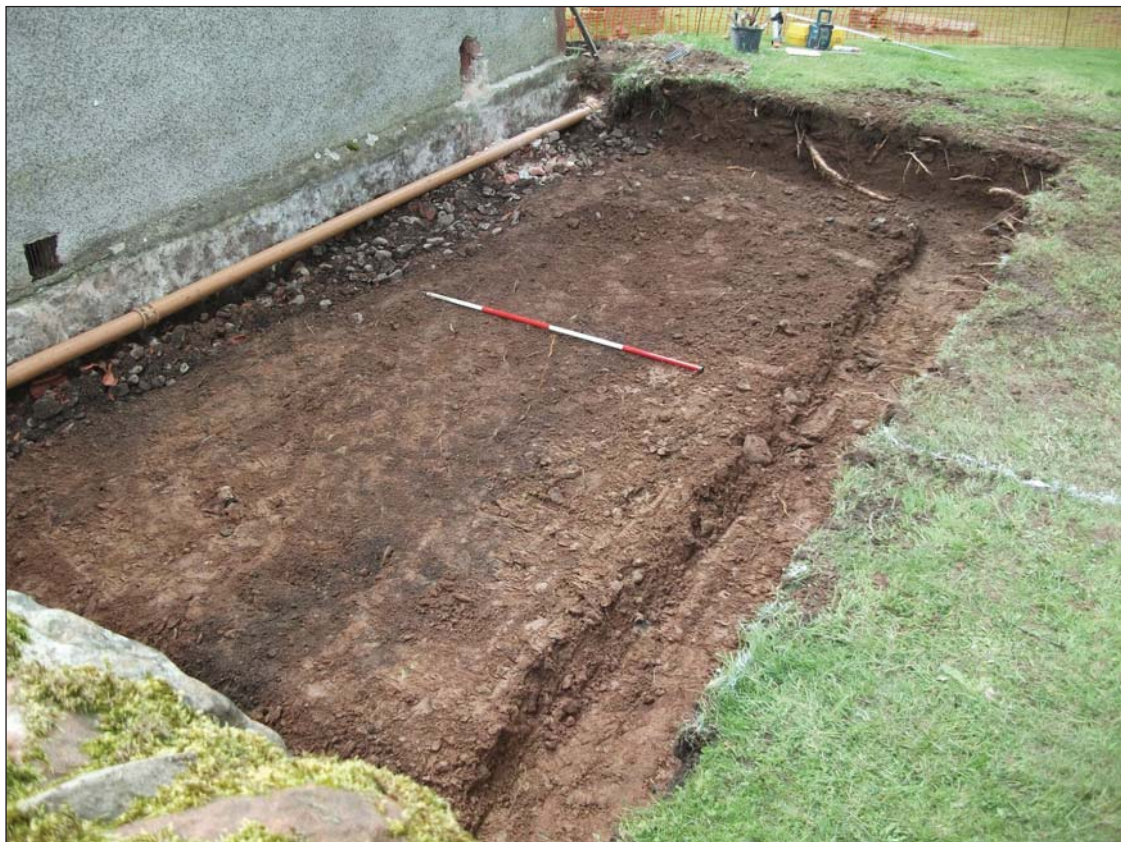
Fig. 3 - Watching brief area following excavation. From the north.

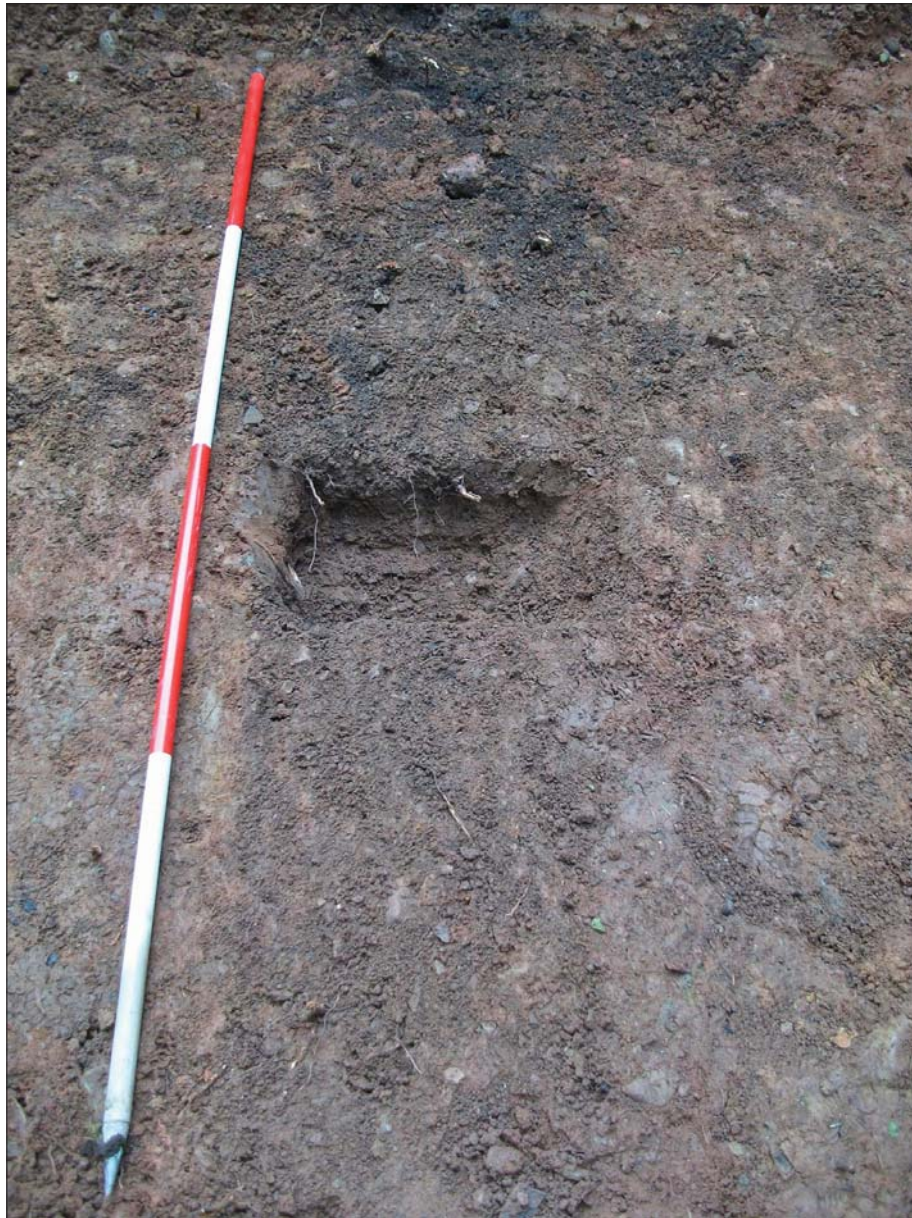
Fig. No: 4		Revision: A	Project: Makerstoun Church, near Kelso. Watching Brief

Fig. 4 - Section of linear drainage feature 003 from SW

A single archaeological feature was discovered during the watching brief. A linear ditch (**003**) aligned roughly north to south was identified, cut into the natural (**002**) and sealed by the subsoil (**001**) (Fig. 4-5). It was exposed for an extent of c.5m and was 0.5m wide by 0.25m deep. It had steep concave sides and a concave base and was filled with mid orange-brown silt (**004**) which contained flecks of coal, fragments of mortar and sherds of 19th and 20th century pottery. Its purpose is unclear but it is likely to have been associated with drainage around the exterior of the 19th century church. No other remains or deposits were identified.

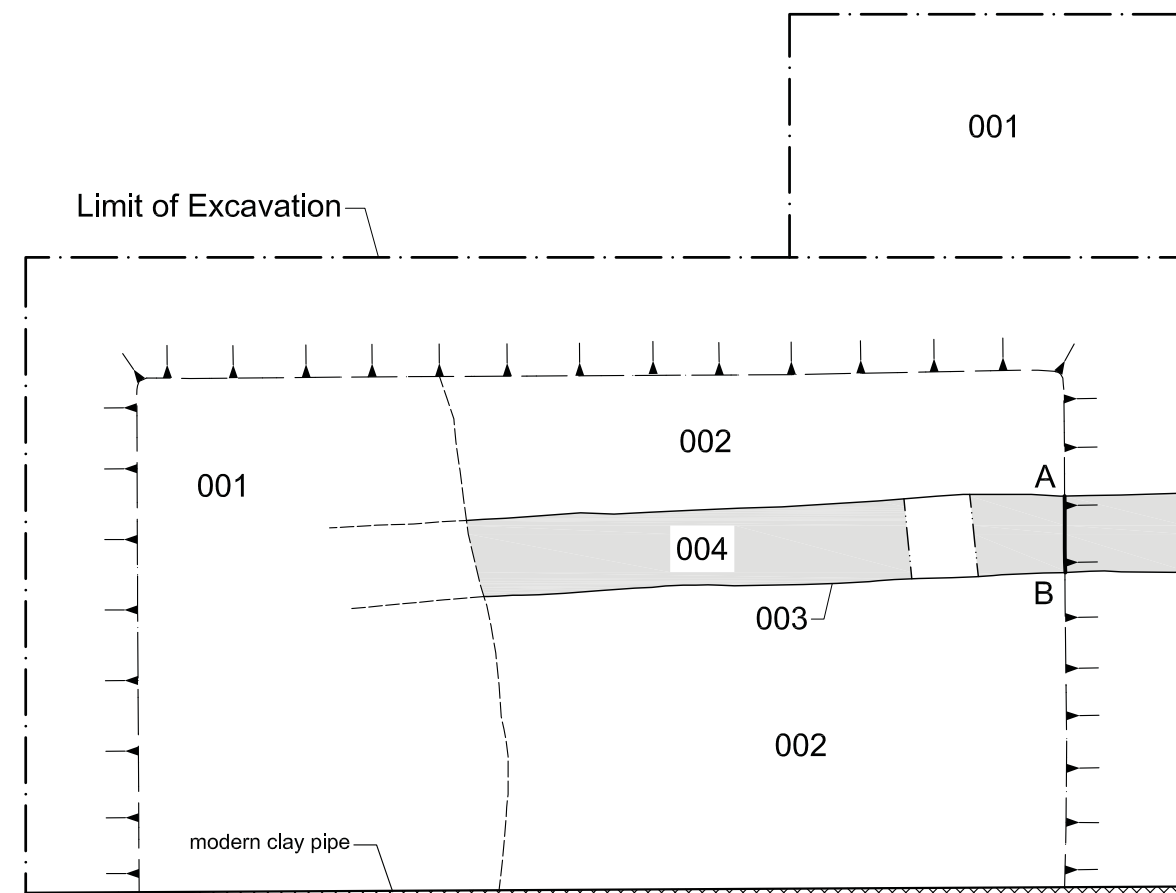
Fig. No: 5 Revision: A

Section through feature 003

Title:
Watching brief area following excavation
